The Heath & Hampstead Society

Planning Ref: 2021/5668/T
Address: Area to front of 1 - 5 Telegraph Hill London NW3 7NU
Description: AREA AT FRONT: 1 x Oak (Quercus sp.) (T1) - Crown reduce by 3m to suitable growth points, prune to clear streetlight by 2m. 1 x Oak (Quercus sp.) (T2) - Crown reduce by 4m to reduce over hang to footpath and road. 1 x Oak (Quercus sp.) (T3) - Crown reduce by 2m to reduce over hang to footpath and road.
Case Officer: Tree Team
Date: 11/12/2021

We wish to object to this tree Notice of Intent.

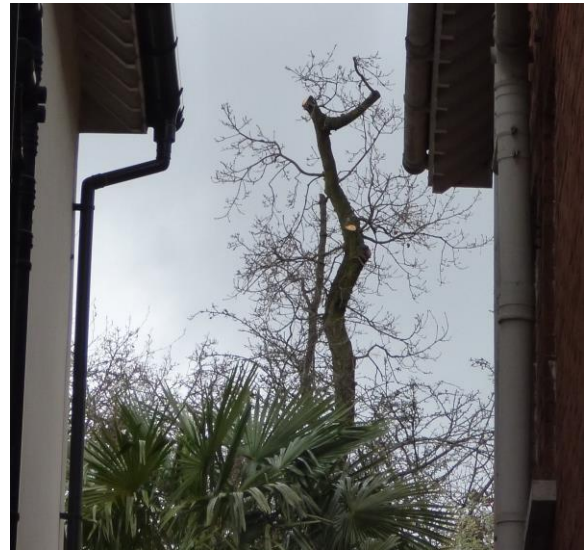
- i) Dead branches from retrenchment in veteran oak trees^{1,2,3} take a considerable time to detach or break, some about 100 years before falling. The proposed work would produce an extremely ugly outcome (see photo on the right of a veteran elsewhere that had its deadwood removed back to live wood) and is overkill.

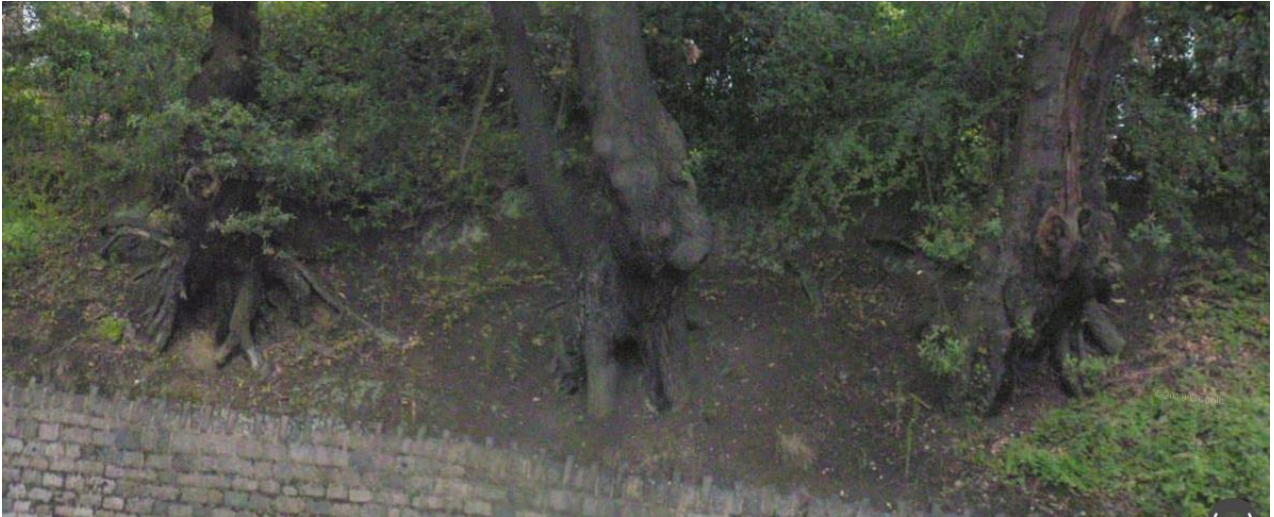
Google Street View August 2008

We suggest the proposed work to the trees is too extreme. If the deadwood is cut out AND the crowns are reduced by 2-4 metres, this will virtually remove the trees and produce an extremely ugly result. Comparing the canopies between photographs of 2007 and 2021 it can be seen that while the trees are increasing their canopies lower down after retrenching, this growth is very slow, which we suggest would be expected for veteran trees of well over 200 years old with root constraint from the retaining wall. We have considered: ‘Trees that tend to produce very large, failure-prone branches are relatively unlikely to have a prolonged ancient phase of life. Intervention in the form of tree work can sometimes extend the lives of such trees.’³ Since these trees are small and already veterans of a significant age, this is clearly not the case here.

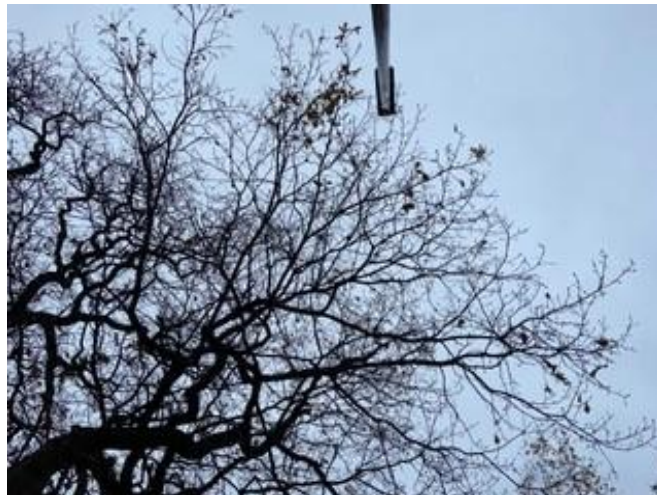
Current photographs (see below) of tree canopy in relation to the streetlight show that only a few leaves and young twigs could possibly touch it in a high wind. These cannot do damage to the light and there is no significant wood within growing distance that is likely to reach it either. Damage to the tree would only be to a few leaves which is probably less than the damage to the tree of removing the terminal branches that they are on. Consequently, we consider that “...prune to clear streetlight by 2m” is over-pruning and inappropriate for veteran trees. We suggest this can either be left until there is sufficient growth to warrant pruning, or limited to 1m from the streetlight or back to a suitable growth point, whichever is less.

Canopy reach to lamp post seen from below

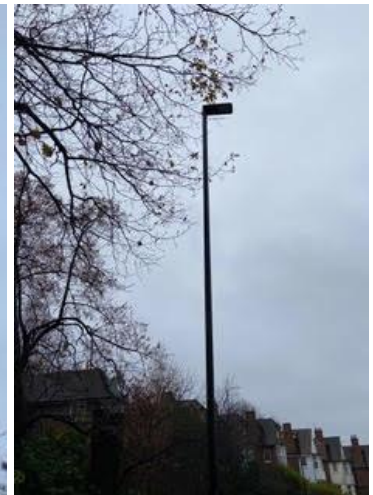
Canopy reach seen laterally
