BS5837 Arboricultural Impact Assessment

Maitland Park Estate, Camden, London, NW3 2EH

Client: London Borough of Camden

Job Reference: 03656R

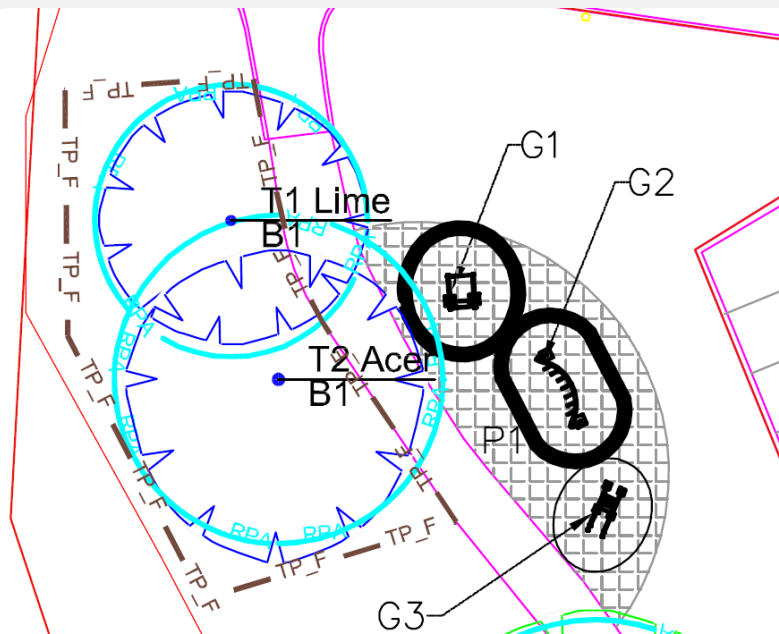
Surface Encroachment (T2)

- 5.5.1 No temporary surfaces are required and the surface installation within the RPA of T2 is minimal in terms of both its form of construction and level of RPA encroachment. The encroaching surface will be formed of Wet pour surface 80mm: Play top Rubber wearing course on 70mm rubber base, on 150mm Type 1 sub-base with a flexible aluminium edging, 150mm deep, pinned to type 1 foundation.

- *Minor encroachment into RPA of T2 (shown left)*
- *Protective fencing prevents any encroachments into remaining RPA but seeks to maintain footpath being open for use.*

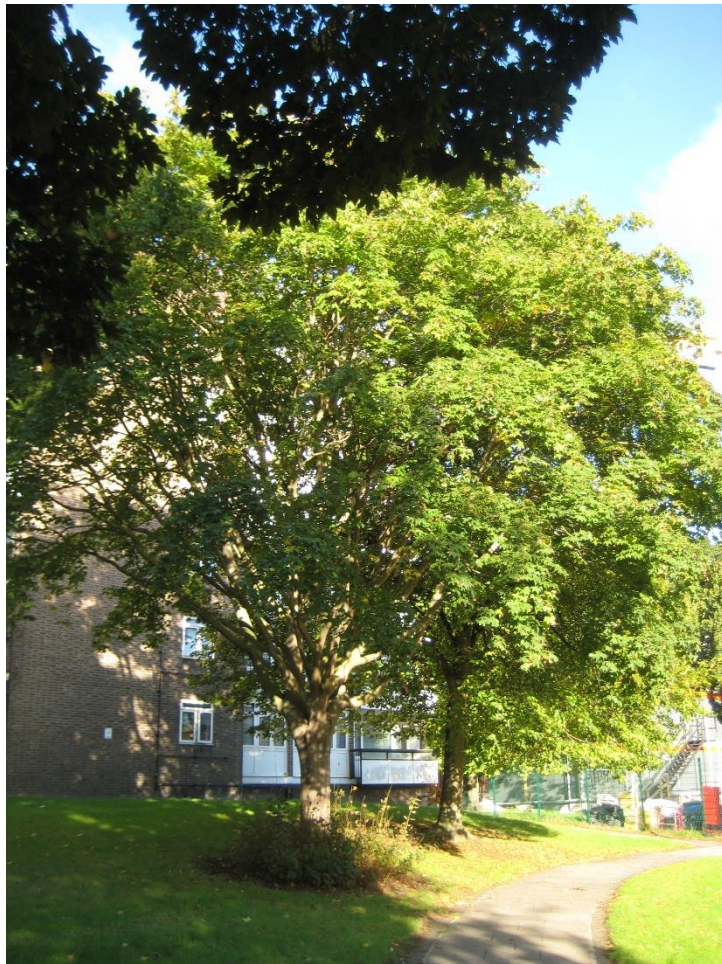
Image 2 – Looking north towards T2 & T1

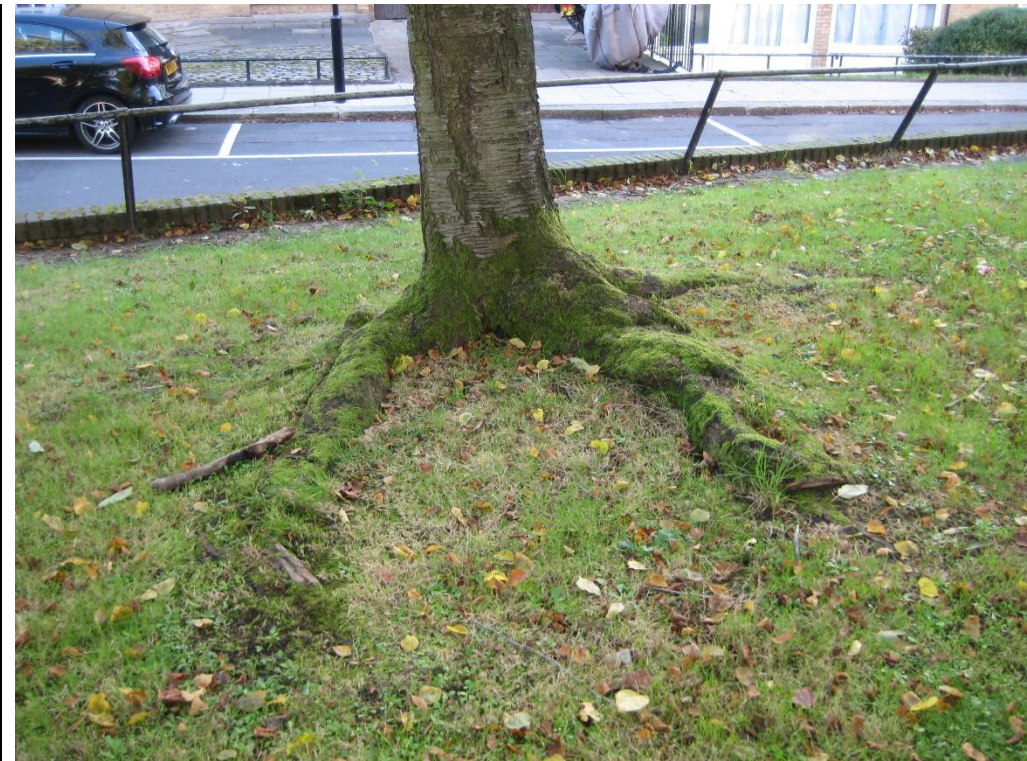
Image 3 –Surface rooting on the site Cherries (example)
