BS5837 Arboricultural Impact Assessment

25a Greencroft Gardens, London, NW6 3LN

Client: Mr M. Abdoula

Job Reference: 03694R

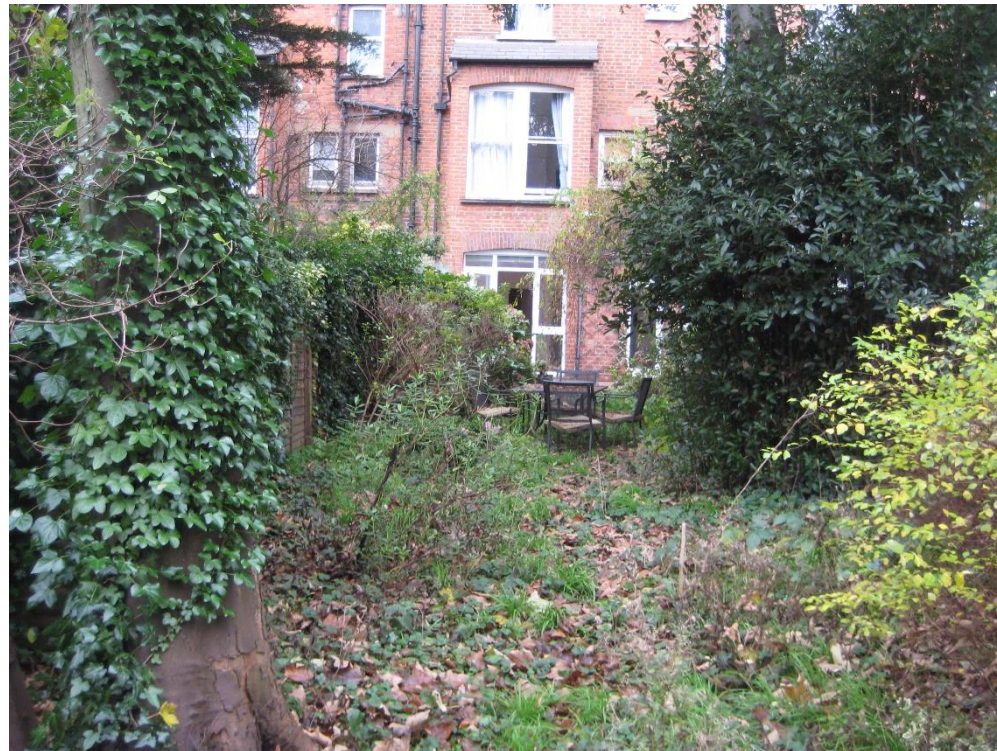
Fig 6 – Existing rear garden looking towards the proposal area.

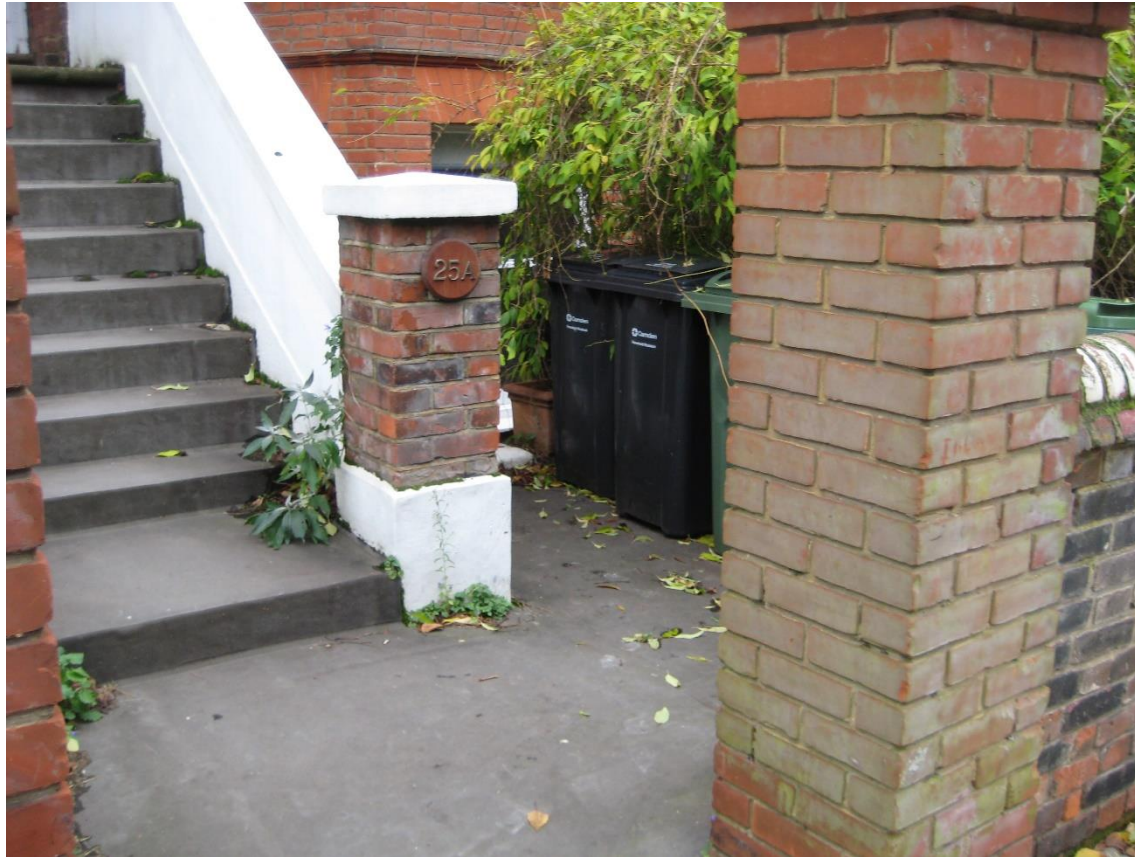
Image 1 – Existing access significantly limits machinery/ materials which can be brought on to site.
