# 32 Cubitt Street, London, WC1X 0LR

Design and Access Statement  
Planning Proposal for roof modification and repair

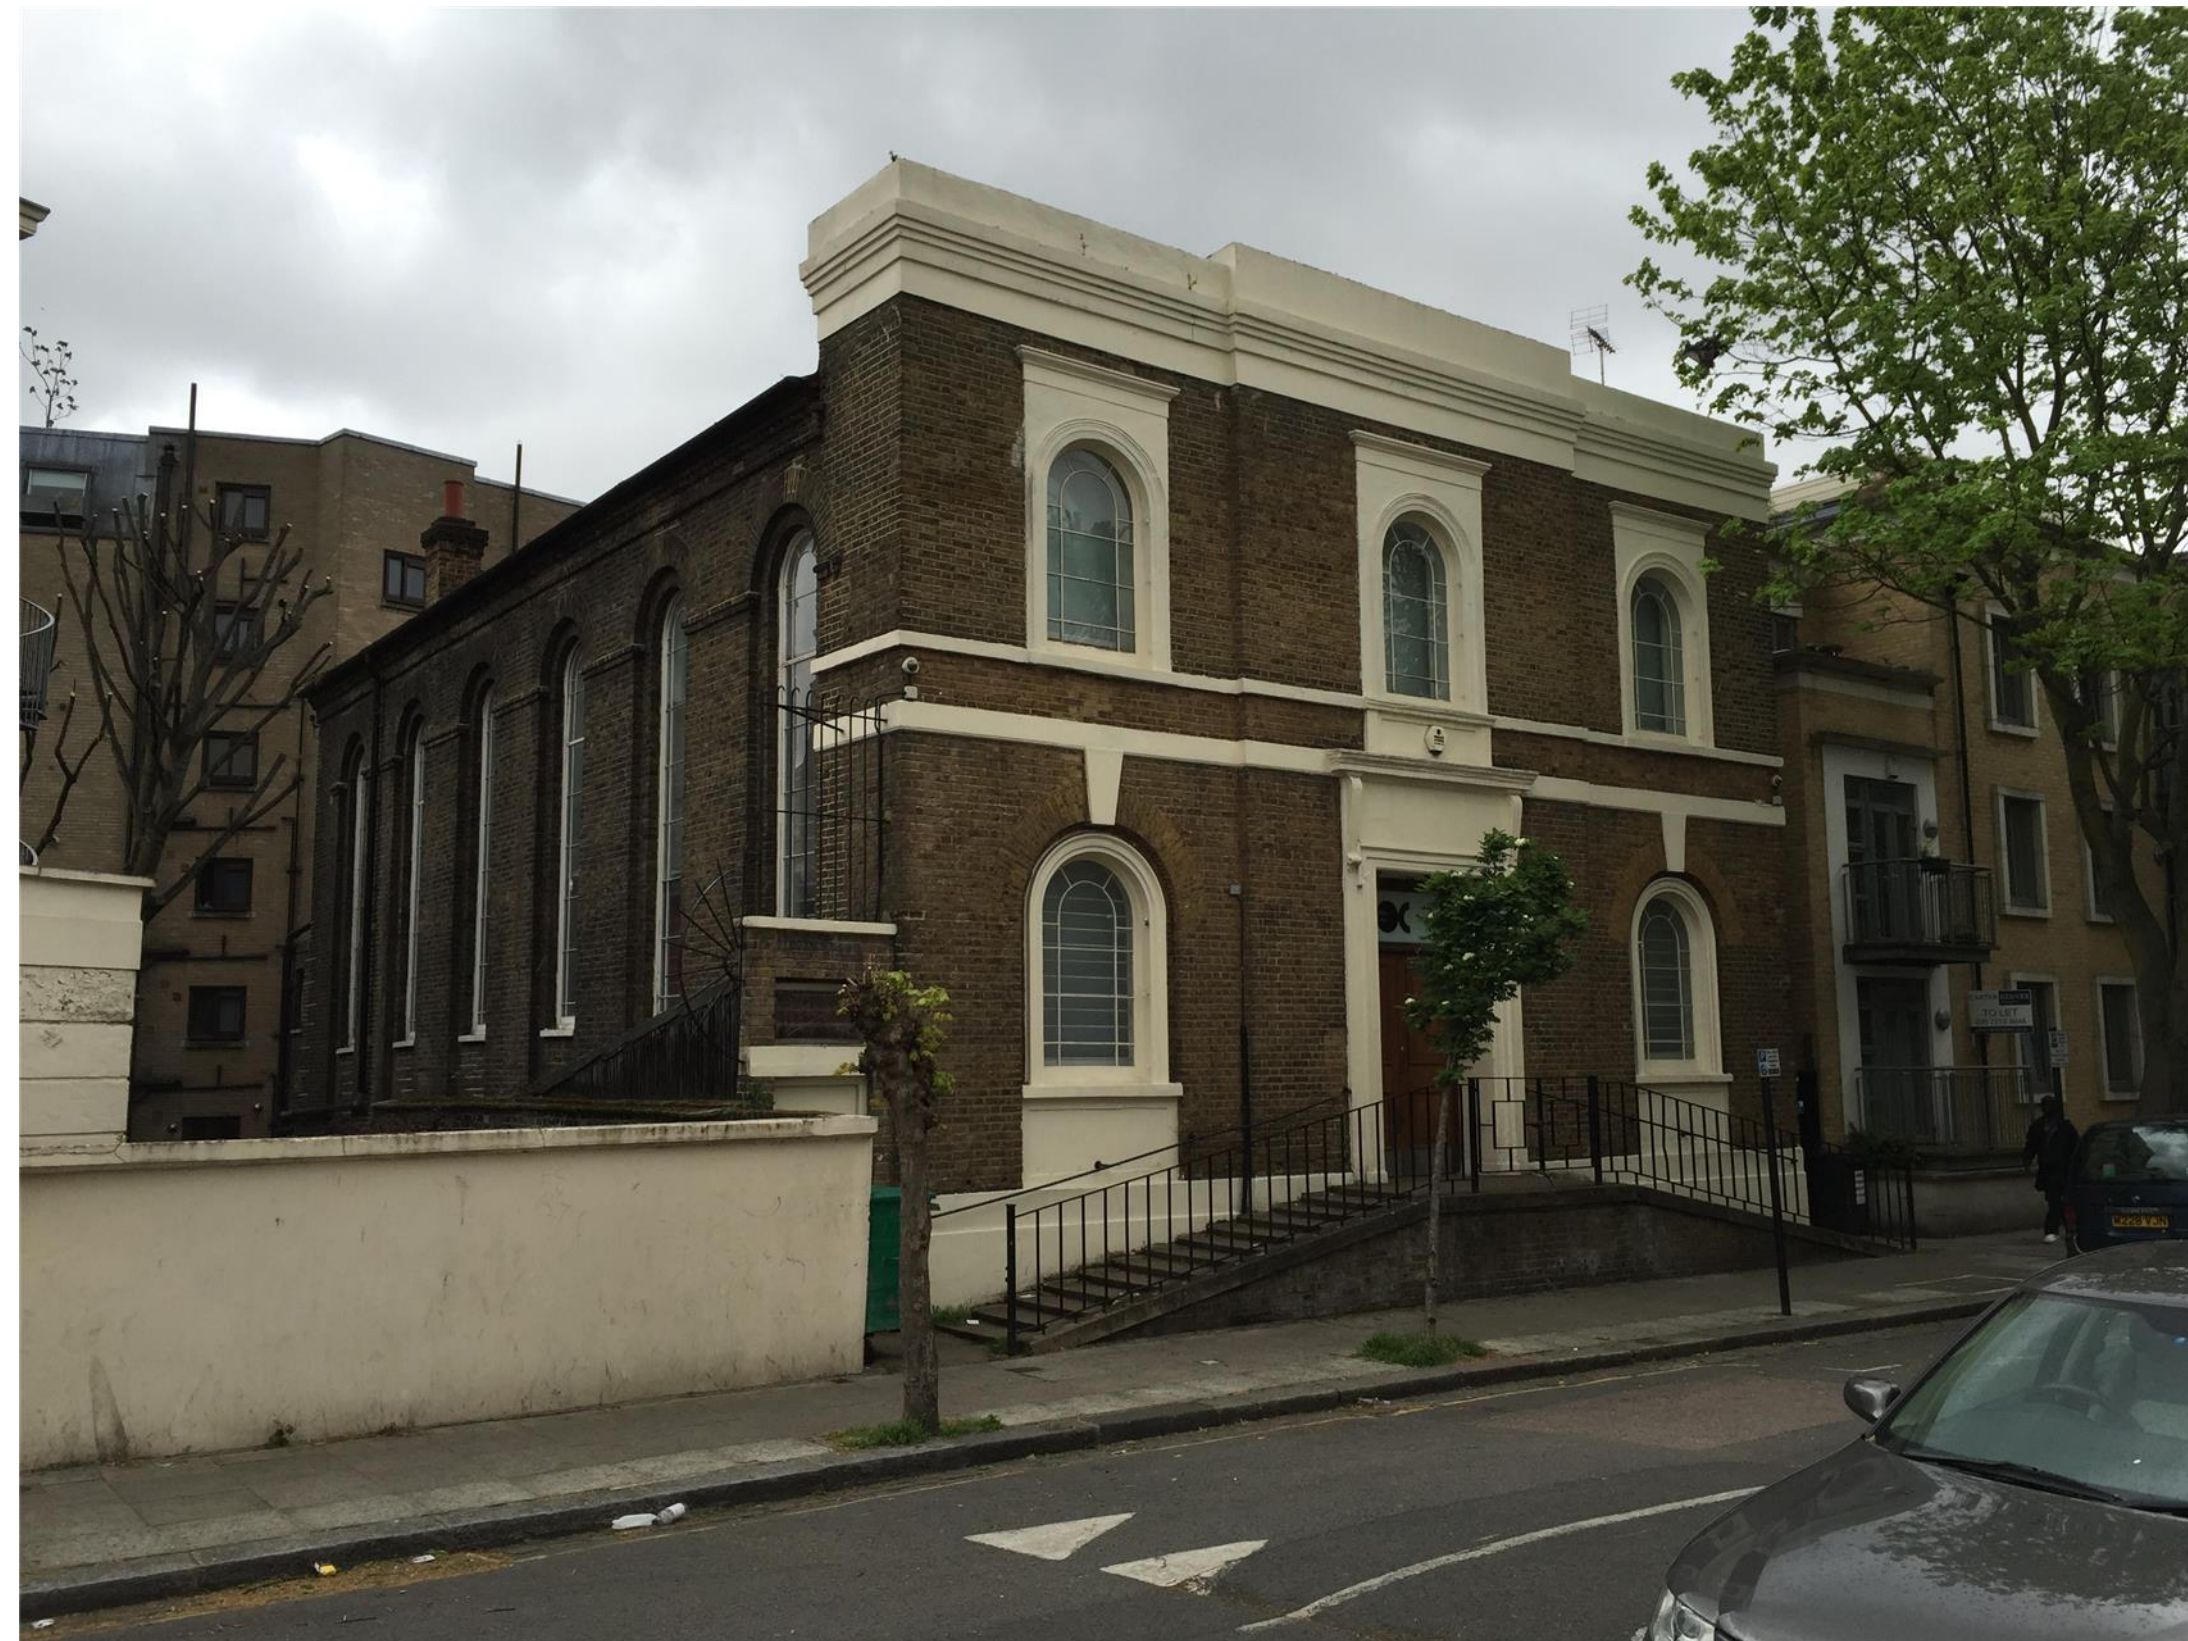
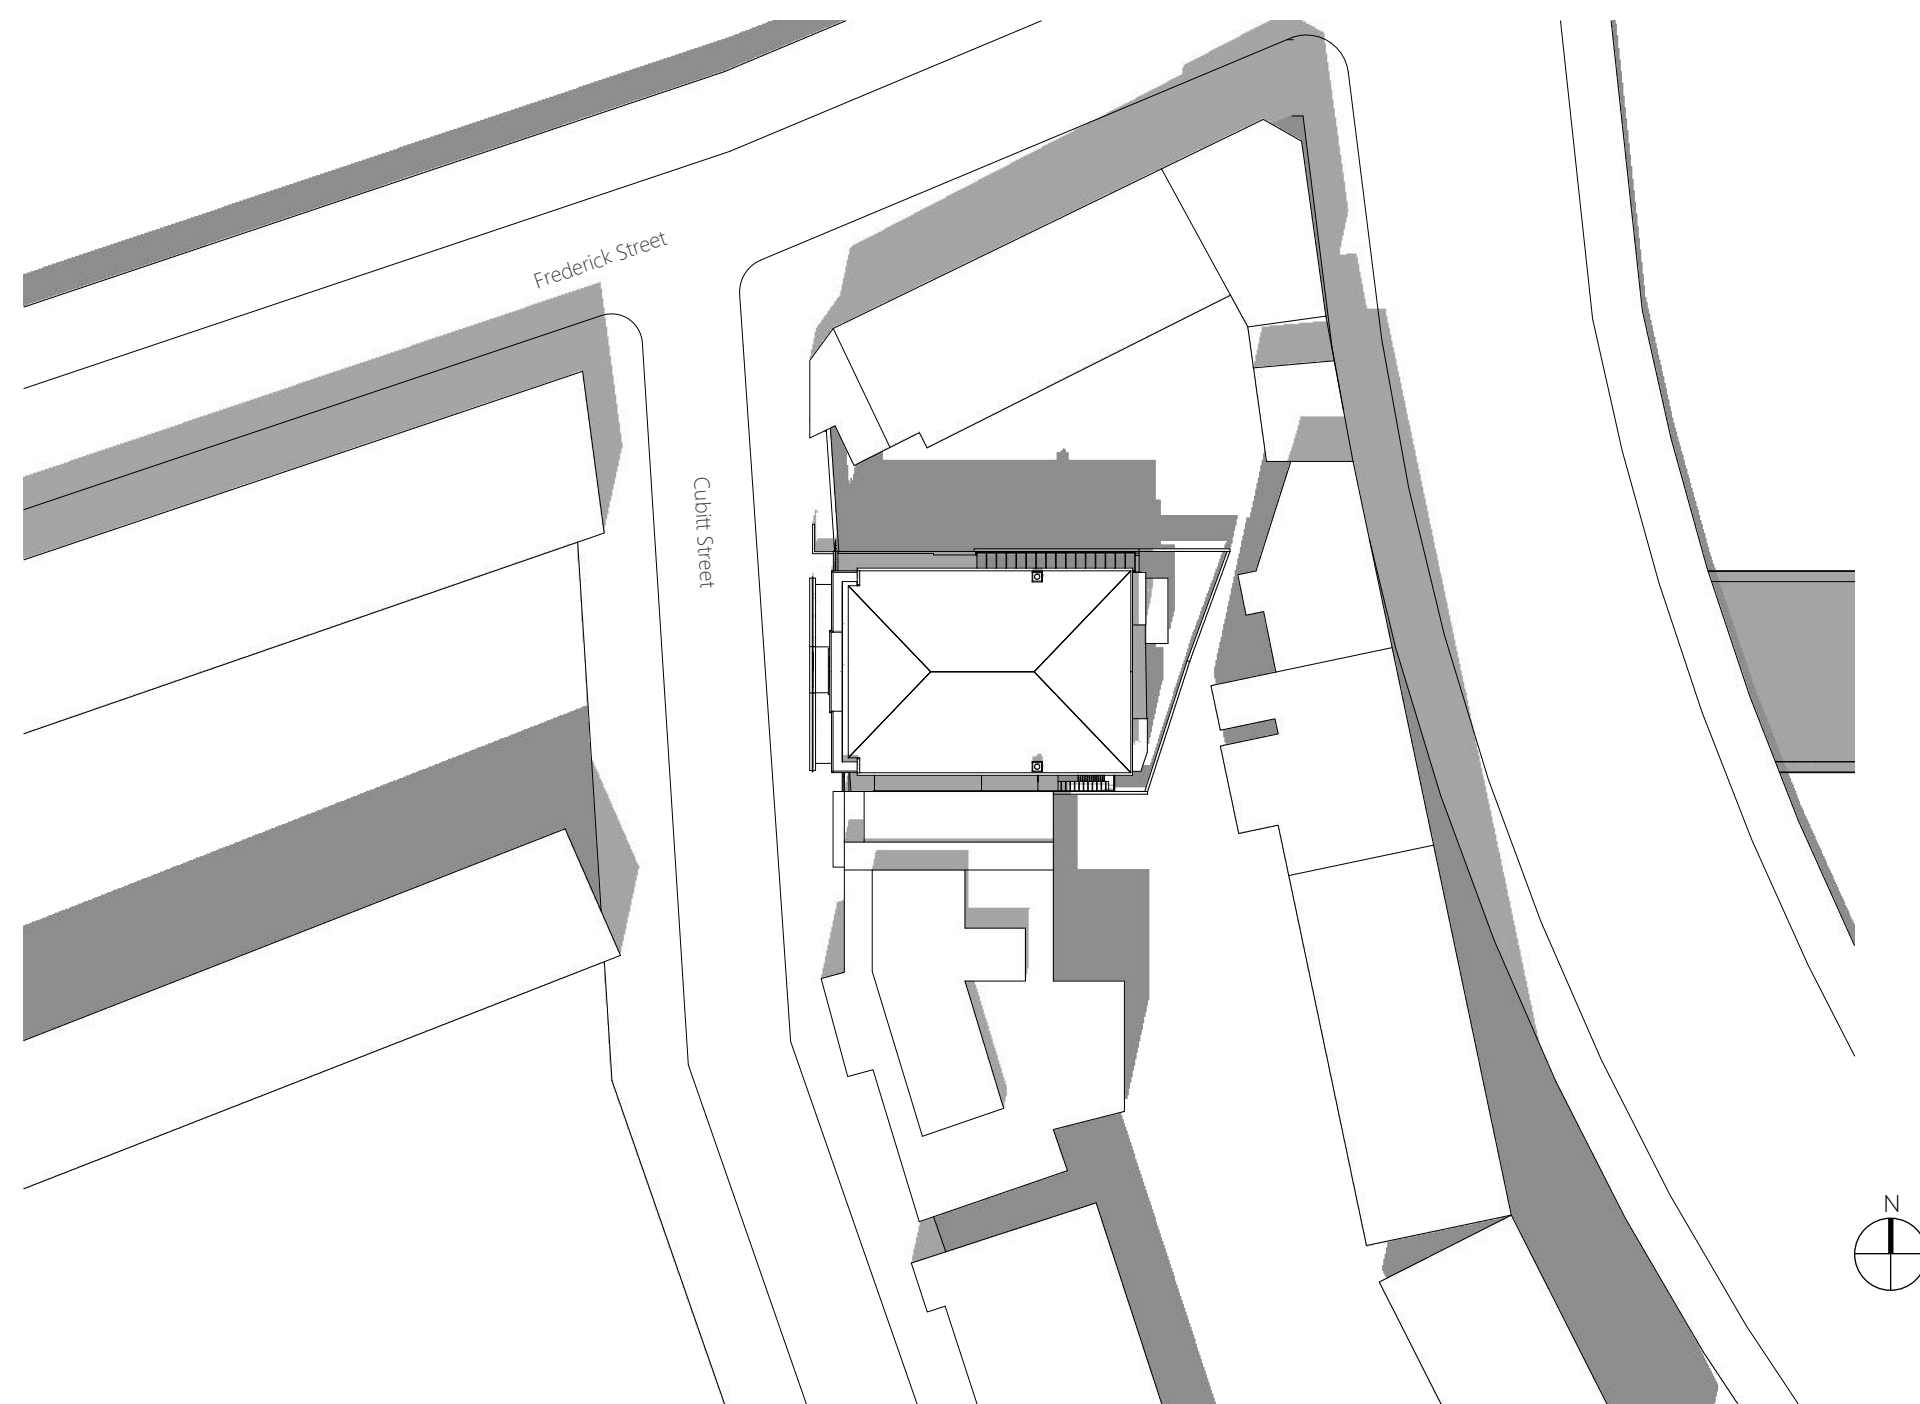
The problem occurs regularly and is caused by the falling leaves, seeds and branches of mature sycamore and plane trees in very close proximity to the building. The accumulated debris regularly causes blockages of the return gullies at each end of the box gutter. This causes rainwater to discharge more slowly than the gutter lining overlap can contain. Consequently, during heavy rain, the rainwater level exceeds the inboard edge of the liner allowing water to seep into the timber structure below and ultimately into the ceiling and plaster mouldings of the building's interior.

The existing western roof slope is predominantly original although the slates may have been replaced many decades ago. The condition of the remaining 'original' slates is generally poor with many showing signs of complete failure. Numerous repairs using modern fibre cement slates have been made over recent years to patch-up where original slate failures have become problematic.

The box gutter has been repaired and re-covered using some form of modern bituminous felt and waterproofing paint which is showing signs of failure at certain joints and stress points.

The proposal includes the installation of an access hatch into the western roof slope to facilitate safe and regular access to the gutter for clearing, maintenance and inspection.

The slates on the western roof slope will likely require replacement including new battens and felt. If any slates are reuseable, they will be salvaged and refitted. Further investigation of the existing sarking will be undertaken during the installation.

The box gutter needs replacing and it is proposed that the existing covering layers of lead, felt and waterproofing paint are removed completely to be replaced with a new liner.
