DESIGN AND ACCESS STATEMENT

CAPITAL WORKS PLANNING

ACTON STREET

CAMDEN

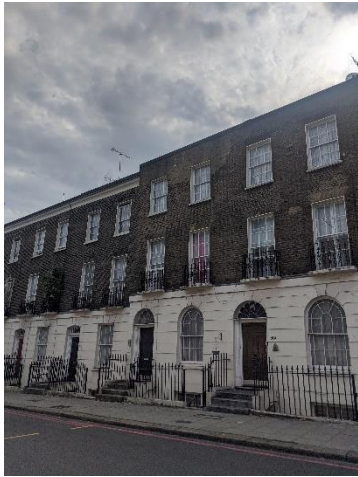
The external painted elements including windows, cills and cornice details on both the front and rear elevation have deteriorated over time with visible cracks evident. These elements are painted in magnolia and white. The brickwork also has visible damage, and they are in poor condition in some areas of the buildings. The proposed work includes for these to be repaired. Currently, both the yellow stock brickwork to upper storey's and the stucco render are affected by how busy the road is, with a layer of soot having discoloured the bricks and render over the years.

Figure 2: Existing painted section on front elevation

It is proposed that all previously painted surfaces will be improved by redecorating with a magnolia and white colour in a suitable paint considering the materials (as below). Where necessary we will be carrying out masonry repairs to brickwork and rendered sections to prevent further deterioration, which will be completed by a specialist contractor. Mortar repairs will be completed in accordance with the below material list, to ensure suitability for the scenario to be used.

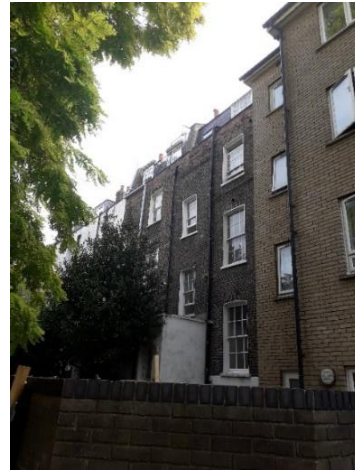
Figure 3: Existing brickwork sections on rear elevation

- Mortar Repairs – All brickwork mortar repairs will use a 3:1 lime-based mix as follows: 2 (Building Sand) : 1 (Sharp Sand) : 1 Lime. The lime part of the mix will be NHL 2.5 for lower level, less exposed areas, and NHL 5 for higher areas of the elevations and exposed areas.

- Brickwork – Brickwork will be sourced to match the existing with reclaimed yellow stock bricks where necessary. To the front the elevations are currently covered in a layer of soot from the congestion along Acton Street, where brickwork needs to be replaced, and the appearance does not blend with the adjacent brickwork, a mild soot wash will be applied to assist in the blending in.

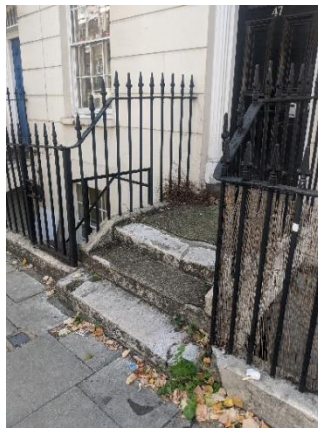
The properties currently have front entrance steps constructed up to the ground floor entrance that requires waterproofing. They are in very poor condition with visible cracks and splits. It is proposed, to retain the existing, suitably cleaned and repaired with concrete fillers. Where other finishes, such as tiles or bitumen, have been applied, these may be removed.

Figure 4: Existing front entrance steps
