18 Grove Terrace, NW5 1PH

Method Statements - Repair of Weatherstruck Repointing / Sample area

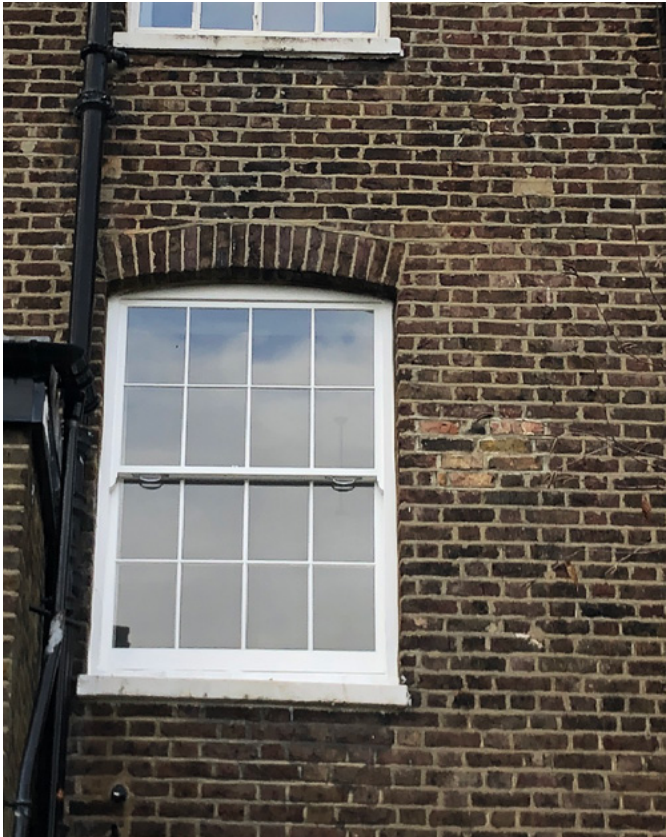
Images of rear exterior and existing pointing conditions - poor, weathered and dirty.

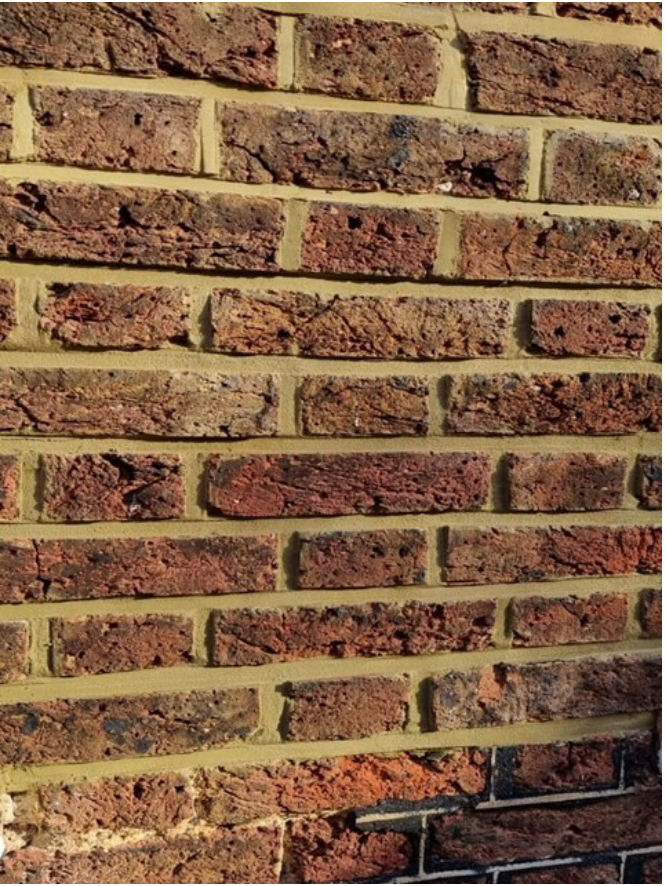
Sample of repointing on front facade with weatherstruck repointing - this is to be repaired using the following method statement.

The sample area was prepared with moderately hydraulic lime and well-graded sharp sand as per manufacturers recommendations.

The pointing used was a weatherstuck pointing.

The defective pointing will be carefully raked out manually using hooked tools or masonry chisels to a depth of at least twice the height of the joint. The mortar will be removed from the top and bottom of the joints leaving a square-cut joint. Dust and debris will be removed from the joints using brushes or even a vacuum cleaner and thoroughly rinsed with water so that no loose dry material is left. The masonry will be thoroughly dampened with a hosepipe with a spray nozzle or a pump-action water sprayer, before placing the mortar.

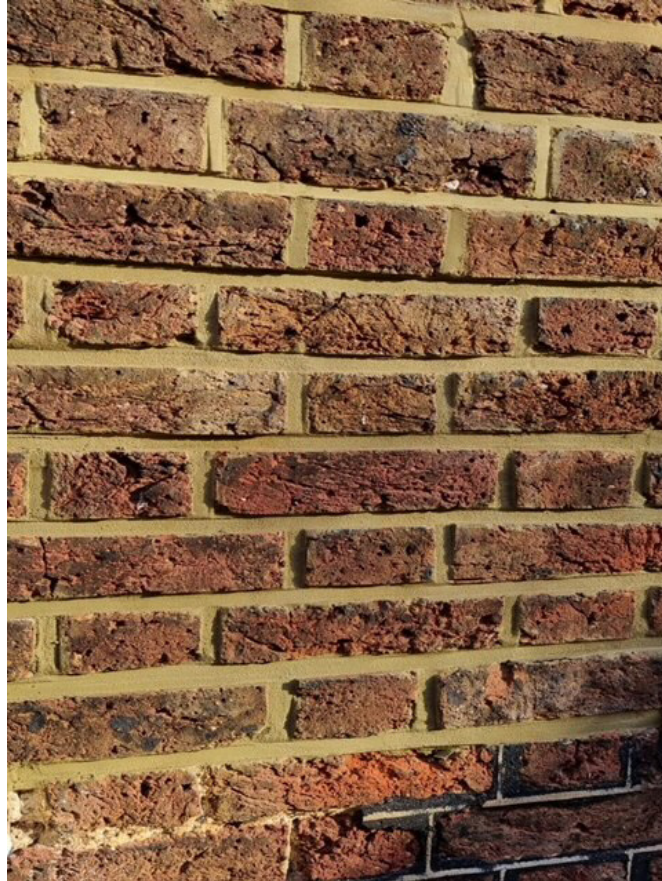
Sample of repointing on front facade with weatherstruck repointing - this is to be repaired using the following method statement and recessed pointing will be employed.

Mortar for repointing to comprise of moderately hydraulic lime and well-graded sharp sand as per manufacturers recommendations. The finished colour of the mortar will depend upon the sand used and samples must be prepared to ensure a good colour match to the existing mortar it replaces. Every effort will be made to match the mortar colour of the properties either side which are a true representation of what the original mortar would have looked like.

Repointing where specified, old mortar in the joints shall be raked out square to depth of not less than 15mm, to give an effective key. Extra care shall be taken where the old mortar is hard or tightly adhering, and with fine joints. On no account shall angle grinders or other power tools be used.

Where it is necessary to remove dense, strong mortar, it shall be cut out using a plugging or a claw chisel. After removal of existing mortar, joints shall be thoroughly cleaned and wetted immediately before filling.

In filling the joints the mortar shall be pressed well in to ensure maximum penetration, compaction and bond to the original bed. At the same time, it shall be kept well within the confines of the joint and never allowed to spread over the face of the brickwork.
