## **TREE DEVELOPMENT REPORT**

**(BS5837:2012 ARBORICULTURAL IMPACT ASSESSMENT)**

<b>OUR REFERENCE</b>	186723/PRO
<b>CLIENT</b>	Vita Architecture Ltd
<b>PLANNING AUTHORITY</b>	Camden Council
<b>SITE</b>	5a Parkhill Road, London, NW3
<b>SURVEY &amp; REPORT BY</b>	Mr Paul Roberts
<b>DATE</b>	3 <sup>rd</sup> February 2022

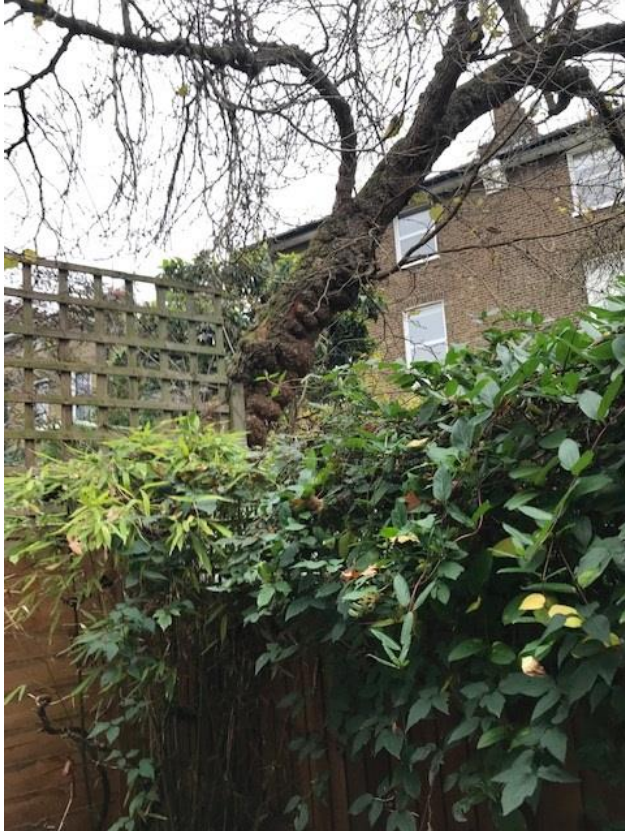
Photograph 1: Showing trees T1 and limb growing over development area to left of photo.

Tree ID	Species	Maturity	Category	
T1	Common Mulberry	Mature	B	Undertake selective branch removal on one branch which grows over garden room area.
T2	Strawberry Tree	Semi-mature	B	Prune back to boundary.

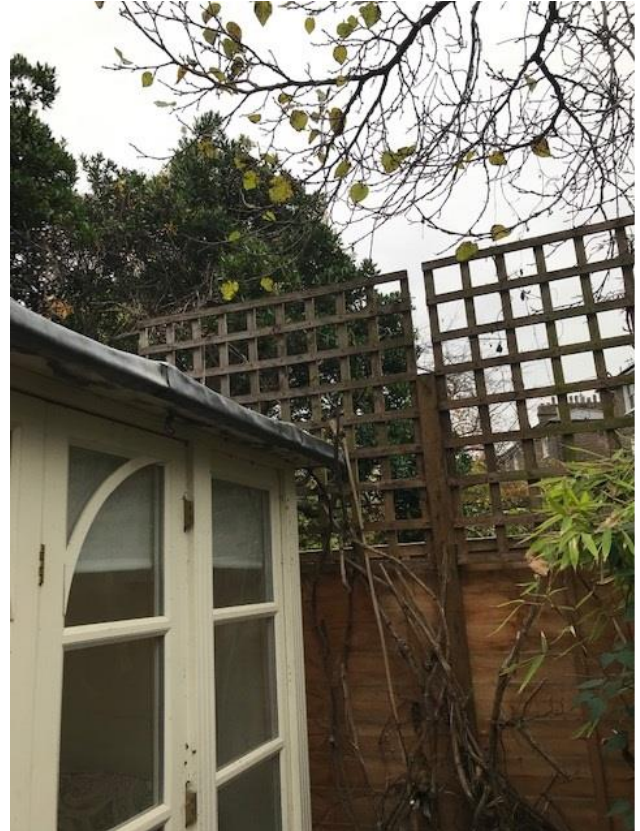
Photograph 2: Showing tree T2 behind fence.

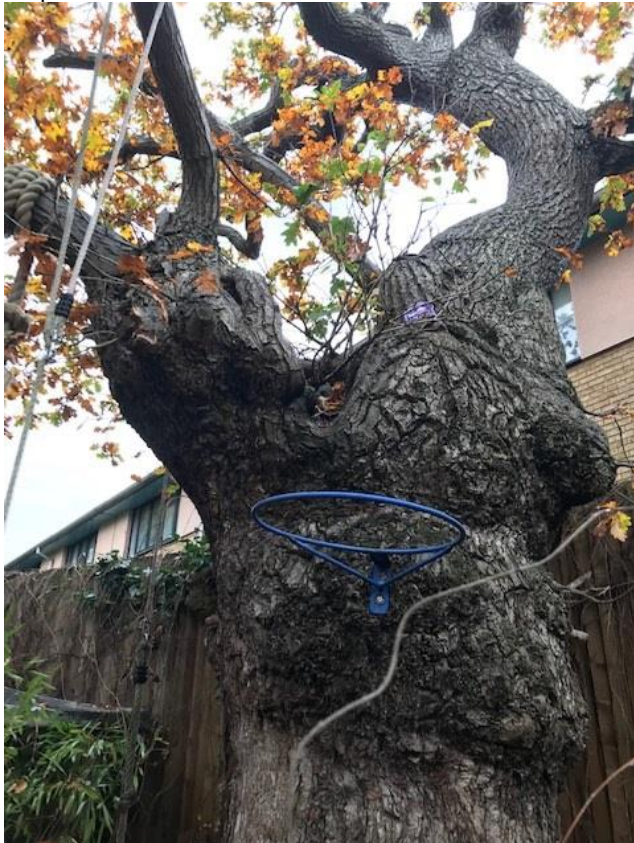
The survey has identified that there are no ‘A’ grade tree on site. However, tree T4 is a prominent Mature Oak located on the rear boundary in an area of existing hard standing. Full details of these trees can be found within the attached tree survey schedule.

Photograph 3: Showing section of T4 (tight access prevented full photo of tree).

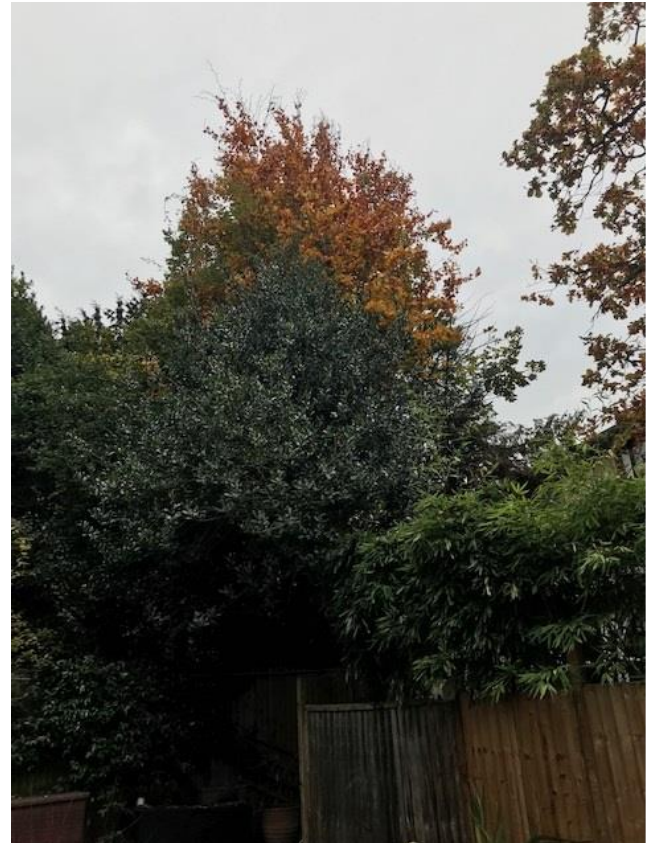
Tree ID	Species	Maturity	Category
T8	Common Holly	Semi-mature	C

Photograph 4: Showing section of T8 (holly) to be removed with further trees behind.
