### Hutton + Rostron Environmental Investigations Limited

# 55 Cumberland Terrace, Mews: Timber condition investigation

Site note 1 for 25 June 2021, job no. 154.11

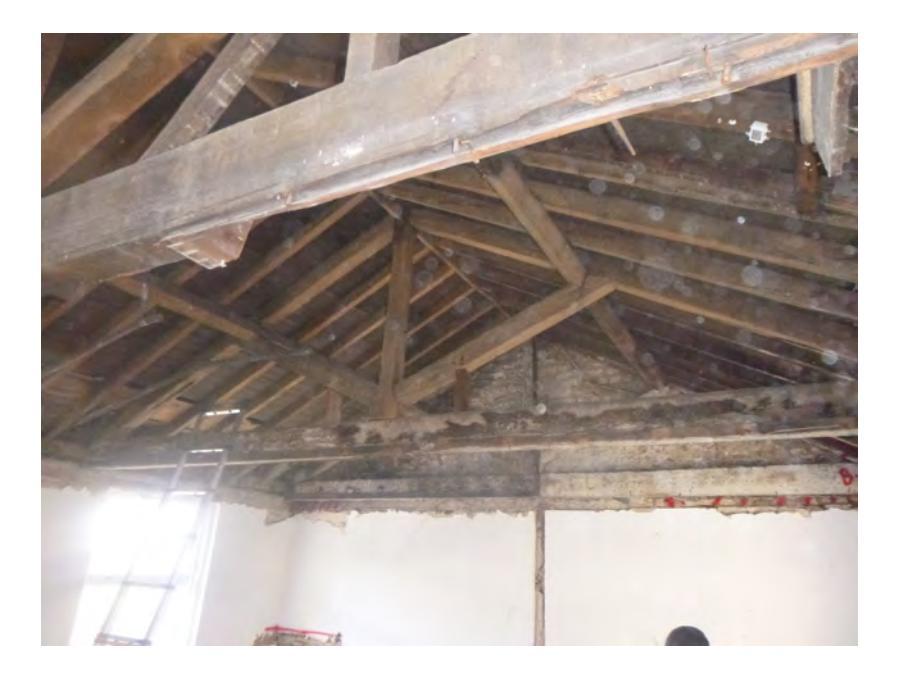
### Fig 1:

Roof structure; showing general view of roof structure construction

Note 4 no. east to west spanning kingpost trusses bore onto tie beam plates at the wall head

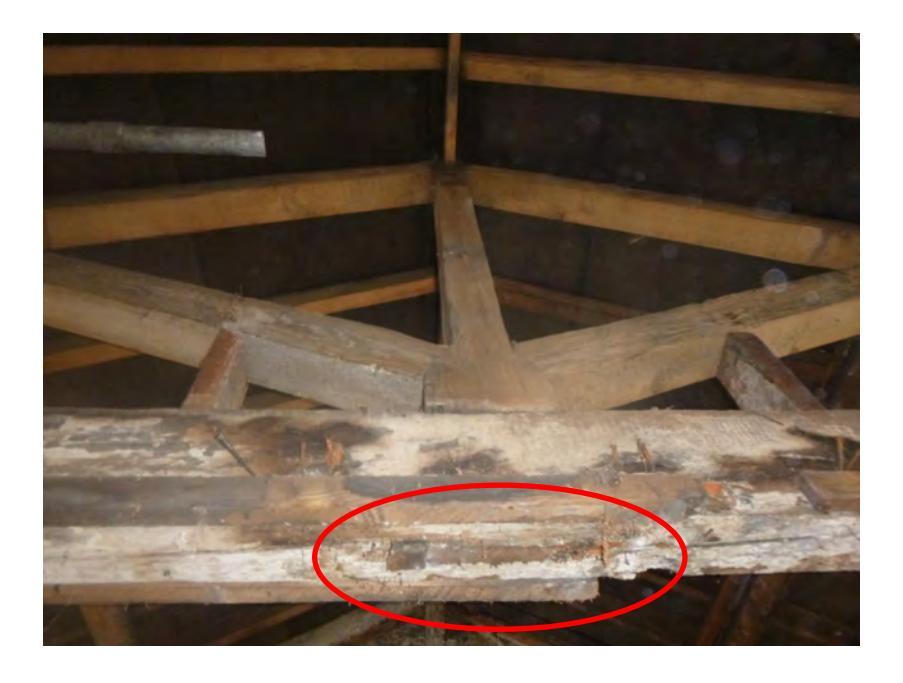
### Fig 2:

Roof structure; showing through tenon kingpost secured by wedge from the underside

Note this is a fairly rare joining technique not often seen. Also note wedges appear to be loose at the time of survey and should be re-secured upon future refurbishment

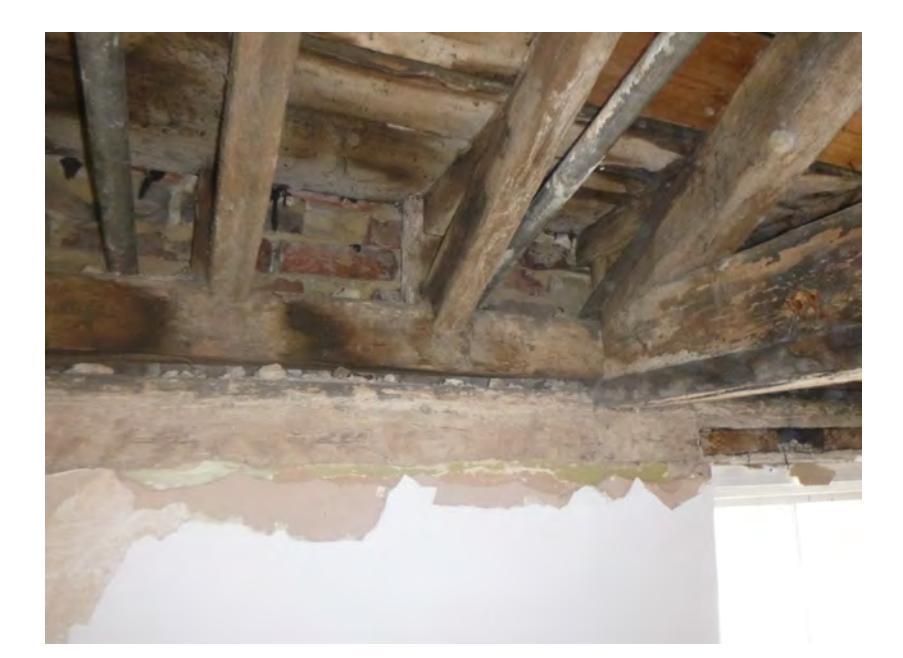
### Fig 3:

Roof structure; showing general constructional nature of eaves. Note all rafters and wall plates were not embedded in masonry. The tie beam plate ran across the building perimeter with the rafter plate above on wedges to provide ventilation beneath

Common rafter feet bird's mouthed onto rafter plate with parapet gutter joints secured to the masonry above supporting parapet gutters to the east and west

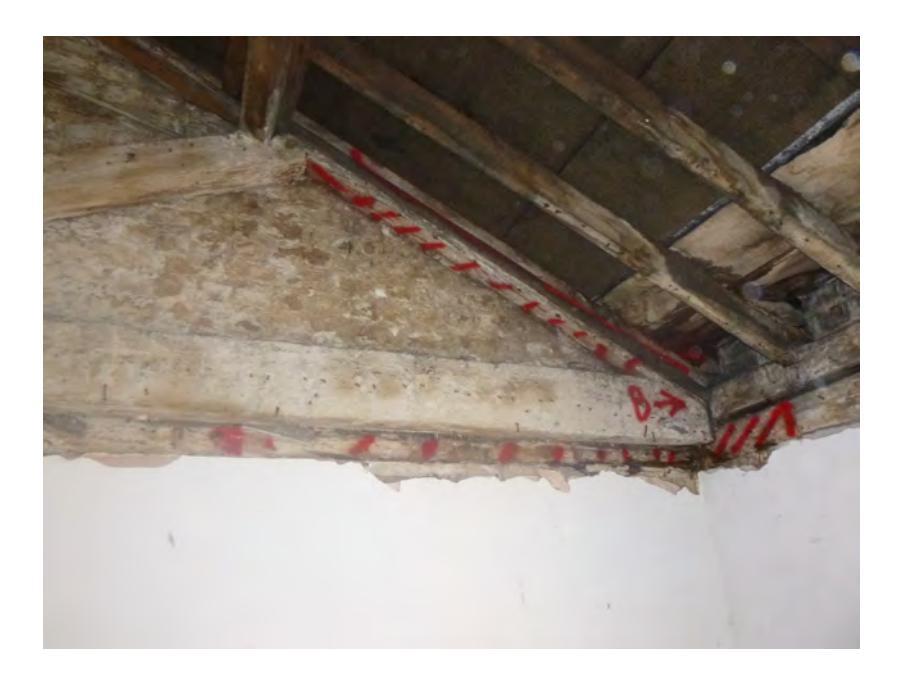
### Fig 4:

Roof structure; showing south west corner. Note structural decay was detected to embedded timber plate within southern gable as well as the southern bearing end of the western tie beam plate

Also note structural decay to the western bearing end of the principal rafter as well as the tie beam within the wall pocket. Note structural decay appeared to be historic and surface and deep moisture contents were below the threshold for decay to be active at time of survey

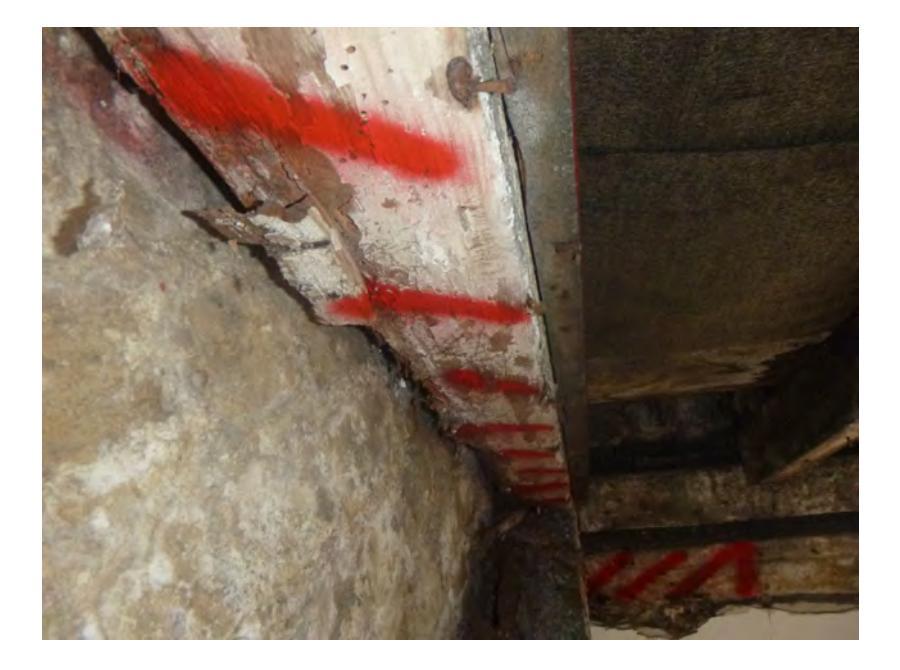
#### Fig 5:

Roof structure; showing evidence of historic wood boring beetle activity to principal rafter to the south west corner causing significant structural decay

Also note surface and deep moisture contents were below the threshold for beetle activity to be active at time of survey

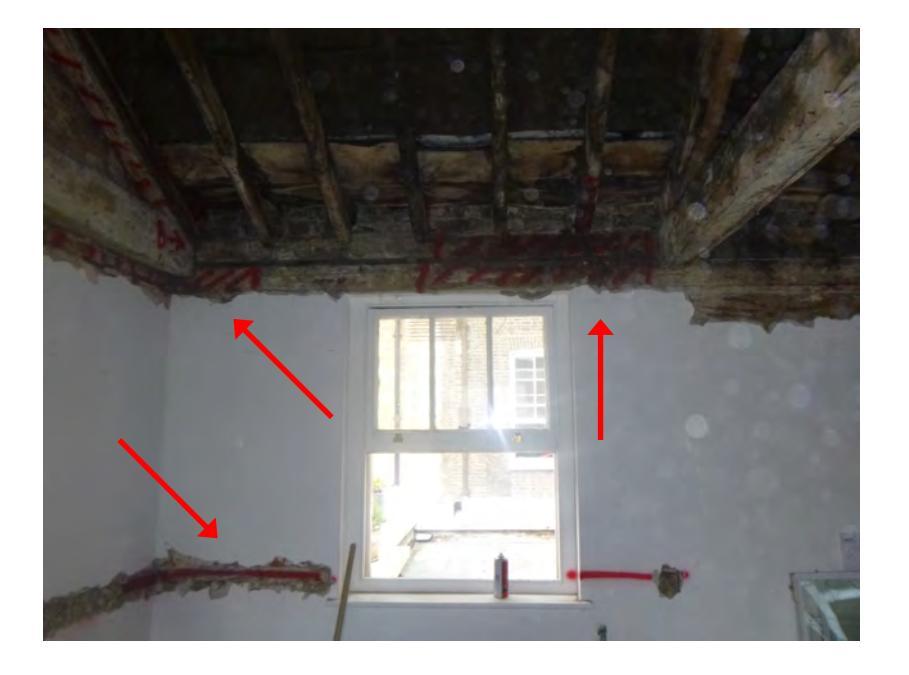
### Fig 6:

Roof structure; showing structural decay to both tie beam and rafter plates to the south west. Note structural decay was also detected to several parapet gutter joists as well as the bearing end of at least 1 no. rafter foot

Also note structural decay detected to bonding timbers at dado level below historically damp affected areas

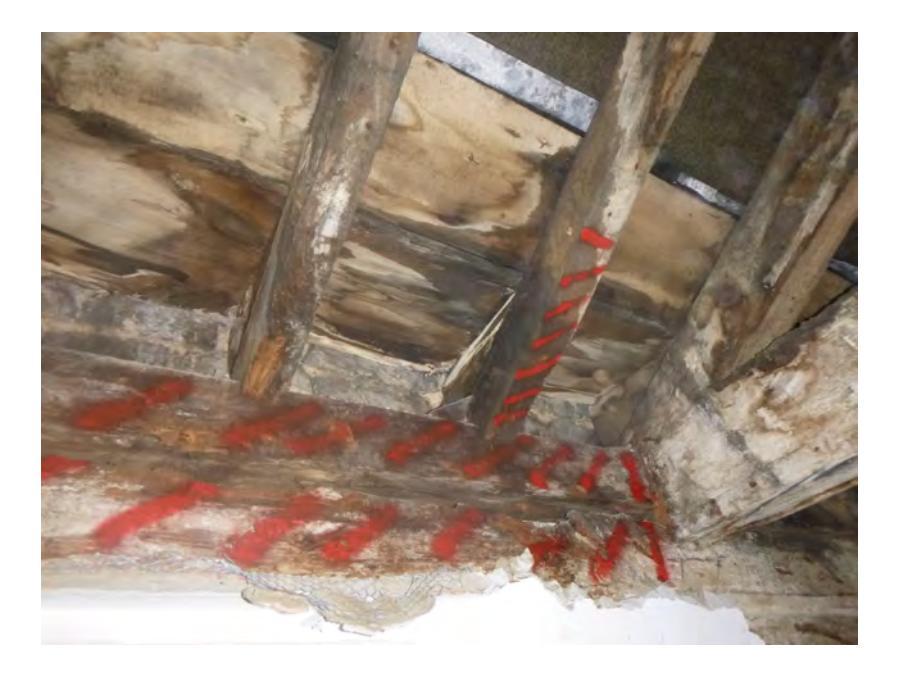
#### Fig 7:

Roof structure; showing buckled area of parapet gutter boarding due to failed/ defective parapet gutter linings above. Note an elevated surface moisture content was detected in this area to timber elements suggesting continued issues of water penetration in the area

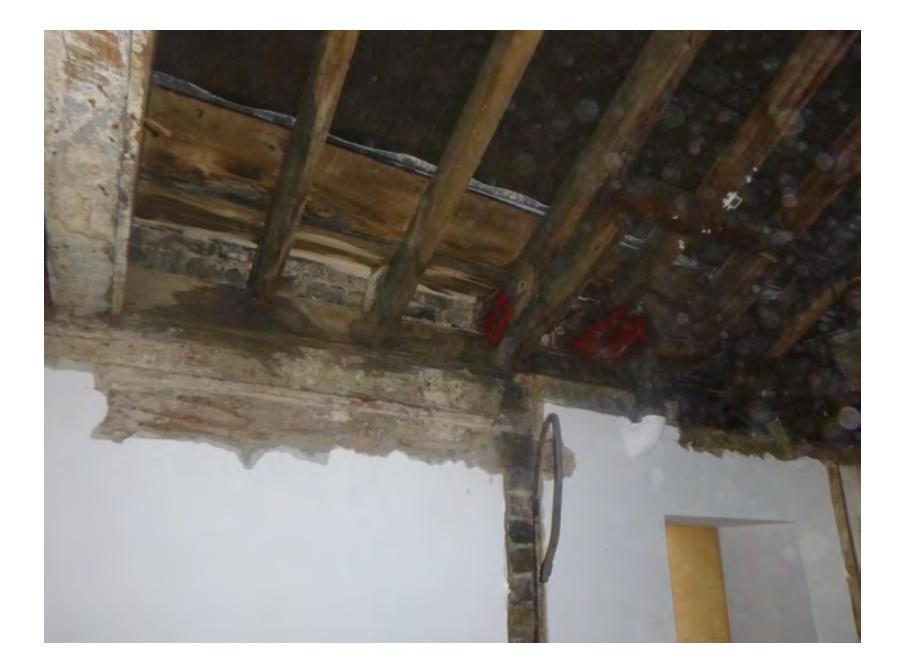
### Fig 8:

Roof structure; showing localised decay to at least 2 no. rafter feet at the centre of the west pitch due to historic failures of parapet gutter linings above

Note deep moisture content was below the threshold for decay to be active at time of survey though timber elements remain vulnerable to future decay as long as roof finishes and gutter linings above are not repaired

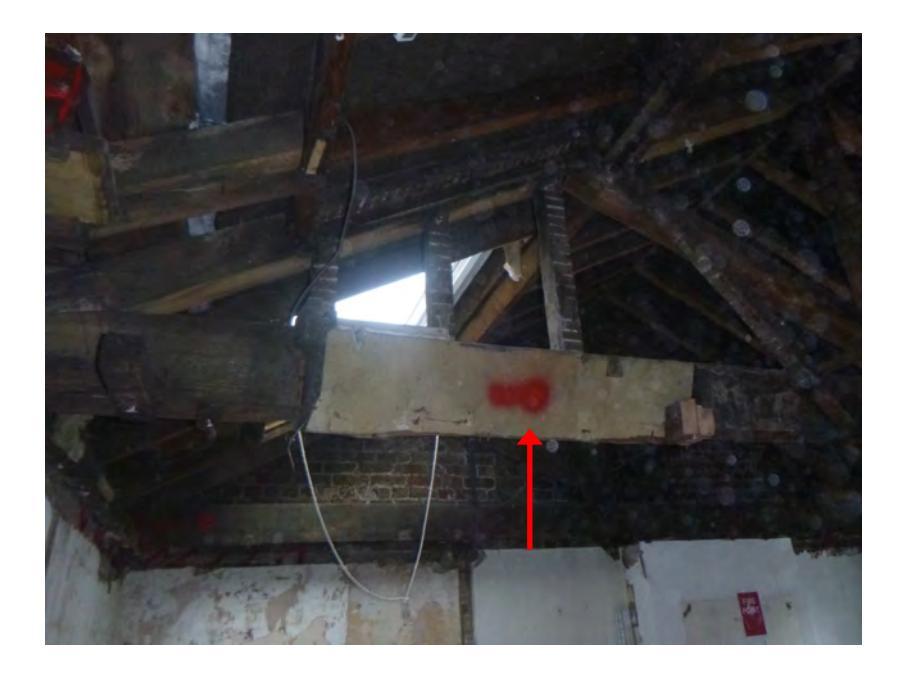
### Fig 9:

Roof structure; showing western end of tie beam 3 towards the north west corner. Note structurally significant notch to the west side of tie beam meaning the tie beam may no longer be structurally adequate

Also note tie beam was scheduled for removal upon refurbishment to be replaced with steel framing elements

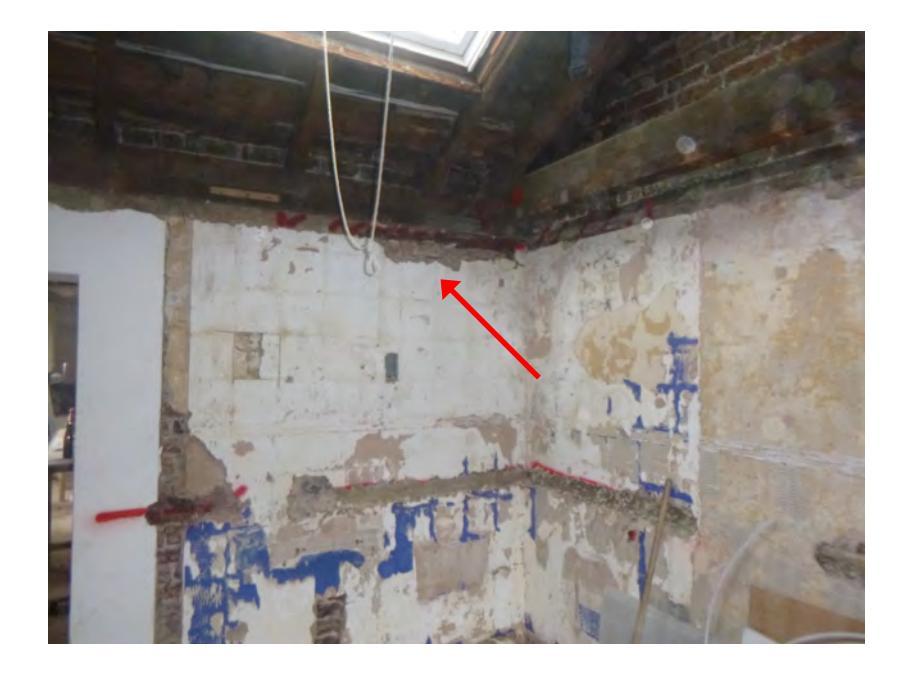
### Fig 10:

Roof structure; showing general view of north west corner. Note significant structural decay to tie beam plate and embedded plates within northern gable due to historic water penetration

Also note structural decay to western bearing of tie beam where embedded in historically damp affected masonry

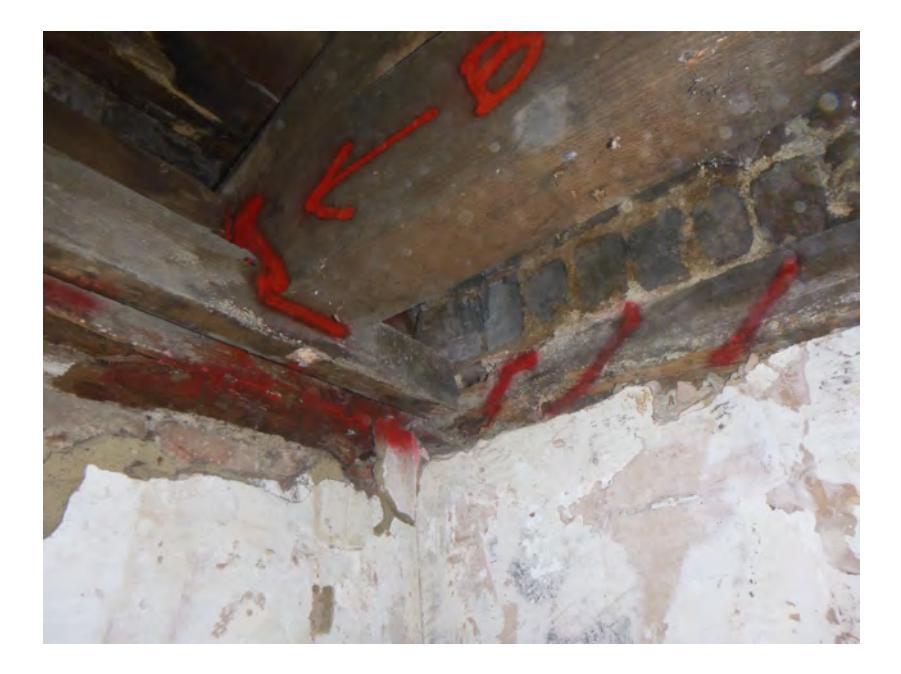
### Fig 11:

Roof structure; showing extent of structural decay to plate elements within the north west corner. Note surface and deep moisture contents were elevated within the west side of the northern gable leaving timber elements vulnerable to further decay

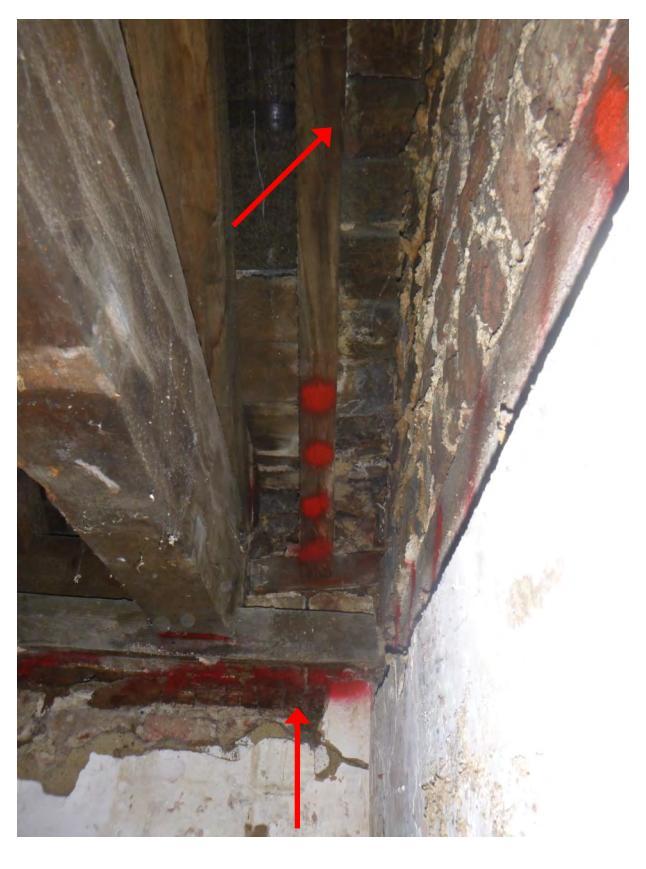
### Fig 12:

Roof structure; showing northernmost rafter within the western pitch. Note rafter was not adequately supported at its bearing and adjacent masonry within the north gable appeared loose

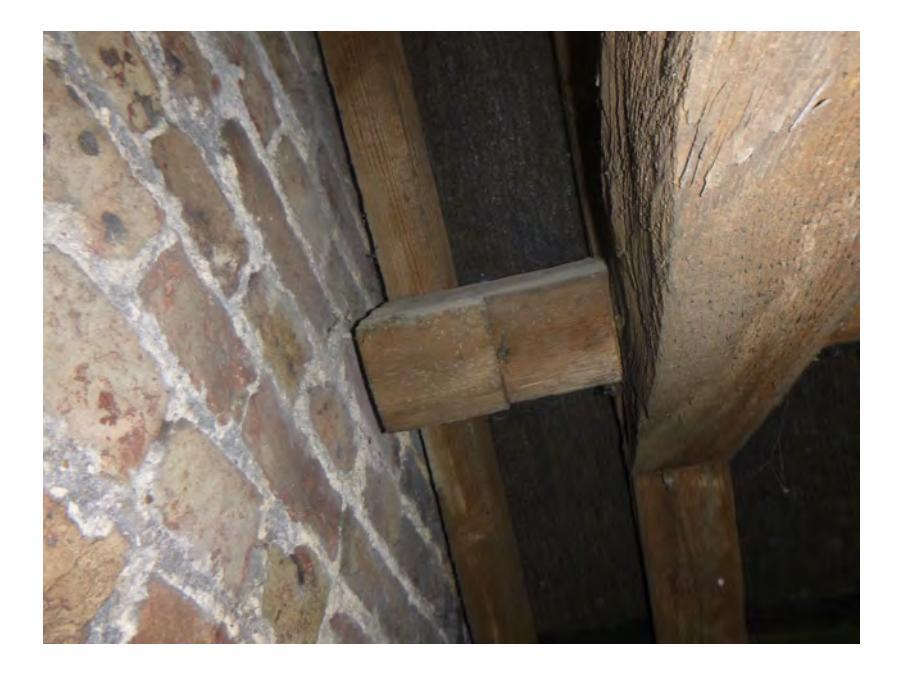
#### Fig 14:

Roof structure; showing general constructional view of purlins which did not bear directly into the north or south gables but were supported at their bearing by the raking struts of the northern and southern kingpost trusses

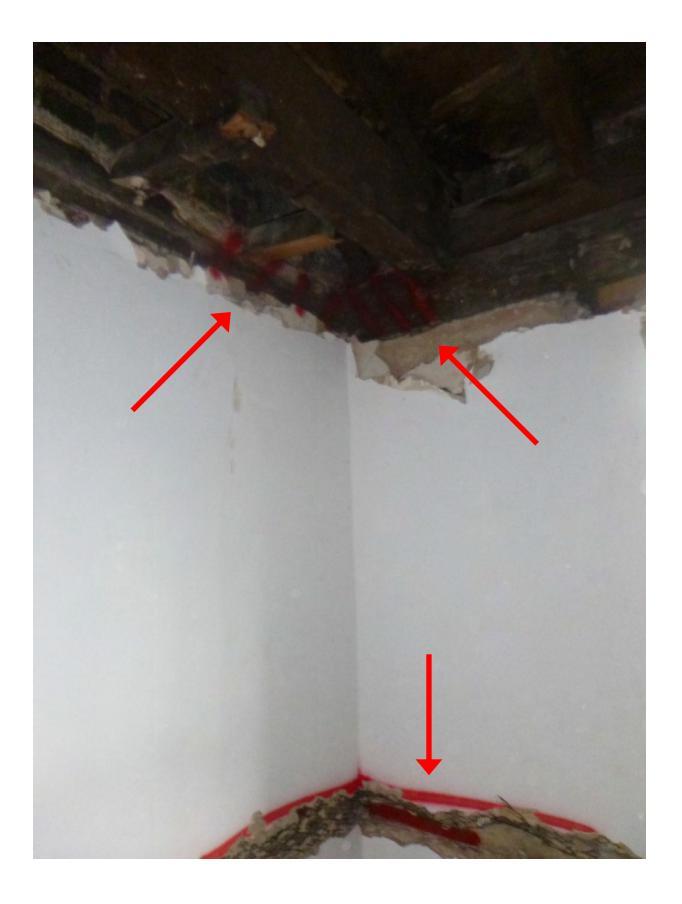
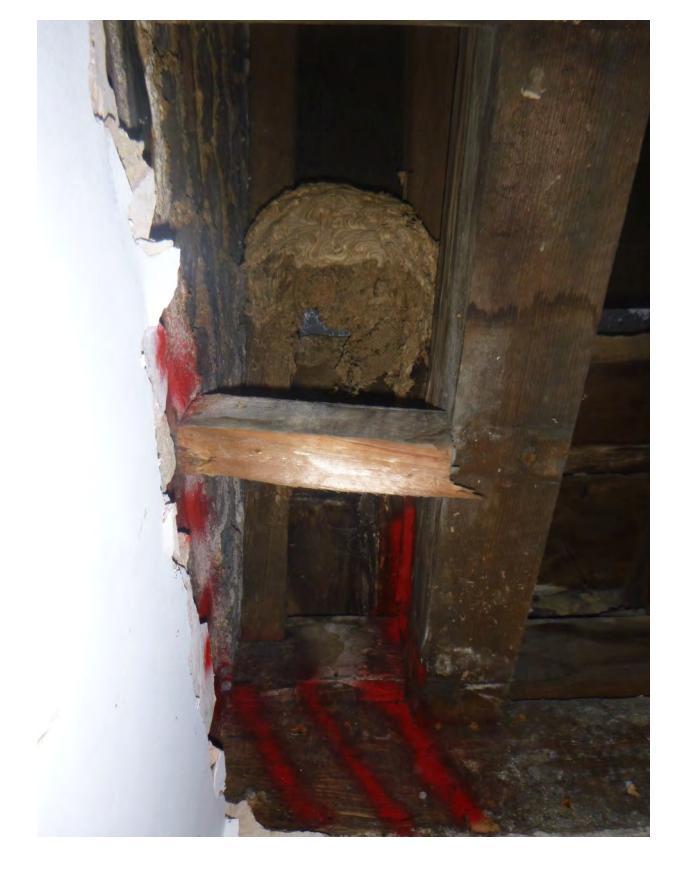
#### Fig 15:

Roof structure; showing general view of north east corner. Note structural decay was detected to the tie beam plate to the north as well as the eastern end of the embedded wall plate of the northern gable

Also note structural decay to north bearing end of bonding timber at dado level below

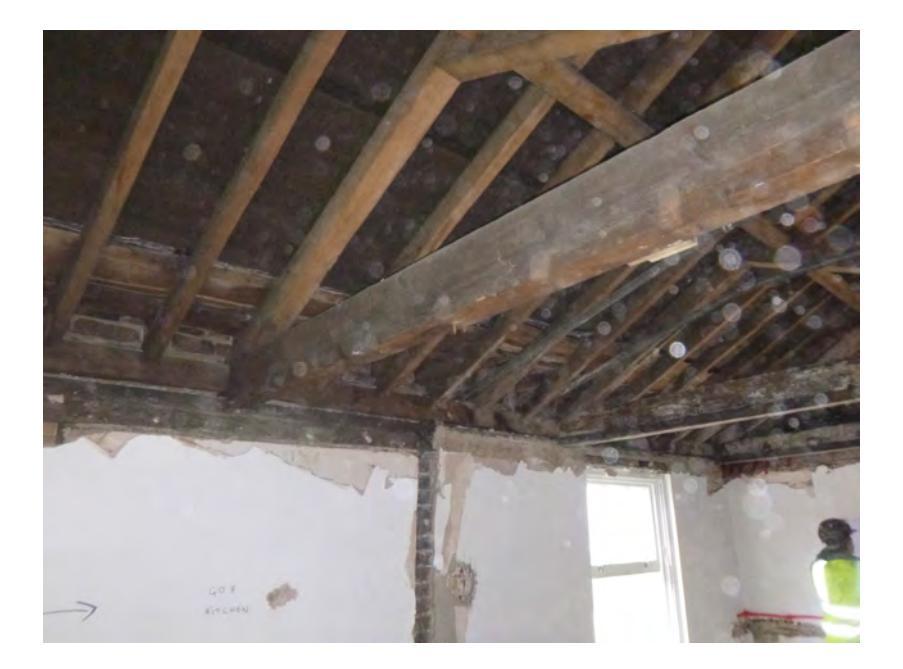
### Fig 17:

Roof structure; showing general view of eastern pitch looking south. Note timber elements were generally free from structurally significant decay and surface and deep moisture contents were below the threshold for decay to be active at time of survey

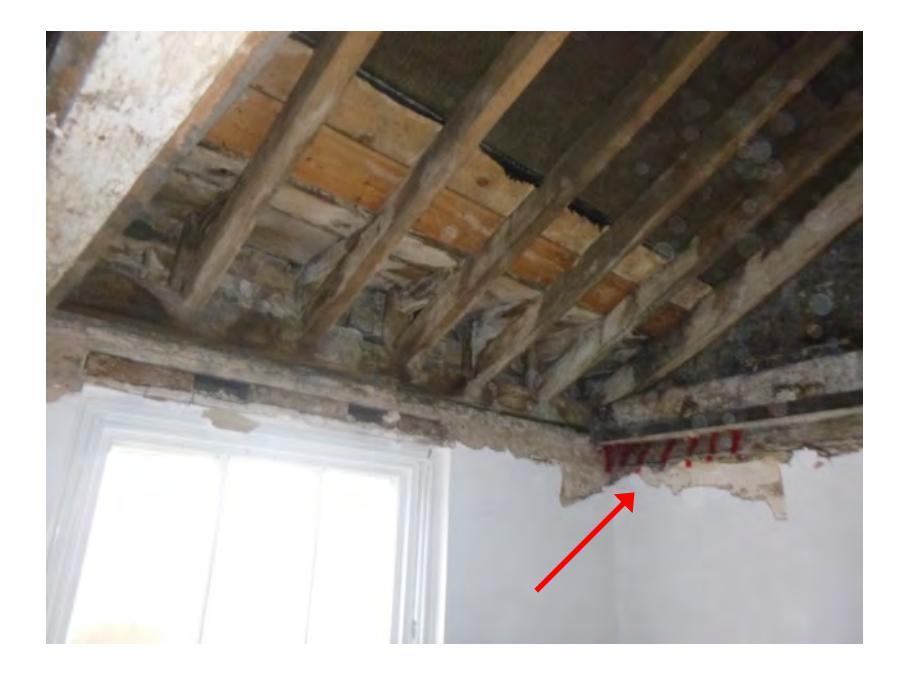
### Fig 18:

Roof structure; showing general view of south east corner. Note structural decay was detected to the eastern end of the embedded plate within the southern gable

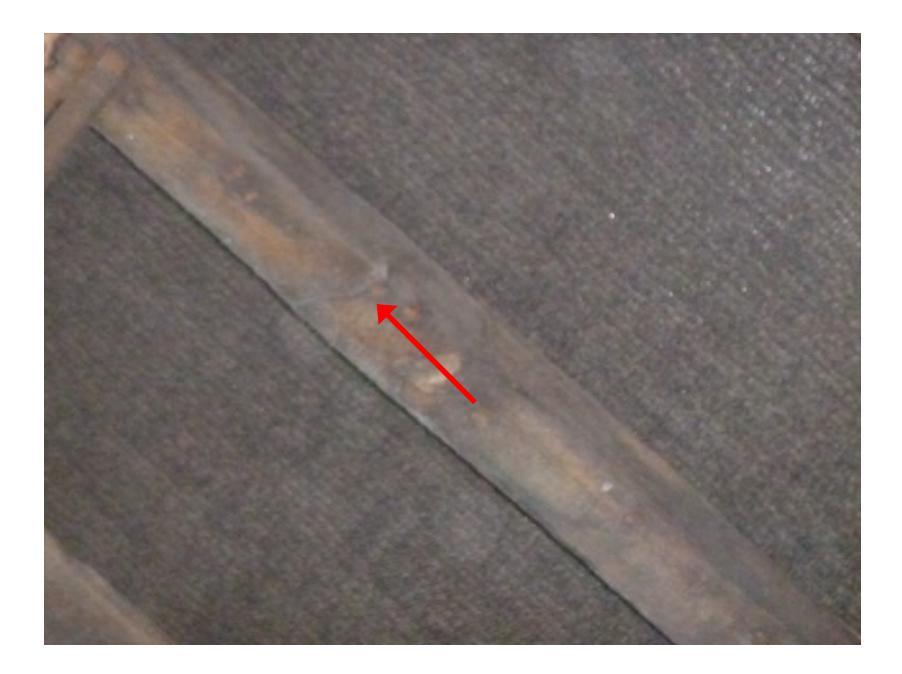
### Fig 19:

Roof structure; showing structural failure of 1 no. rafter to the south west due to crack through the grain

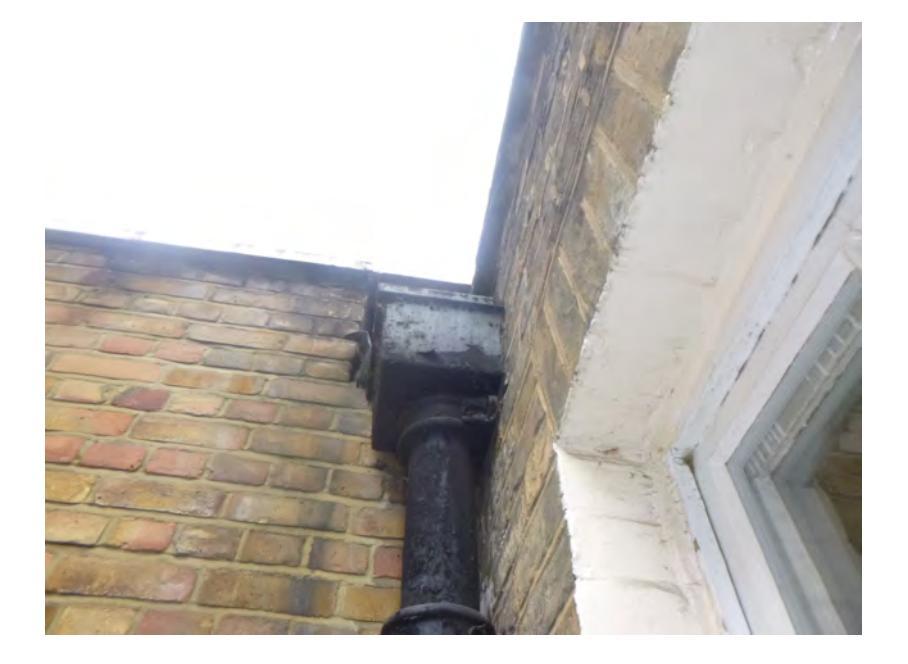
### Fig 20:

Roof structure; showing hopper to the centre of the west pitch. Note this was directly adjacent to structurally decayed timber elements within suggesting correlation between failure/blockage of rainwater goods and water ingress to the structure

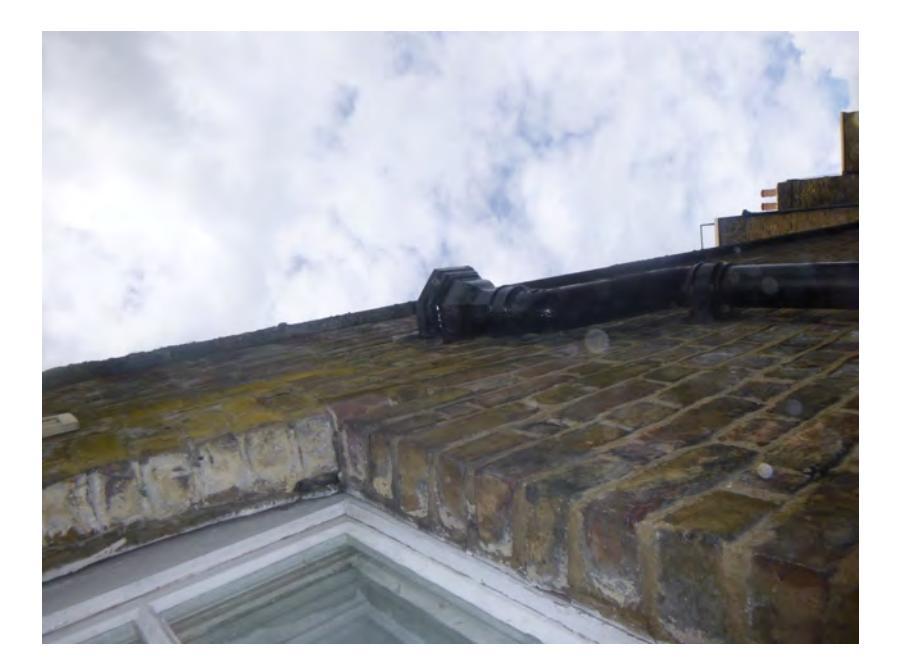
#### Fig 21:

Roof structure; showing exterior hopper to the north east. Note this was directly adjacent to area of structural decay to timber elements within suggesting correlation between failed/blocked rainwater goods and water ingress to the structure

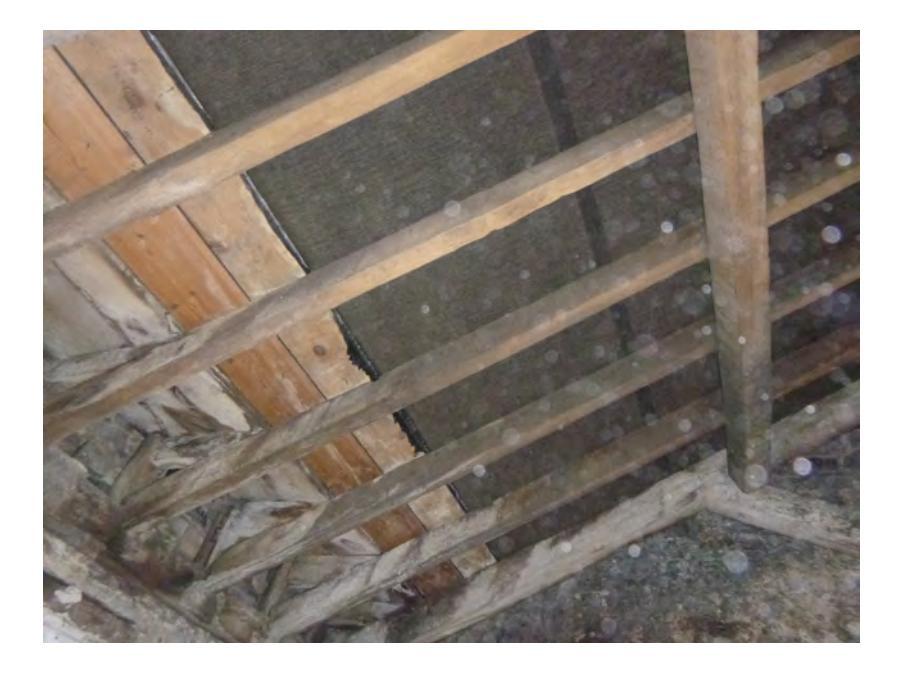
### Fig 22:

Roof structure; showing constructional view of roof structure with non-original bituminous sarking felt laid directly above rafters

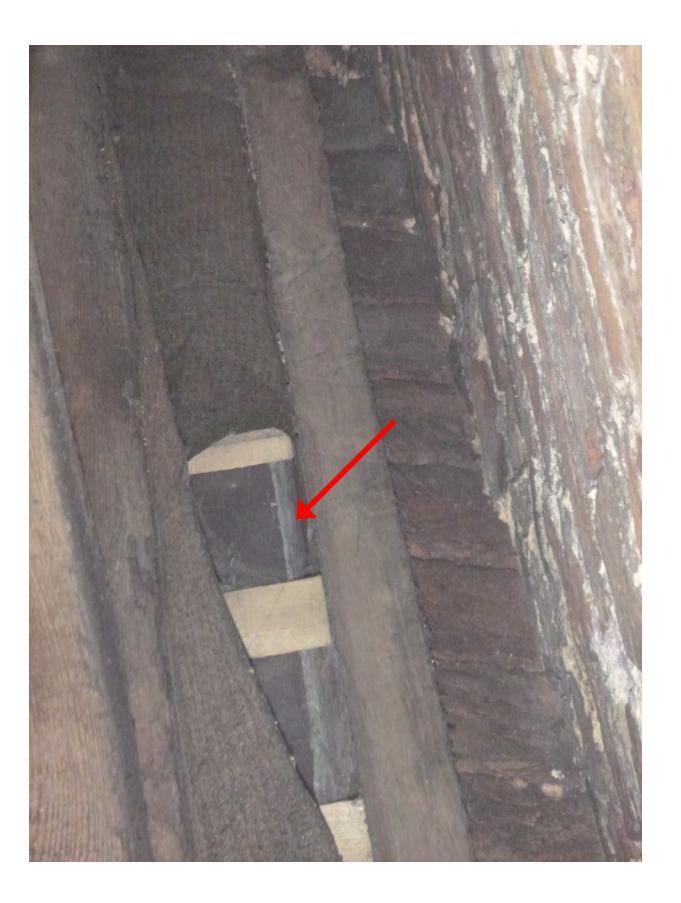
### Fig 23:

Roof structure; showing area of failed sarking felt to the north side allowing water to penetrate during periods of heavy rainfall to the structure below

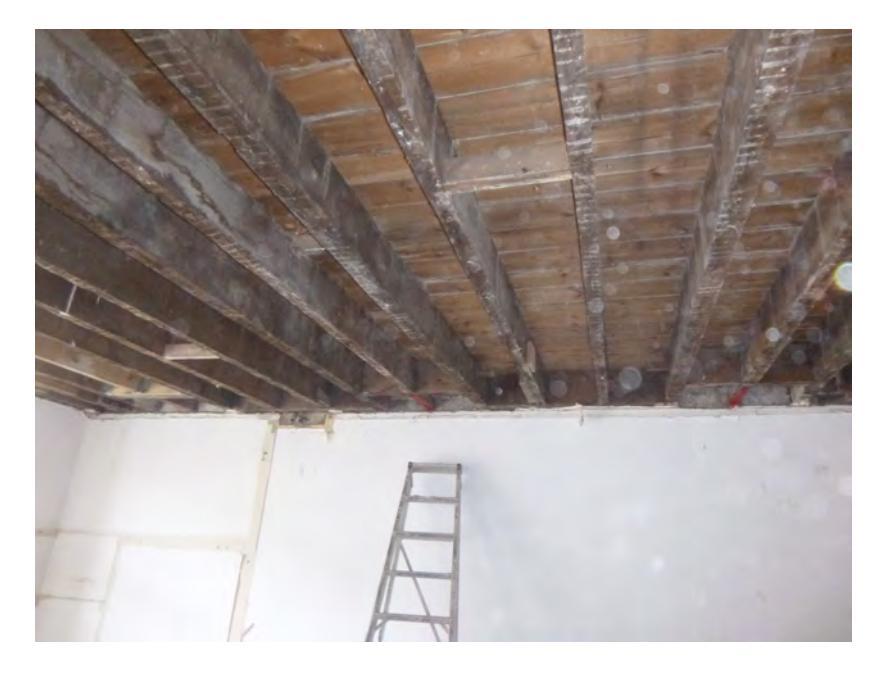
#### Fig 24:

Floor structure; showing general view of south end of first floor. Note timber joists bore into masonry pockets above an embedded timber plate

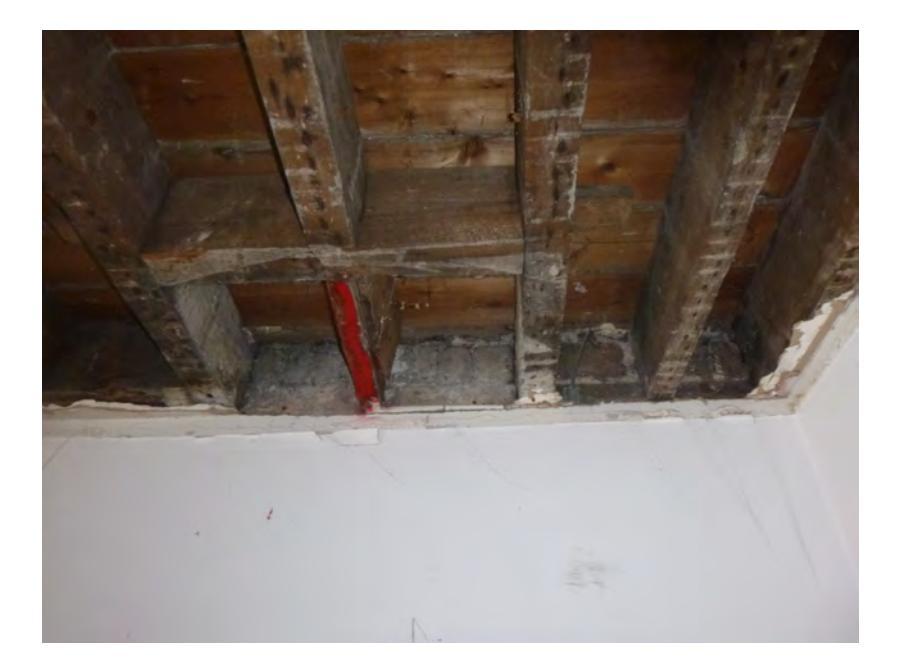
### Fig 25:

Floor structure; showing structural decay to southern bearing end of floor joists to the south west. Note this was not a full length timber floor joist and was a jack/ trimmer element

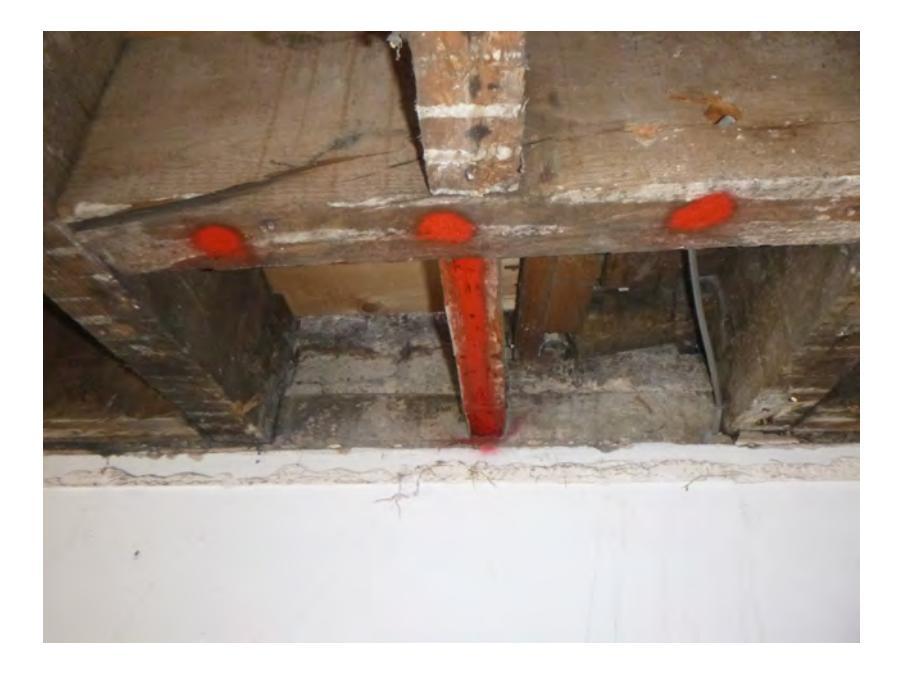
### Fig 26:

Floor structure; showing structural decay to southern bearing end of timber floor joists to the south east. Note trimmer element had also structurally failed due to split

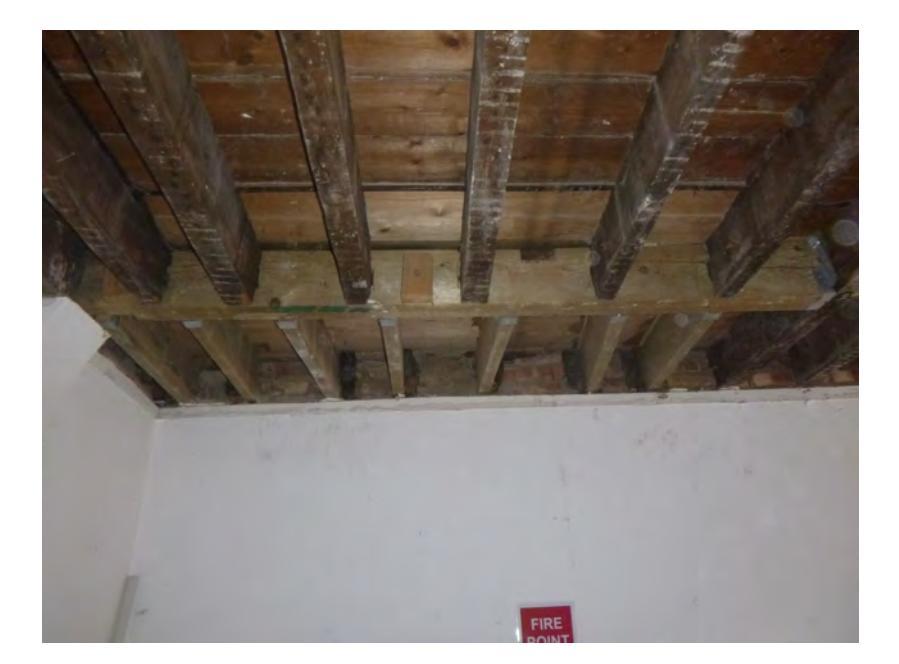
#### Fig 27:

Floor structure; showing west side of first floor structure at the centre. Note a nonhistoric/original masonry wall had been installed to provide midspan support to floor joists

Also note area of past remedial works where contemporary softwood element had been installed as a trimmer on hangers to support 7 no. new floor joists

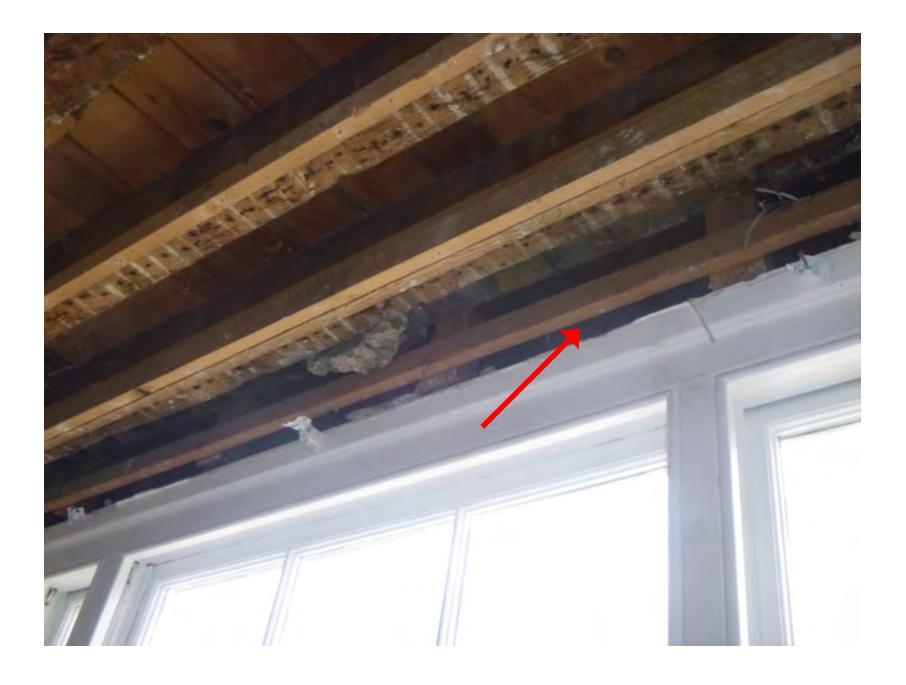
### Fig 29:

Floor structure; showing steel lintel carrying window to the south east

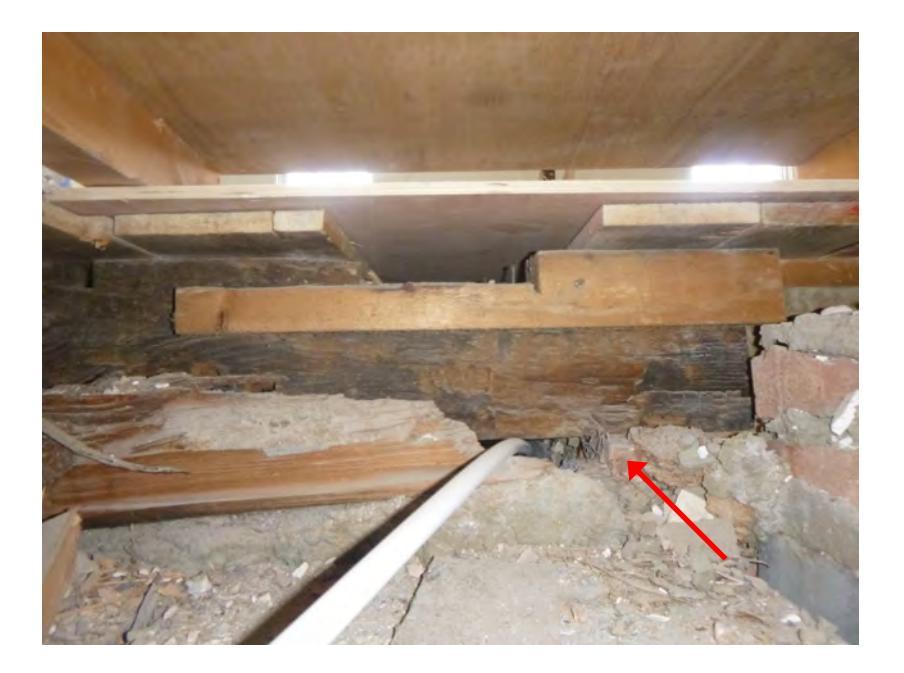
#### Fig 31:

Floor structure; showing structurally decayed floor plate above masonry running north to south to the north west above steel lintels. Note surface and deep moisture contents were below the threshold for decay to be active at time of survey

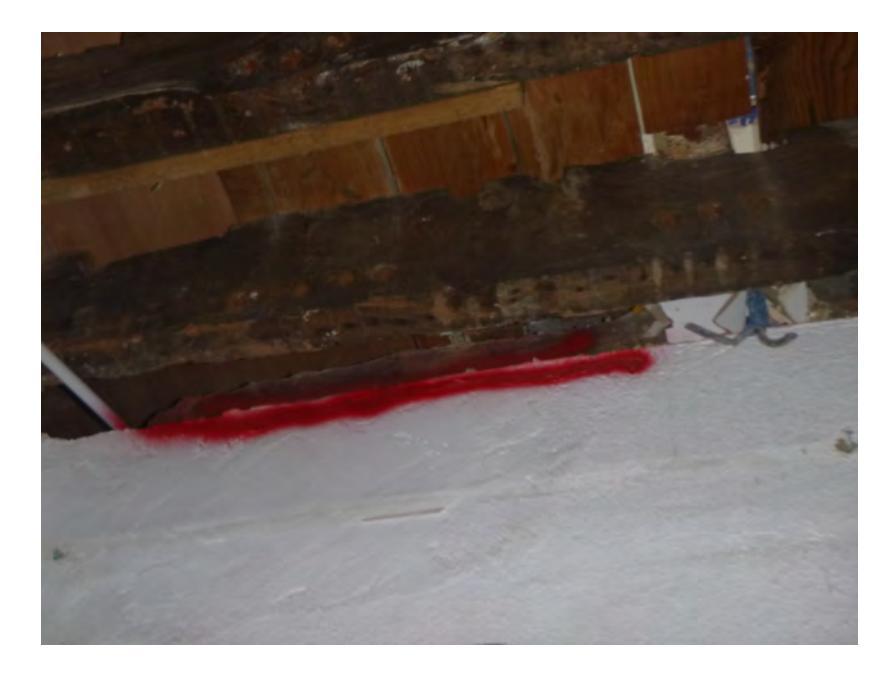
### Fig 32:

Floor structure; showing approximately 400mm of structural decay to wall plate at wall head as seen in previous figure

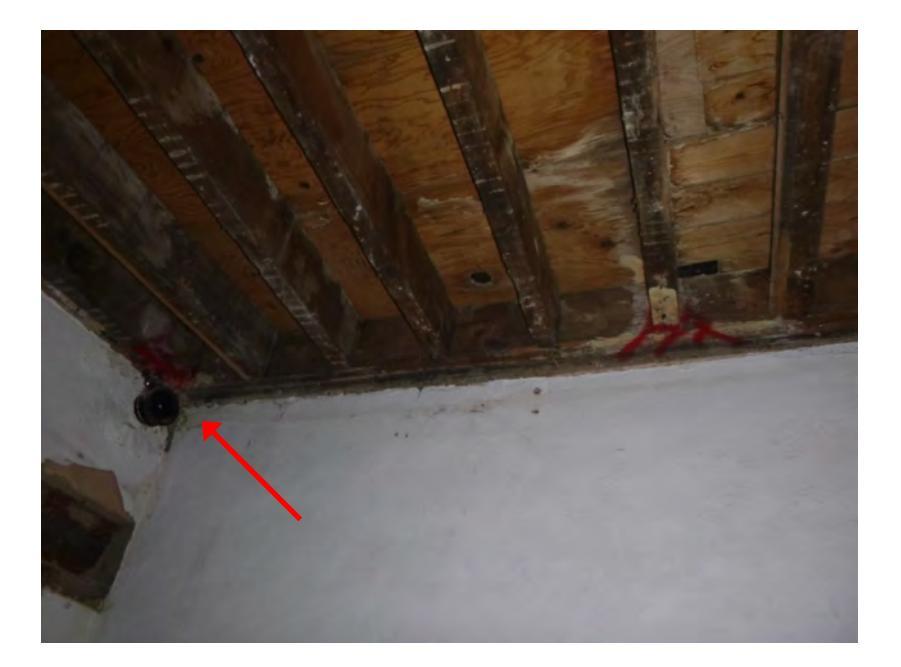
#### Fig 33:

Floor structure; showing general view of north west corner. Note excessive notching had occurred to westernmost floor joist rendering it structurally inadequate

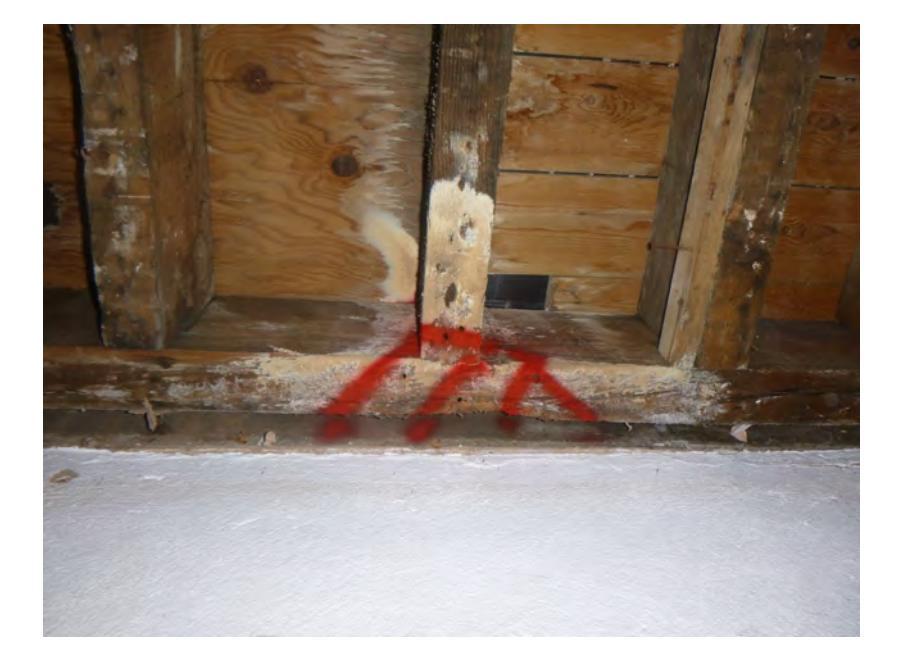
### Fig 34:

Floor structure; showing area of active wet rot decay to 1 no. floor joist and approximately 150mm of trimmer. Note surface and deep moisture contents were above the threshold for decay to be active at time of survey

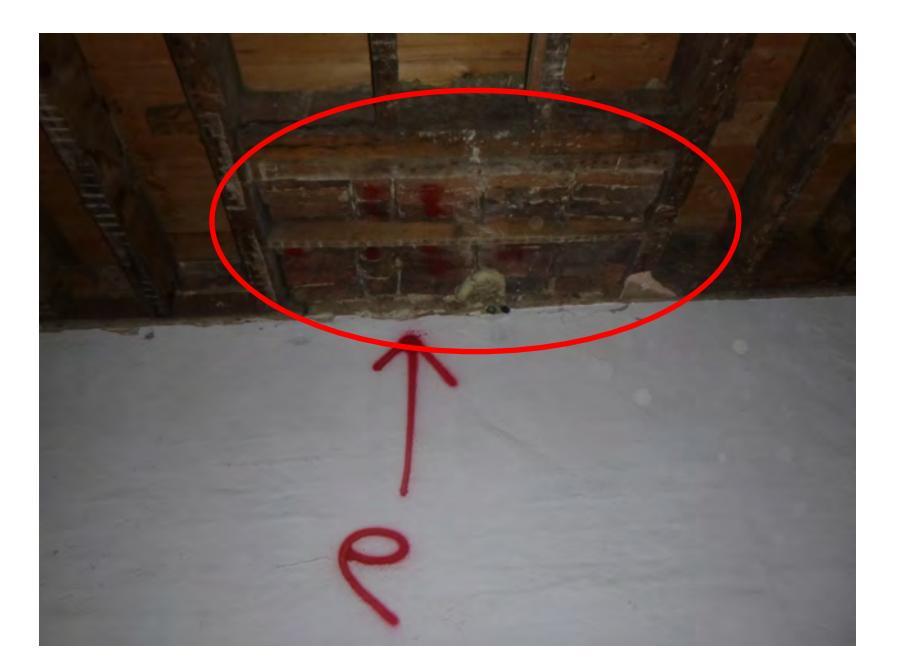
#### Fig 35:

2 Masonry hearth to the north of the first floor: During investigative drilling to timber trimmer elements around the brick hearth to the north, it was noted that several of the bricks were loose to the touch and highly vulnerable to collapse if significantly disturbed during refurbishment works

Floor structure; showing loose hearth masonry within floor structure vulnerable to collapse during refurbishment

Structural Engineer to comment. Provisionally allow for acro-propping of loose hearth masonry during refurbishment. Allowance should be made for masonry to be made good prior to completion of works

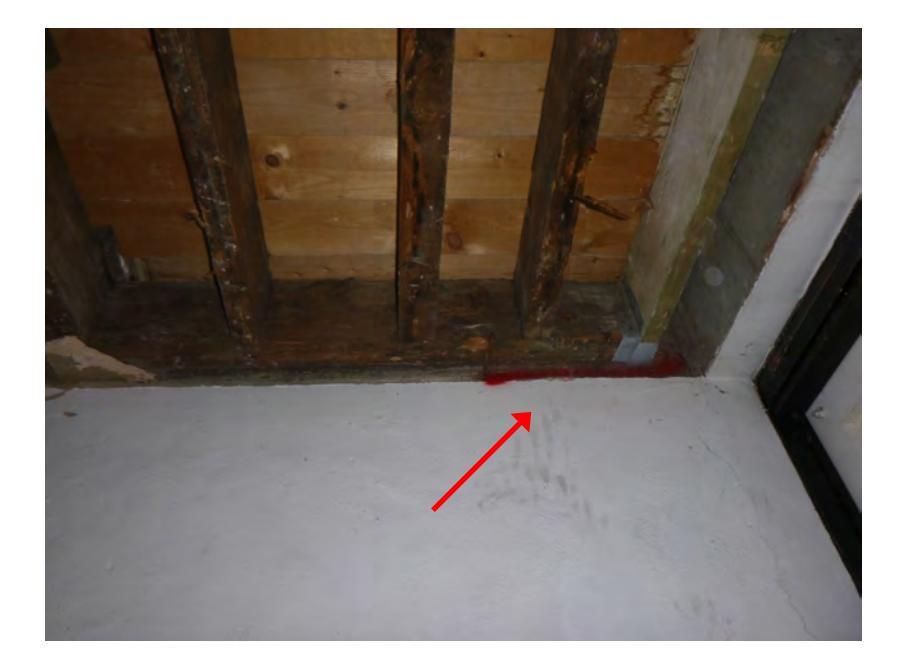
### Fig 36:

Floor structure; showing north east corner where embedded floor joist plate was structurally decayed for approximately 300mm due to historic water ingress

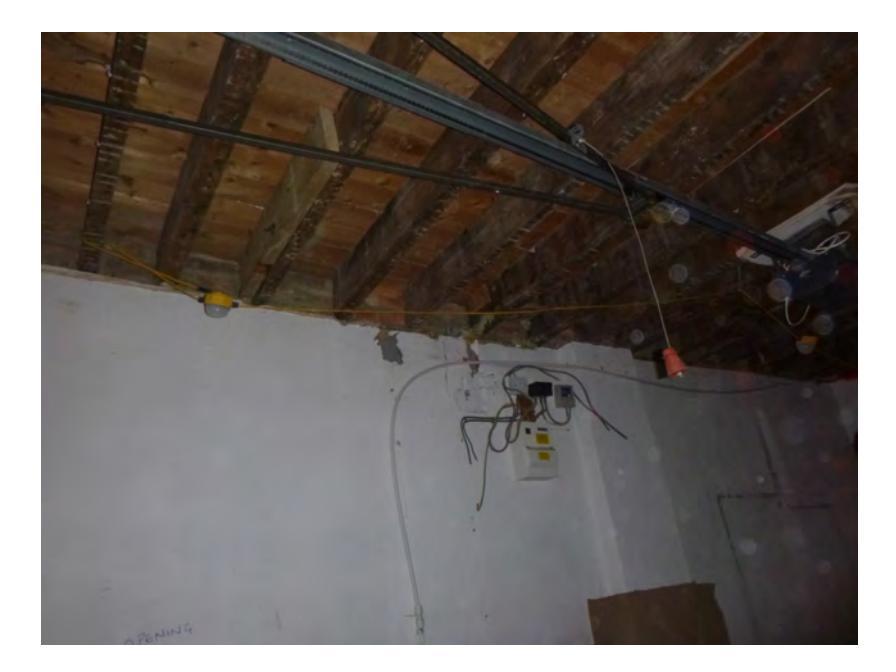
#### Fig 37:

Floor structure; showing general view of central non-original masonry wall providing midspan support to floor joists
