### Hutton + Rostron Environmental Investigations Limited

# 55 Cumberland Terrace, Mews: Timber condition investigation

Site note 1 for 25 June 2021, job no. 154.11

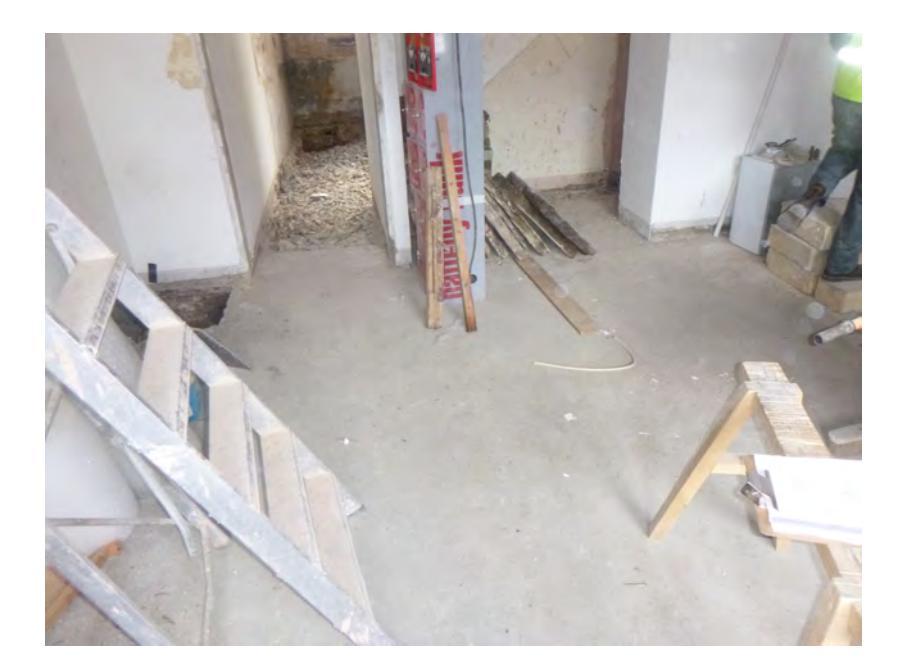
### Fig 39:

Floor structure; showing solid floor construction at ground floor level

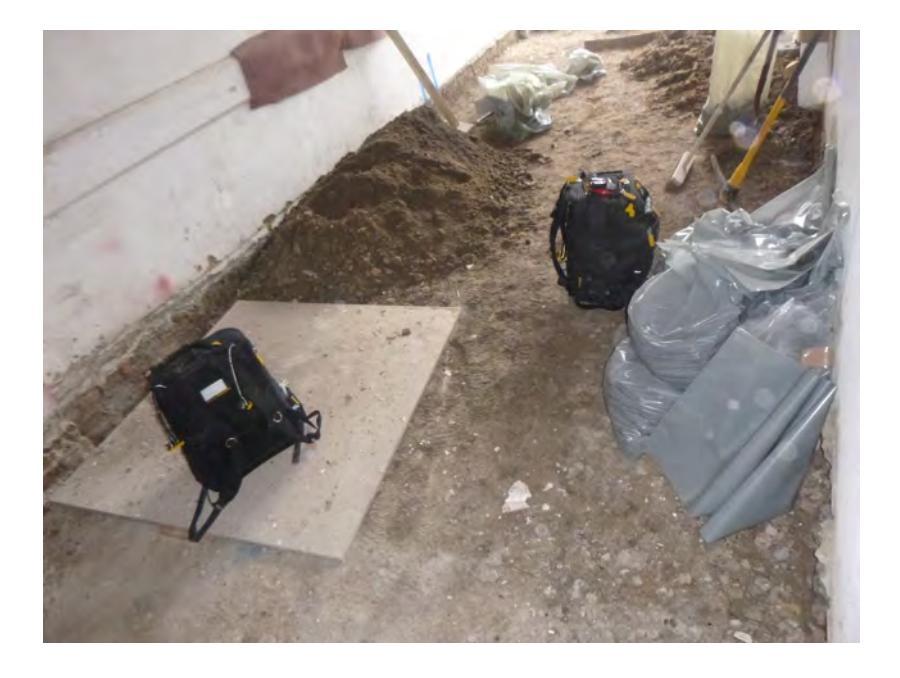
### Fig 40:

Floor structure; showing solid floor construction at ground floor level

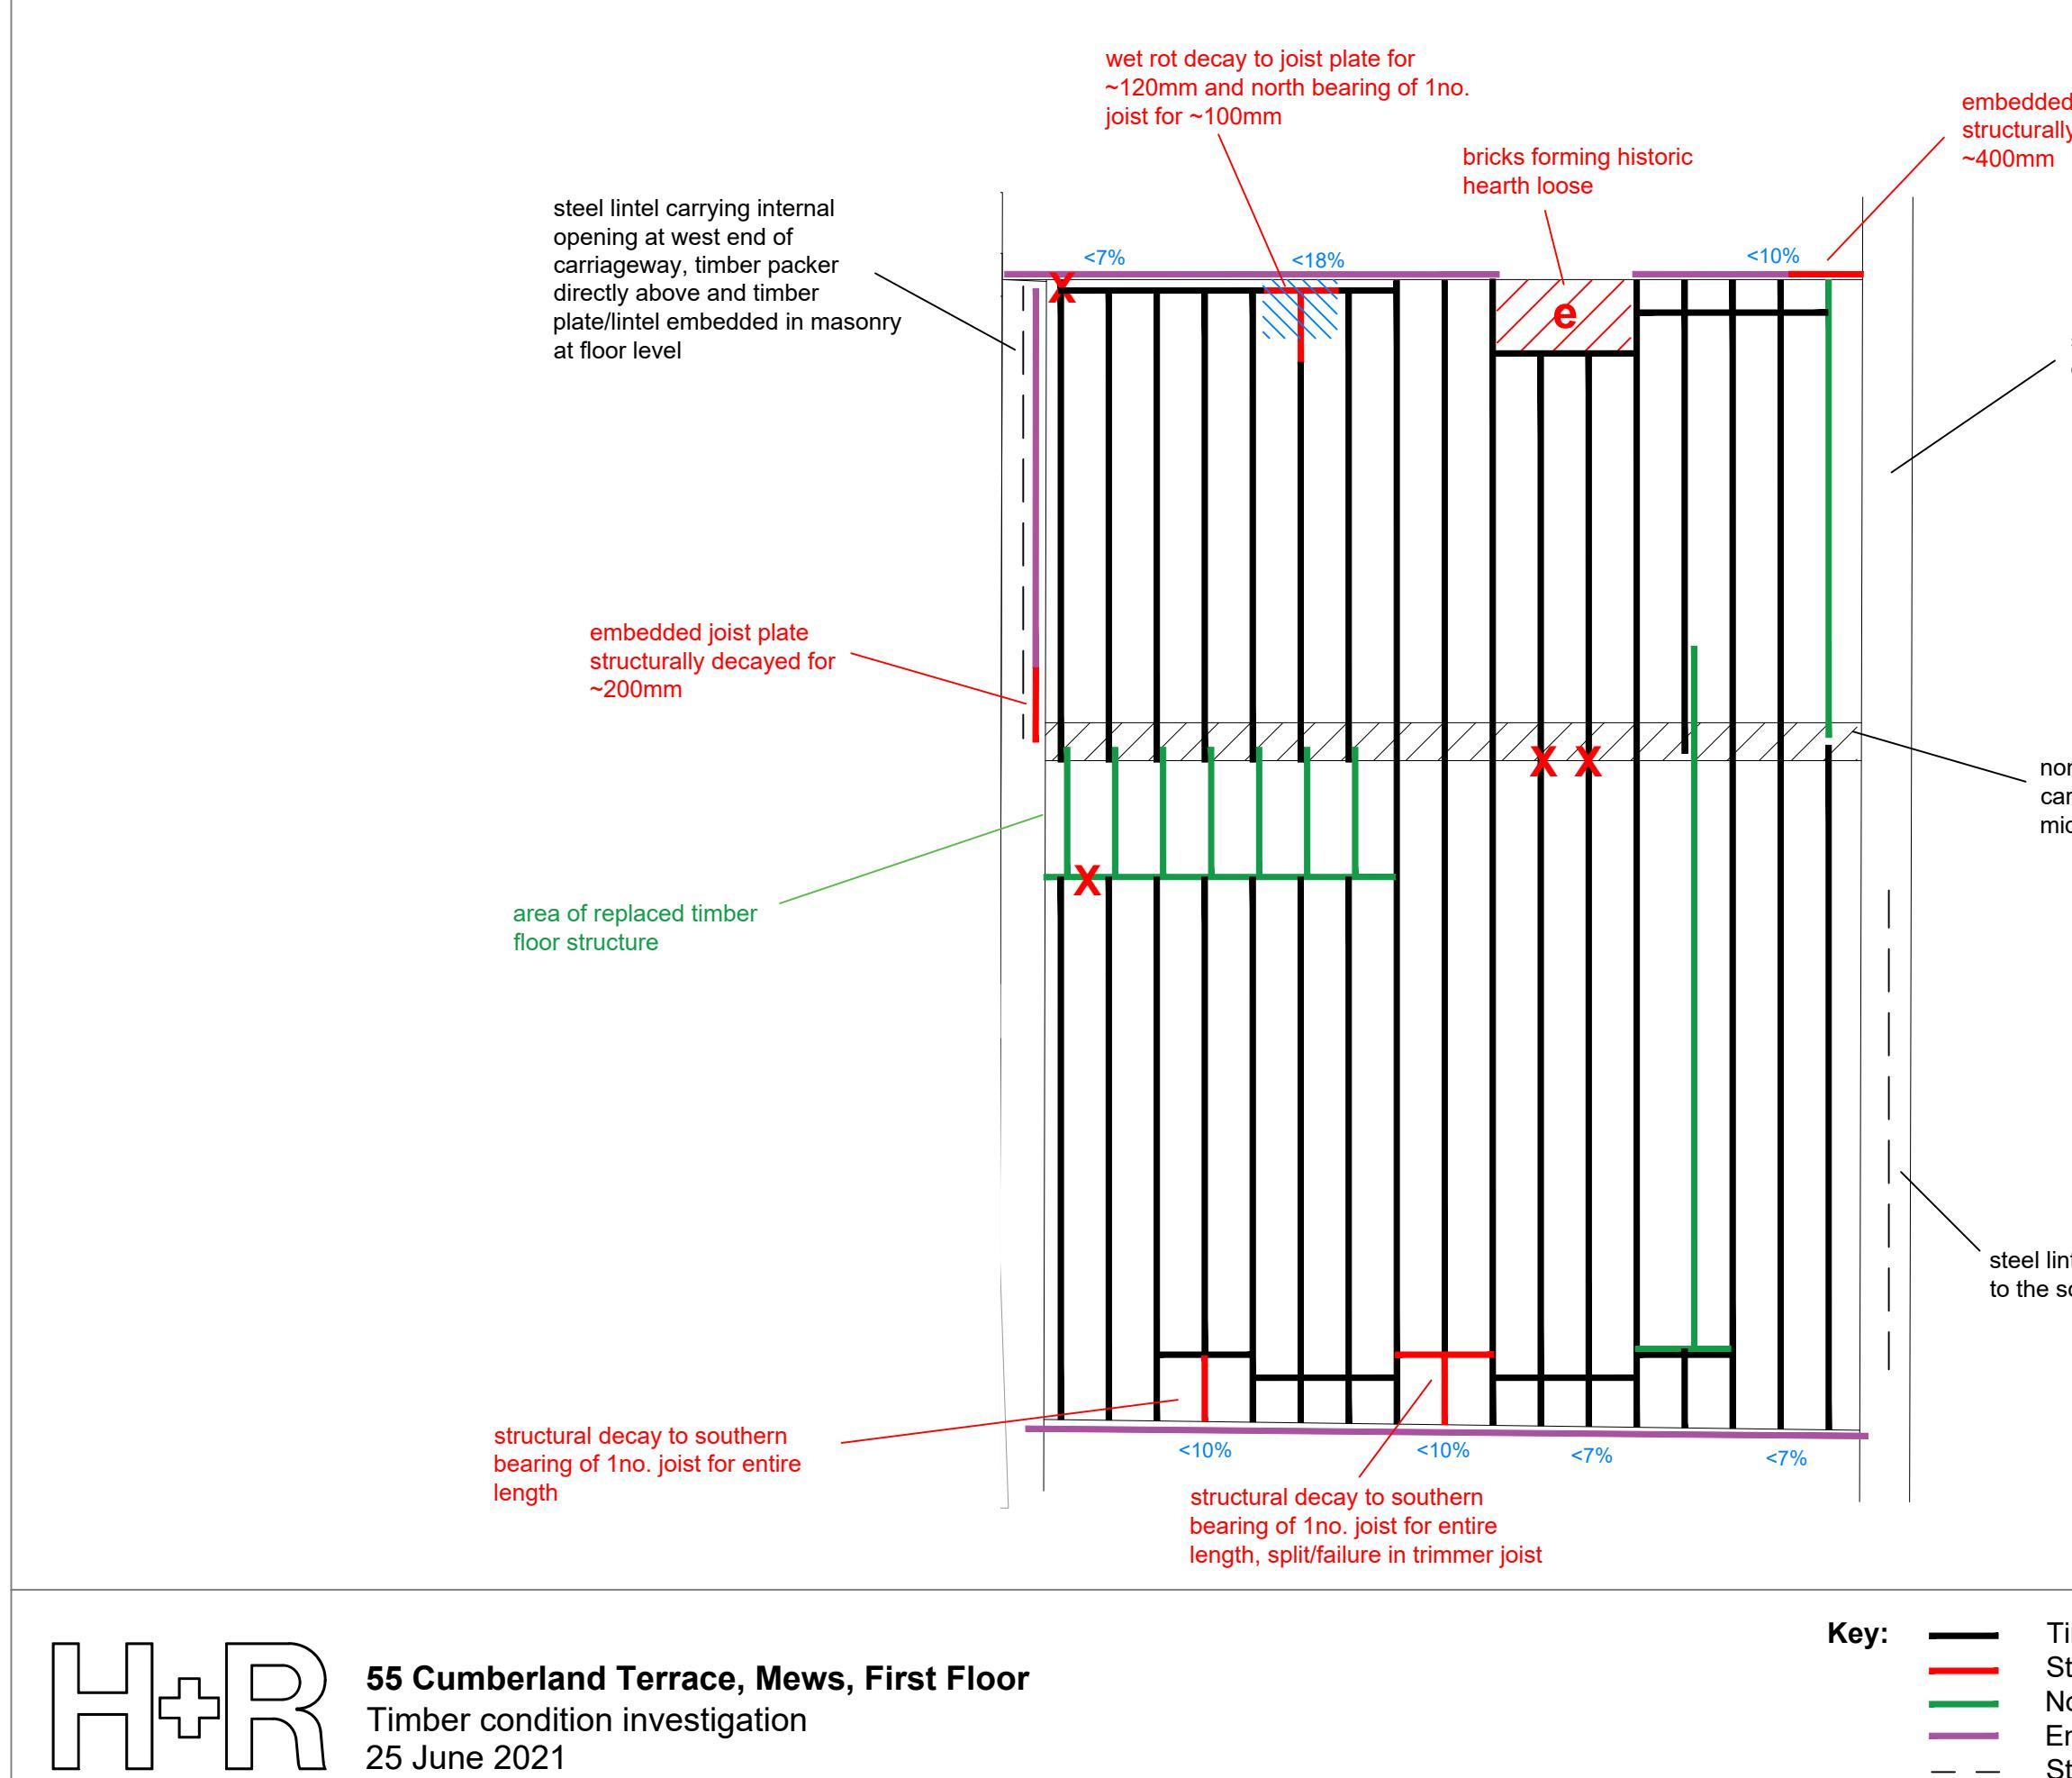
embedded joist plate structurally decayed for
