BS5837 Arboricultural Report,

Arboricultural Impact Assessment

OUR REFERENCE	AC.2021.426.3
CLIENT	Mr Karl Noonan
SITE	Flat 2, 68 Priory Road, Camden, London, NW6 3RE
REPORT BY	I S Thompson (known as Tom) MArborA., BSc. (Hons) Arb, MSc. eFor
DATE	21st February 2022
DATE OF SITE VISIT	1st October 2021

**Application Ref No Unknown Side extension to existing residential ground floor
apartment.**

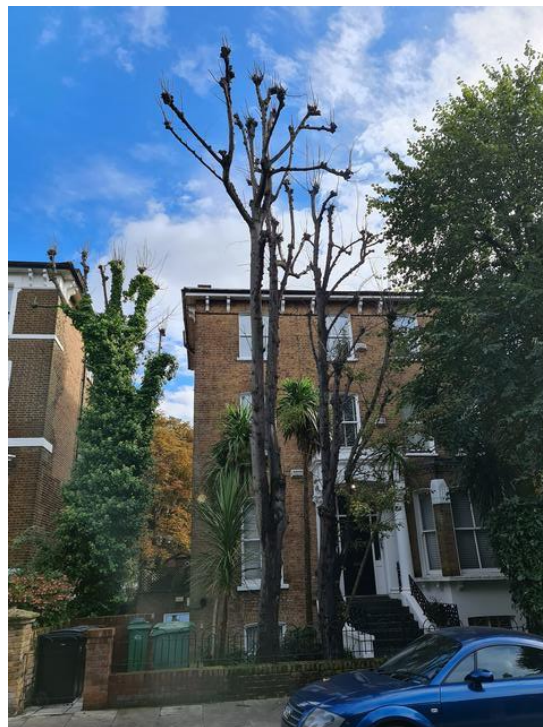
12.2 There are two dead or dying trees on the adjacent property. The owner of these trees is advised to remove them. These trees are T02 and T03 both lime trees. It is recommended that T09 a small rowan is cut back to the site boundary.

Image 2 T2 and T3 to left of the entrance.

The proposed scheme allows for all the existing healthy mature trees to be retained. There are no trees being removed as part of this application however it is advised that the owner of the two dead or dying trees T02 and T03 at the front should get them removed.

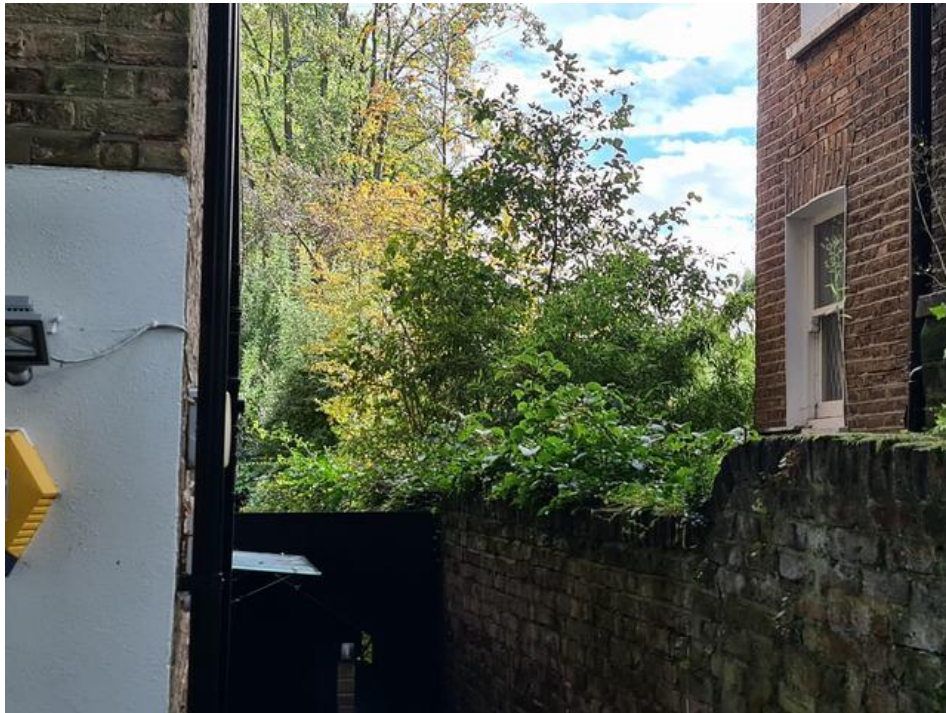
Image 6 T9, a small rowan tree in the adjacent property.
