## BS5837 Arboricultural Impact Assessment

38 Hillfield Road, London, NW6 1PZ

Job Reference: 03725R

February 2022

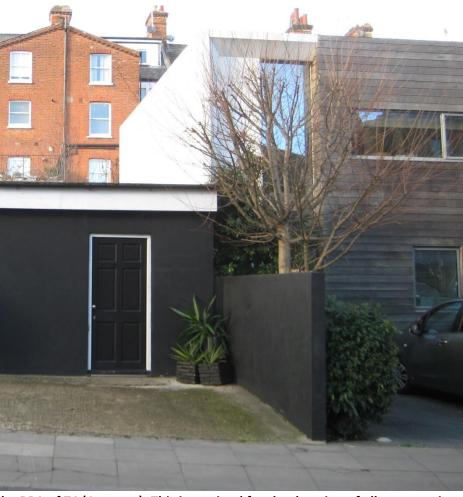
Fig 6 – Existing hard standing within the RPA of T4 (Acer spp). This is retained for the duration of all construction works before being removed by hand and soft landscaped.

5.4.5 Existing surfacing within the protected area of T4 will be broken out at the end of the main construction project and prior to landscaping. This limits the risk of tracking of exposed ground and contamination from undertaking the work earlier in the development cycle.

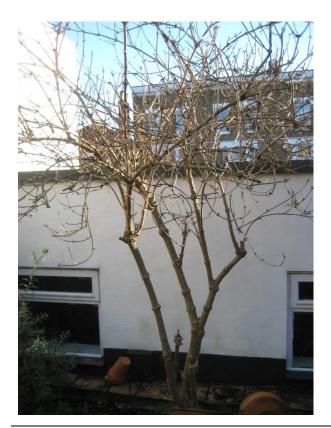
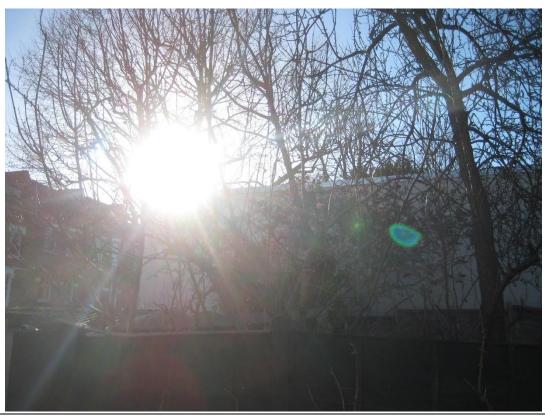
Fig 8 – T1 (Elder) (left) and TG1 (Prunus & Ash) (right) will be removed to facilitate the proposal. Note: TG1 is located on 3<sup>rd</sup> party land and agreement is therefore required before these works can be completed.

Tree No. Species		Species Proposed Tree Works			
T1	Elder	Remove to facilitate the proposal	C1		
TG1	Prunus & Ash	Remove (subject to 3 <sup>rd</sup> party permission) to facilitate the proposal.	C1

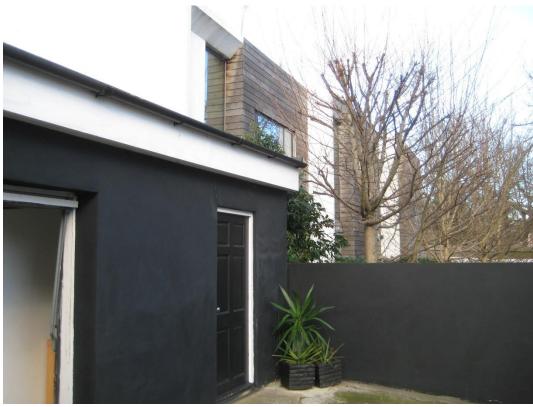
Fig 9 – Branches of T4 are already close to the existing structure and this relationship remains unchanged. Intermittent pruning will be required to address this relationship as this tree growths further. The 3<sup>rd</sup> party tree owner already has the tree under an apparent form of cyclical crown pruning management.

- Intermittent cutting back of T4 will be required as this tree develops. There is already evidence of some crown pruning management to the tree and the need for future pruning is not altered by the proposal as this relationship already exists between the tree and existing garage building.
- **Note:** This is an indicative assessment. All and any future works should be undertaken in accordance with BS3998 (Tree Works) and we recommend the use of Arboricultural Association approved contractors.<sup>6</sup>

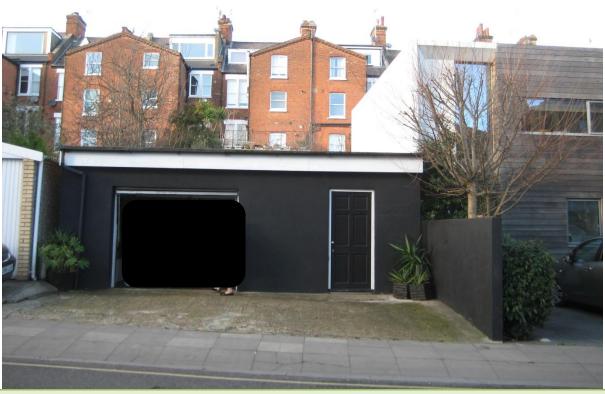
**Image 1** – Looking towards existing garage structure with T4 visible right.

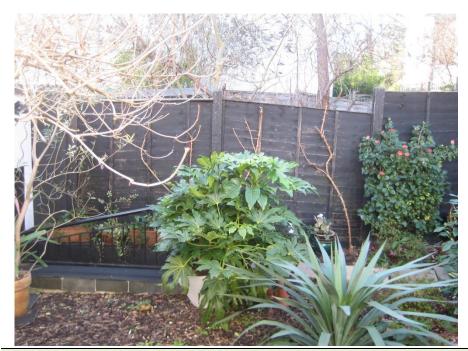
Image 2 – Looking west towards boundary and TG1

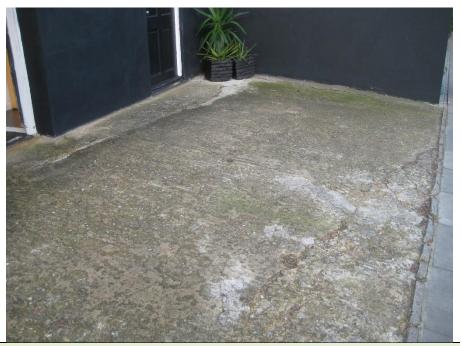
Image 3 –Existing hard standing within the RPA of T4. This should be retained during the works and removed only after all the main construction activity is complete.
