ARBORICULTURAL IMPACT ASSESSMENT AND METHOD STATEMENT REPORT
BS 5837:2012 'Trees in relation to design, demolition and construction. Recommendations'

13 Elsworthy Road, Primrose Hill, London NW3 3DS

DATE: April 2022
OUR REF: SHA 1531

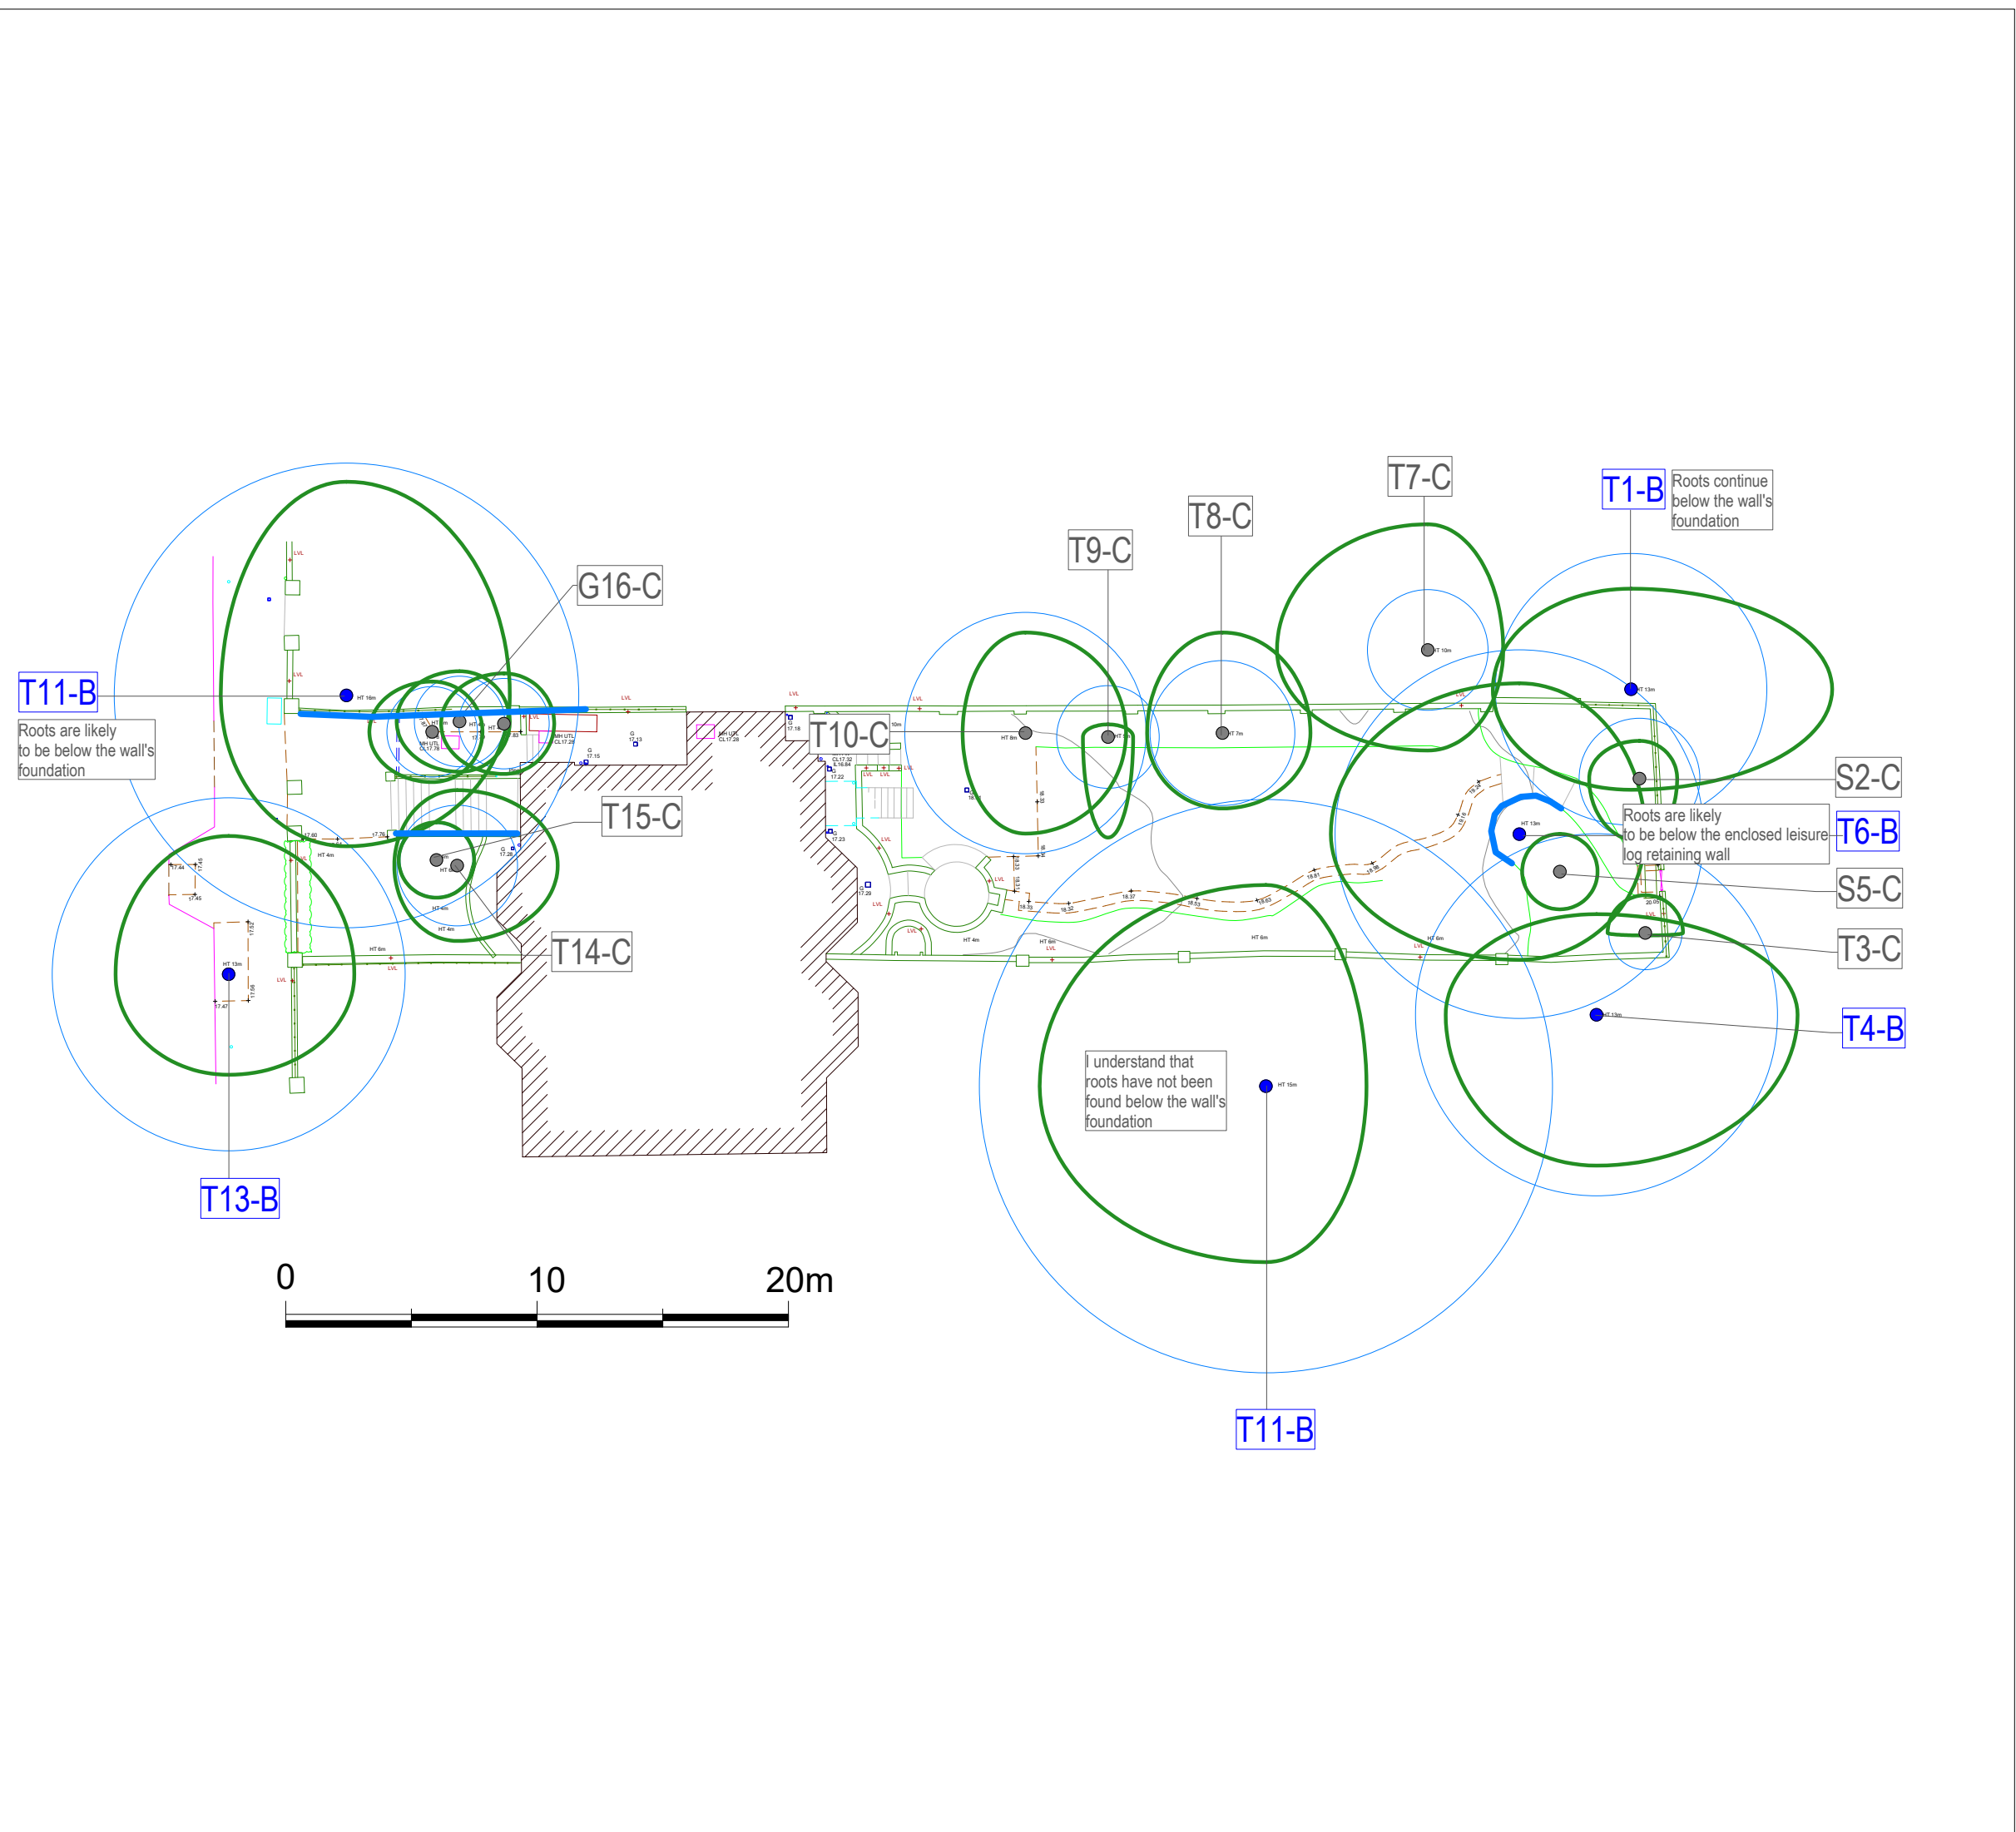
Tree survey plan SHA 1531 TSP

4.1. *Generally:* There are 13 individual trees, 2 shrub groups and 1 group of trees which form the subject of this survey. Full details are found in the survey sheets at appendix 1 and their location on the tree survey plan SHA 1531 TSP at appendix 2.

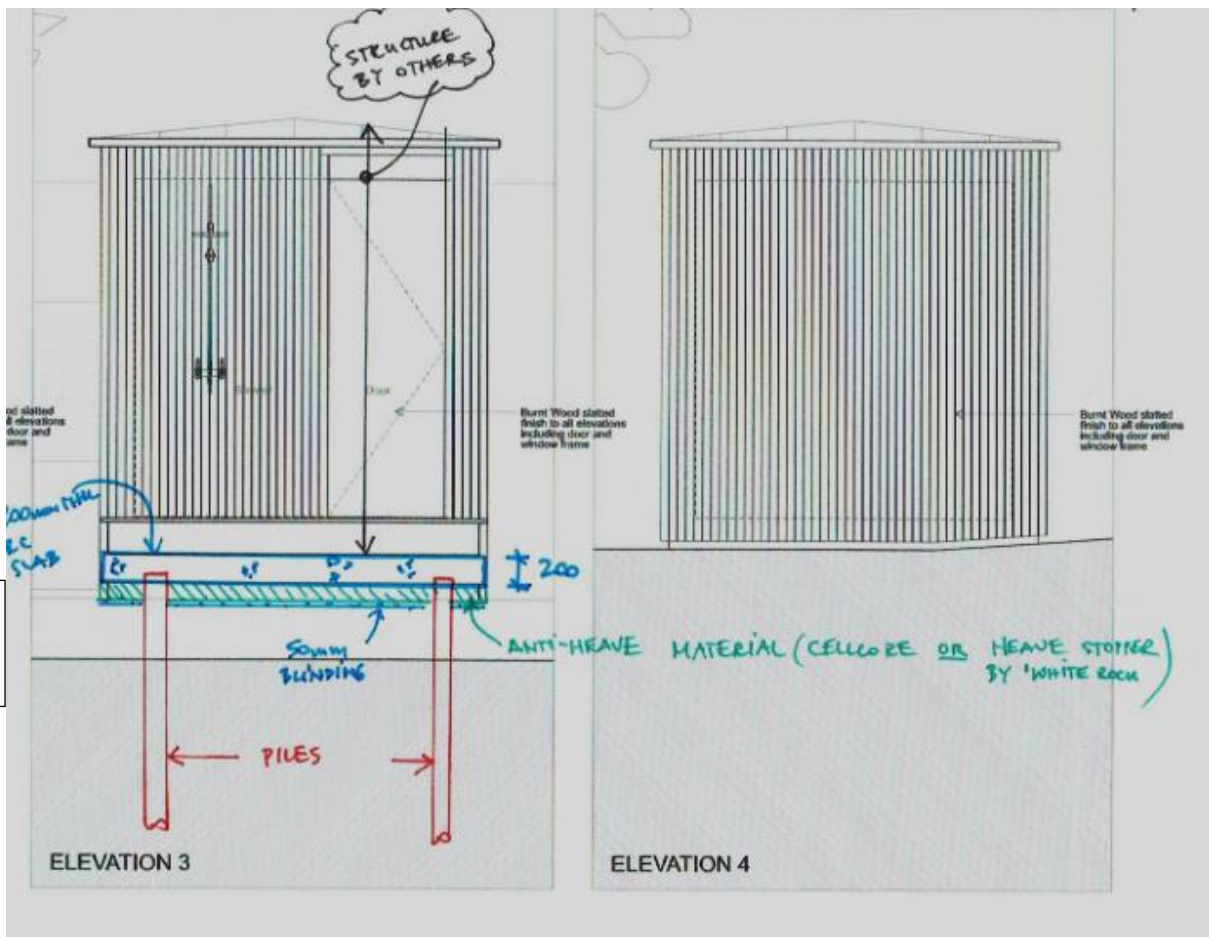
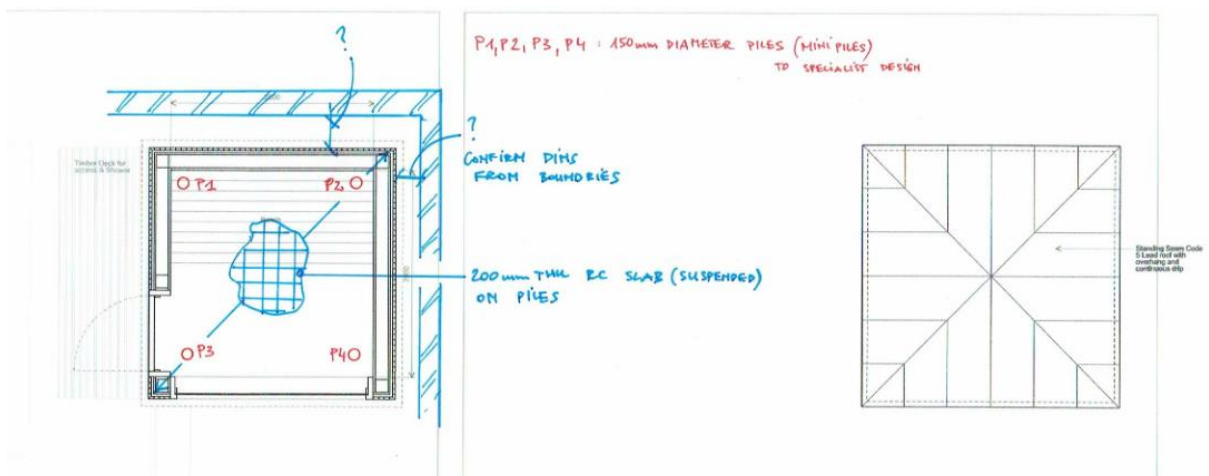
Extract from sketches by structural engineer. Do not scale.

The sauna will be constructed with 4 x 150mm diameter piles down to 6m deep on a concrete pad with anti-heave measures below. The following is based on the fact that a trial pit found roots from the offsite lime tree T1 just below the wall's foundation (c.400mm) and the fact that the sauna is in the root protection area of T6 mulberry.

- Mark the location of the sauna and pile locations with spray paint
- Underground services check to be made
- Under arboricultural supervision, hand dig the location of the piles down to 1m or the depth of a root with a diameter greater than 25mm (whichever is greater). If roots of this size or larger are found, then the hole will be shifted in a location to avoid roots and the slab will be cantilevered. Any smaller roots will be pruned cleanly with bypass secateurs to assist digging. If the hole is found to have larger roots (>25mm diameter), it will be immediately backfilled.

- The 4 piles will be installed with a mini rig that will not need a pile mat or pruning of either tree.

- Anti-heave measure to be installed
- Reinforced concrete slab to be installed. The concrete will be mixed away from the root protection area of the trees and transported by wheelbarrows on running boards. The timber shuttering for the pad will prevent leakage onto the soil and the anti-heave measure will prevent it from mixing on the ground.
- The erection of the building will be made by building the pre-made sections.
