52 AVENUE ROAD LONDON NW8

PRELIMINARY ROOST ASSESSMENT

2021

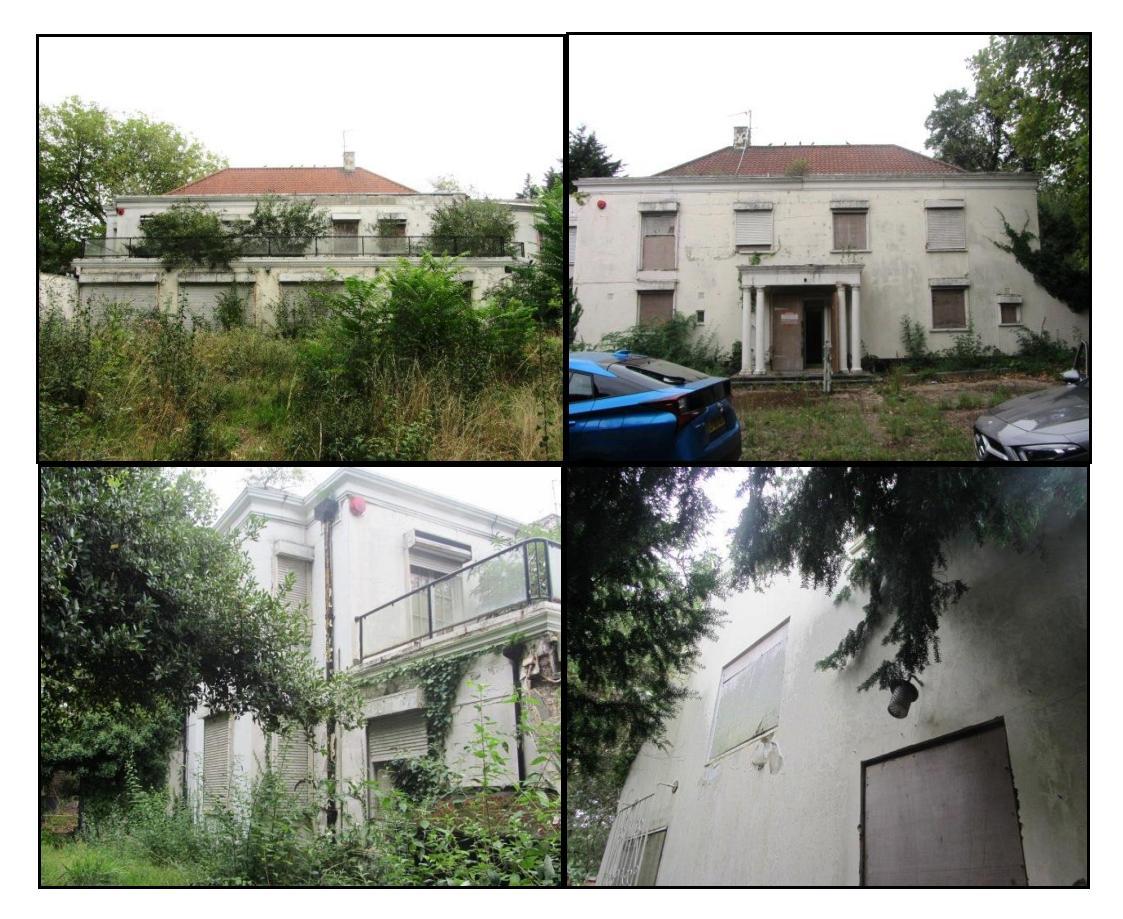
Photographs 1 - 4: Front, rear and side elevations

The roof of the house is tiled and this was found to be in excellent condition throughout with no missing/damaged tiles, mortar or other gaps visible that could act as potential bat ingress points. A single chimney is present.

In contrast, the single-storey, flat-roofed front extension is in a very poor state of repair, with large holes in the roof providing a draughty and wet interior. This extended part of the house, however, contains no potential roost features suitable for use by bats.

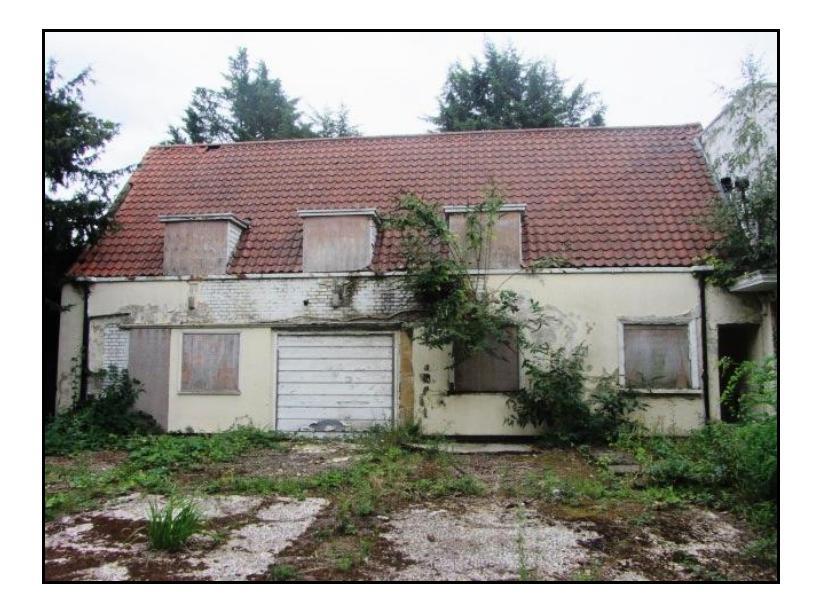
Photograph 5: Garage block

The single-storey adjoining garage on the rear elevation has a pitched, tilecovered roof that is in excellent condition and three boarded-up dormer windows on its frontage (see photograph 5 above). The fascia boards were all found to be tight-fitting and do not offer any suitable bat access points into the roof. As a result of the structure of the main part of the house and garage, and its excellent condition throughout with no potential bat access points identified, the building was assessed to be of '<u>negligible potential</u>' as a roost site for bats.

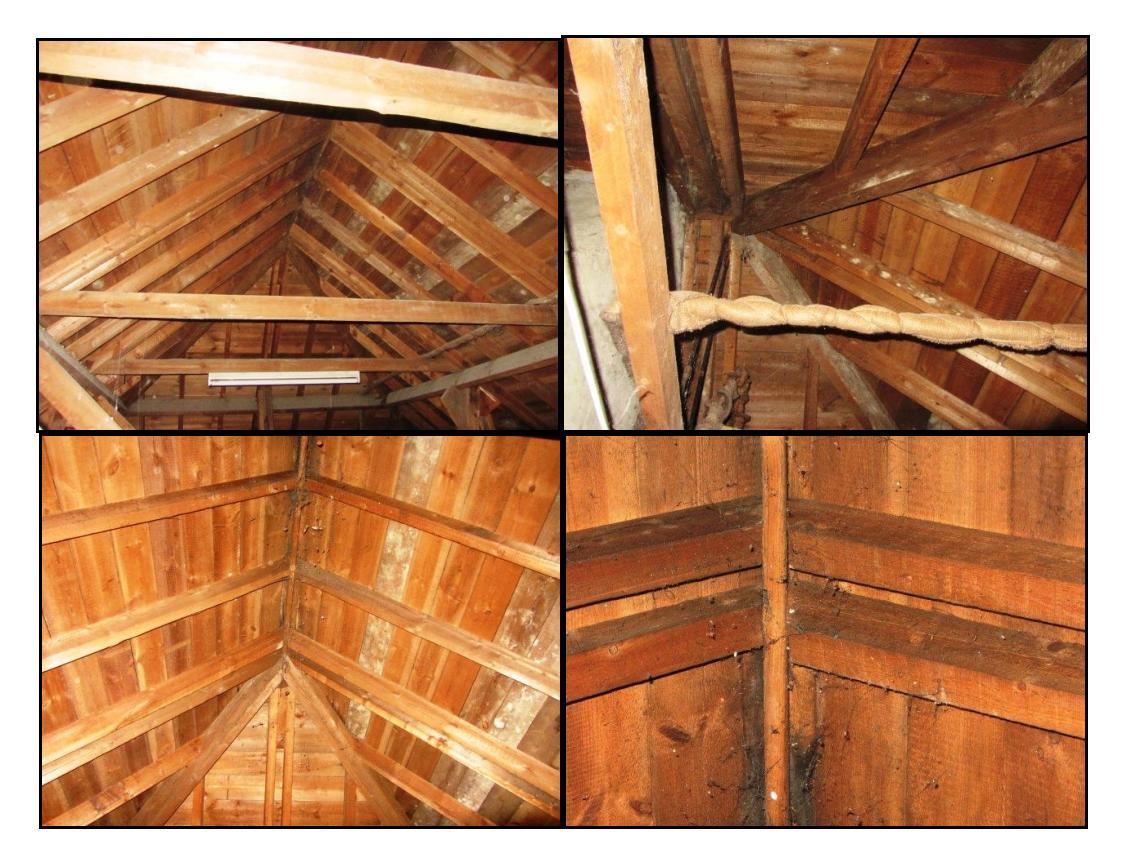
The main roof is lined with sarking and the material was found to be in good condition throughout. The rafters are all modern-sawn timbers, commensurate with the recent age of the property, with no open mortise joints that are typically utilised by bats as roost locations and there is also no large central ridge beam present (see photographs 6 - 9 below). Old fibre-glass floor insulation is present throughout the roof space.

The loft void shows no signs of past usage by the previous owner, thereby providing optimal undisturbed internal conditions for recording any current or historical bat activity.

Photographs 6 - 9: Internal roof void

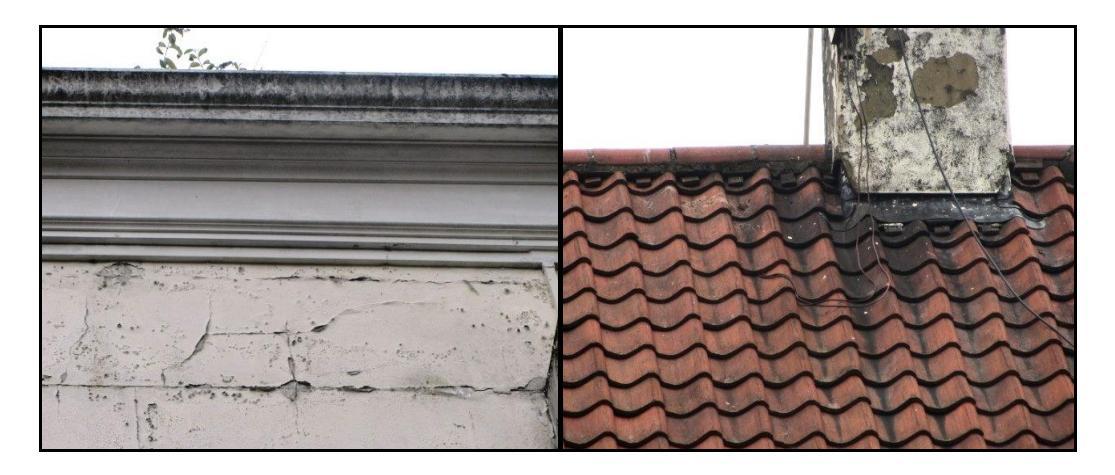
The various soffits and chimney flashing were all found to be tight-fitting with the walls and tiles and afforded no potential points of ingress for bats to utilise (see photographs 10 - 11 below).

Photographs 10 - 11: Examples of close-fitting soffit & chimney flashing

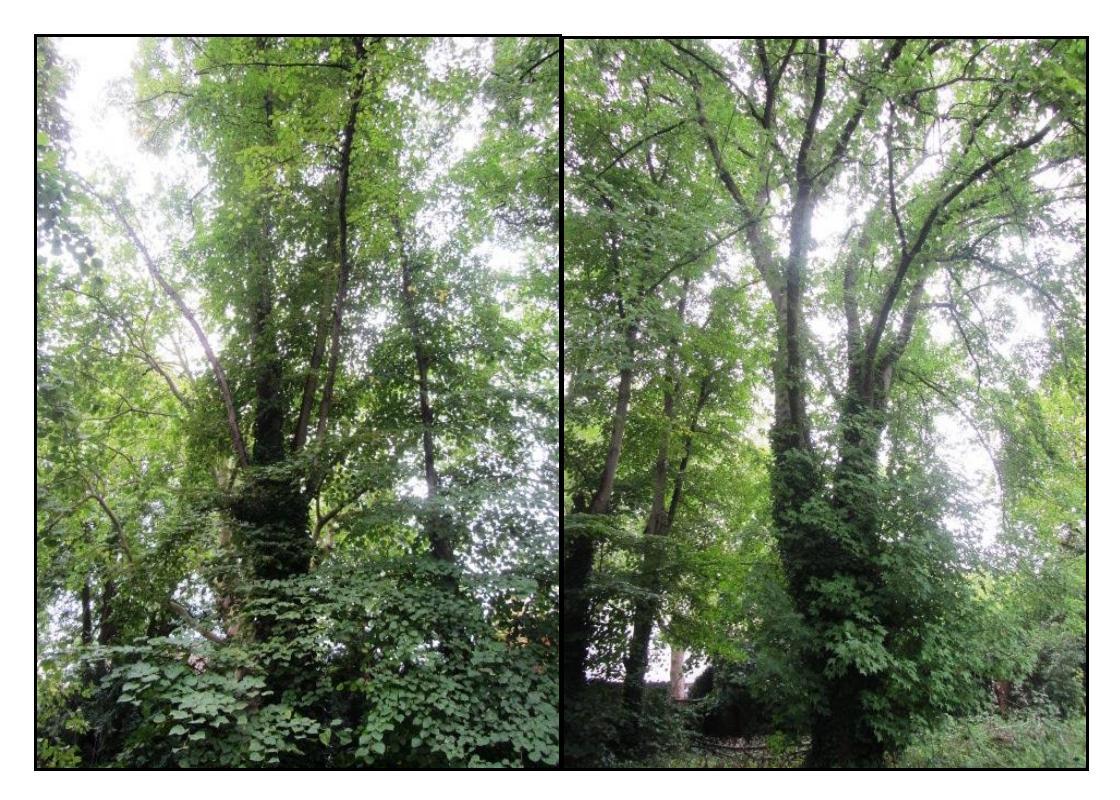
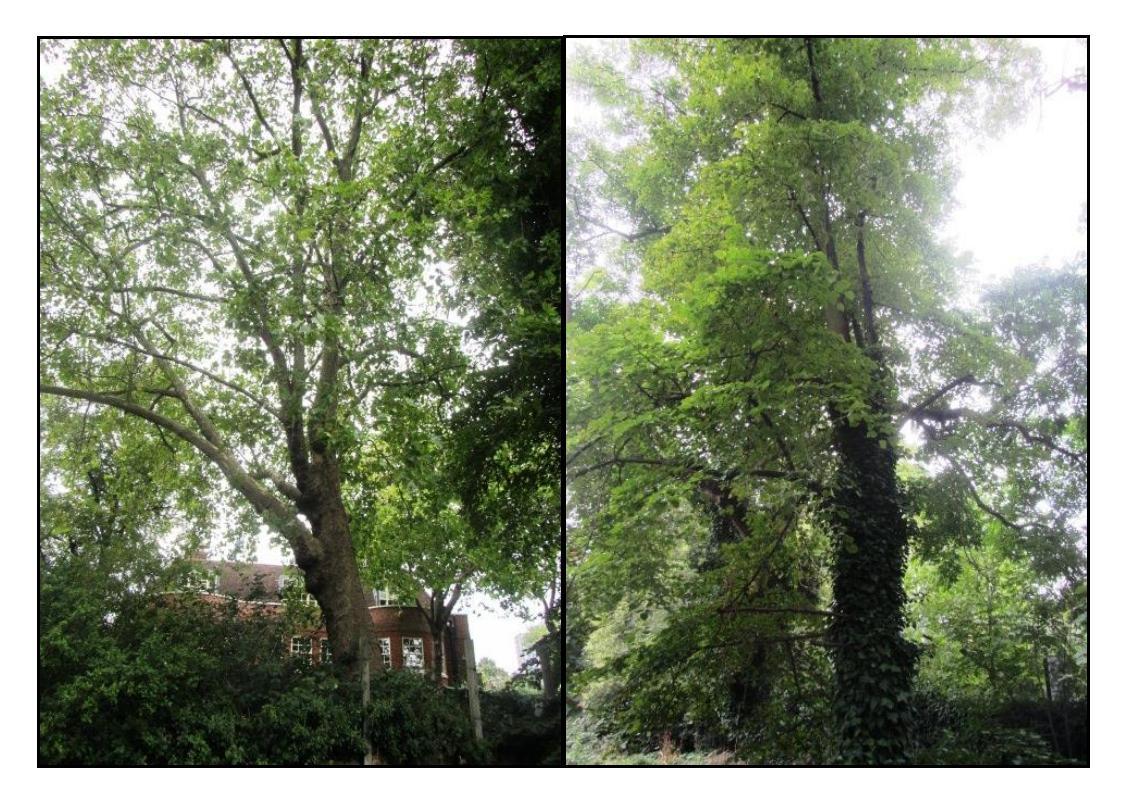
Photographs 12 - 15: Mature trees around site perimeter

No suitable 'potential roost features' (such as old woodpecker holes, splits, loose bark, rot holes etc) that could be utilised by bats were found in any of these mature trees.

All of the trees were therefore determined to have '<u>negligible potential</u>' to act as a bat roost site.
