**TREE PROTECTION &  
CONSTRUCTION METHOD STATEMENT  
FOR REDEVELOPMENT OF  
KINGS CROSS COMMUNITY HUB  
51 ARGYLE ST,  
LONDON  
WC1H 8EF**

**ARBORICULTURAL SOLUTIONS LLP**

**ORIGINAL – DECEMBER 2020.**

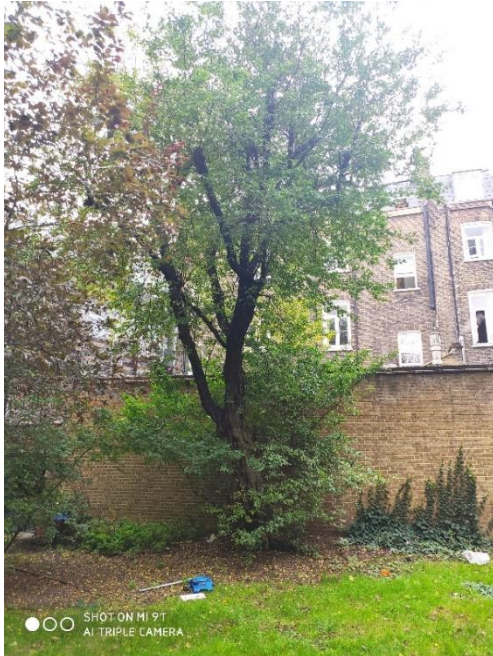
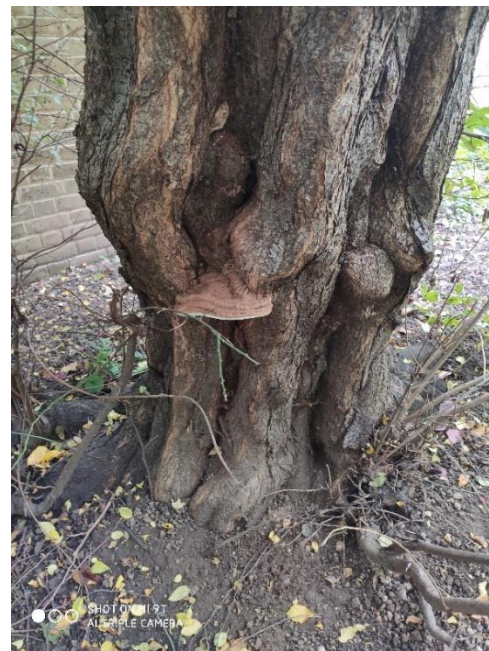
5.4.1. Tree 1 has been categorised as U (Trees unsuitable for retention) as it has a fungal bracket of *Ganoderma* on the trunk and is in such a condition that it cannot realistically be retained in the context of the current land use for longer than 10 years.

**Photographs 1 and 2 showing tree 1 (Cherry Plum) and fungal bracket on trunk.**

- Trees 1 (Cherry Plum), 5 and 6 (Purple-leaf Plum) and tree 9 (Downy Birch) will require removal to facilitate the redevelopment.
- Trees 3 (Downy Birch), 4 (Italian Alder), 7 and 8 (Fastigate Hornbeam) are outside the proposed construction area. These trees will be protected and retained.
- Trees 2 (Purple-leaf Plum) and 10 (Downy Birch) are within the construction area. These trees will be retained and will require special precautions (refer to 8.1 Tree Protection Method Statement) to minimise the risk of damage to the roots.

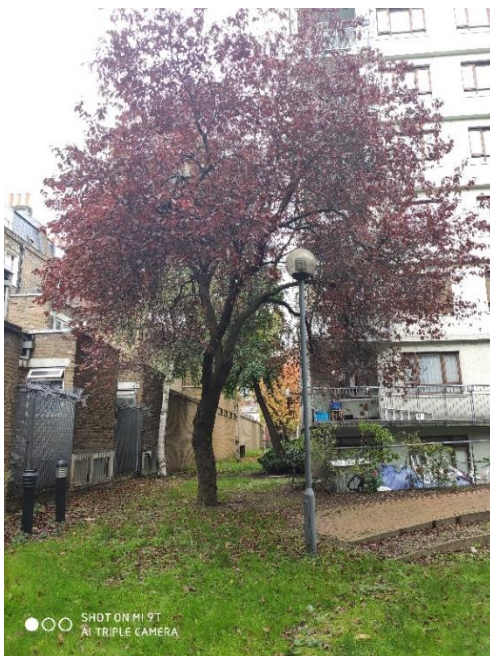
5.4.2. Trees 2 to 6 are considered to be of low category reflecting their small size and restricted amenity value. These trees are growing at the rear of the existing Community Centre building and so are of restricted public amenity value (refer to photographs 3 to 6 below).

**Photograph 3 showing tree 2.**

6.1.6. Trees 2 & 10 will be protected and retained. The circular representation of the root protection areas extends into the proposed construction areas. The basement excavations encroach slightly into the RPA of Tree 2 (Purple-leaf Plum). This is a very minor incursion and is unlikely to have a significant impact on the stability or health of the tree. In addition, new paving is proposed over approximately 25% of the area of the RPA. This will need to be of porous permeable design laid on a 'minimal dig' base to prevent damage to the rooting zone.

8.4.2. Before any basement or foundation excavation works commence the outline of the basement within the RPA of tree 2 will be carefully excavated by hand and any roots crossing into the footprint of the basement cleanly cut before the excavation works commence.

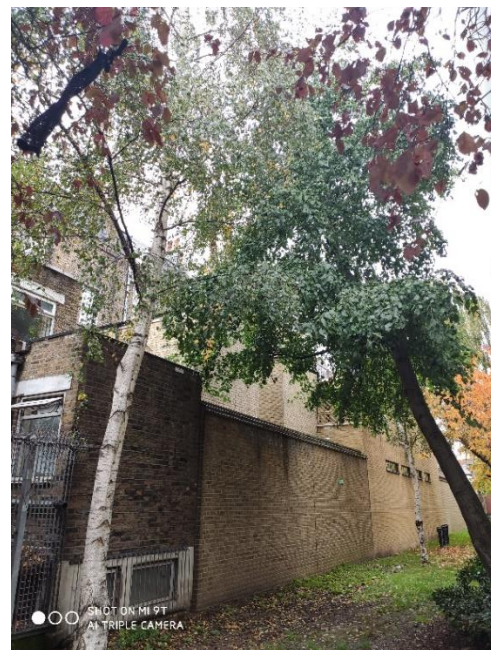
**Photograph 4 showing trees 3 and 4.**

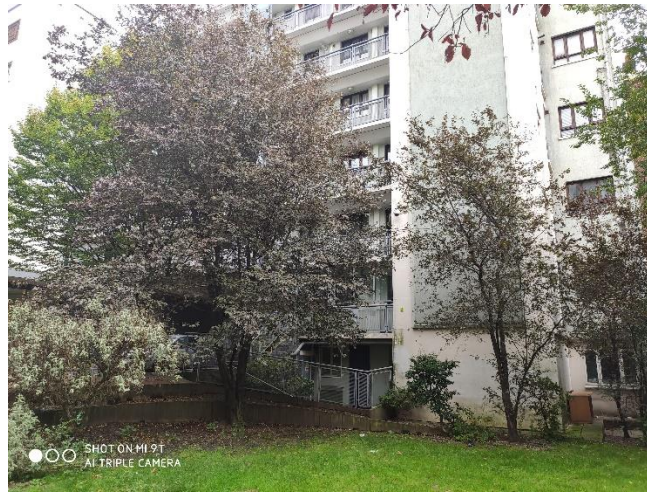
**Photograph 5 showing trees 5 and 6.**

6.1.5. The basement excavation extends into the west side of the RPA of tree 5 and in addition, the tree is located within the proposed garden area. Plum trees are recognised by a number of authorities as being shallow to moderately deep rooted on clay soils. Excavations within the RPA may lead to significant root damage or loss and result in a decline in the health of the tree concerned. Plum trees (*Prunus* species) are vulnerable to infection by *Ganoderma* as the infection is considered to be associated with root damage and severance. As with any fungal species that causes root and butt rot in living trees, decay by *Ganoderma* can cause mechanical failure of the stem base or root plate.

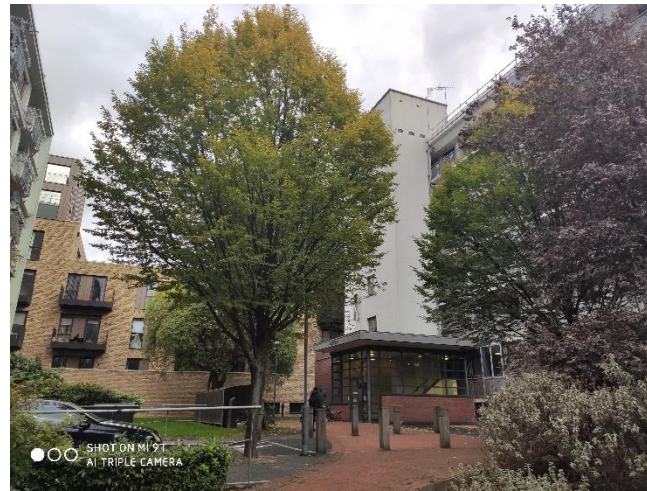
5.4.3. Trees 7, 8 and 10 have been categorised as B2. Trees 7 and 8 are in good condition and of long-term potential and tree 10 is a prominent tree at the front of the buildings (refer to photographs 6 and 7 below).

**Photograph 6 showing tree 5 to right of tree 7 at centre.**

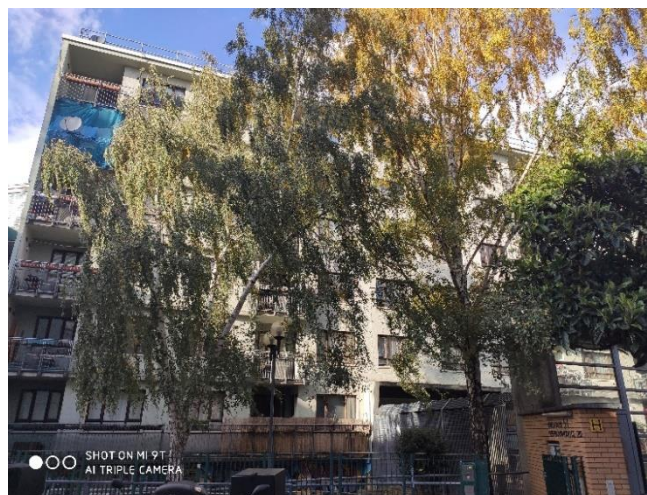
**Photograph 7 showing trees 9 and 10 at the front of the building.**

6.1.7. Tree 10 (Downy Birch) is located at the front of the property within the existing stepped and ramped access to the building and the. There are several elements of hard landscaping and hard surfacing making the prediction of the root locations difficult. The existing ground level slopes downward towards the existing building and the encroachment within the RPA to create the lower ground level patio area is less than 15% of the RPA. Birch trees tend to be shallow rooted and intolerant of root damage so any works within the RPA will require careful
