ARBORICULTURAL IMPACT ASSESSMENT REPORT FOR:

32-34 Avenue Road
London
NW8 6BU

Ref: SHH/32AVR/AIA/01a

Date: 25th April 2022

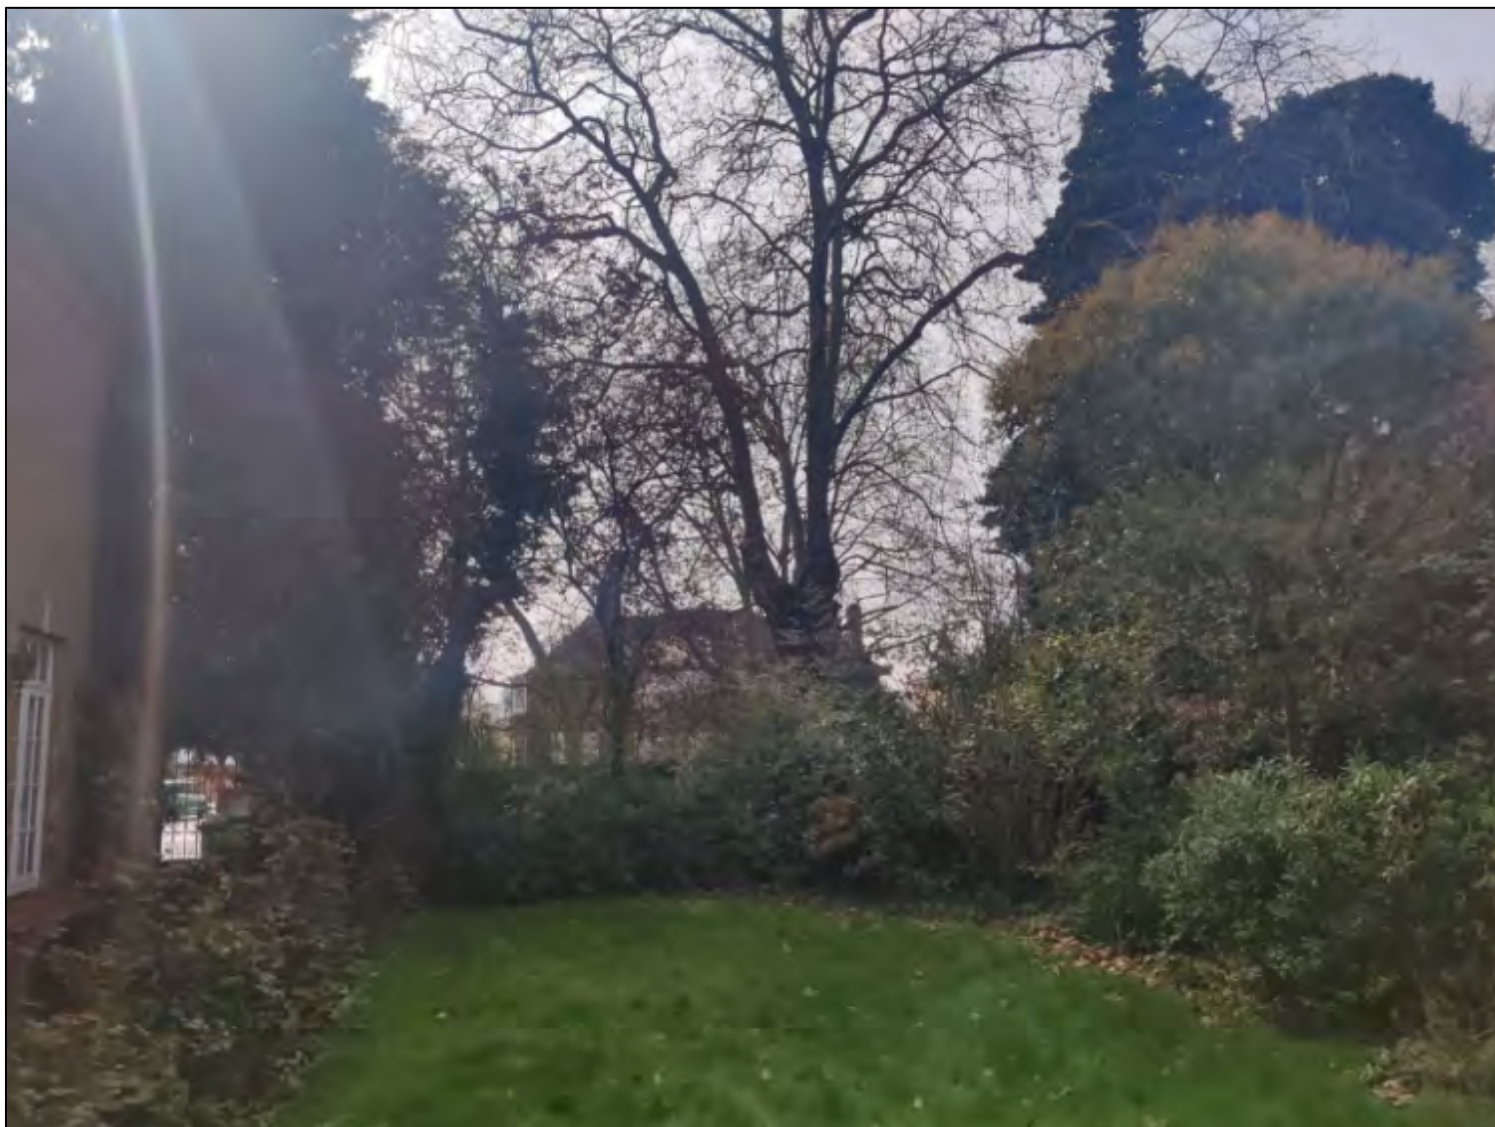
Photograph 2: London plane T22

- 6.1.2 Further impacts to retained trees comprise the encroachments of the RPAs of T's 8, 9, 10, 14 and 22 by the proposed LGF level with these encroachments ranging from 2%-7%. There is an additional impact to T22 of approximately 1% of its total RPA from the ground floor of the replacement building. In our view, the tree(s) are of a species, age and condition sufficient to remain viable in the circumstances, given that the area lost to encroachment can be compensated for elsewhere, contiguous with the RPA, and provided the series of mitigation measures outlined below are followed to both reduce the immediate impact of working methods and also improve the soil environment that is used by the tree for growth. Supervision and monitoring of such measures will also be essential. Subject to these provisos the net impacts are assessed as being low. Trial pits can of course be provided to confirm these assessments.

Tree No.	English Name	B.S. Cat	Height	Ground Clearance	Crown Spread	Recommended Works	Comments/ Reasons
21	Cherry, Japanese	U	5	2.5	2423	Fell	Dying, decayed stem, silver leaf Management priority 2
22	Plane	A	22	3.5	10	CCL Crown clean & climbed inspection for Massaria	Minor deadwood & hangers throughout crown, Early & limited decay in base Garden arisings piled around base, ivy clad Management priority 2
24	Cherry, Japanese	U	5	1.6	3	Fell	decay fungus @base N side compression union@1m Mature Gannoderma spp brackets Management priority 2

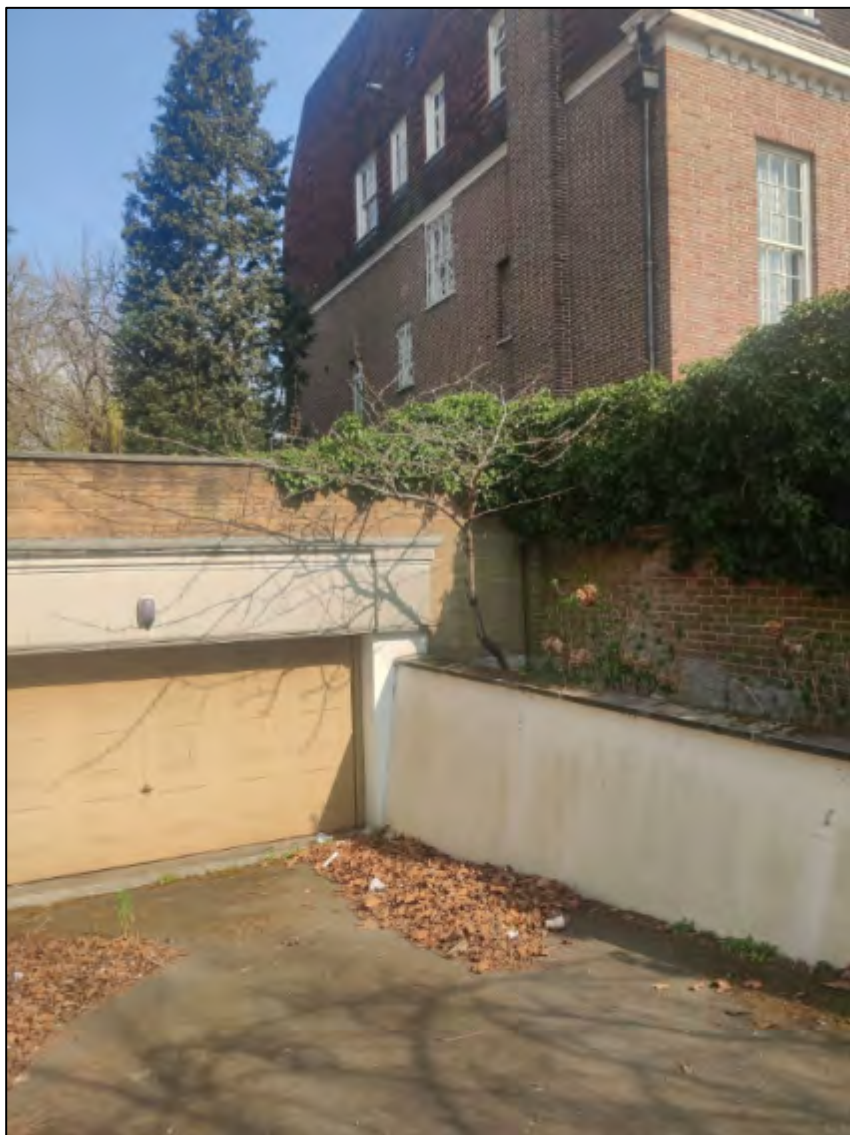
Photograph 3: Sunken garage

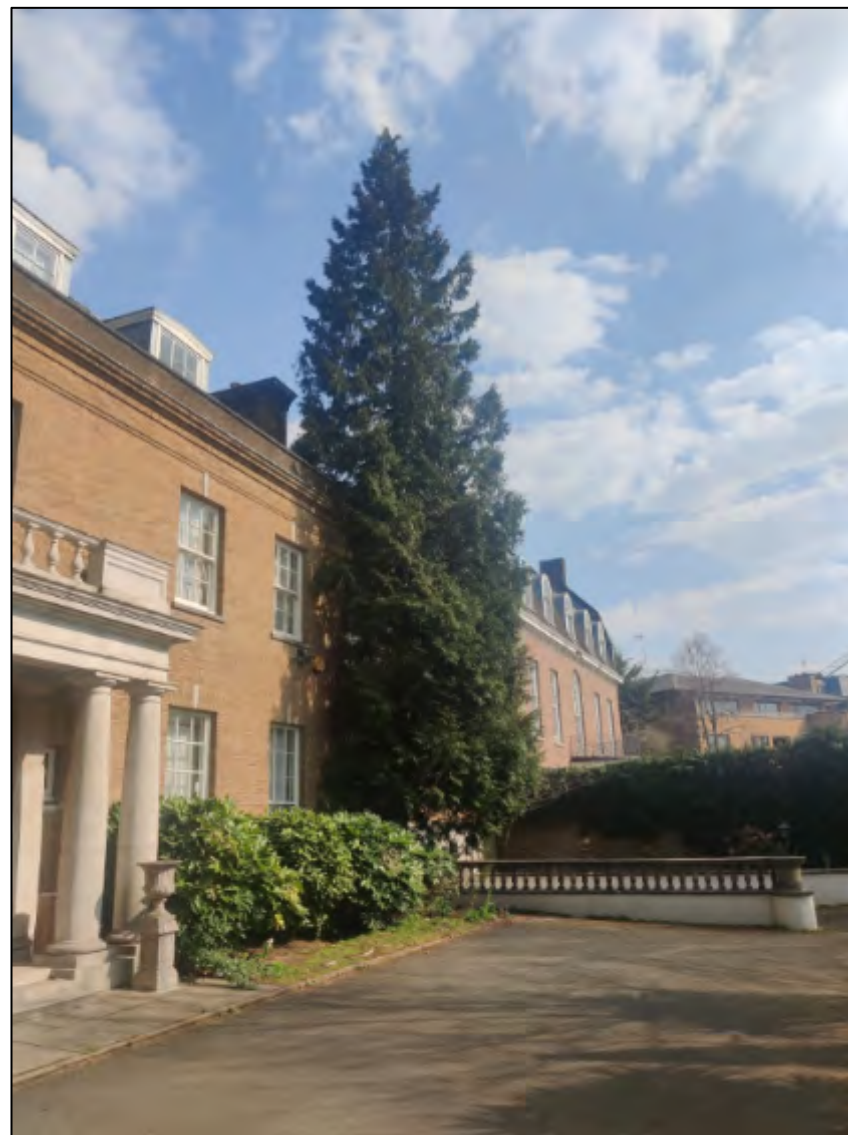
Photograph 4: Western red cedar T23
