ARBORICULTURAL IMPACT ASSESSMENT REPORT FOR:

31 Elsworthy Road
London
NW3 3BT

Ref: BBP/31EWR/AIA/01d

Date: 4th May 2022

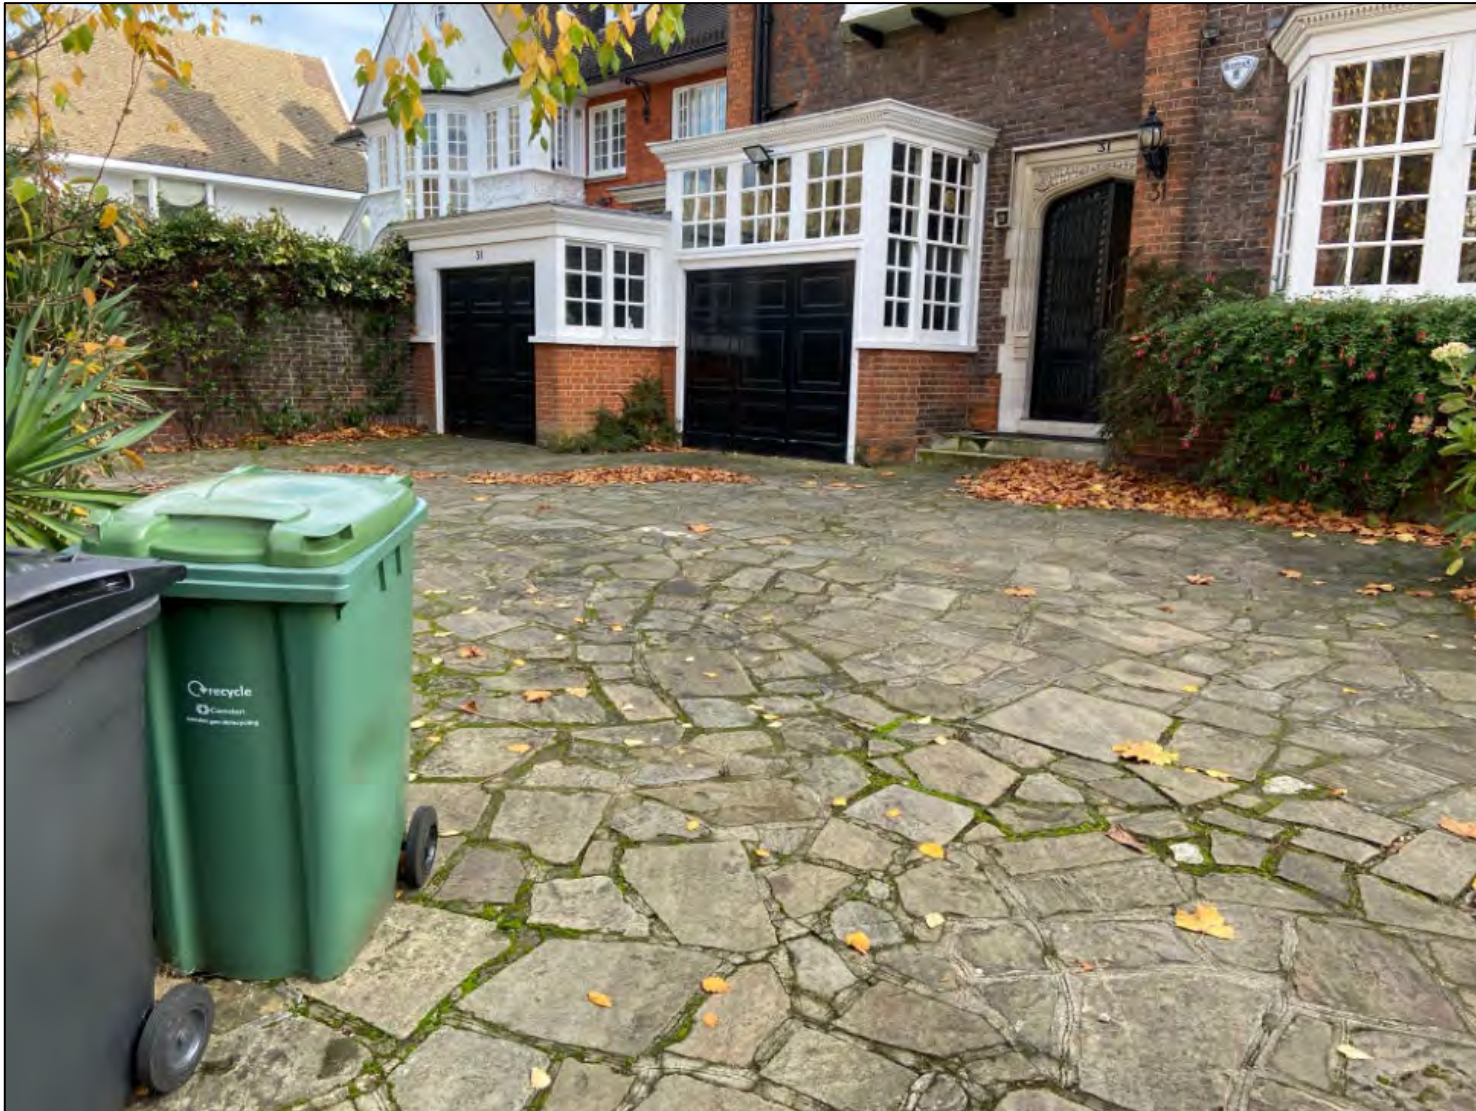
Photograph 2: Existing front driveway surface

- 6.1.3 The replacement of the front driveway encroaches within the RPA of the retained trees on the site's frontage and therefore will need to be undertaken in a controlled manner.

- 6.3.5 The replacement paving/hard landscaping will require a no-dig construction technique, either using a cellular confinement system with no fines aggregate for the sub-base or simply building upon the existing sub-base without disturbing the ground below. Choice of construction method will initially depend upon root penetration within the existing sub-grade. The key principle is not to excavate in the presence of roots and to provide a porous surface to promote healthy soil water relations for future root growth. A further consideration in the use of a more expensive cellular confinement system or similar, may be the claimed reduction in risk of possible future slab / surface displacement by roots of trees growing in paved areas.
- 6.3.6 The immediate canopy encroachment can be avoided with a minor crown reduction to T2.

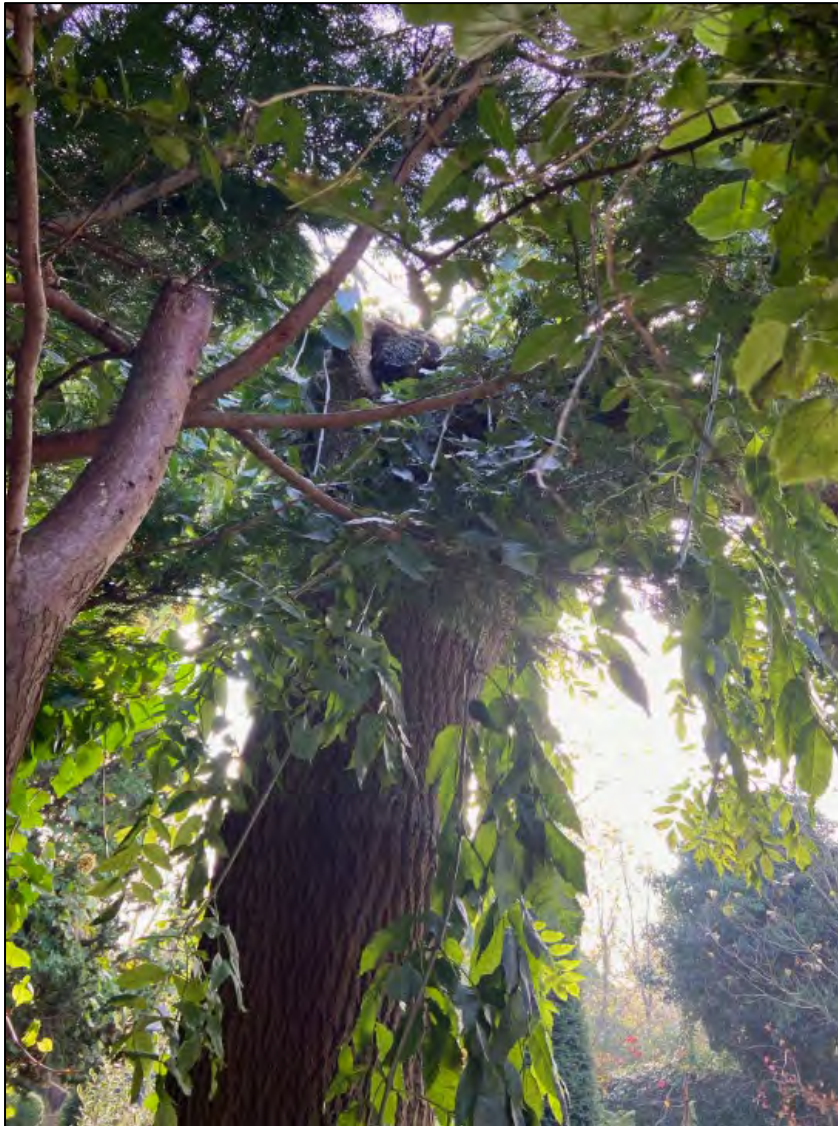
Photograph 3: Stem of the ash T13

6.3.2 RPA encroachments of >5% area are shown in Plan 2 compensated for elsewhere on contiguous land. The parts of the RPA of T13 within the application site that are outside the basement footprint will be treated with biochar or similar to improve rooting conditions therein.

6.3.3 The path of the basement foundations through the RPA of T13 will be manually excavated to 750mm depth under arboricultural supervision; any roots encountered within the trenches / pits will be cleanly pruned back to an appropriate junction with a sharp pruning saw or secateurs back to a junction. Roots larger than 25mm diameter may only be cut in consultation with an arboriculturalist. The path of services to the A/C unit could be box hoarded above ground through the shrub border above the roots of T7 birch.

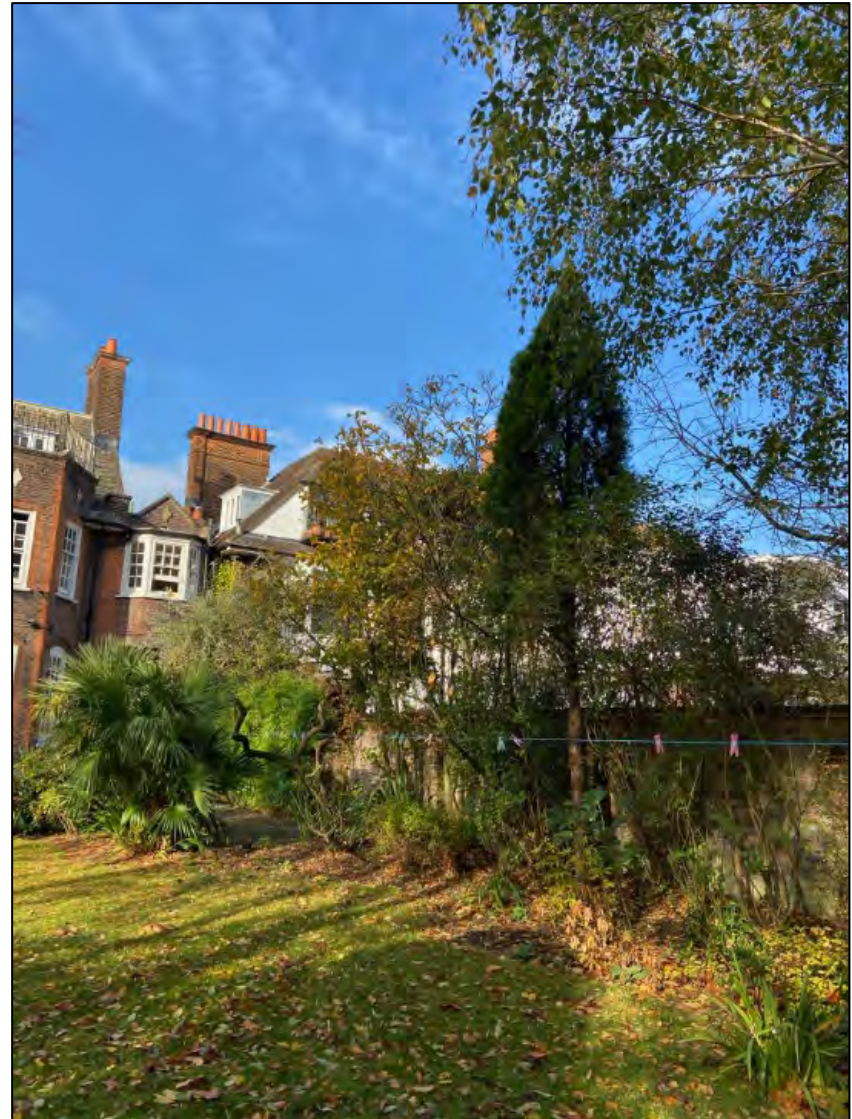
Photograph 4: The low quality T8 – T12

- 7.4 The trees that are recommended for felling are of little individual significance, such that their loss will not affect the visual character of the area.

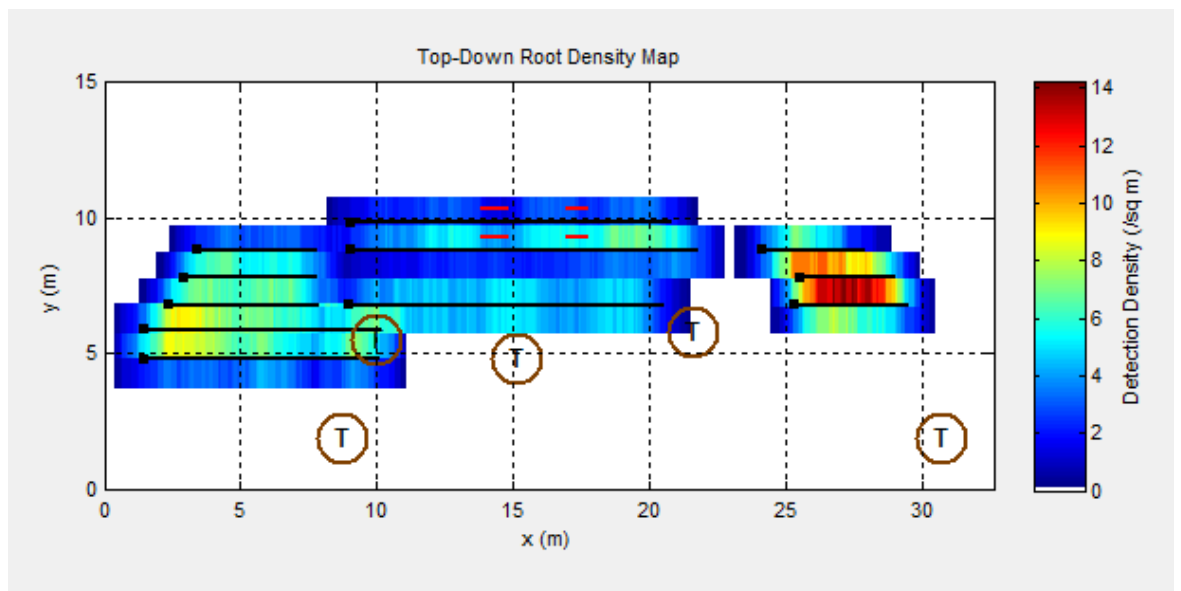
(i) Root detections located adjacent to T13, T1, T2, T3

The Top Down Root Density Map details areas of the scan that show the most root detections across the whole scan area. Areas of higher density (12 detections per M²) appear in red, with areas of lower root density (0-2 detections per M²) appearing in blue. Detections refer to individual root detections and do not relate to root size or amount of root biomass, therefore it is typically expected to see higher densities further away from the tree.
