**ARBORICULTURAL IMPACT ASSESSMENT REPORT FOR:**

52-54 Avenue Road  
London  
NW8 6HS

**Ref:** DML/52AVR/AIA/01d

**Date:** 6<sup>th</sup> May 2022

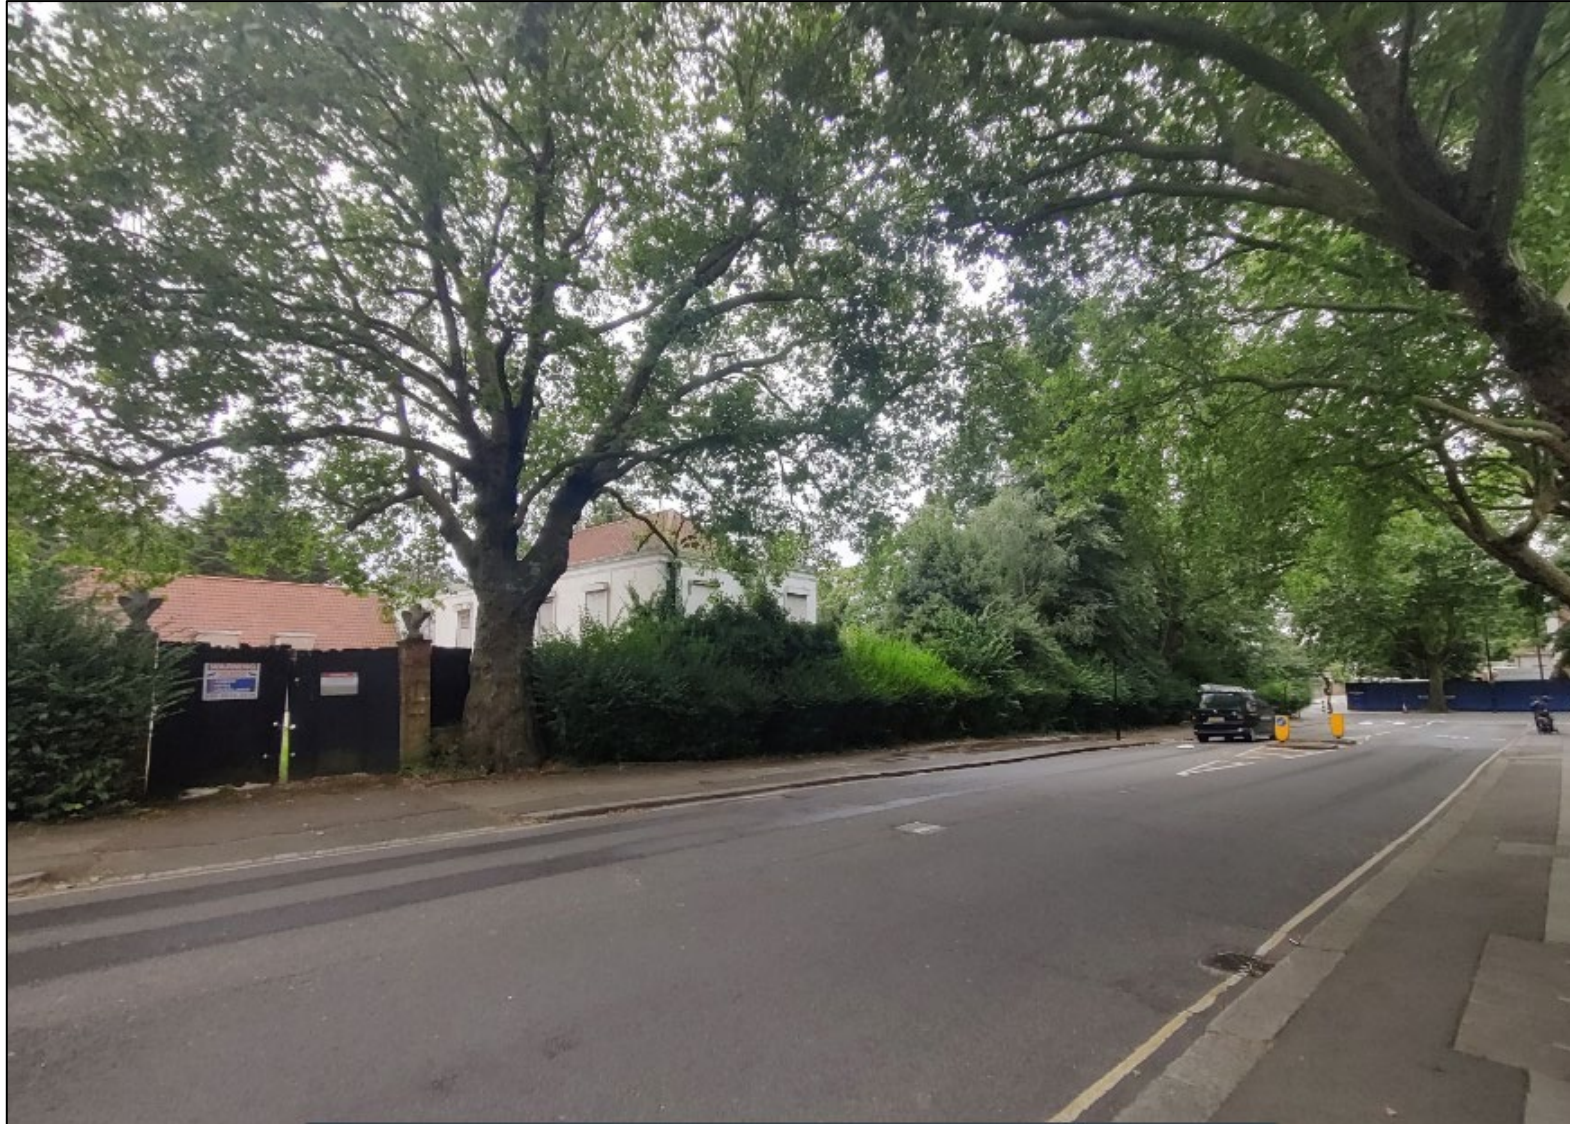
Photograph 2: The site's frontage along Elsworthy Road

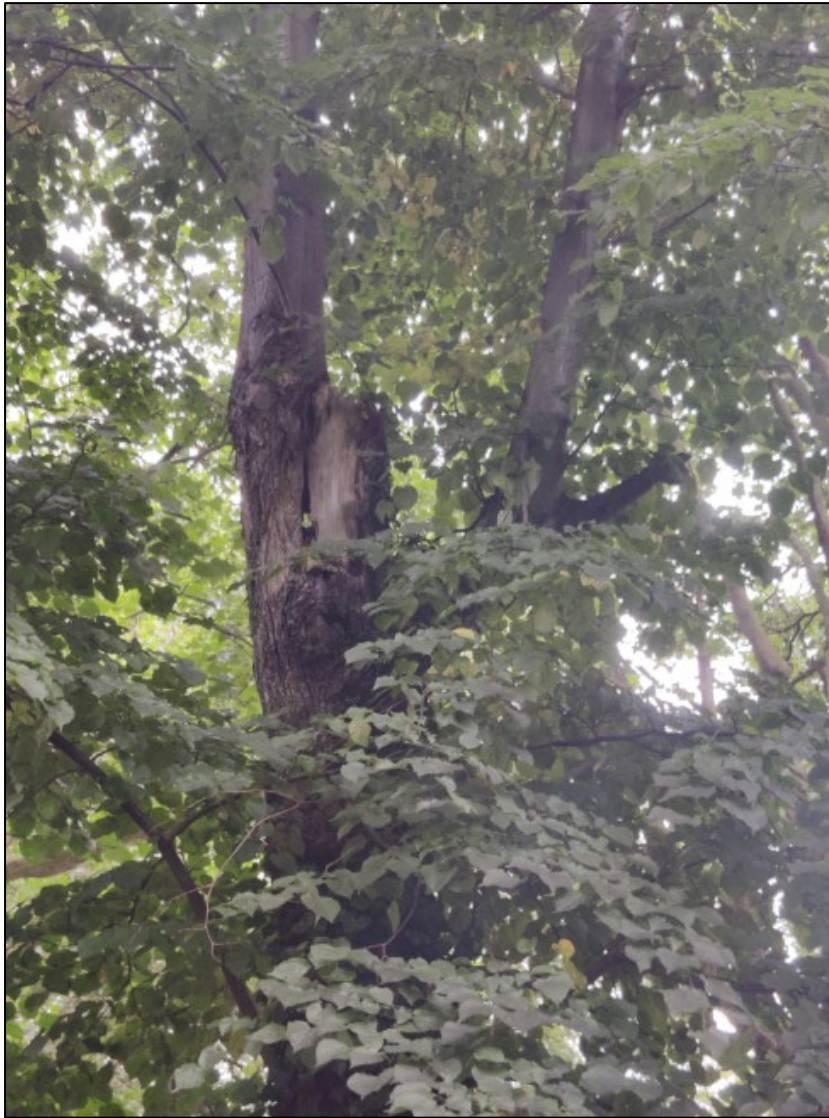
Photograph 3: Decay at pollarding point of T7

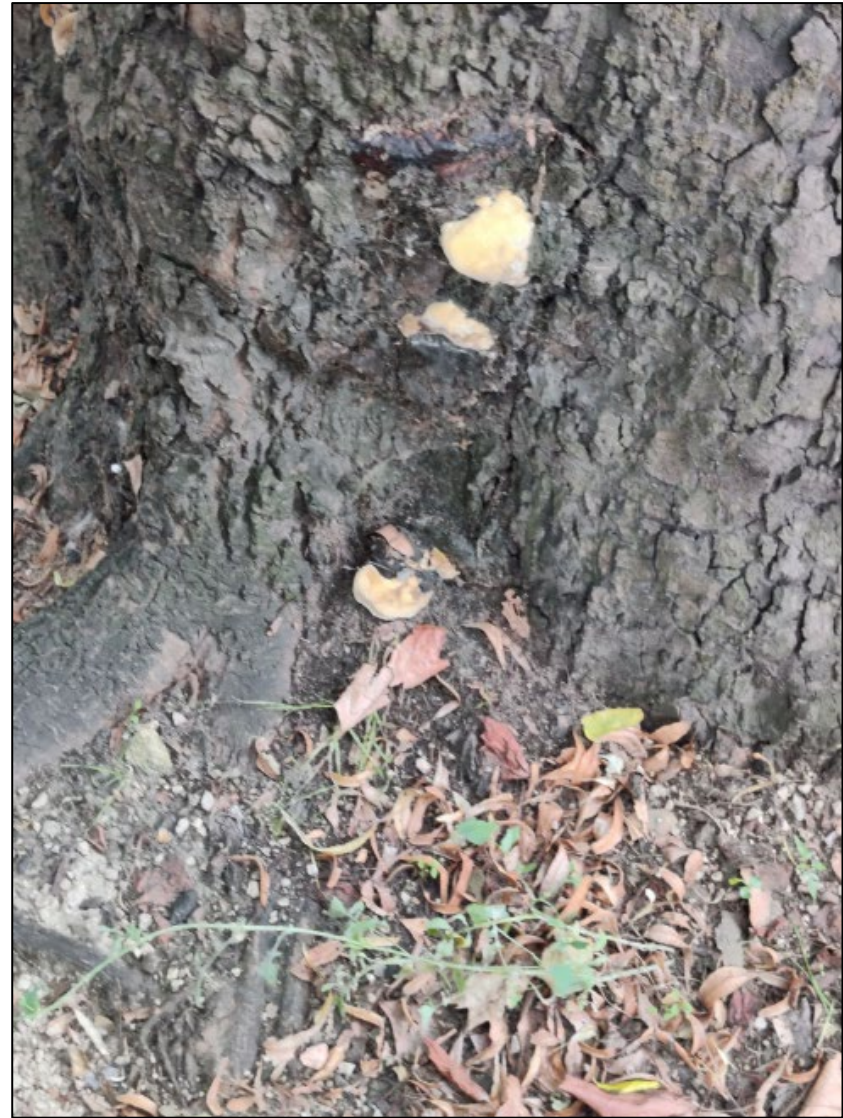
Photograph 4: Fruiting bodies at base of T12
