# 24 John Street

## Heritage Statement

24 John Street  
Bloomsbury  
London  
WC1N 2BH

London Borough of Camden  
June 2022

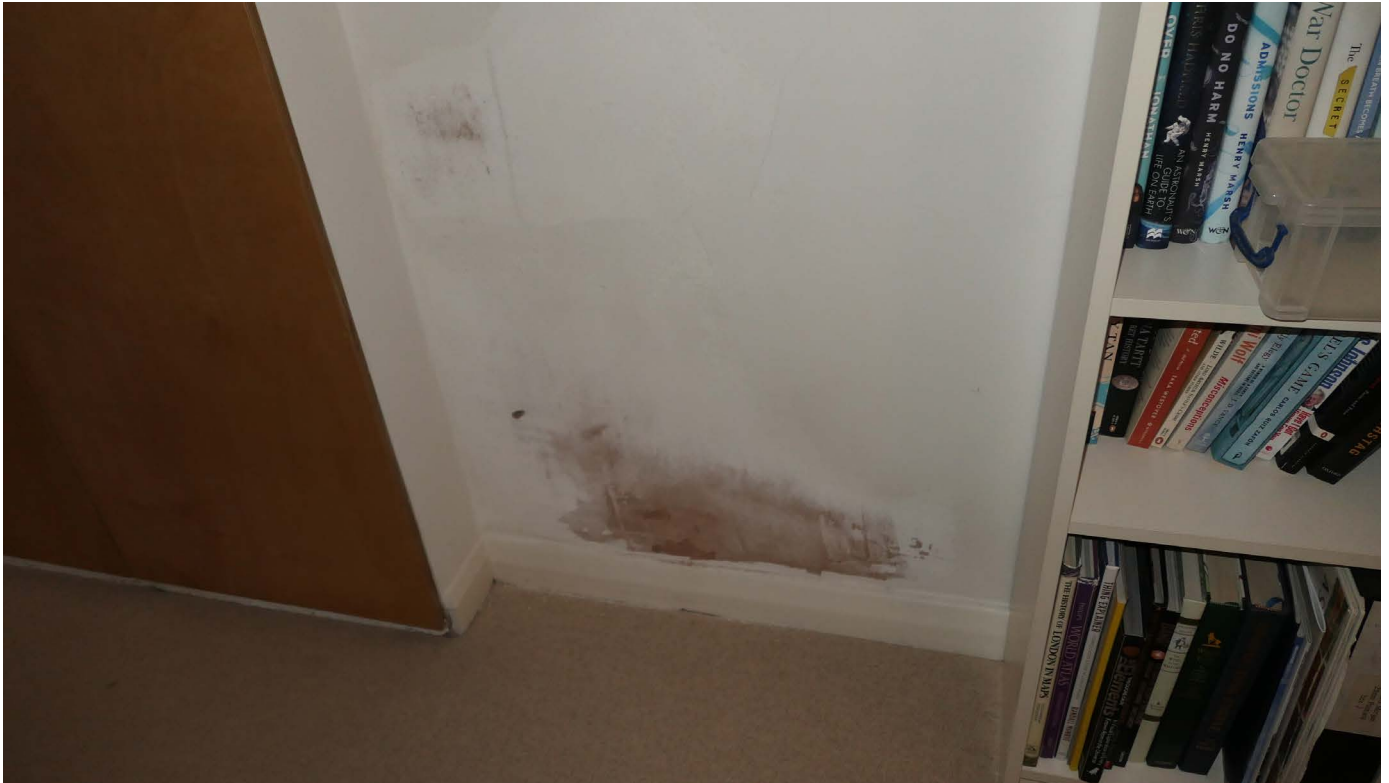
**Figure 1**

The problem appears to be a typical case of rising damp, exacerbated by a lack of proper ventilation. As damp proof courses ('DPCs') only became common in London from c.1870 onwards, the brickwork and plaster on the walls is in direct contact with the moist ground below via the footings to the foundation. This allows capillary action to draw up water from the ground through the brickwork and plaster, where it evaporates into the drier and warmer interior of the house.

As the water originates in the ground and travels through the brickwork, there are usually salts dissolved into the water, particularly nitrates. Upon evaporation at the wall surface, these salts are left behind in increasing amounts on the wall and in the brickwork. The presence of these salts, which can be observed visually or tested for chemically, is the main symptom of rising damp.

Typical example of dampness present in the basement. The dampness is most severe at the base and decreases in severity further up the wall. The moisture and salts gradually disintegrate the paintwork and eventually the gypsum plaster.

We propose to do this by removing all cementitious render and linings back to brickwork, and subsequently replastering in traditional lime plaster applied directly to the wall. The lime plaster would then be panelled up to a height of approximately 1.1m, and painted above in breathable clay mineral paint.

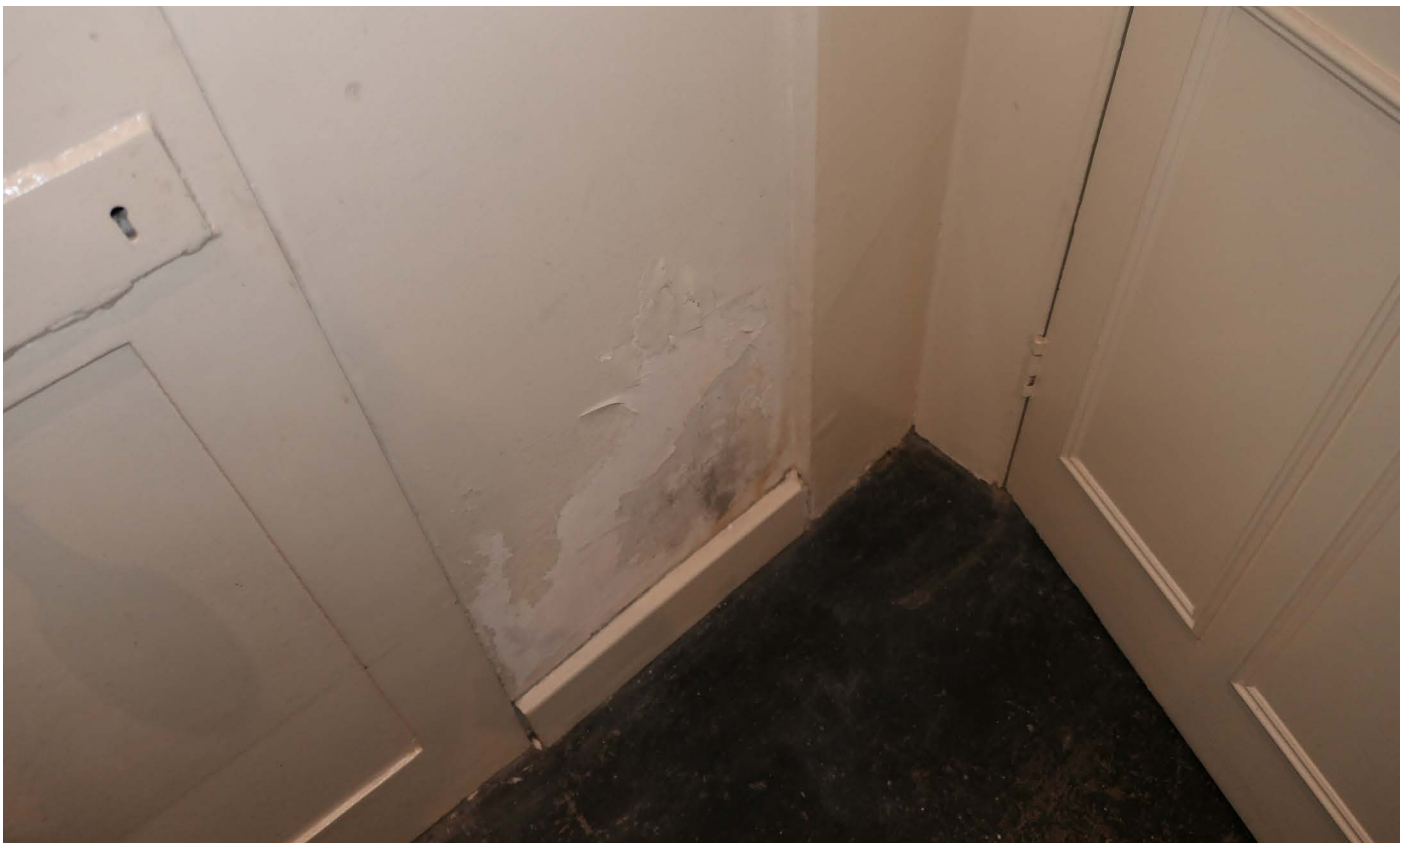
**Figure 2**

Another example of the effects of dampness. In this case the modern skirting board has begun to detach from the wall surface

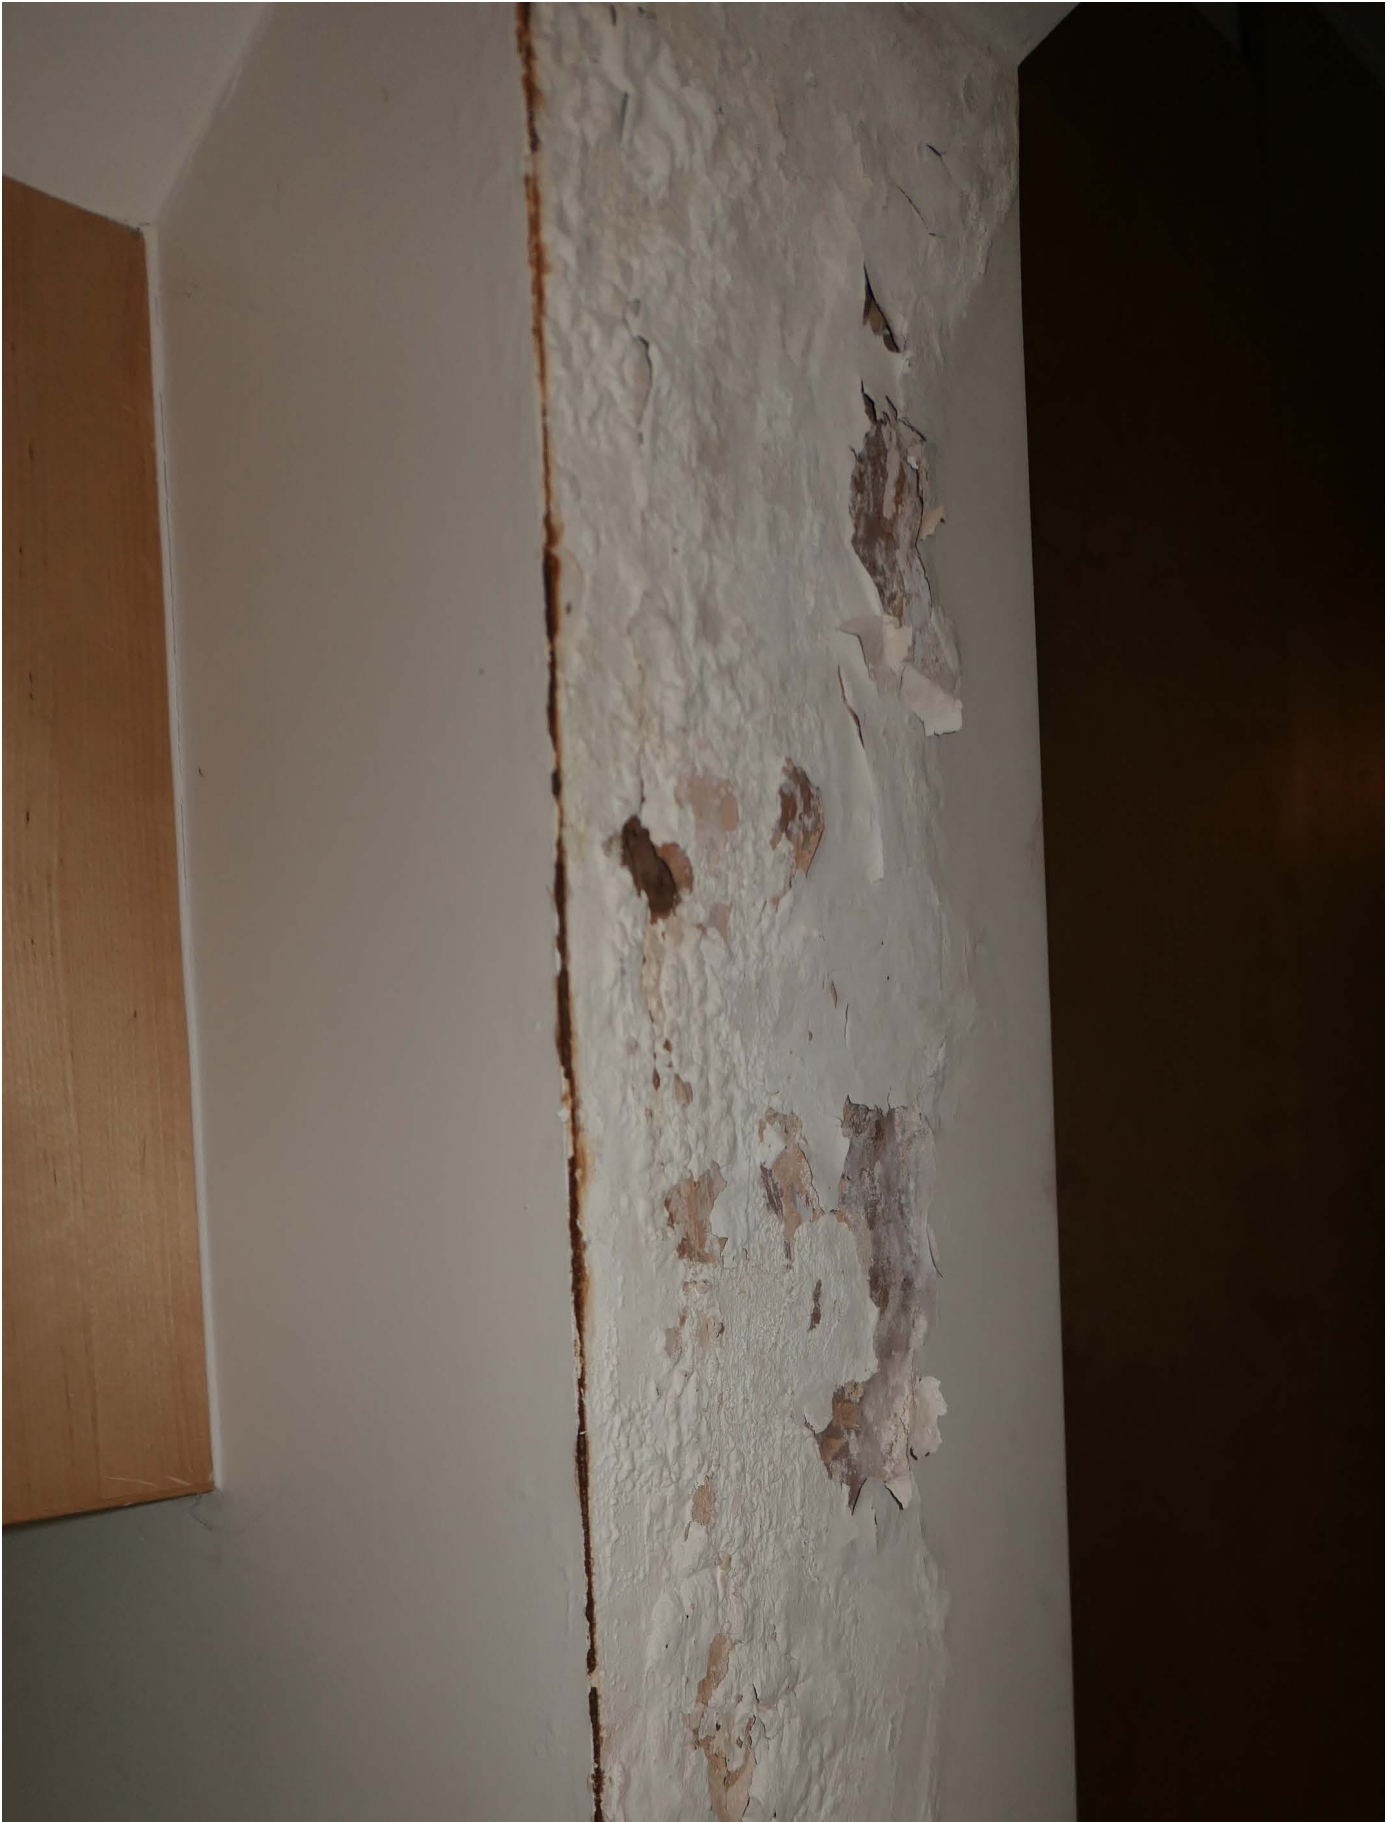
### Figure 3

One of the worst affected areas of damp, just below the entrance. Here there is quite serious damage to the finishes and corrosion to the steel plasterboard bead.

A french drain would also be installed just in front of the front elevation to the house. This is because the internal dampness is particularly severe in this location, and severe dampness at this location appears to be common to Georgian houses in this area.

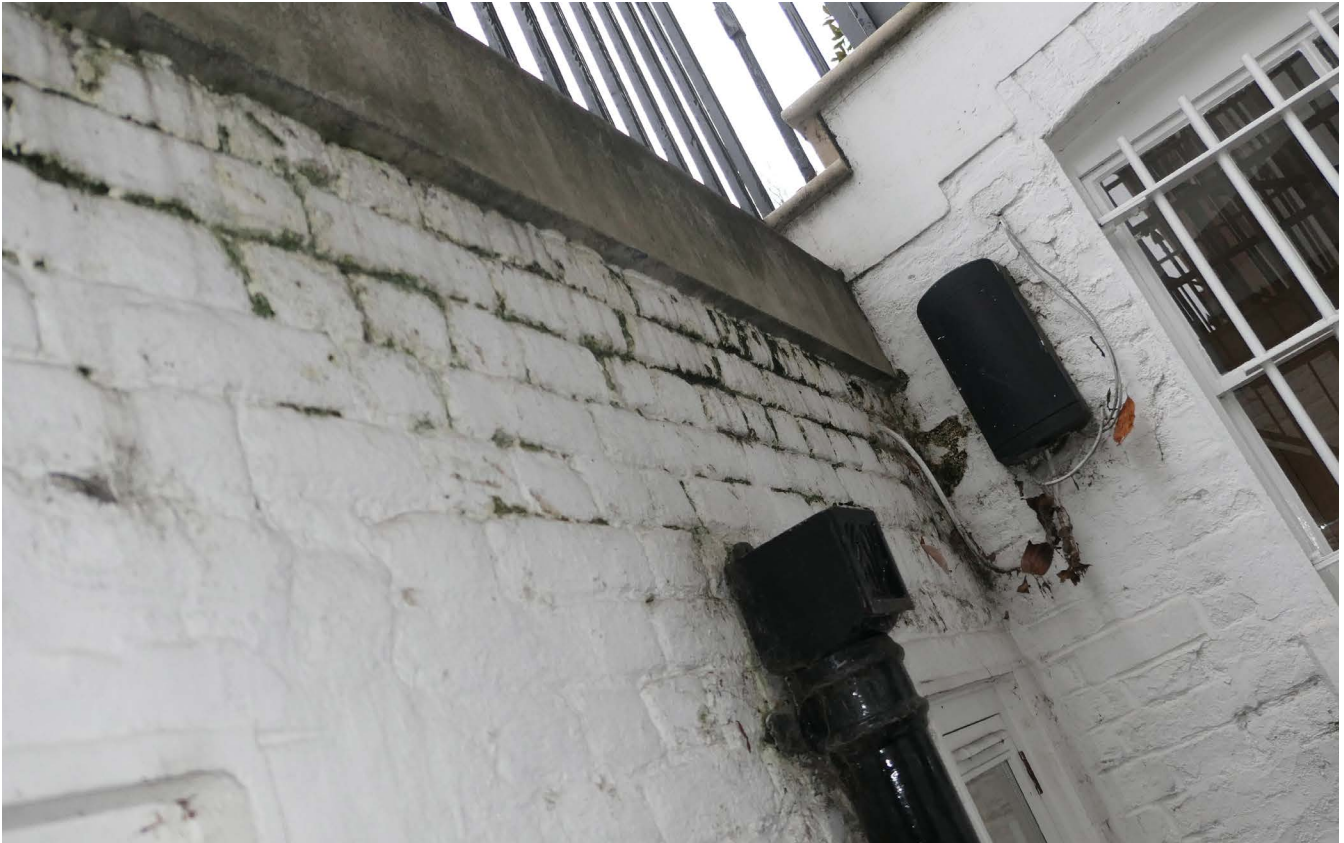
Figure 5

Discolouration etc of retaining wall in front lightwell. Railings to street seen above.

1. **Front Lightwell Alterations.** The existing lightwell is painted brilliant white on all four sides. These walls are discoloured and encouraging algal and moss growth due to excessive moisture in the soil behind the retaining wall. It is proposed to strip the paint on all sides excepting the building itself, which will be kept white to match neighbours. It is also proposed to install an electric car charging point in the lightwell, and a tap for watering the plants at the entrance. If considered of importance, the location and design of these items could be secured by condition.

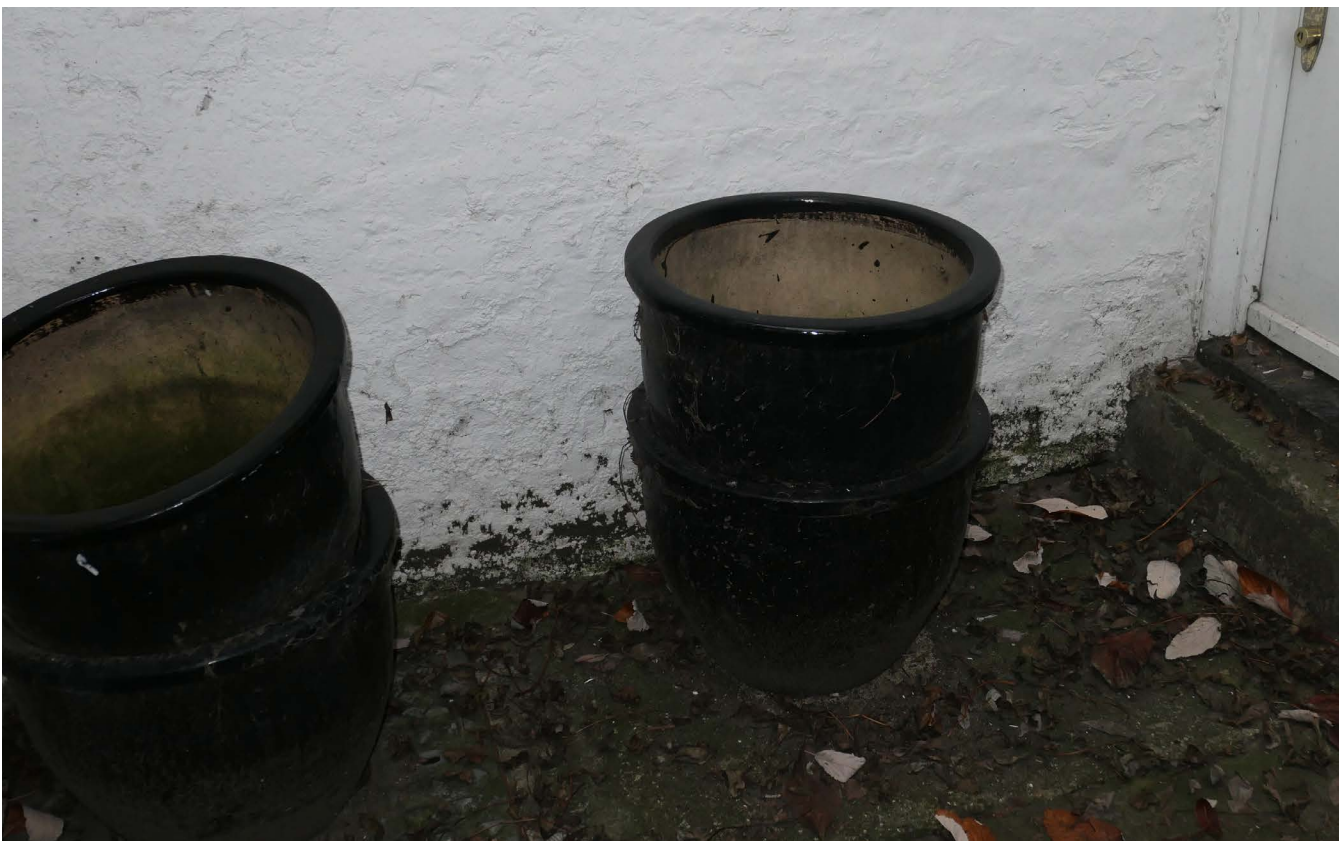
Figure 6

General accumulation of sludge in front lightwell due to lack of proper drainage etc

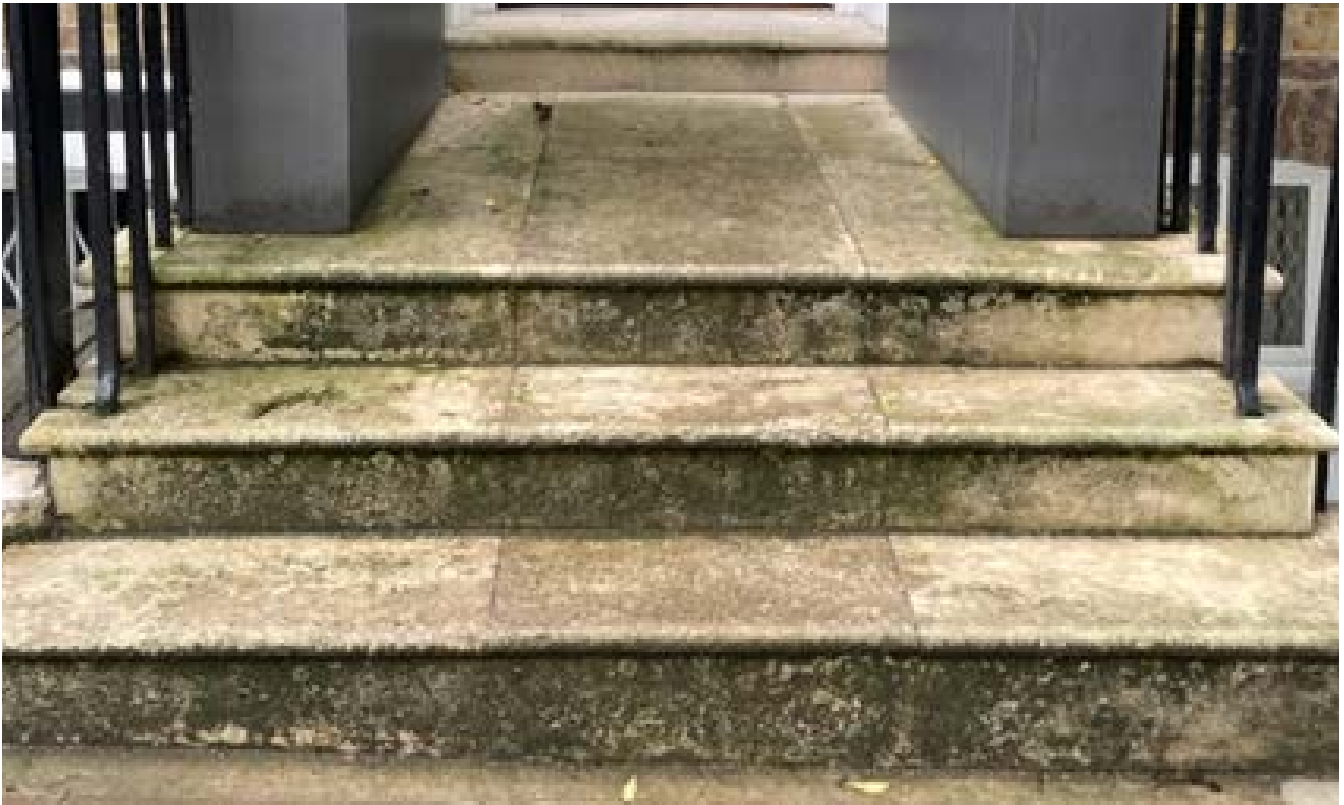
**Figure 9**

The front entrance steps have degraded unusually quickly. This is thought to be due to an inferior stone.

5. **Refurbishment of Entrance.** The entrance steps have suffered from delamination, and as such it is proposed to replace them in bull-nosed York stone. It is also proposed to install dim lighting at the entrance. It is anticipated that details will again be secured by condition.

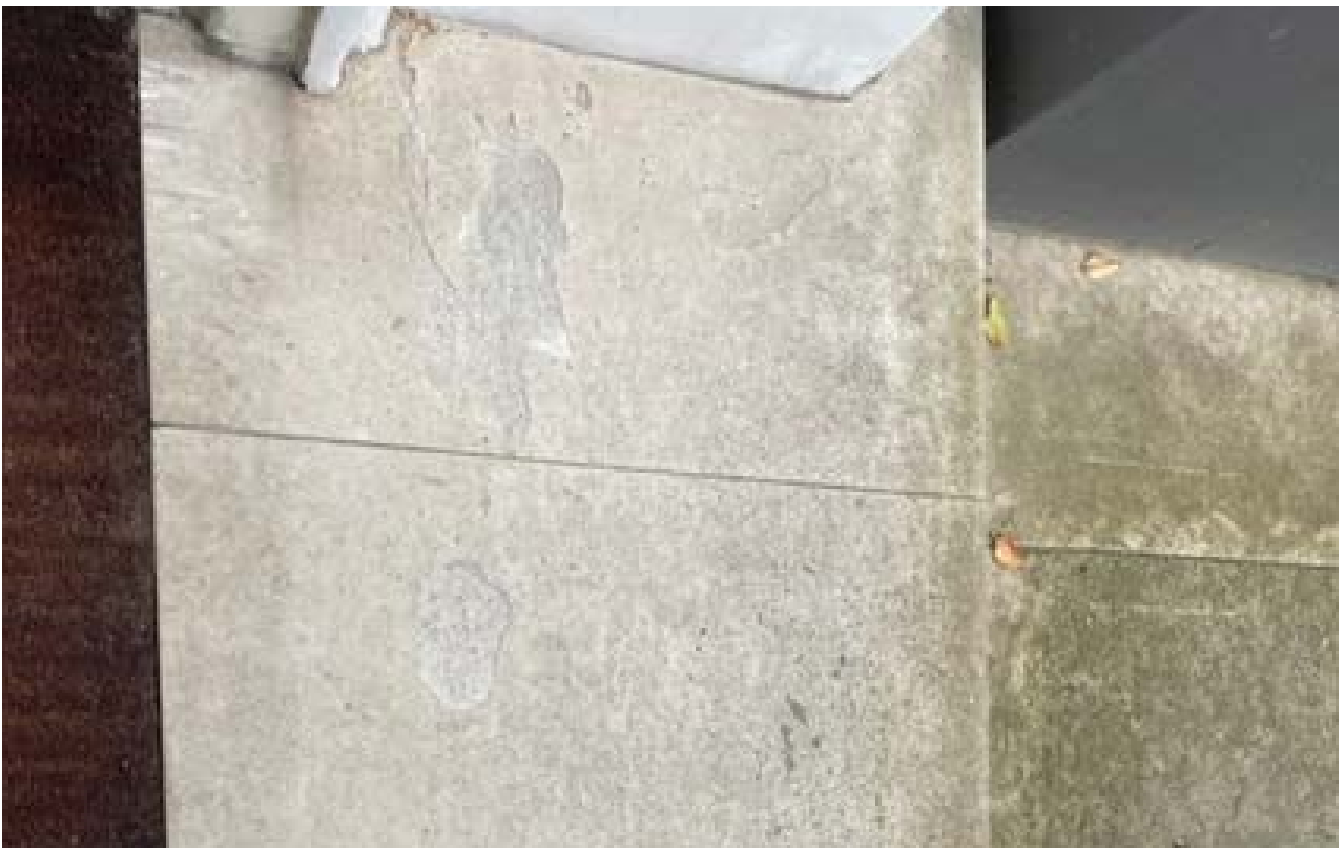
**Figure 10**

Delamination of entrance steps at threshold.
