BS5837 Arboricultural Impact Assessment & Method Statement

Flat 6, 9-11 Belsize Grove, Belsize Park, London, NW3 4UU

Client: Mr J Delaney

Job Reference: 03792R

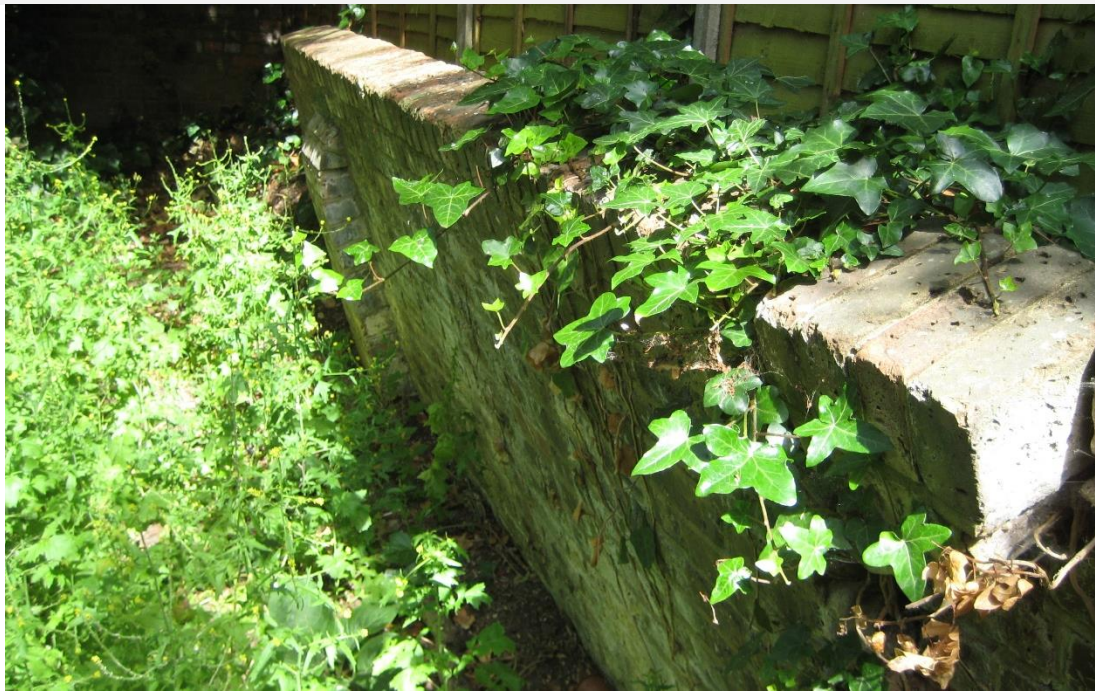
Existing Wall – North Boundary

- 5.4.1 No demolition is required. It was noted that the boundary wall to the north of the site is in a state of collapse but we have not been advised of any works to address this issue.

- In the event of any works to remove/replace or stabilise the boundary wall to the north of the site please contact us for further detail as to how this could impact retained trees.*

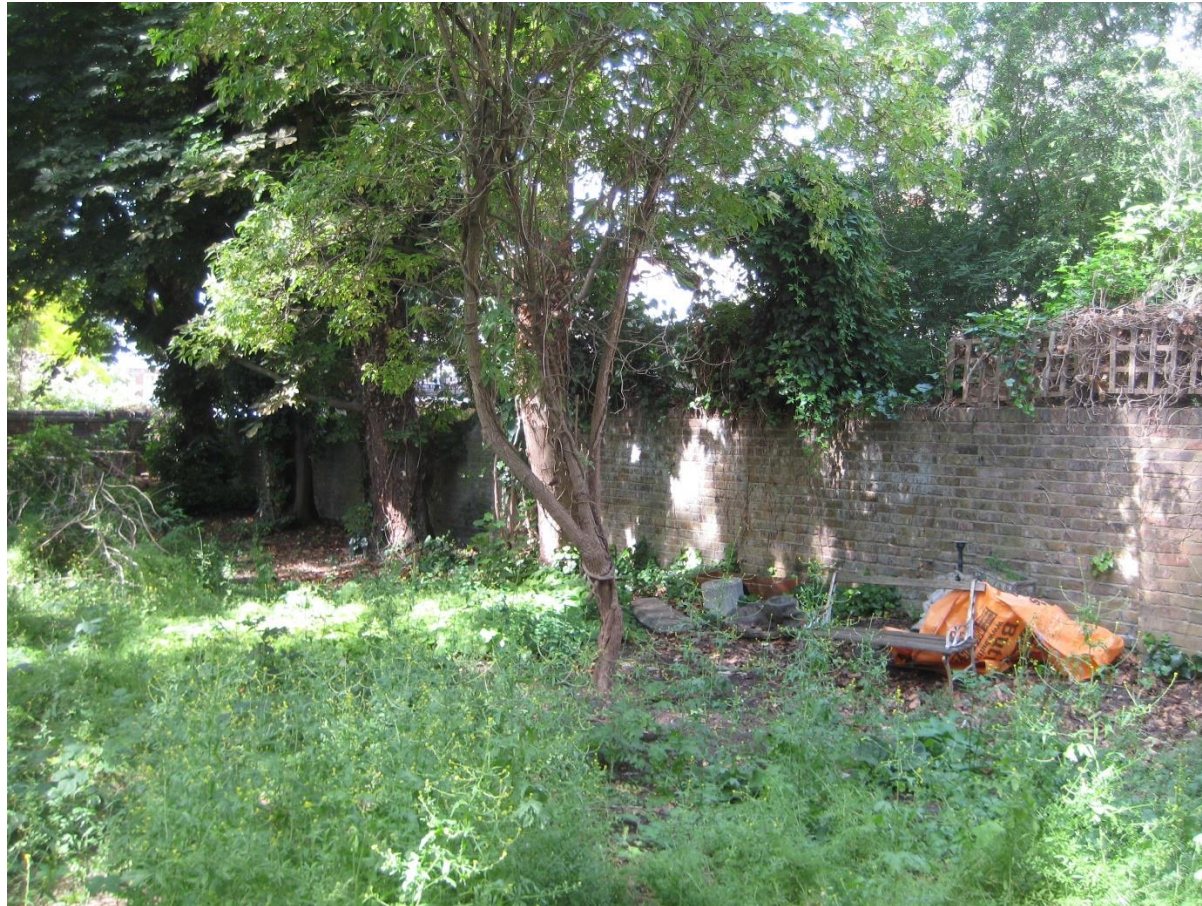
Image 1 – Proposal area and existing ground conditions with T4 Elder (centre)

5.3.1 T4 will be removed to facilitate the proposal and is a small Elder. T2 & T7 have been identified as U Cat trees and should be considered for removal on the basis of their identified condition (see images in Appendix 7).

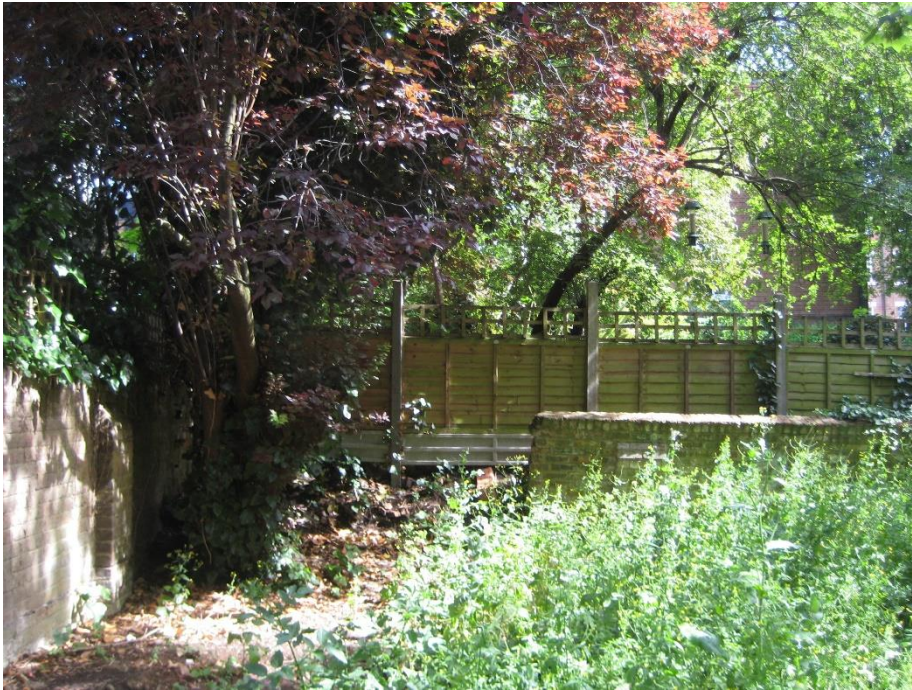
Image 2 – Looking towards T5

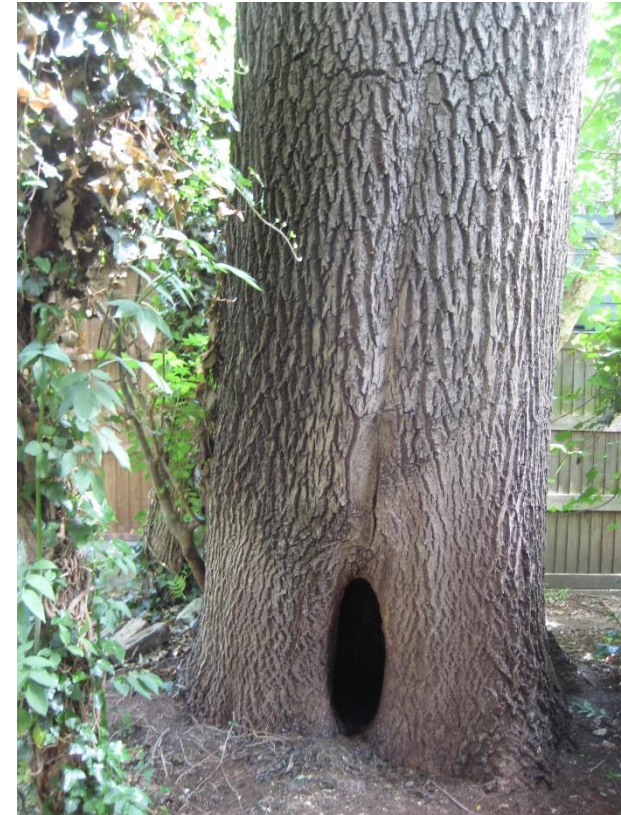
Tree No.	Species	DBH (m)	No of Stems	Ht (m)	Crown Spread				BS Cat	Age Class	Life Expect	Cr Ht (m)	Observation	Recommendations	RPR (m)
					N	E	S	W							
T1	Ash	1.1	1	20	8.3	10	11	13.5	C1	Mature	10 to 20	4	Very large and spreading example. Marked down due to likelihood of Ash Dieback and the large cavity and established decay at base. Branch breakouts indicate elevated vigilance for info outs advised.	No works	13.2
T2	Horse Chestnut	0.62	1	11	3	3.1	3.1	2.2	U	Mature	<10	1.7	Well established decay with possible Kretzschmaria deusta. Previously reduced. In light of new garden room target and to diversify age class removal and replacement advised.	Remove	7.4
T3	Sycamore	0.47	1	16	4	4.7	4.2	3.9	C1	Mature	20 to 40	3	Previously topped but now regrown. Decay pocket at 2.5m.	Crown reduce to points of previous reduction to reduce weight on stem with identified decay. Repeat	5.6

Tree No	Species	DBH	Height	Age Class	Life Exp	Observations	BS Cat	RPR
T1	Ash	1.1	20	Mature	10 to 20	Very large and spreading example. Marked down due to likelihood of Ash Dieback and the large cavity and established decay at base. Branch breakouts indicate elevated vigilance for <i>Inonotus hispidus</i> advised.	C1	13.2
T2	Horse Chestnut	0.62	11	Mature	<10	Well established decay with possible <i>Kretzschmaria deusta</i> . Previously reduced. I light of new garden room target and to diversify age class removal and replacement advised.	U	7.4
T3	Sycamore	0.47	16	Mature	20 to 40	Previously topped but now regrown. Decay pocket at 2.5m.	C1	5.6
T4	Elder	0.17	4.8	Mature	> 40	Small tree of limited visual significance or growth potential.	C1	2.0
T5	Plum (Purple)	0.34	6	Mature	20 to 40	Multi stemmed tree. Localised screening between properties but limited quality. Spring feature tree.	C1	4.1
T6	Ash	0.8	19	Mature	20 to 40	3rd party tree with no access to inspect. Vigilance for Ash Dieback advised. Level change between tree and site.	B2	9.6

Image 3 –Lower stem of T1 Ash

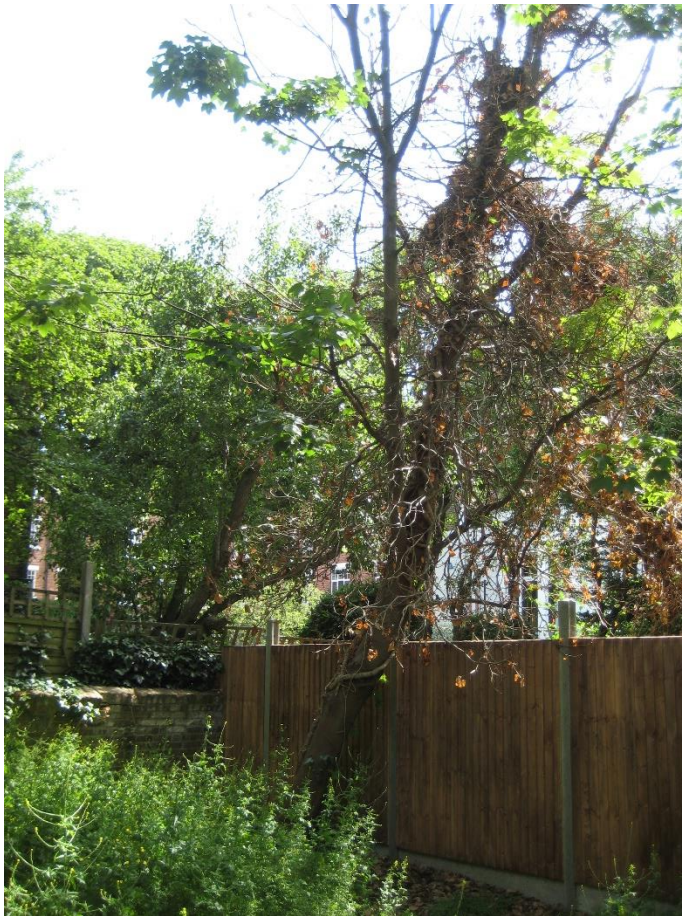
Tree No.	Species	DBH (m)	No of Stems	Ht (m)	Crown Spread				BS Cat	Age Class	Life Expect	Cr Ht (m)	Observation	Recommendations	RPR (m)
					N	E	S	W							
														at 5-year intervals. All works to accord with BS3998 Tree Works.	
T4	Elder	0.17	M/S	4.8	2.6	3.6	3.3	2.5	C1	Mature	> 40	1.8	Small tree of limited visual significance or growth potential.	Remove to facilitate proposed development	2
T5	Plum (Purple)	0.34	M/S	6	3.5	4	4.7	3.3	C1	Mature	20 to 40	1.7	Multi stemmed tree. Localised screening between properties but limited quality. Spring feature tree.	No works	4.1
T6	Ash	0.8	1	19	7	7	7.2	7	B2	Mature	20 to 40	8	3rd party tree with no access to inspect. Vigilance for Ash Dieback advised. Level change between tree and site.	No works	9.6
T7	Sycamore	0.3	1	10	4.4	3	4	4	U	Mature	<10	2	Previously Ivy covered. 3/4 dead. Removal required on health and safety grounds.	Remove	3.6

T7	Sycamore	0.3	10	Mature	<10	Previously Ivy covered. 3/4 dead. Removal required on health and safety grounds.	U	3.6
TG1	Elder x3, Ash x1	0.25	4.6	Early-mature	20 to 40	Small trees below T1.	C1	3.0
TG2	Hawthorn x1, Pear x1	0.25	5	Early-mature	> 40	3rd party trees with no access to inspect. Spring feature trees.	C1	3.0

Image 4 – T7 in severe decline

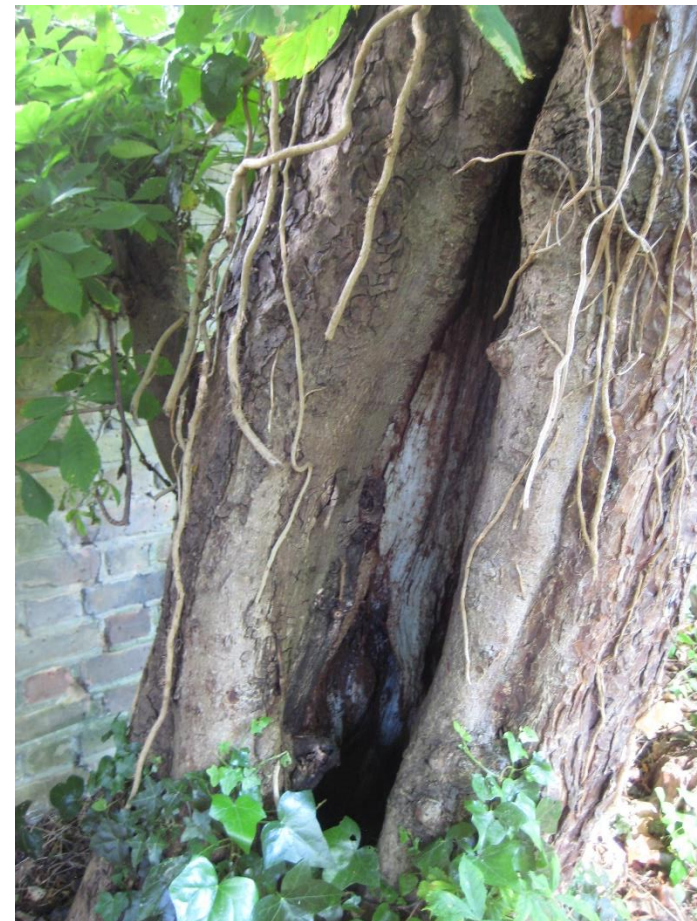
Image 5 –Lower stem decay of T2

- 1.2 T4 (Elder) will be removed to facilitate the proposal and T2 (Horse Chestnut) and T7 (Sycamore) have been identified as BS U Cat trees and recommended for removal based on their condition.
