PROJECT CREPE DELICIOUS

89 LEATHER LANE
CENTRAL LONDON
EC1N 7TS

EXISTING
ELEVATION

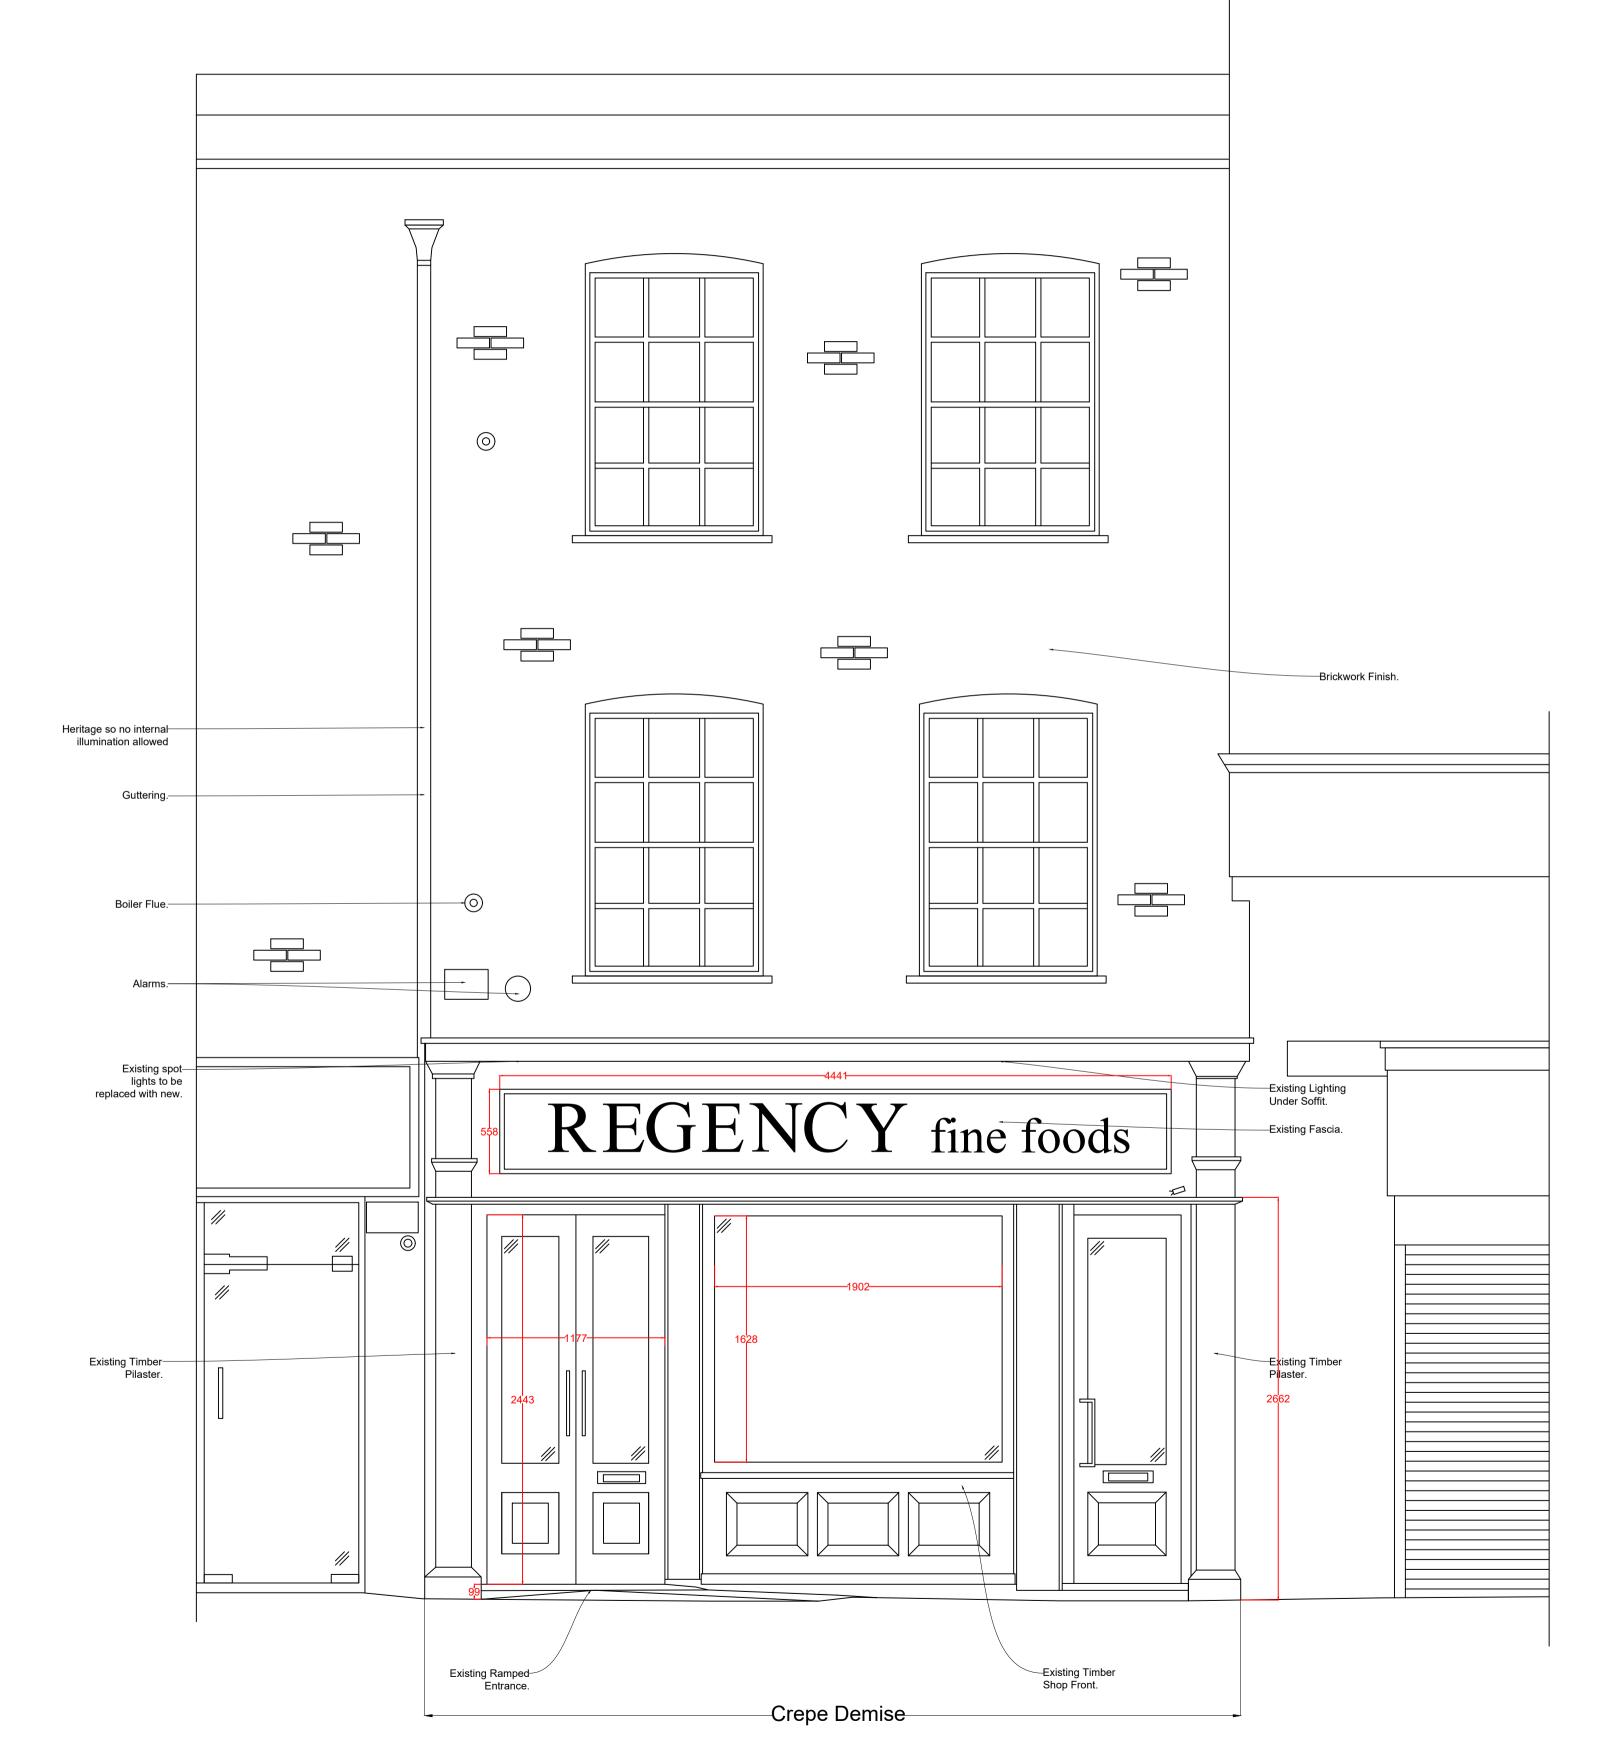
- FURTHER INVESTIGATION REQUIRED TO ASCERTAIN TRUE EXTENT OF COLUMNS AS HIGHLIGHTED ON THE PLANS.
- SIGNS OF WATER DAMAGE/ DAMP IN BASEMENT AT LOW LEVEL.
- EXISTING SHOP FRONT DOORS HAVE A STEPPED THRESHOLD.
- VENT LOCATED NEAR THE SHOP FRONT BETWEEN GROUND AND BASEMENT.
- UNIT IS LOCATED WITHIN A HERITAGE AREA.
