Swiss Cottage Library

Fin inspection London Borough of Camden

22 April 2022

5206133-ATK-XX-XX-RP-SE-000001

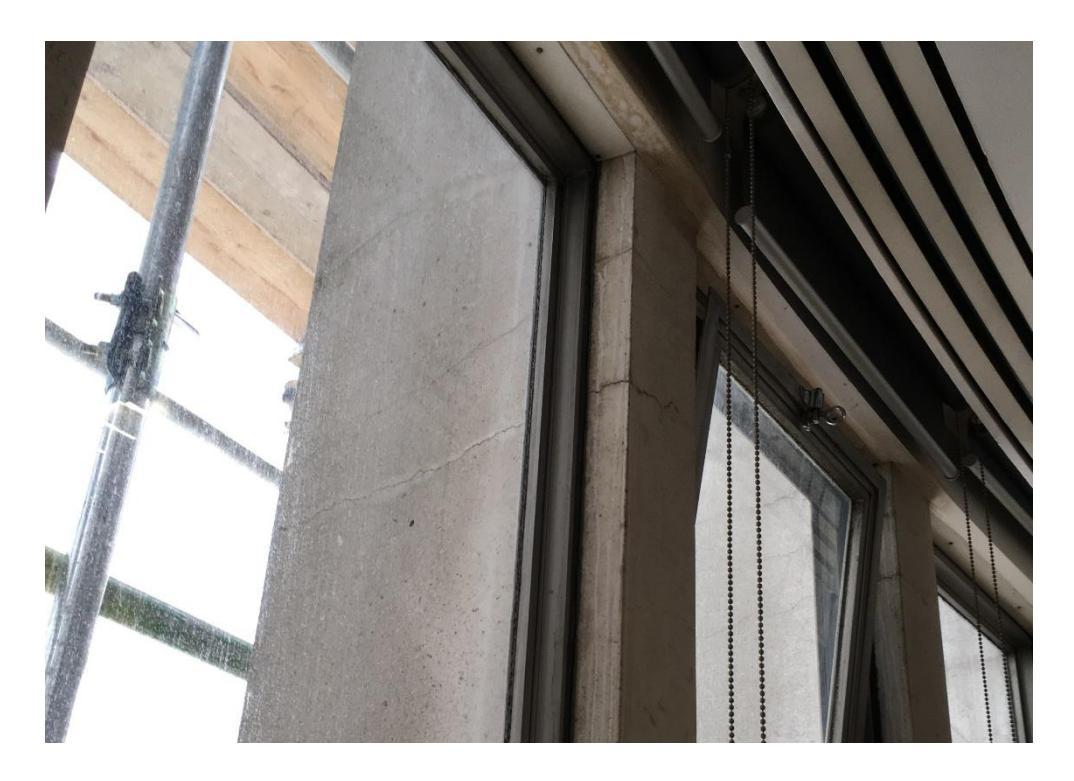
Figure 2.2 illustrates cracking over the full fin width. As these bridge the window line, this may provide a path for water ingress into the building.

Figure 2.2 – Wide cracks bridging window line and likely to allow water ingress in addition to corroding the fin reinforcement

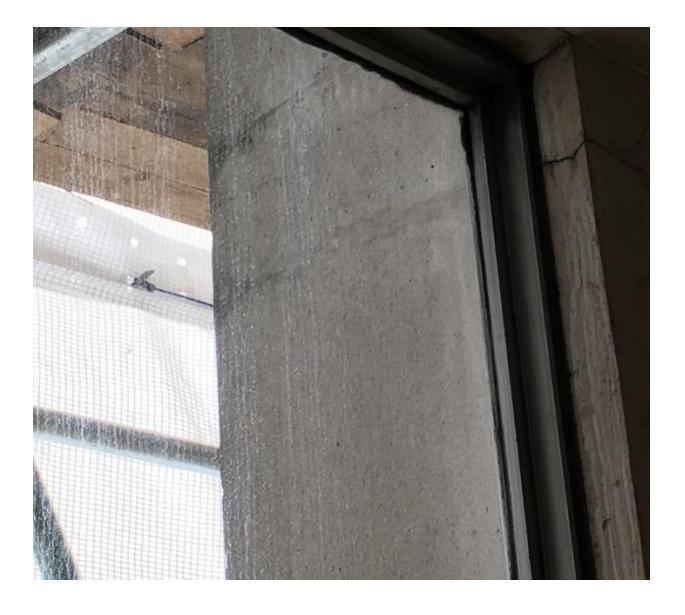
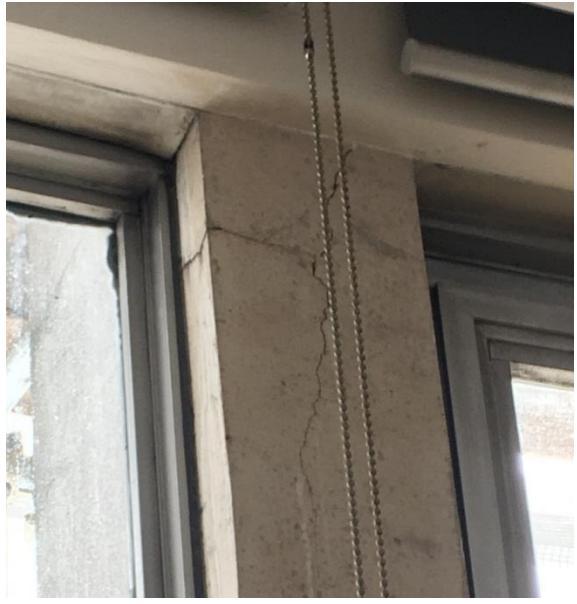
Figure 2.3 is an example of one of the few internal vertical cracks seen on the rear of the fins. The horizontal crack that intersects it also continues through the window line and appears to have been patched at some point. Whilst there is no clear cause of the vertical crack, the general damage in this area requires further investigation to determine if corrosion of the reinforcement in the fin is a contributing factor.

Large internal crack and the external repair Figure 2.3 – Vertical and horizontal cracking

Rear face of fin with vertical crack

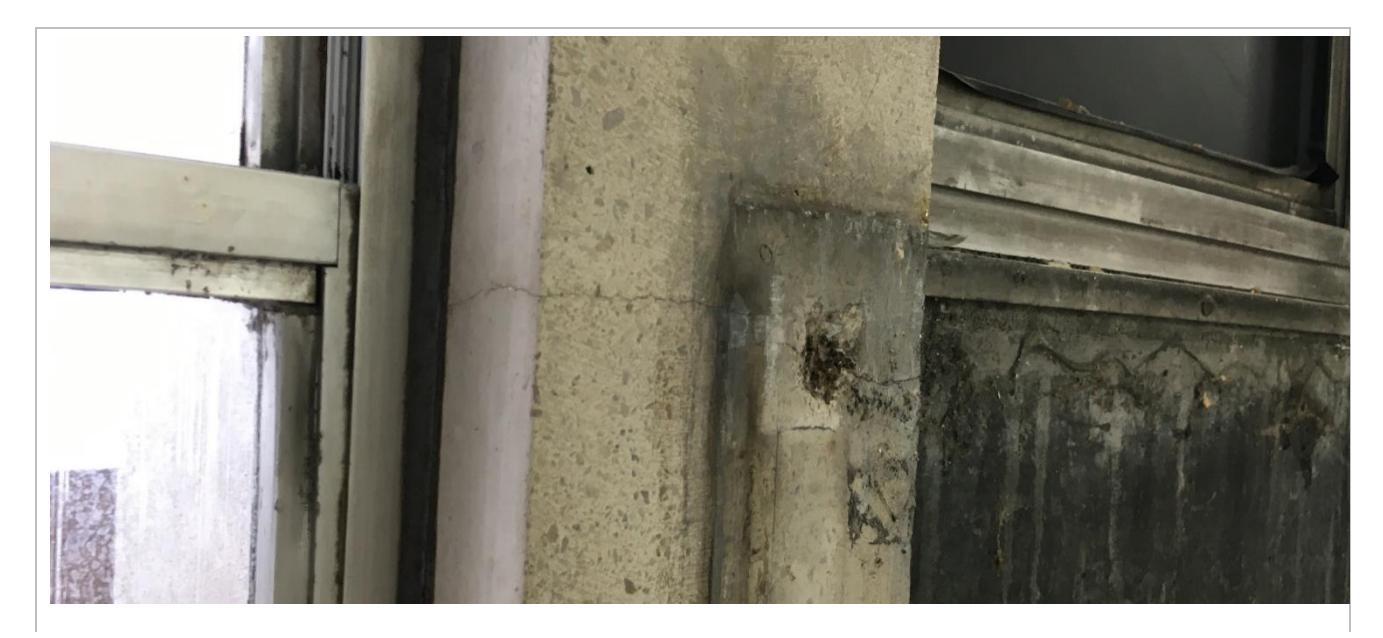
Figure 2.4 illustrates where something has been fixed to the rear of a fin and a crack that coincides with it. Whilst this is clearly an old fixing, it may have been the instigating factor for the crack to appear at this point.

Figure 2.4 – Fixing to rear of fin may have instigated cracking

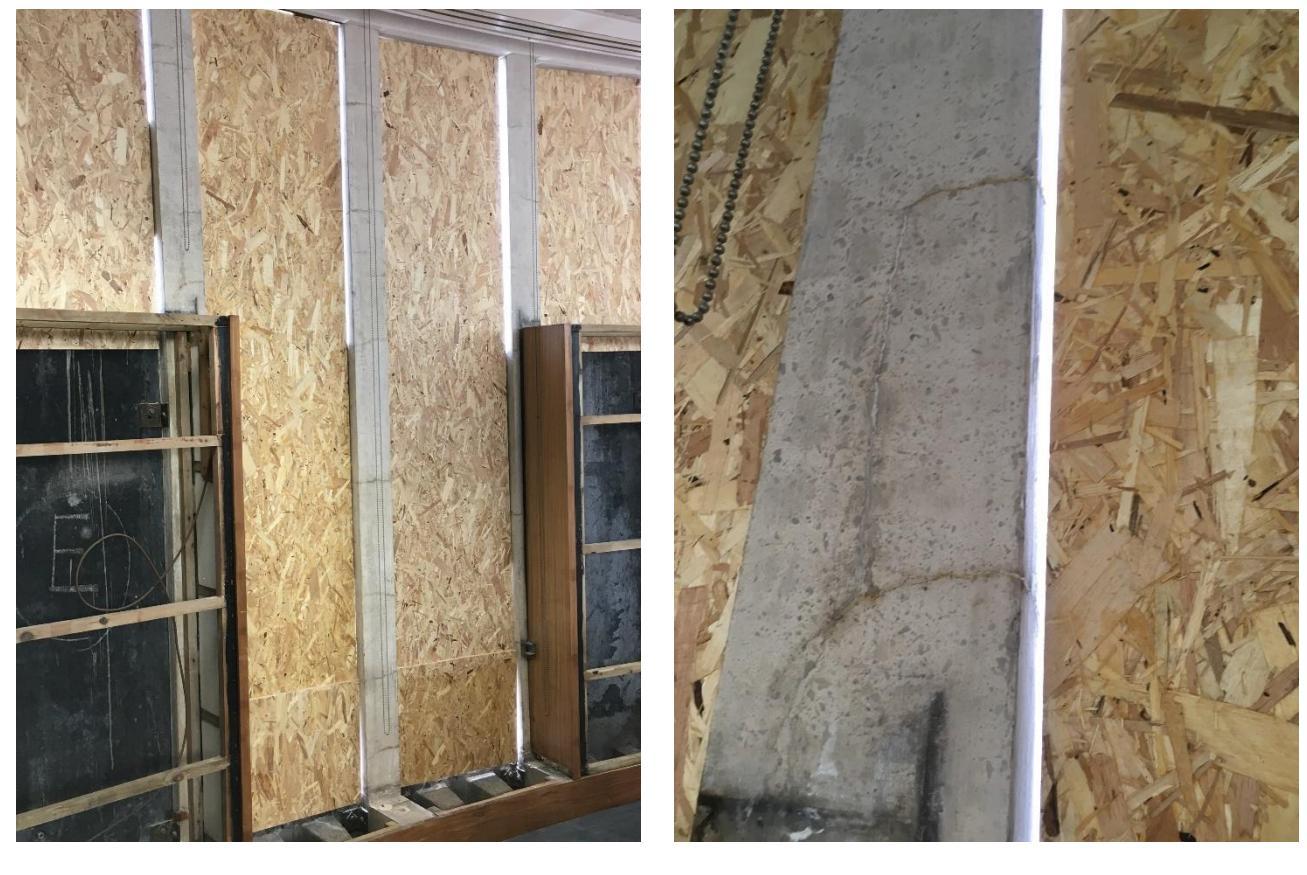
Figure 2.5 shows regular cracking on a south facing fin and rust staining. This suggests that the crack continues to the external face and is wide enough to allow water to penetrate to the inner face of the section to allow corrosion to occur.

Regular cracking on fin

Figure 2.5 – Cracking and rusting of fin

Rust staining indicating corrosion of bars

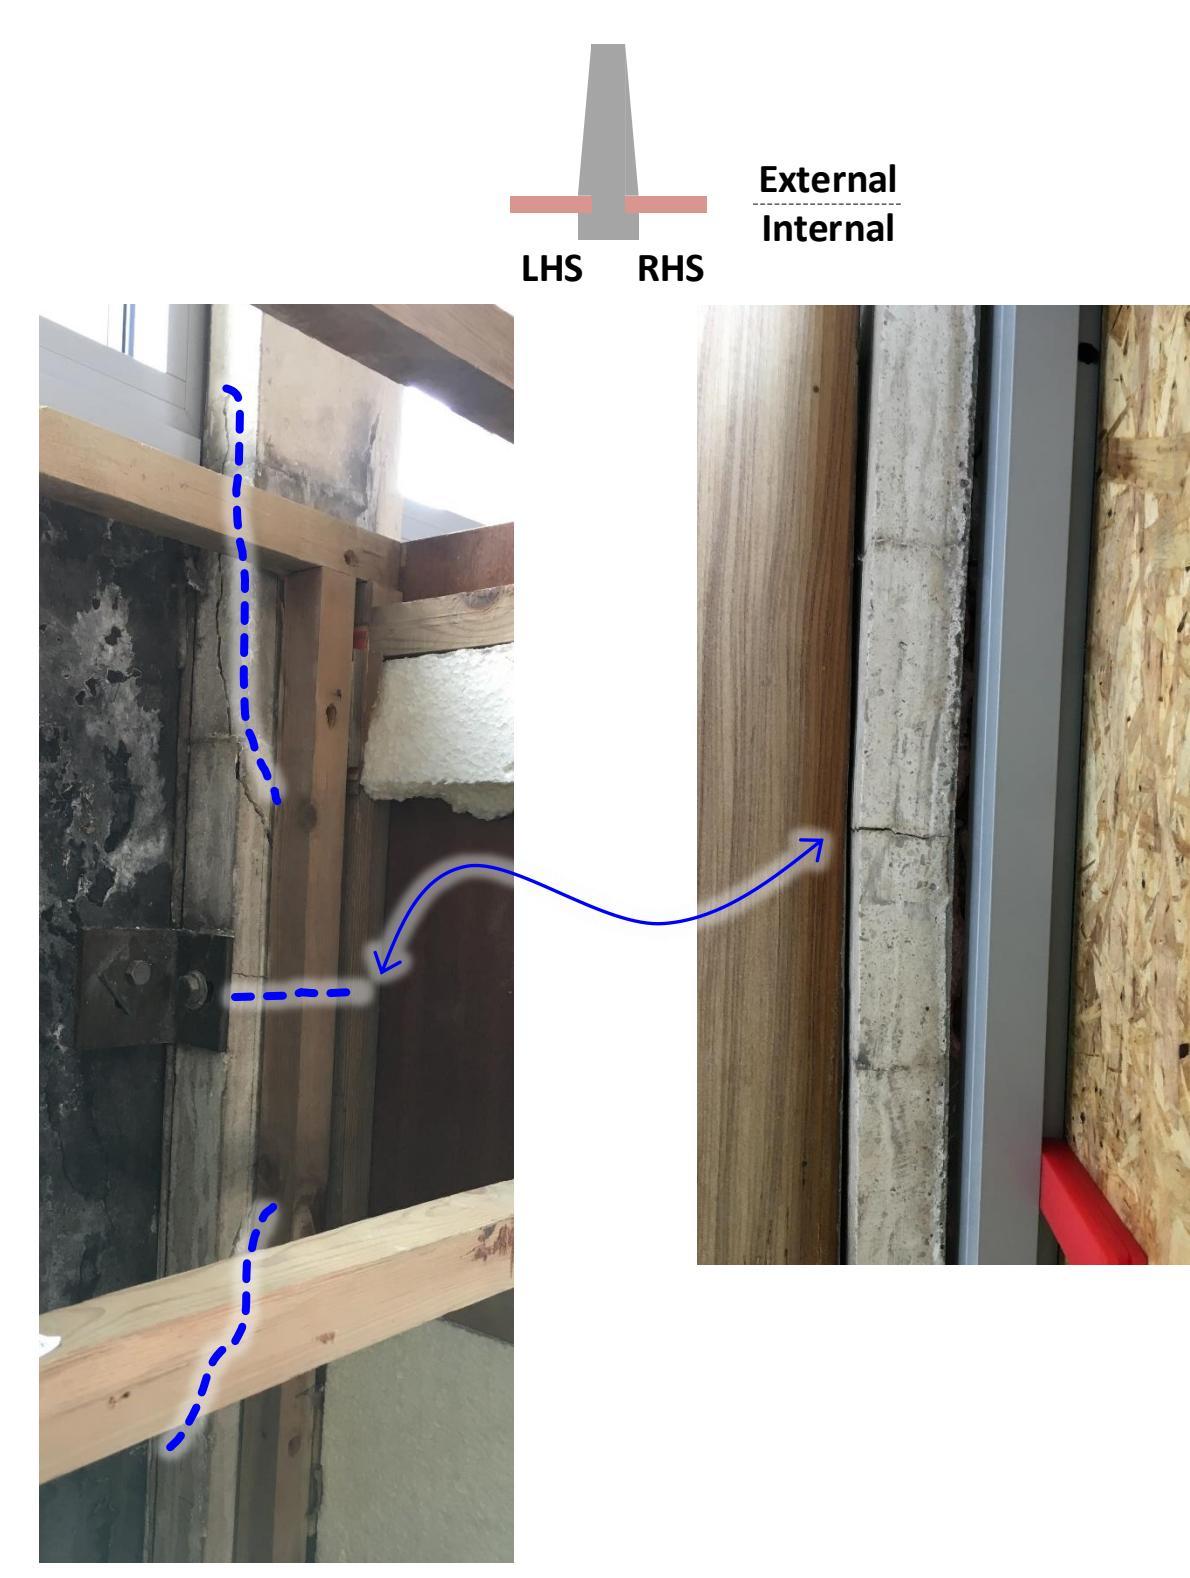
The badly damaged fin highlighted by the contractor is in Zone 3 on the 2nd floor and is shown in Figure 2.6.

This has occurred at lateral restraint connection to a cladding panel with each panel being restrained at two points on each fin. There is considered to be a low risk of the cladding panel falling away as whilst the severe cracking is likely to make one connection ineffective, the other three lateral fixings to the panel appear undamaged with the nibs on the back of the panel, providing vertical support, are soundly grouted in place.

With respect to the figure, whilst the failure zone on the left-hand side (LHS) of the fin (when viewed from the inside) appears to be a localised cone failure; the cracking on the right-hand side (RHS) is not. The bulging/cracking seen on the RHS of the fin suggests that it may have been used as a fulcrum in prying out the existing window or that the cladding panel is bowing outwards at this corner causing the observed deformation as the fixing rotates.

LHS

Figure 2.6 – Damaged fin

RHS; the crack width is in the order of 1.5mm at the corner. Note also the bow of the concrete.

This fin cannot be left as-is and a structural investigation is required as to its soundness and in order to develop a suitable repair solution.

The two fins where fixing points have failed should be assessed structurally to develop a suitable remedial solution; they should not be left in their current condition.

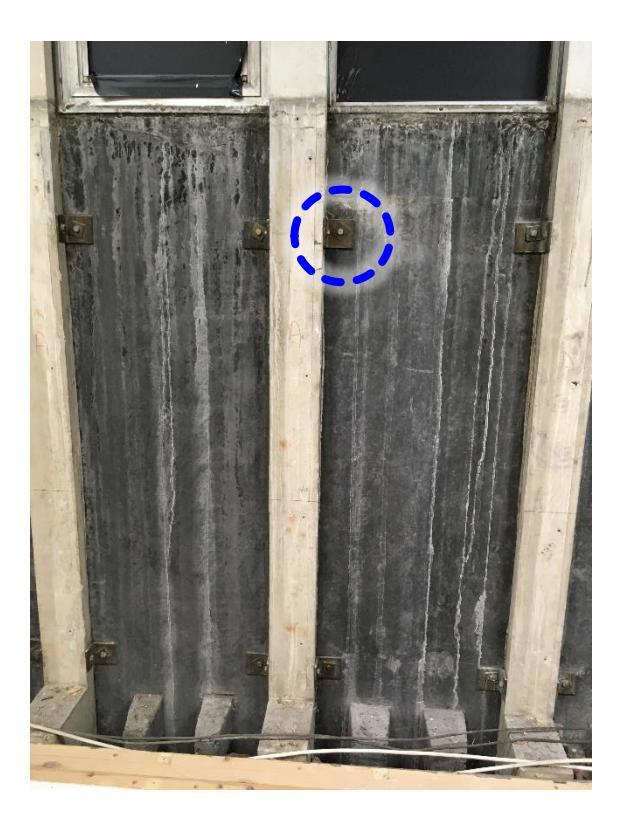
Note that one other location in Zone 2 exhibited the cone type failure of a cladding panel fixing and is shown in Figure 2.7 and Figure 2.8. This suggests that there may be a recurring issue with this detail, amplified by the relatively small edge distance from the fixing to the concrete surface and should be investigated further.

Figure 2.7 – Cladding panel fixing; failure zone circled

The fixing detail between fins and cladding panels should be reviewed due to two of these details having failed.

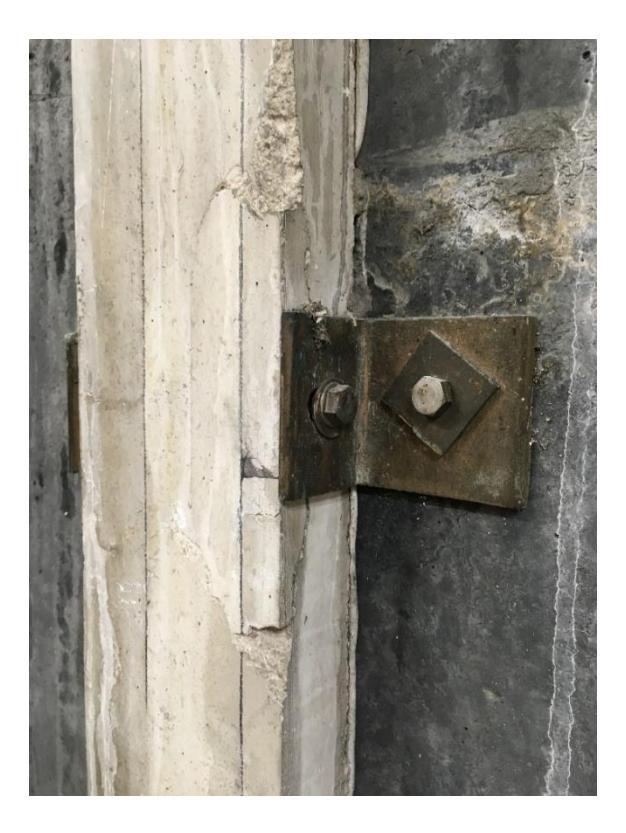
Figure 2.8 – Close-up of failure zone

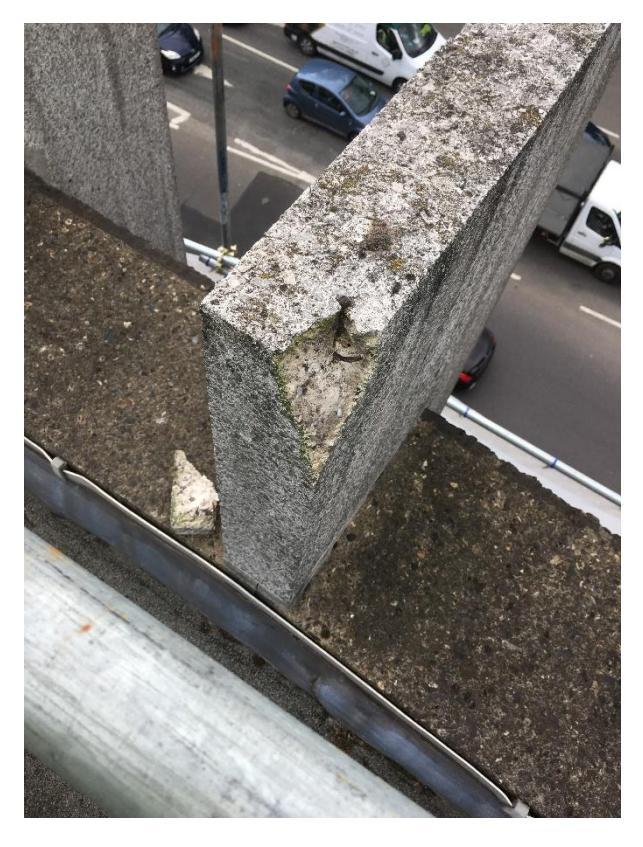
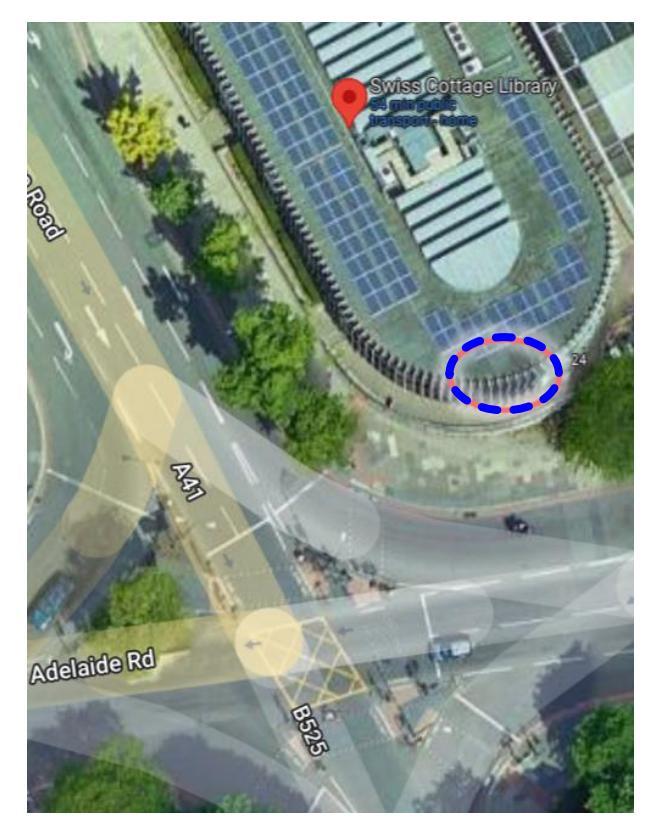
Whilst visually they appear to be in good condition, whilst measuring a noticeable crack, a fist sized lump of concrete broke away as shown in Figure 2.9 and Figure 2.10.

Figure 2.9 – Spalling at top of fin with location indicated on plan

A detailed inspection of the tops of all fins is required, including cleaning the tops in order to facilitate this and consideration should be given to applying a cap to the tops of all fins (such as metal flashing or a high strength grout) to protect the exposed top surface.

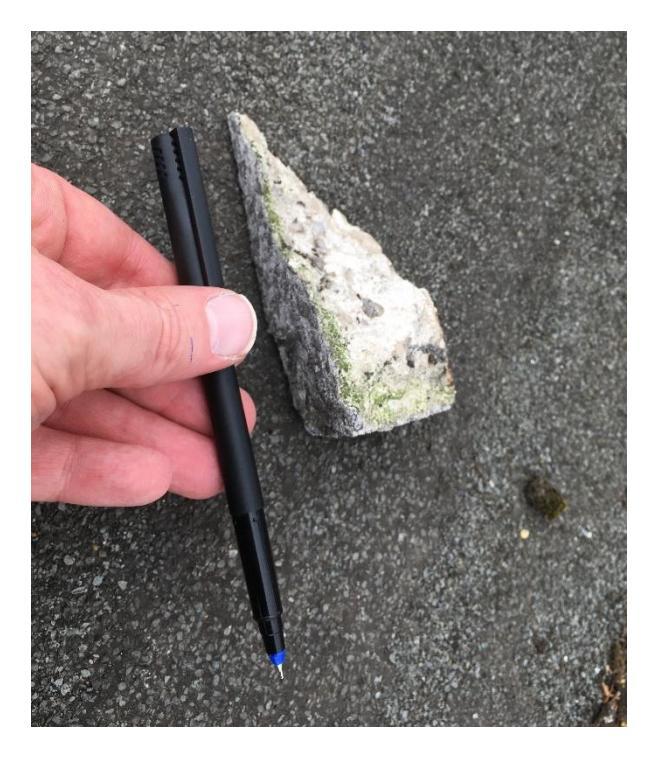
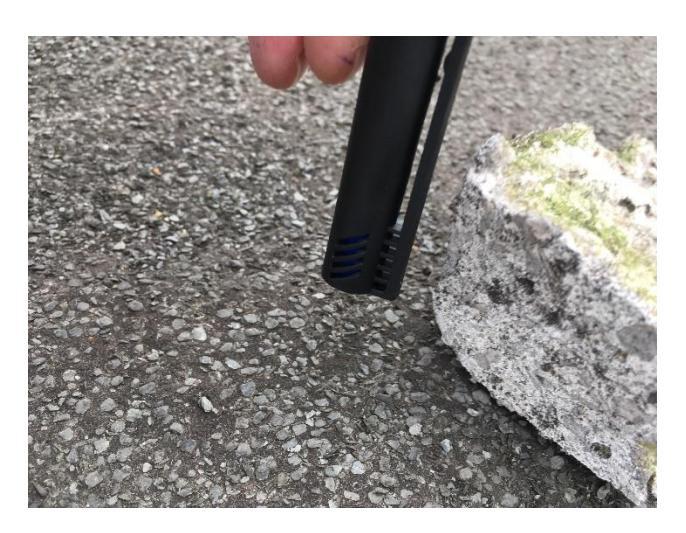
Figure 2.10 – Close-up of broken concrete piece

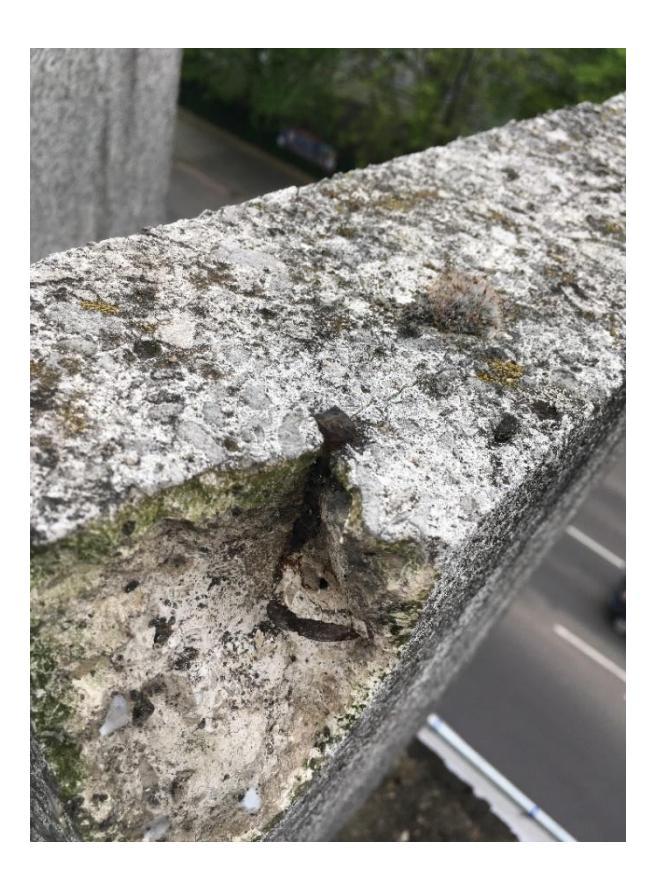
Figure 2.11 is a close-up view of this area and shows that in addition to the horizontal reinforcing bar being close to the surface, a vertical bar protrudes past the top concrete surface. Exposure and hence corrosion of the latter is likely to have been the root cause of this fracture.

This arrangement may be indicative of systematic quality control issues with the fin construction. This would relate to low levels of concrete cover to the reinforcement in an external environment.

Figure 2.11 – Reinforcing bar projecting to surface and low cover

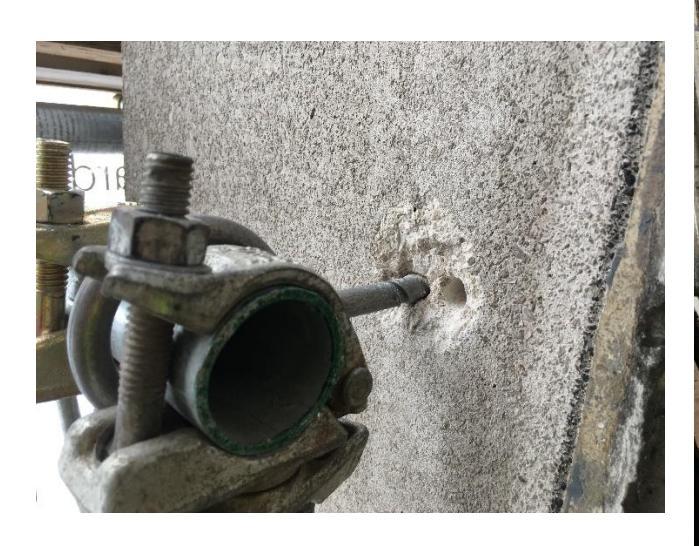
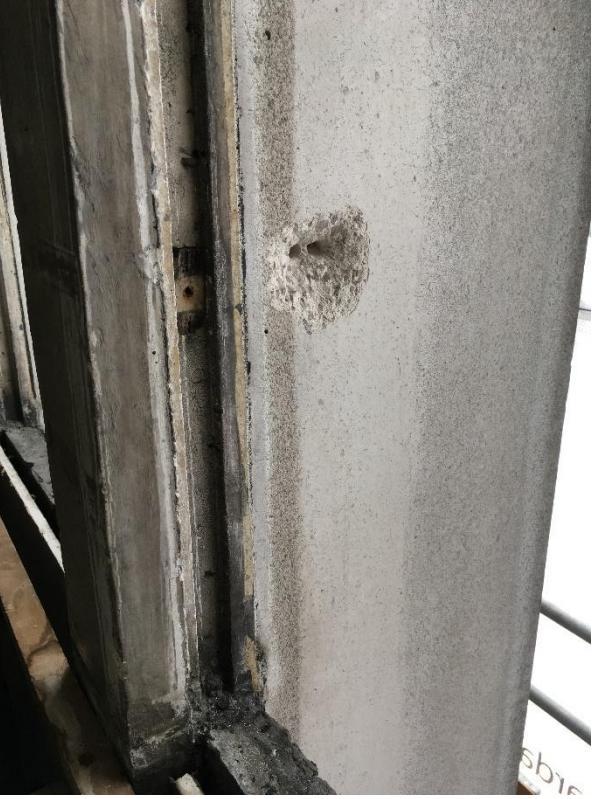
It was noted that the scaffolding has been fixed to the fins at regular intervals and has caused significant damage in a number of locations, for example Figure 2.12. If this is not suitably repaired, for example by breaking back to a sound substrate, and patched with a suitable repair mortar, it is likely that these areas will be a point of weakness, as can be seen with older patch repairs to the fins. Furthermore, it is not known if the contractor's temporary works designer has assessed the strength of the fins to be adequate for restraint of the scaffolding.

Figure 2.12 – Damage to fins due to scaffold fixings

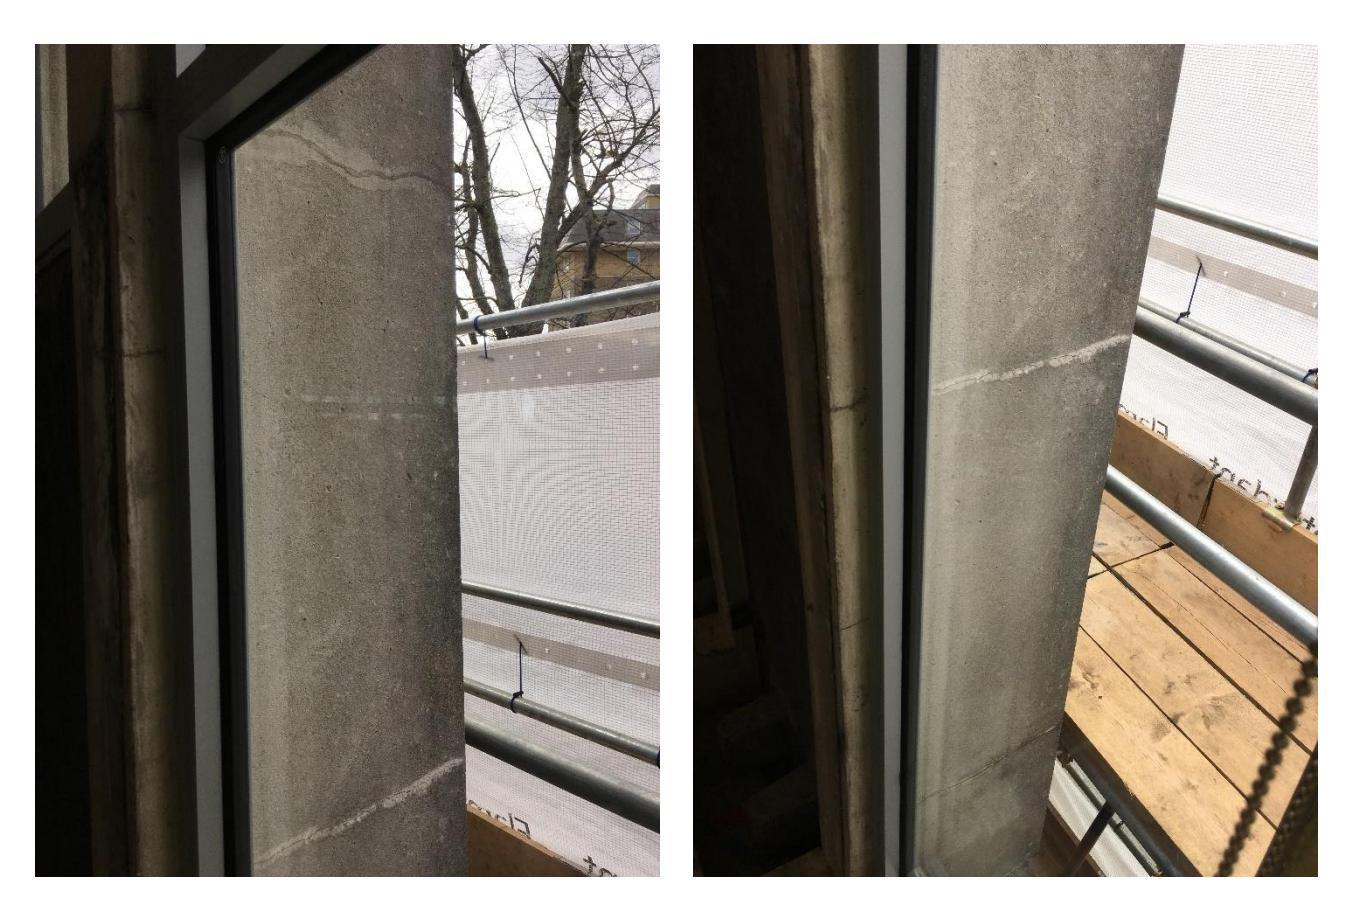
In other locations, older cracking could clearly be seen as could associated patch repairs. Examples are shown in Figure 2.13, Figure 2.14, and Figure 2.15. The repairs have not always been successful with cracking again being seen that these points. Where cracking is unpatched, signs of minor rust staining were noted suggesting corrosion of the reinforcement. Elsewhere, the horizontal white staining seen on the fins at crack positions appears to be a sign of efflorescence which is described by the Concrete Society as:

Note the continuation of the cracks from external to internal parts of the fins Figure 2.13 – Repairs to fins, open cracks, and possible efflorescence

Further investigation, including testing, would be required to assess the significant of this with respect to the soundness of the fins.

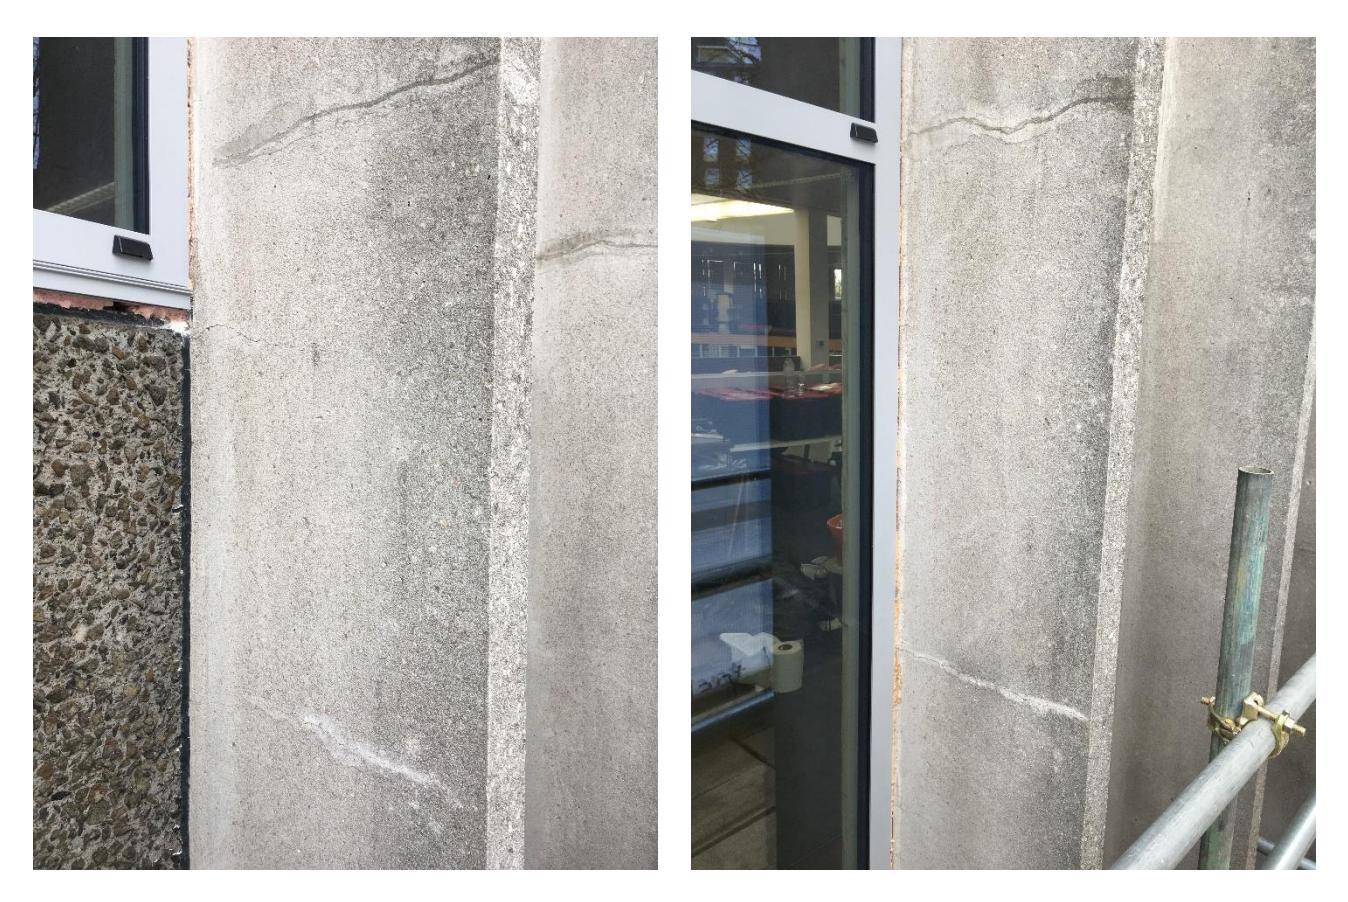
Note the crack adjacent to top of cladding panel

Figure 2.14 – Repairs to fins, open cracks, and possible efflorescence

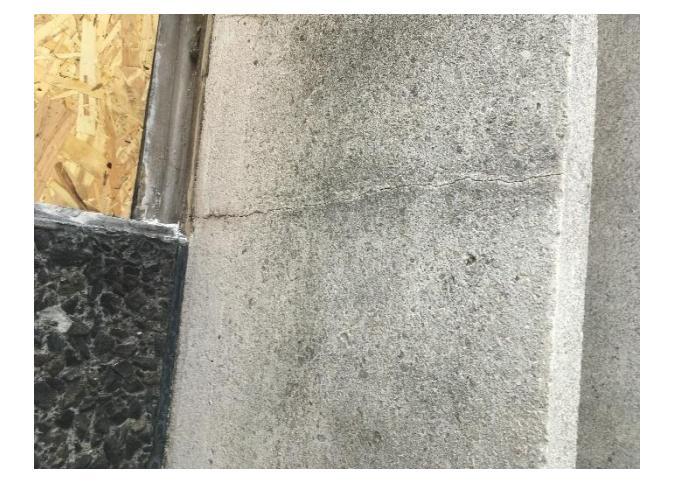
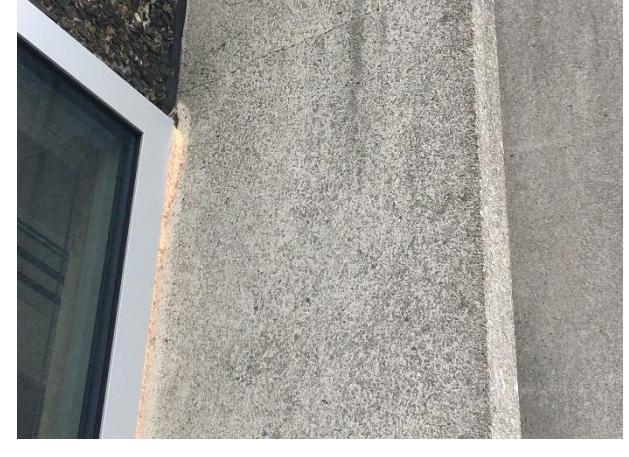
Figure 2.15 – Open cracks with some rust staining

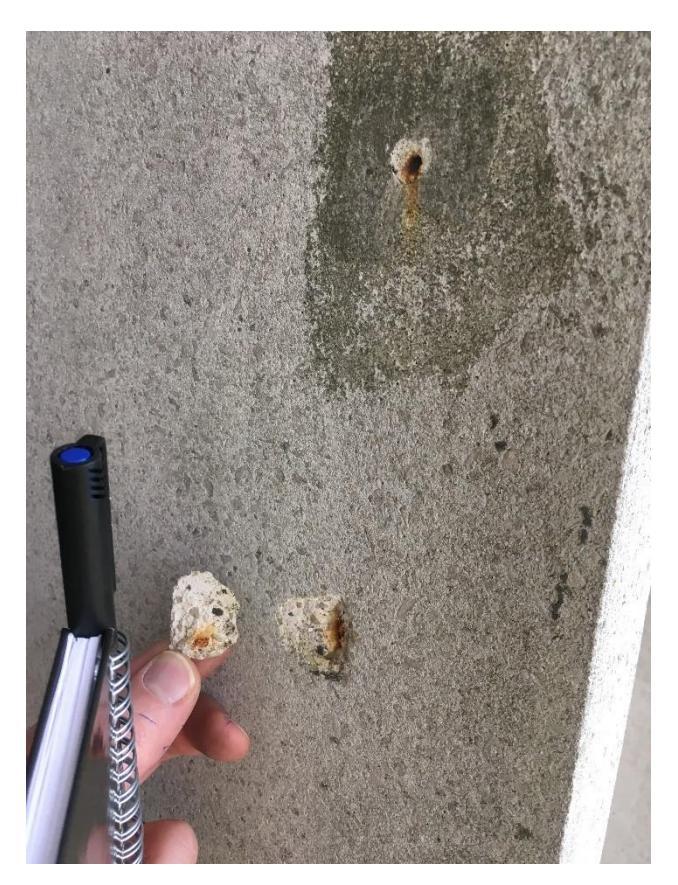
An issue of low cover, rusting, and spalling was also noted on one fin at first floor level as shown in Figure 2.16. and, as with the observations at roof and ground level, this suggests there to be an issue with low cover and bar placement in the fins that increase their risk of deterioration.

Figure 2.16 – Rusting and spalling; rust spot at top appears to be the end of a reinforcing bar

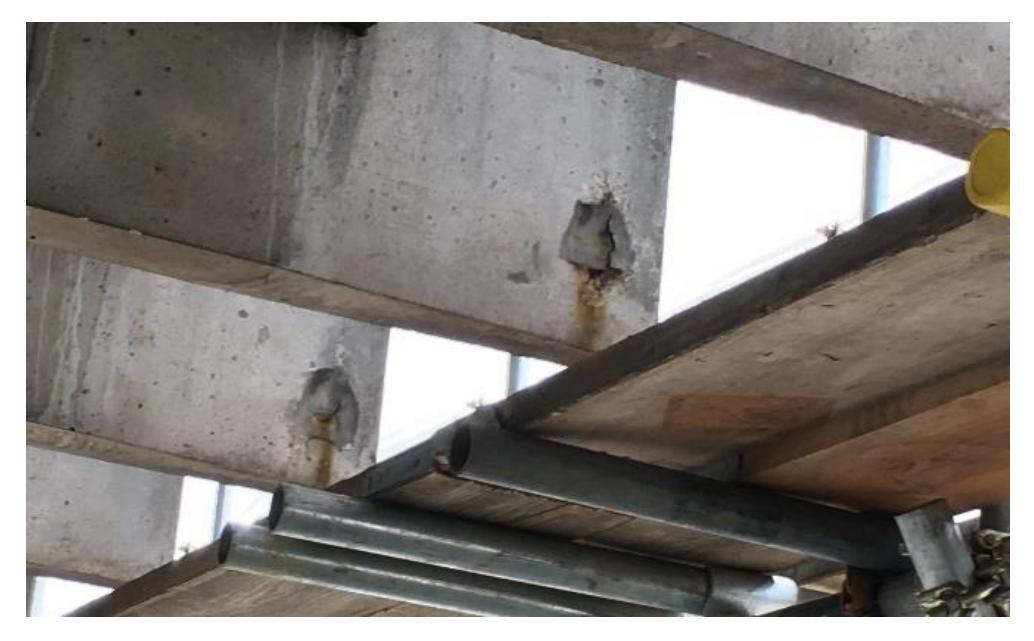
The bases of some of the fins show the highest levels of deterioration observed during the inspection. Considering the clear signs of corrosion and significant horizontal and vertical cracking at the base of the fins, there is a high risk of sections of concrete spalling in the future if action is not taken to address this. Whilst the visible damage is at the south end of the building, the bases of all fins should be inspected.

Figure 2.17 – Bursting of previously patched concrete and rust staining

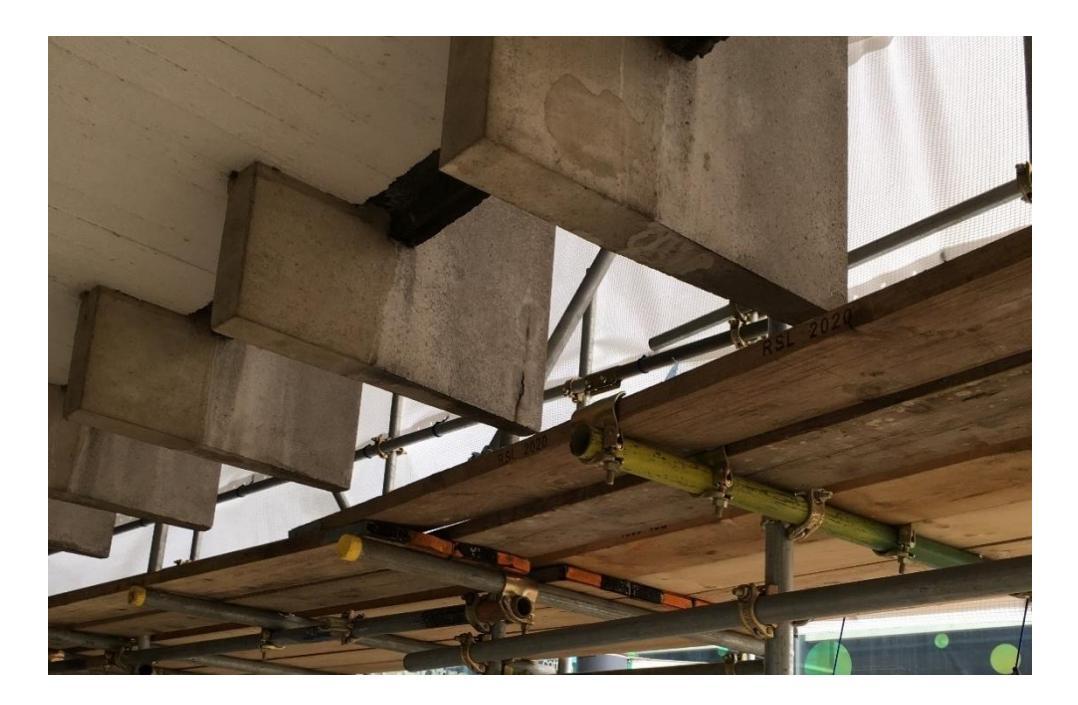
Figure 2.18 - Vertical crack in previously patched area with rust staining

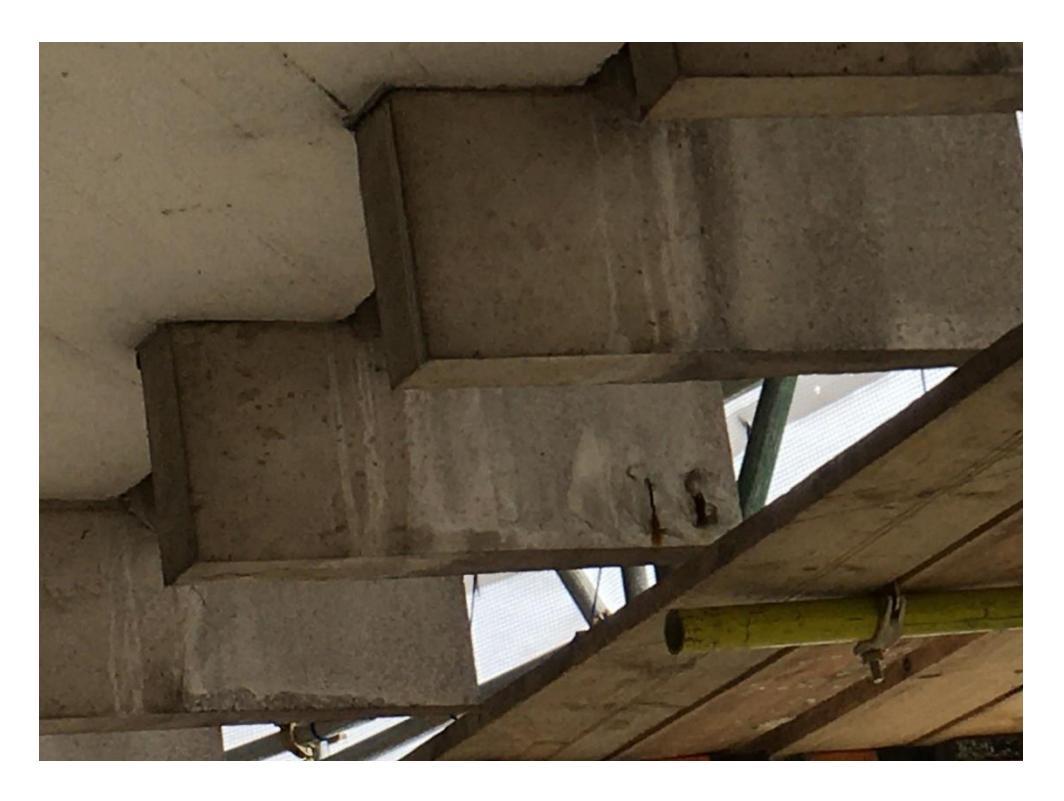
Figure 2.19 – Reinforcement bars clearly exposed and rusting.

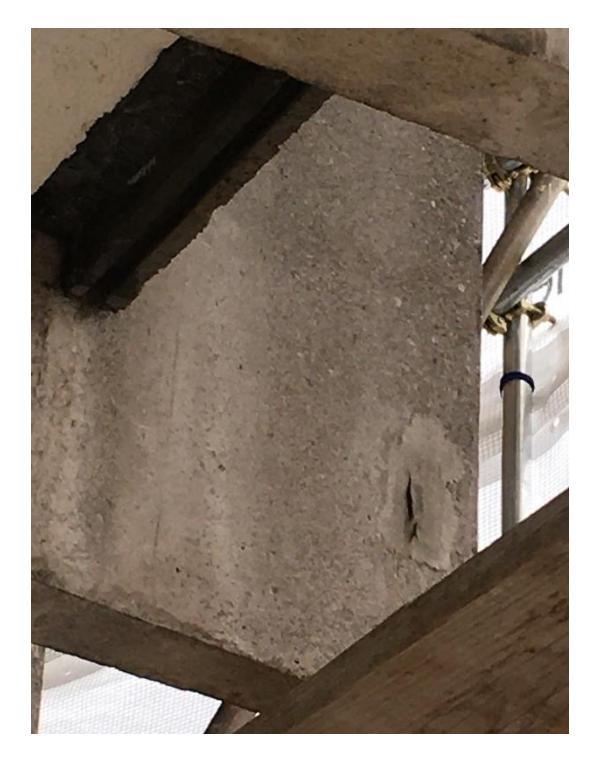
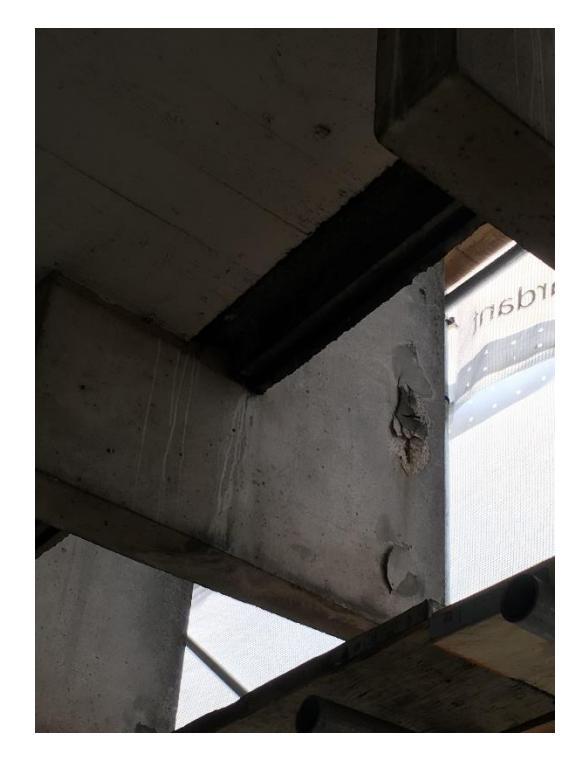
Failure of existing patch repair

Significant spalling is likely due to corrosion of reinforcement

Figure 2.20 – Spalling and corrosion of vertical bars

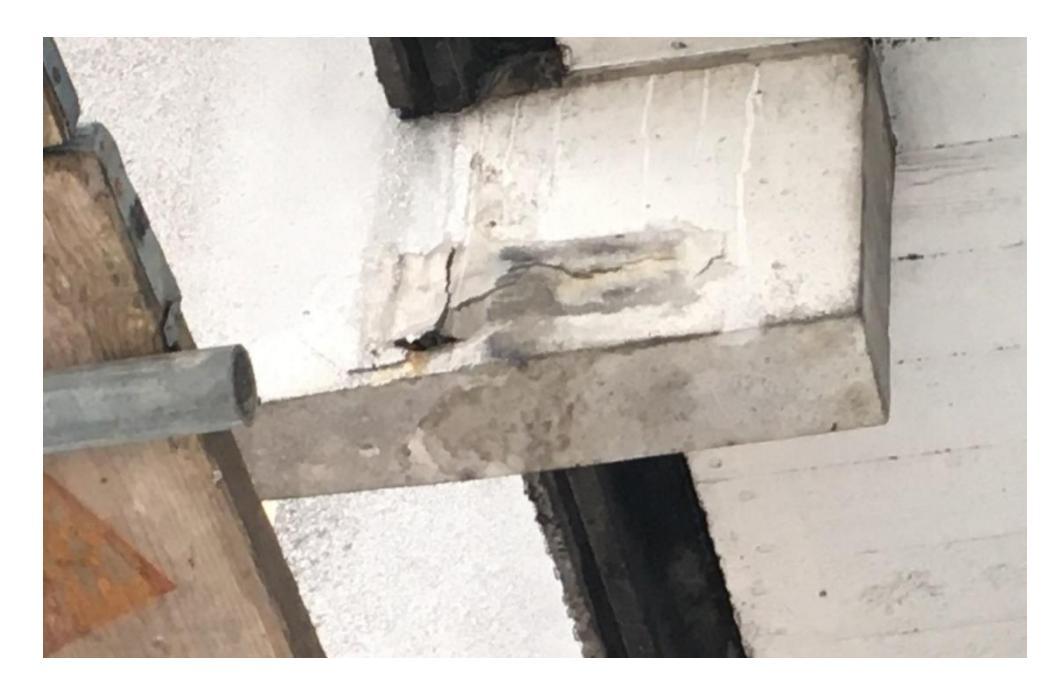
Figure 2.21 – Significant horizontal fracture and bursting

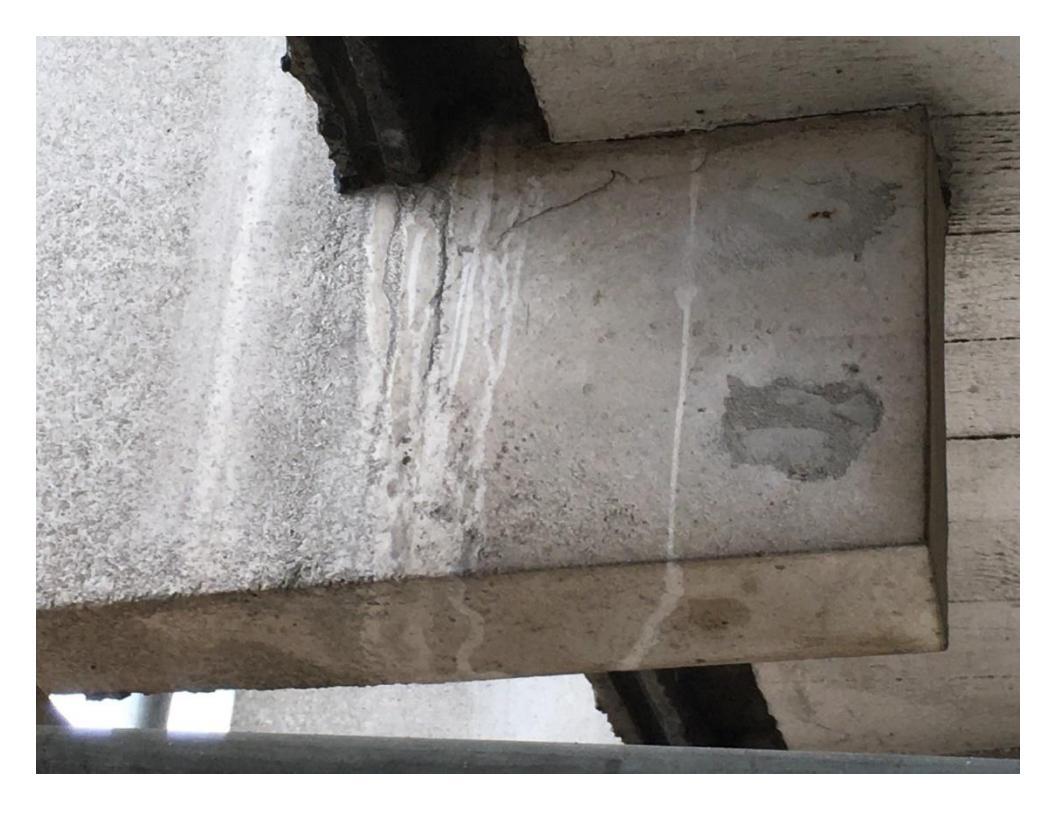
Figure 2.22 – Rebar at surface hence rust spots, evidence of previous patching, appears to be tow significant cracks (vertical and inclined to the horizontal)

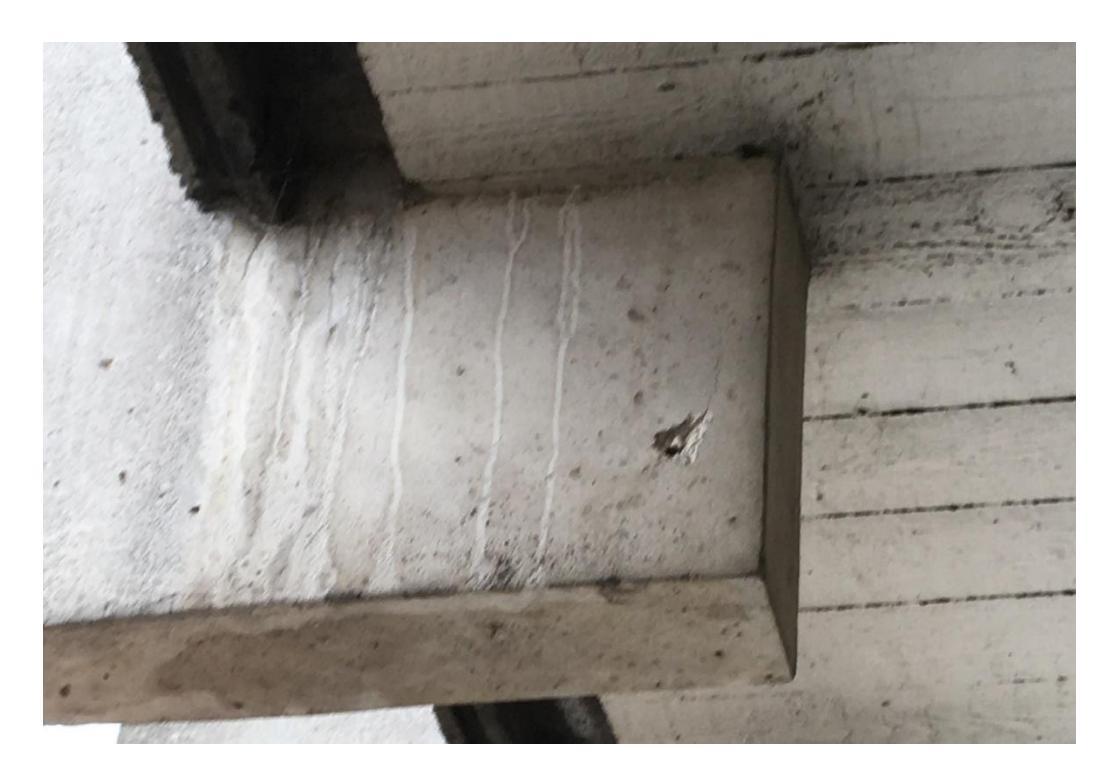
Figure 2.23 – Spalling due to rusting of near surface reinforcement appears to have instigated cracking; risk of corner spalling

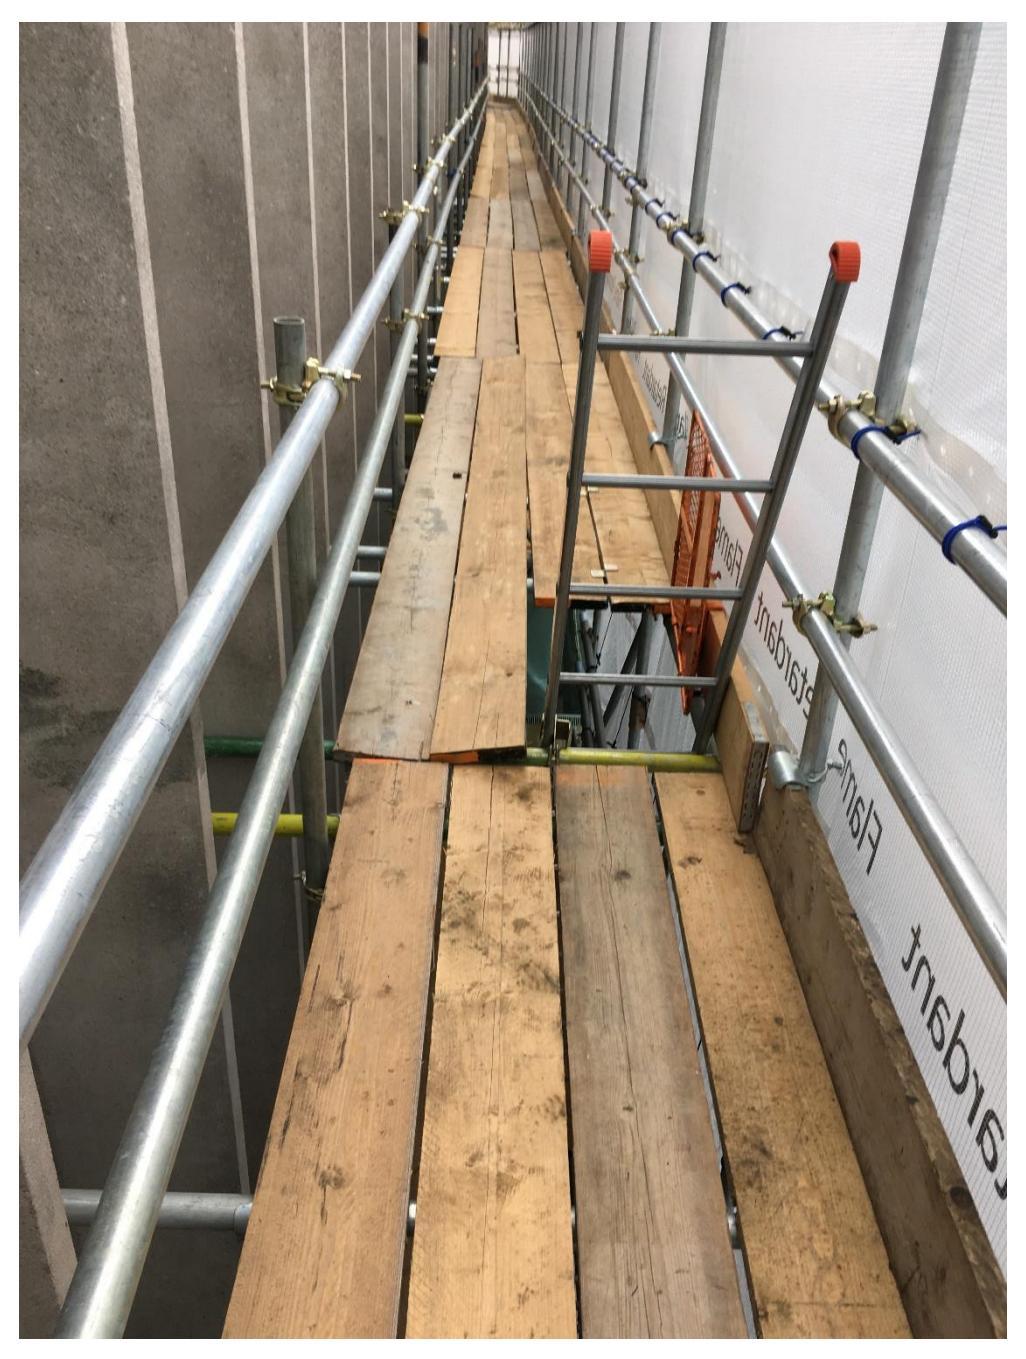
It was noted that a number of scaffolding boards were warped and my present a trip hazard.

Figure 2.24 – Warped scaffolding board

Several the scaffolding boards were noted to be warped and these should be replaced as a matter of urgency as they present a significant trip hazard.
