**PLANNING DESIGN AND ACCESS STATEMENT
FOR LISTED BUILDING CONSENT**

**AT
38 GLOUCESTER CRESCENT, LONDON NW1 7DL
ON BEHALF OF
SIMON ROBERT-TISSOT**

Revision B – 26.07.22

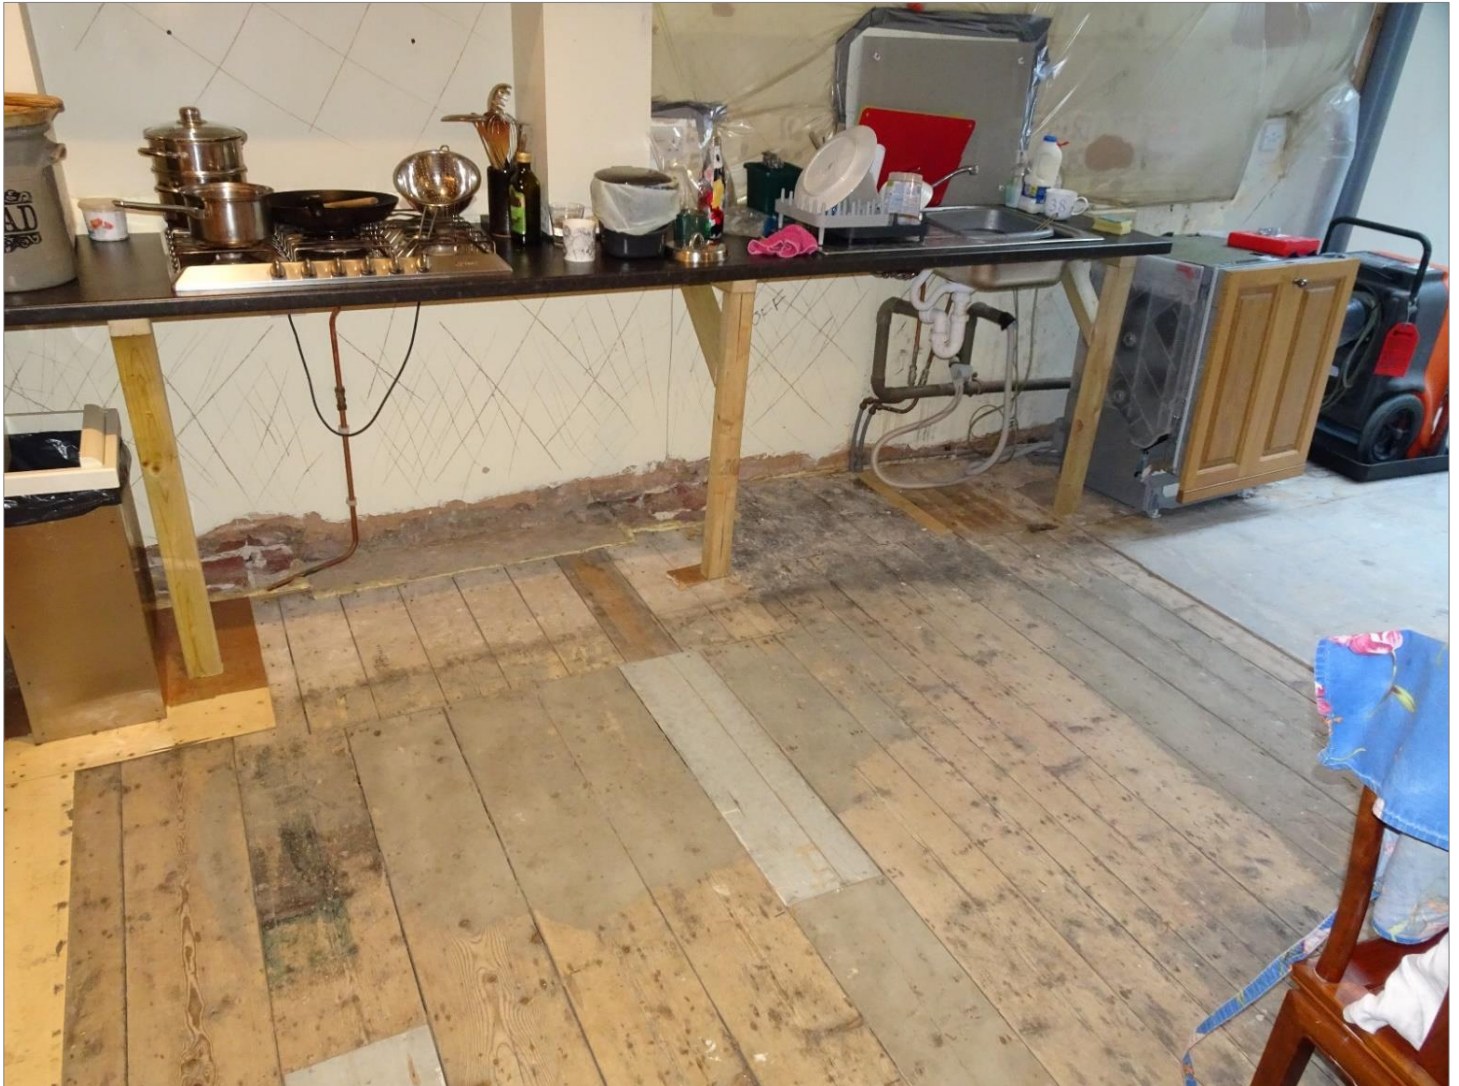
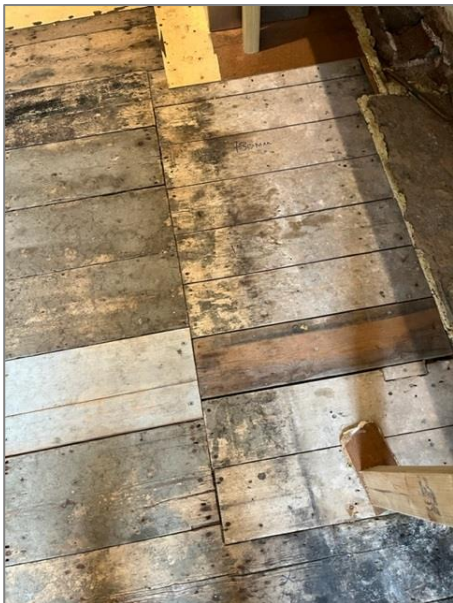
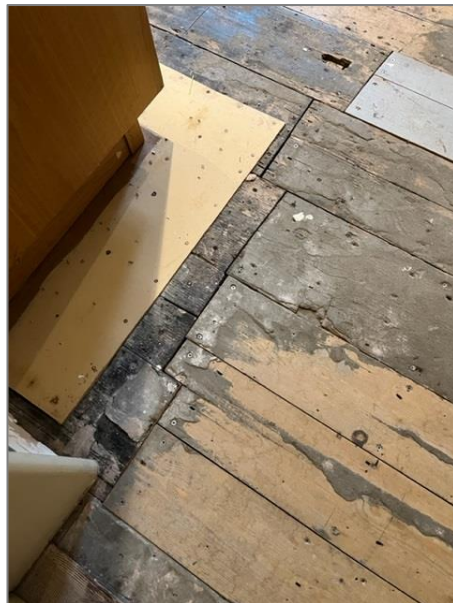
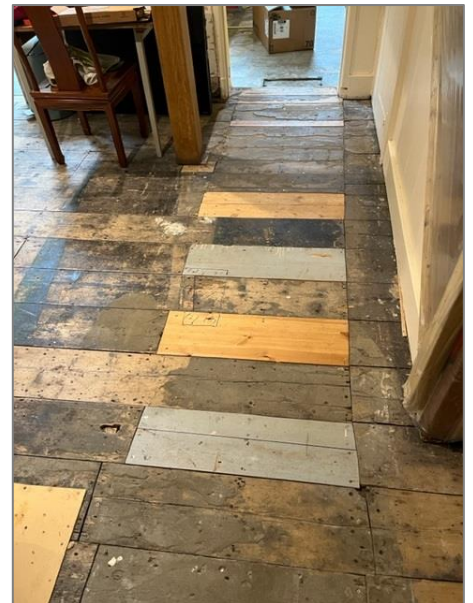
Photograph 1
Kitchen floor - selection of photographs showing patch repairs and non-original floorboards.

- (ii) It is proposed to replace the non-original floorboards to the kitchen with a plywood covering and to lay porcelain tiles on a Ditra isolating membrane.

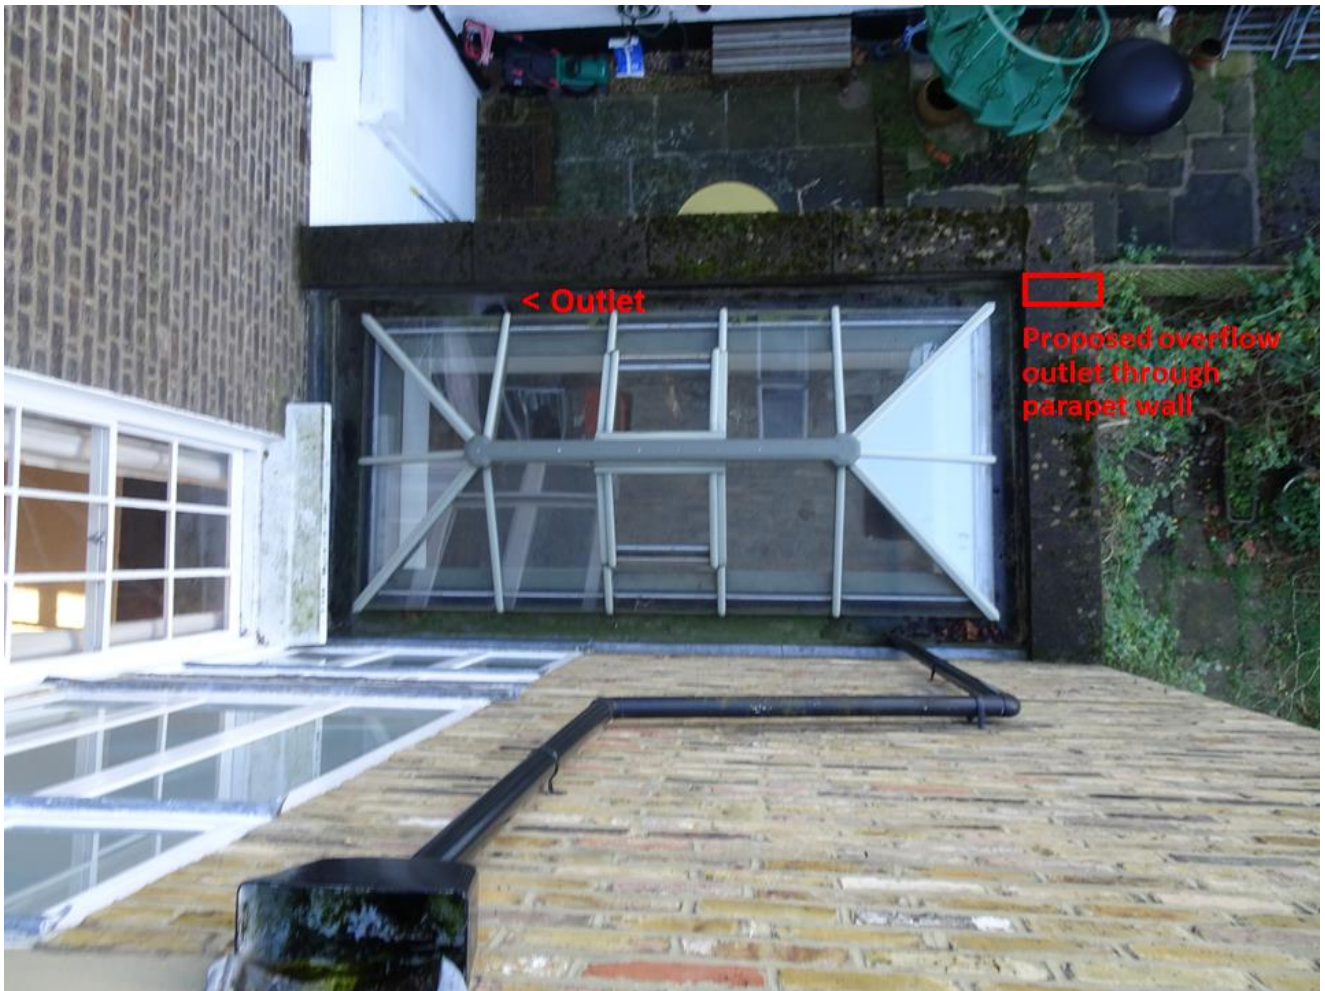
The conservatory extension roof is asphalt with a lantern light and parapet walls to the rear elevation and boundary with 39 Gloucester Crescent. There is a single rainwater outlet to the west of the lantern light.

Flash flooding during the summer of 2021 resulted in overloading of the single rainwater outlet and affected the conservatory, closet wing basement and kitchen. A smaller amount of water came into the basement at the front of the house in the vault and hallway.

Photograph 2
Conservatory extension roof.

- (viii) Form an overflow outlet to the conservatory extension rear parapet in the position indicated on photographs 2 and 3. The proposed position of the outlet is to the side of the parapet as working space centrally is restricted by the lantern light. The outlet will be approximately 225mm wide over approximately 2 to 3 brick courses high. It will be asphalt and lead lined on WBP plywood to form an overflow and its base will be above the level of the asphalt roof so that it only becomes effective in the event of the rainwater outlet being overloaded.

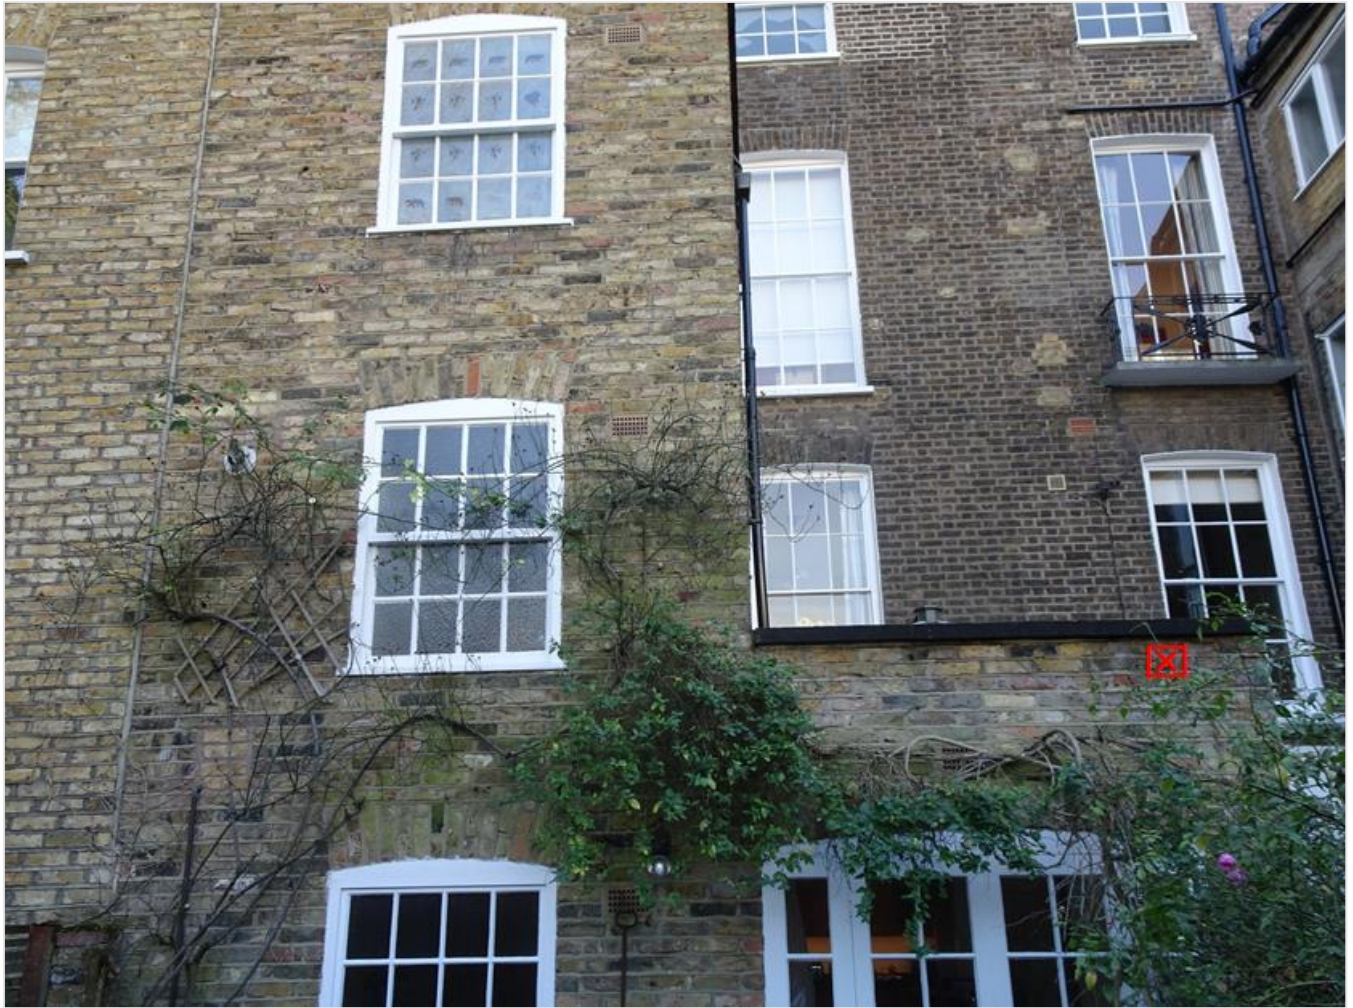
Photograph 3
Proposed overflow outlet to rear parapet of conservatory extension.

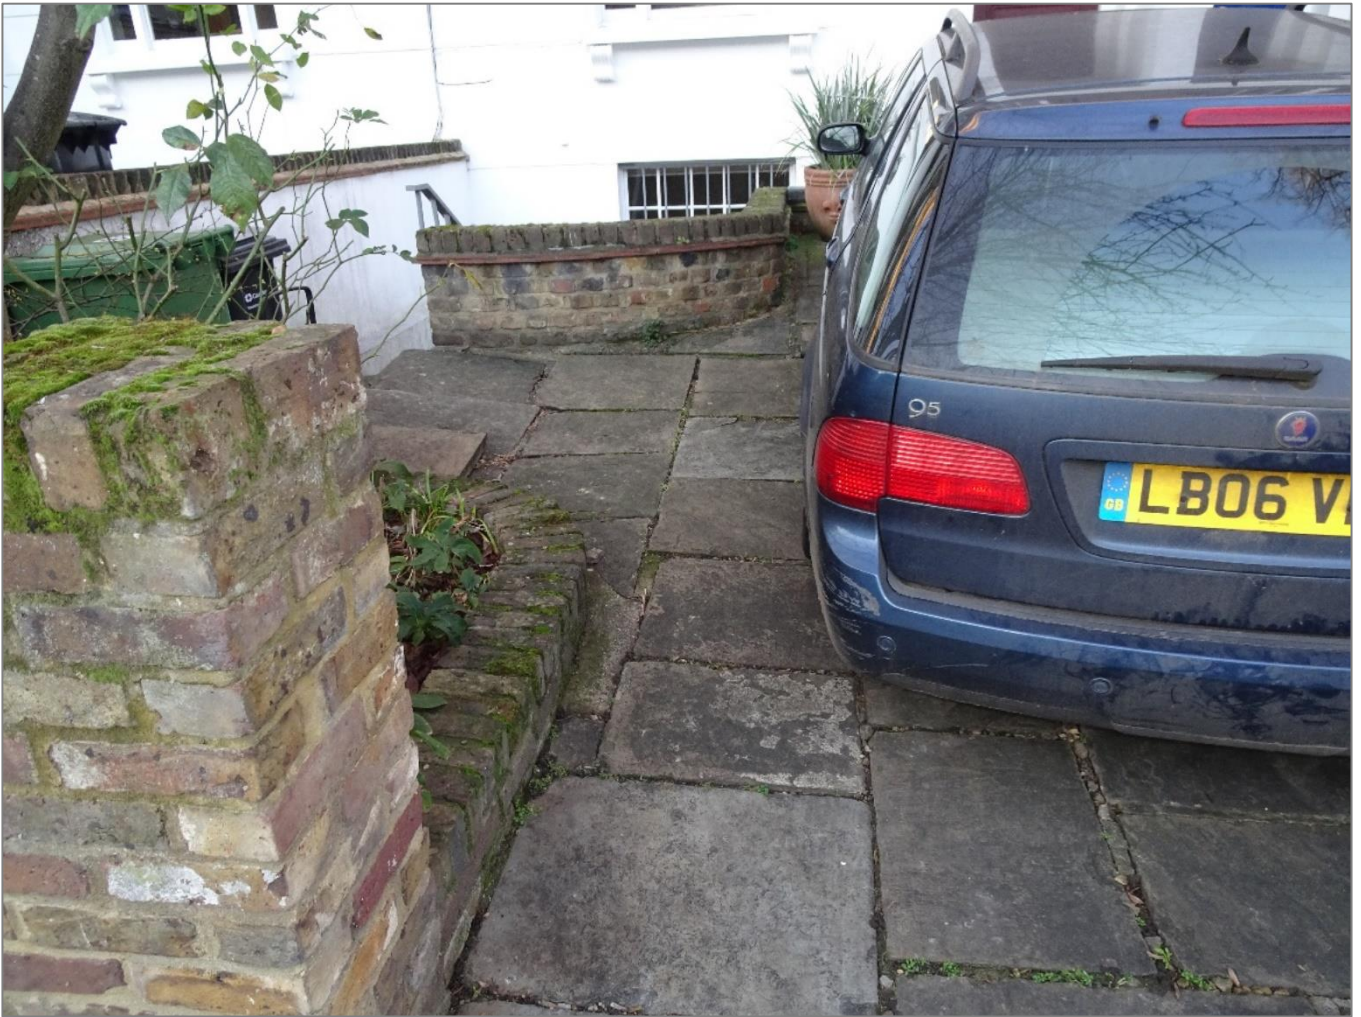
- (ix) To the front of the property the entrance drive and basement lightwell are York stone paved. Desiccation of the subsoil and root action has resulted in erosion of the sub-base. It is proposed to lift and set aside the stone paving, consolidate the base, import granular fill and to re-lay the York stone paving to level.

Photograph 4
Front drive

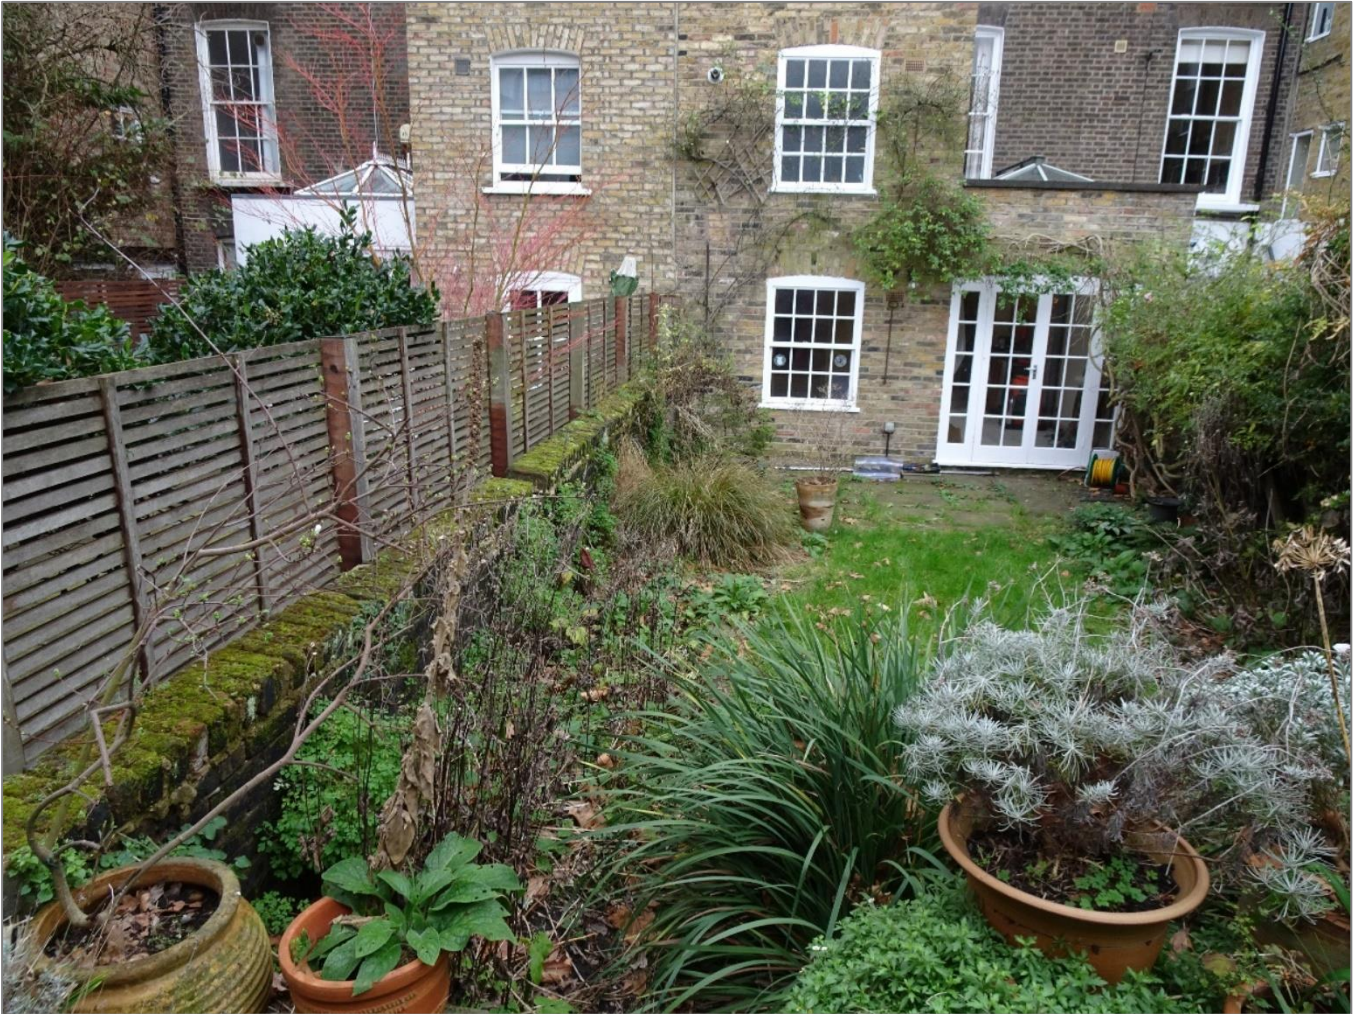
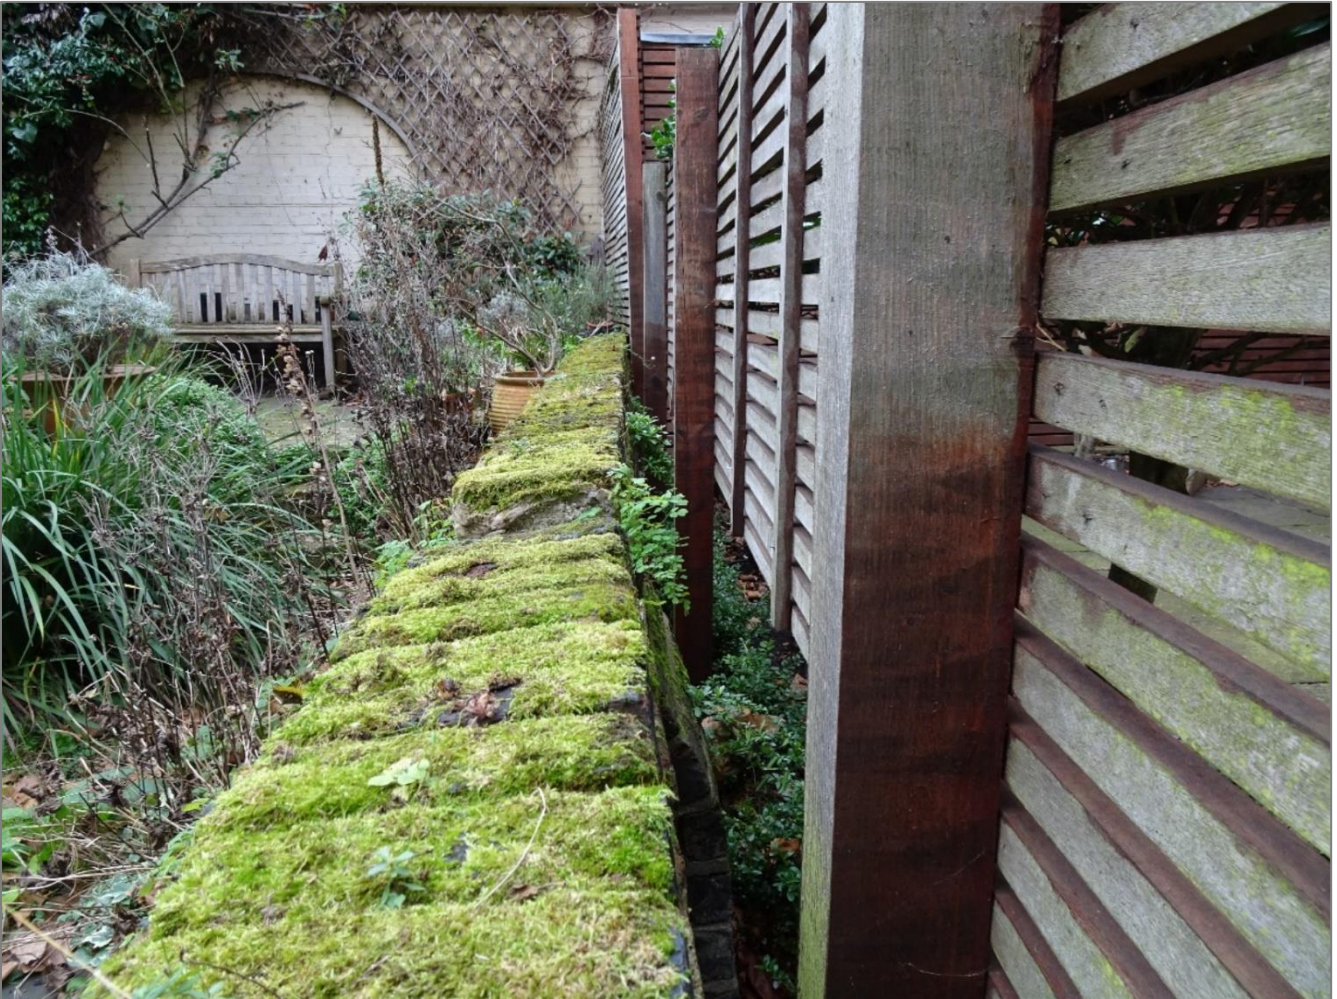
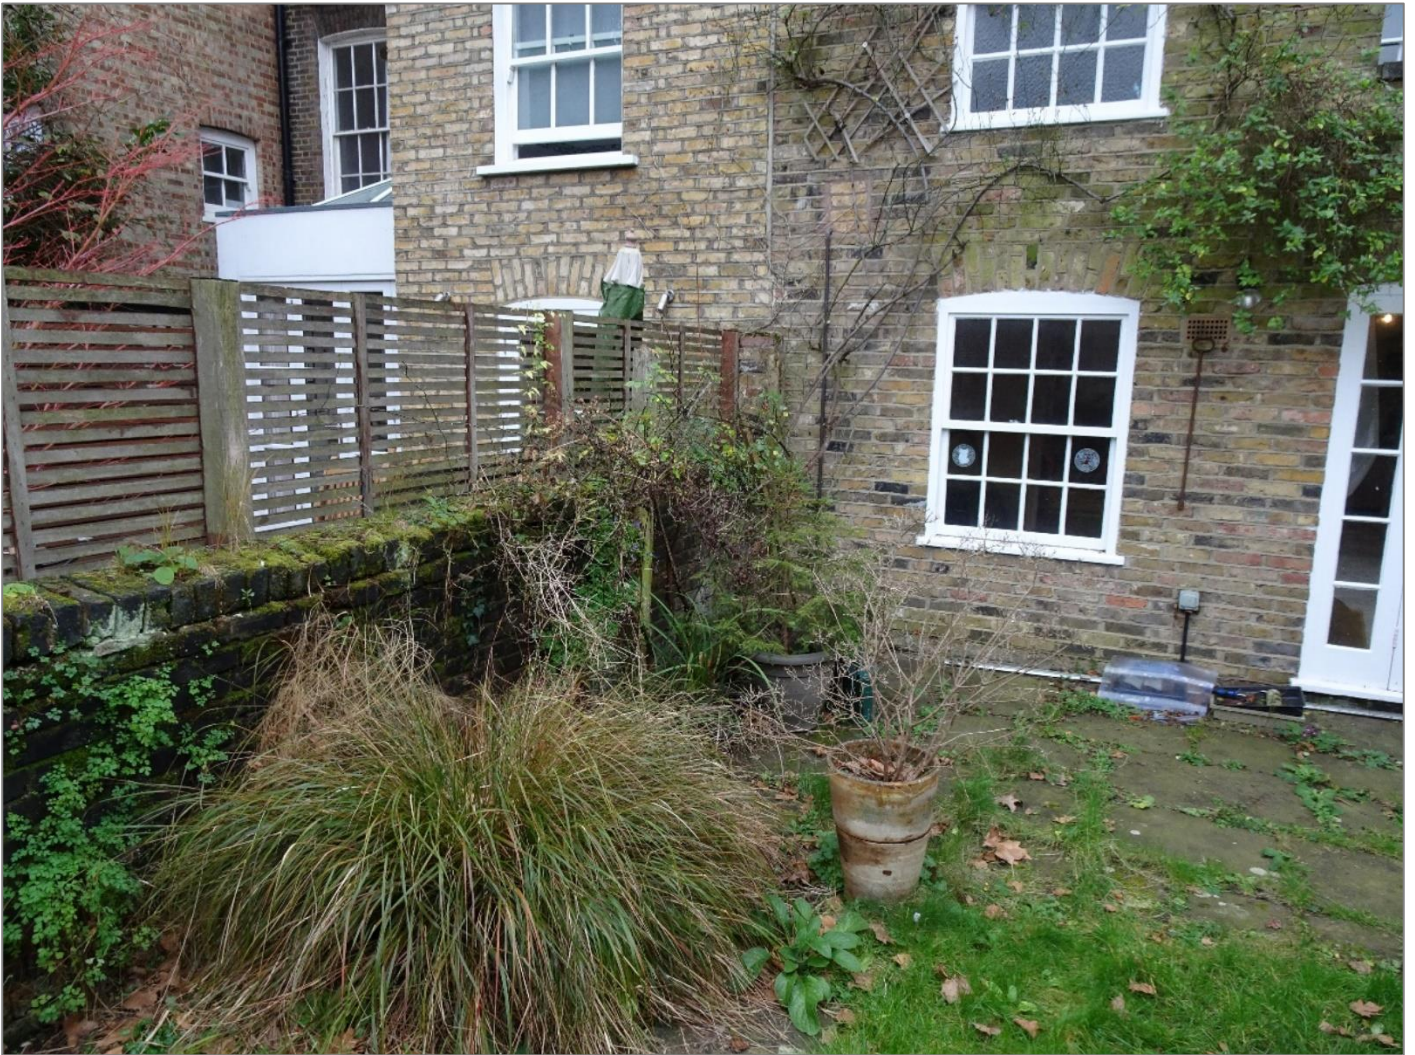
- (vii) The rear party fence wall with 37 Gloucester Crescent leans towards the application property. The lean is such that movement is self-propelling and rebuilding the wall is proposed to avoid collapse. It is proposed to rebuild the wall in its entirety to its existing profile using existing bricks from new foundations and bricks bedded and pointed in lime mortar. Matching salvaged London Stock bricks will be sourced as required where bricks are weather damaged beyond use and/or missing. The wall will be rebuilt to match existing bond which is a form of Monk bond comprising two stretchers and a header.

Photograph 5
Party fence wall with 37 Gloucester Crescent.

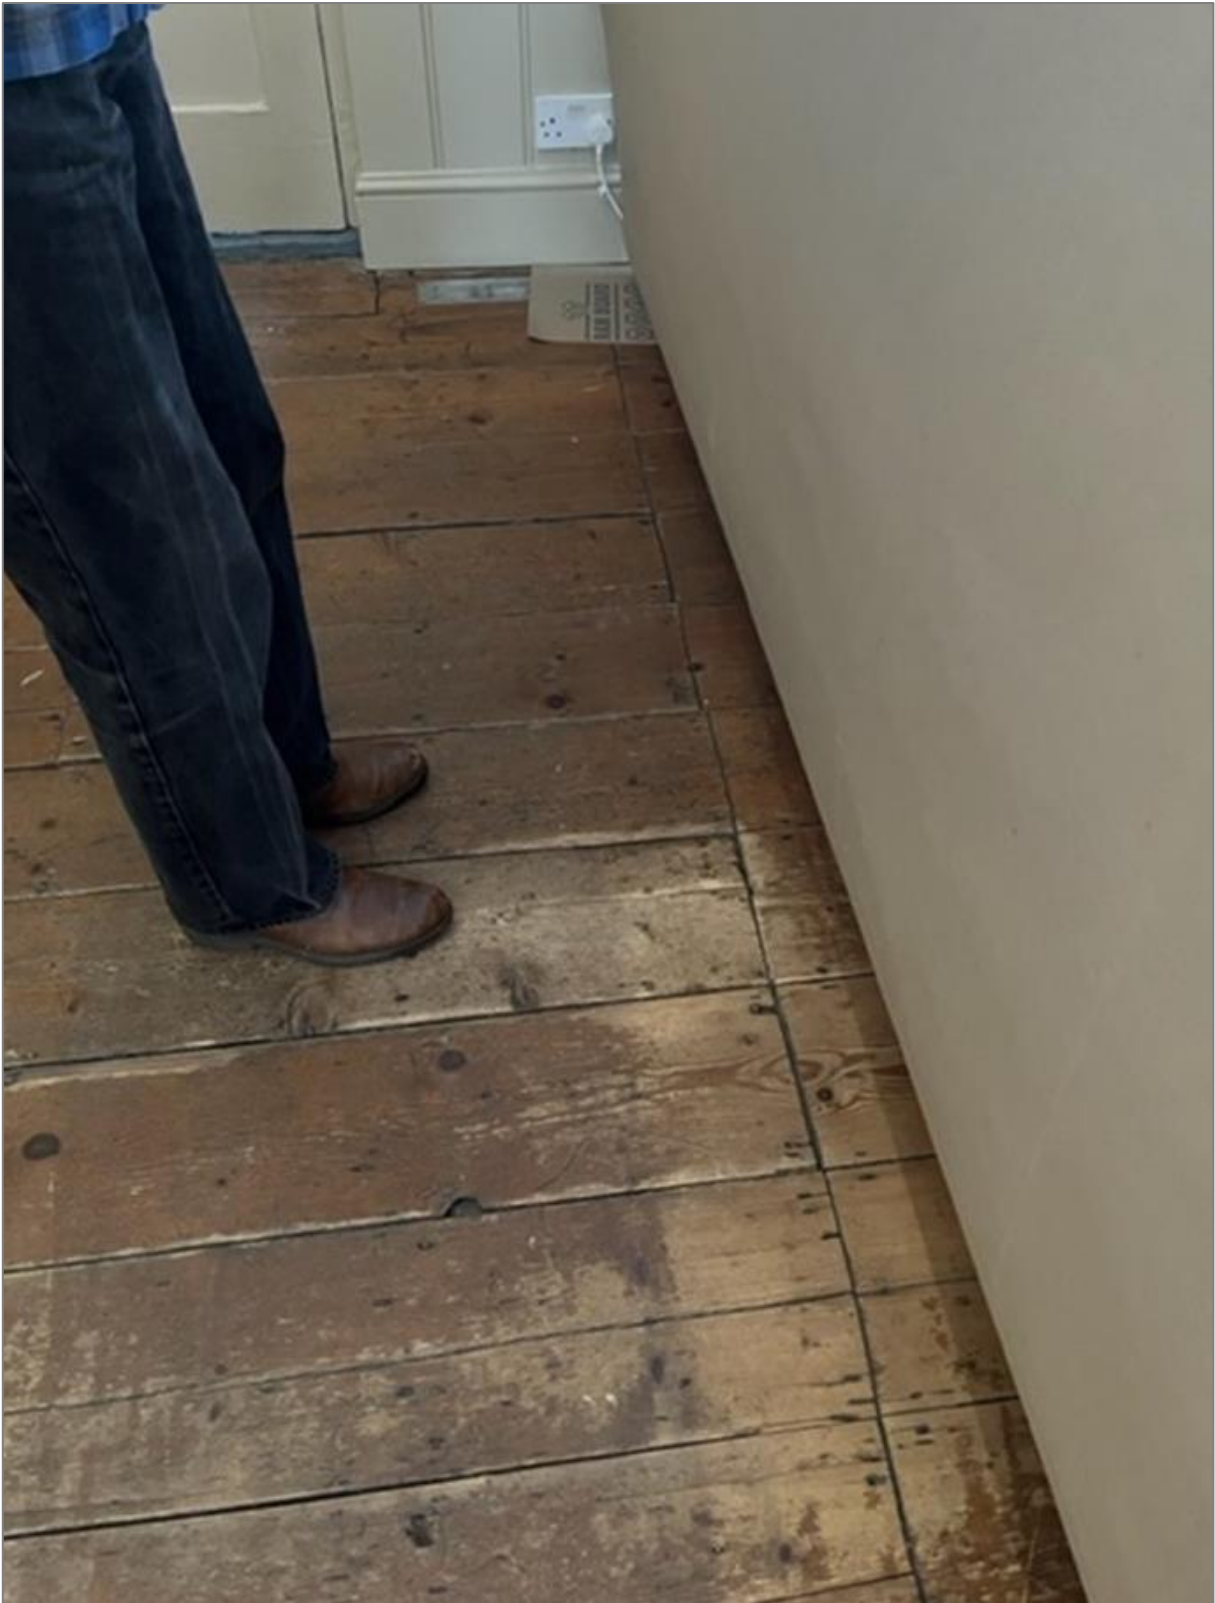
Photograph 8
Cut floorboards requiring repair/possible replacement to dining room

- (iv) In conjunction with the treatment of the joists and introduction of a slate dpc to the dining room, it is proposed to repair and replace damaged floorboards with salvaged boards to match the existing. The condition of the dining room floorboards is shown in photograph 8. Lifting and reinstatement of floorboards to the dining room will be carried out in accordance with the method statement in Appendix 3 hereof.

1. Floorboards to the dining room appear to be original and are fixed to the joists with cut nails.
2. Starting from the kitchen where non-original floorboards are to be removed, the dining room floorboards will be sequentially lifted from each joist by use of bolster and nail bar, taking care to lift boards without splitting timber.

3. When necessary to lift boards from both sides, protection will be used to adjoining boards to prevent damage.
4. Nails will be removed as boards are carefully lifted from each joist as work proceeds. Nails will be removed prior to storage of boards for reuse. Any nails remaining within the joists will be removed.

5. Following completion of treatment of floor joists with a 20% boron solution, the floorboards will be relayed using new cut nails. Matching salvaged floorboards will be used to replace any floorboards that have been damaged historically as required.

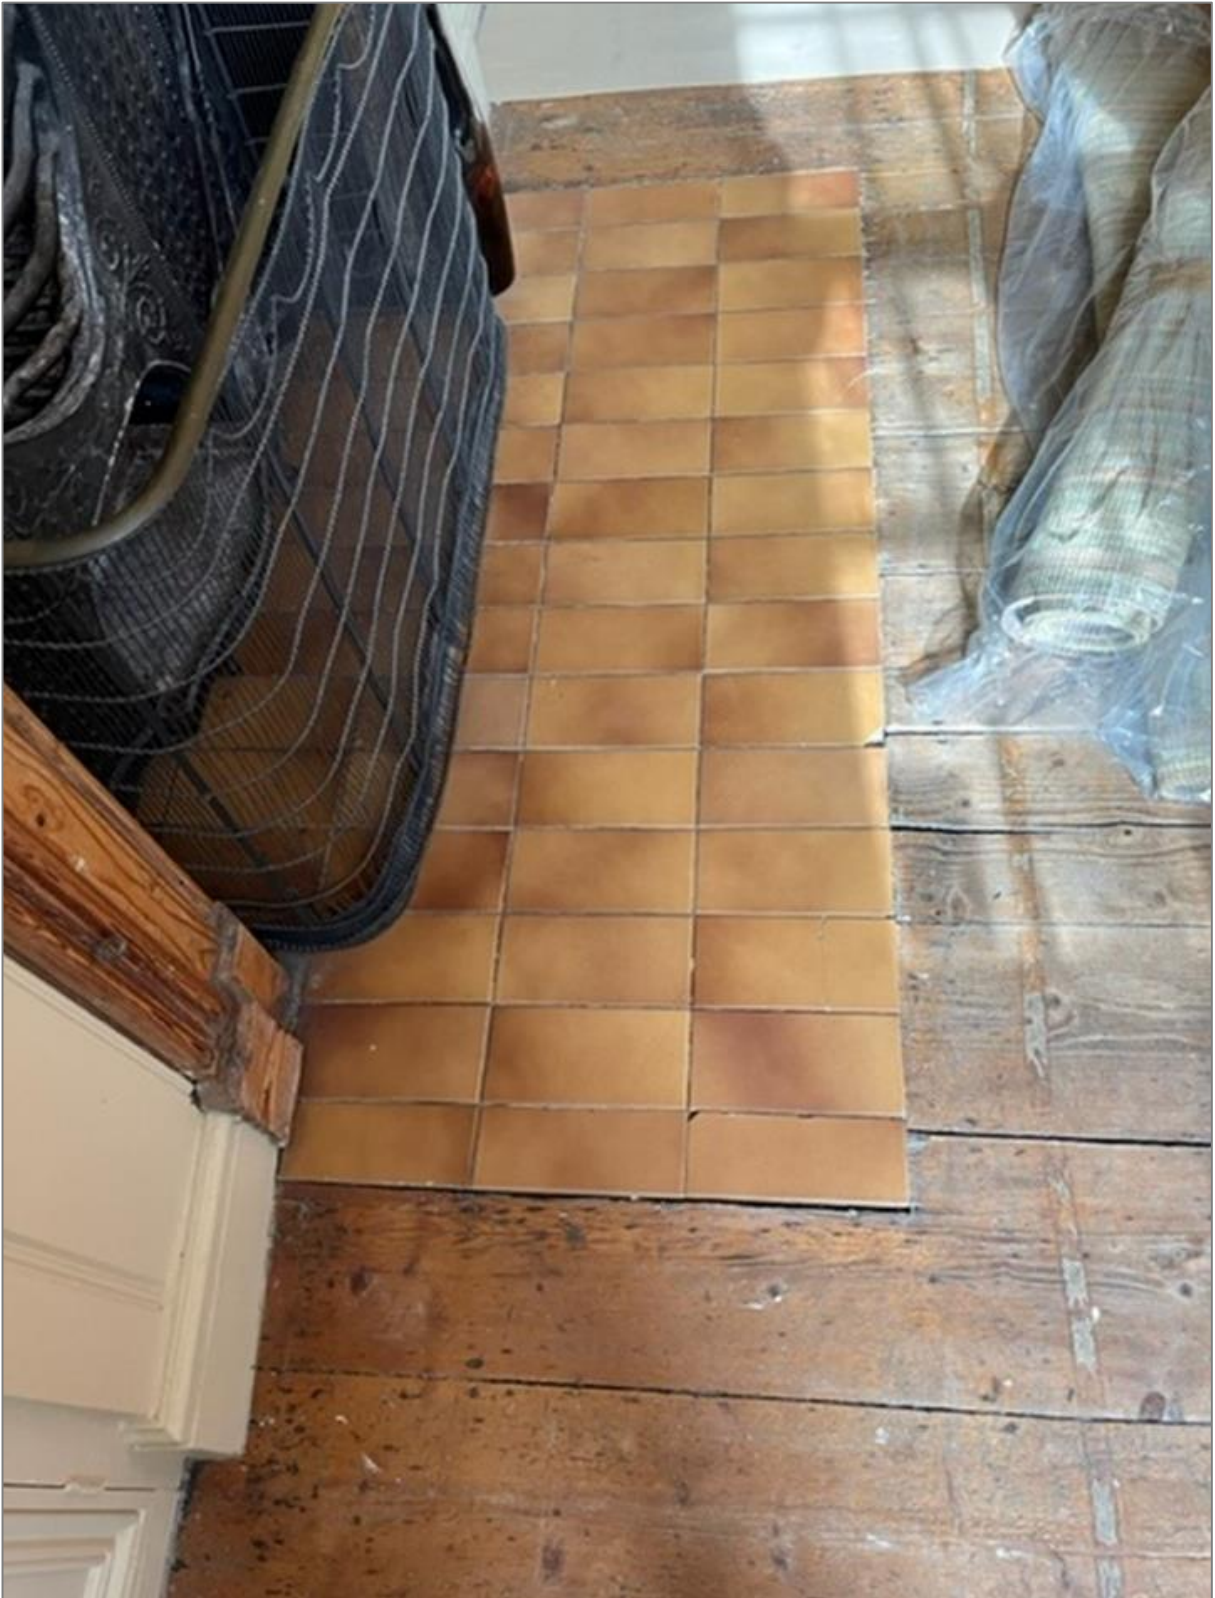
Photograph 9
Cracked non-original tiles to hearth.
