Landmark Trees

**ARBORICULTURAL IMPACT ASSESSMENT REPORT FOR:**

1 Grange Gardens  
London  
NW3 7XG

**Ref:** LVP/1GG/AIA/01

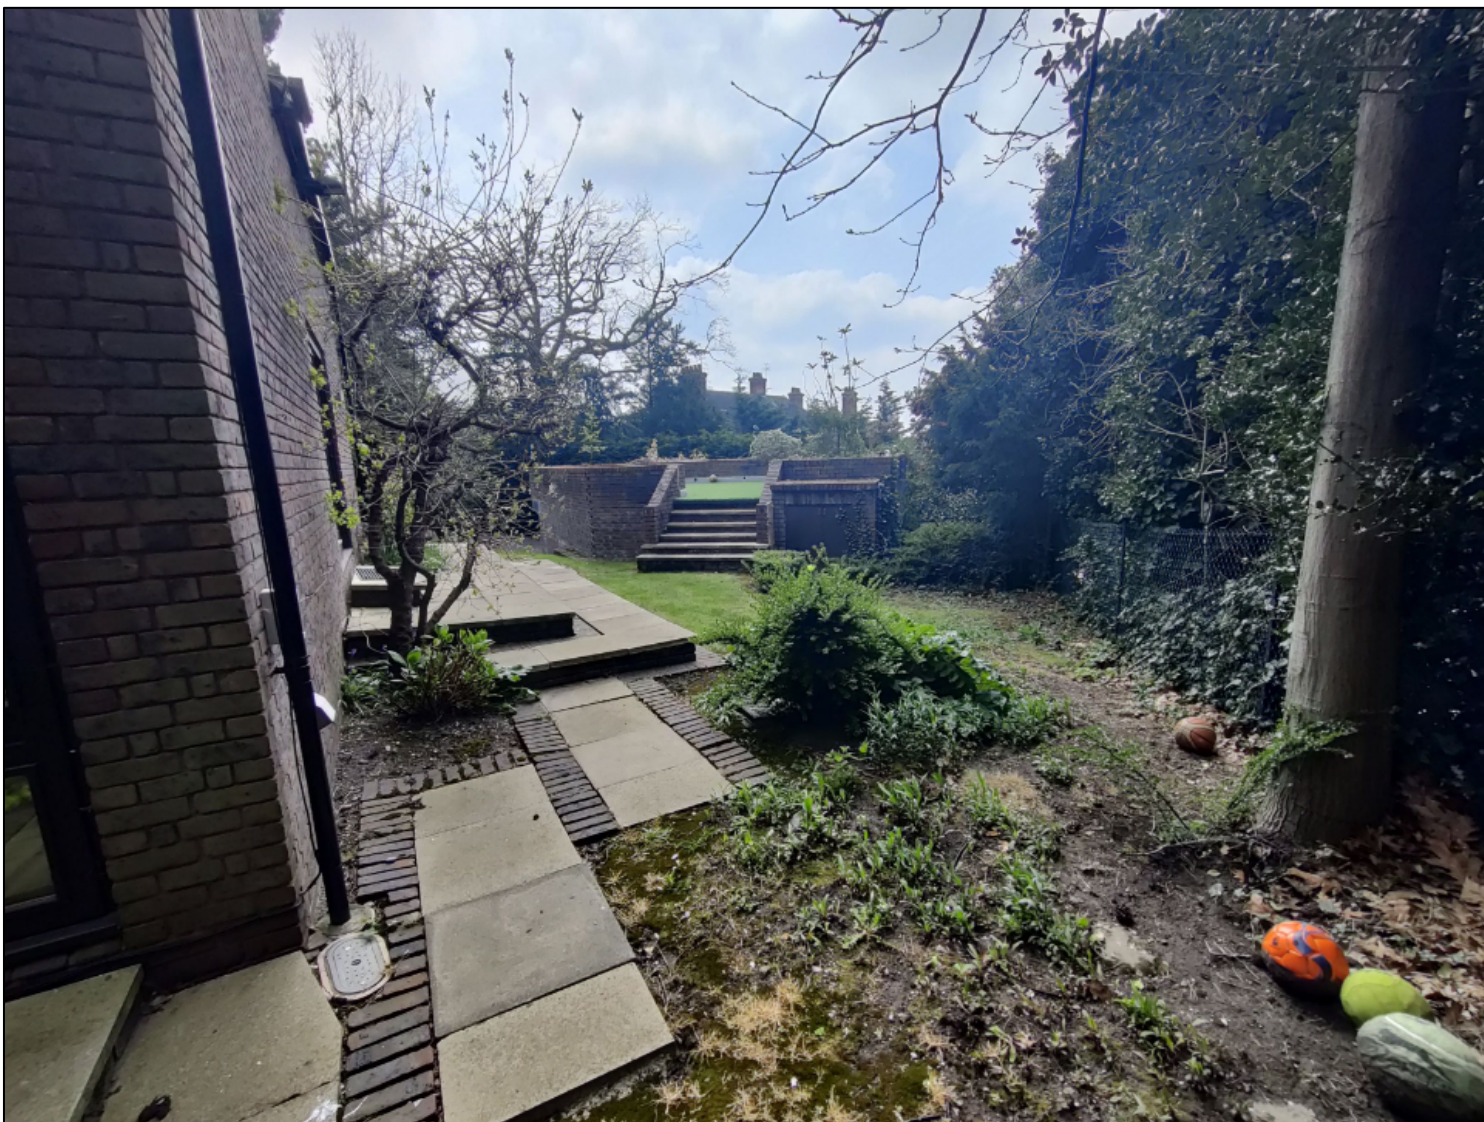
| 2.1.2 | The application relates to the demolition of a one storey annex building with roof terrace located at the south end of 2 Grange Gardens, to be replaced with a new 2 storey, split level single family home. |

Photograph 2: Single storey annex to be replaced

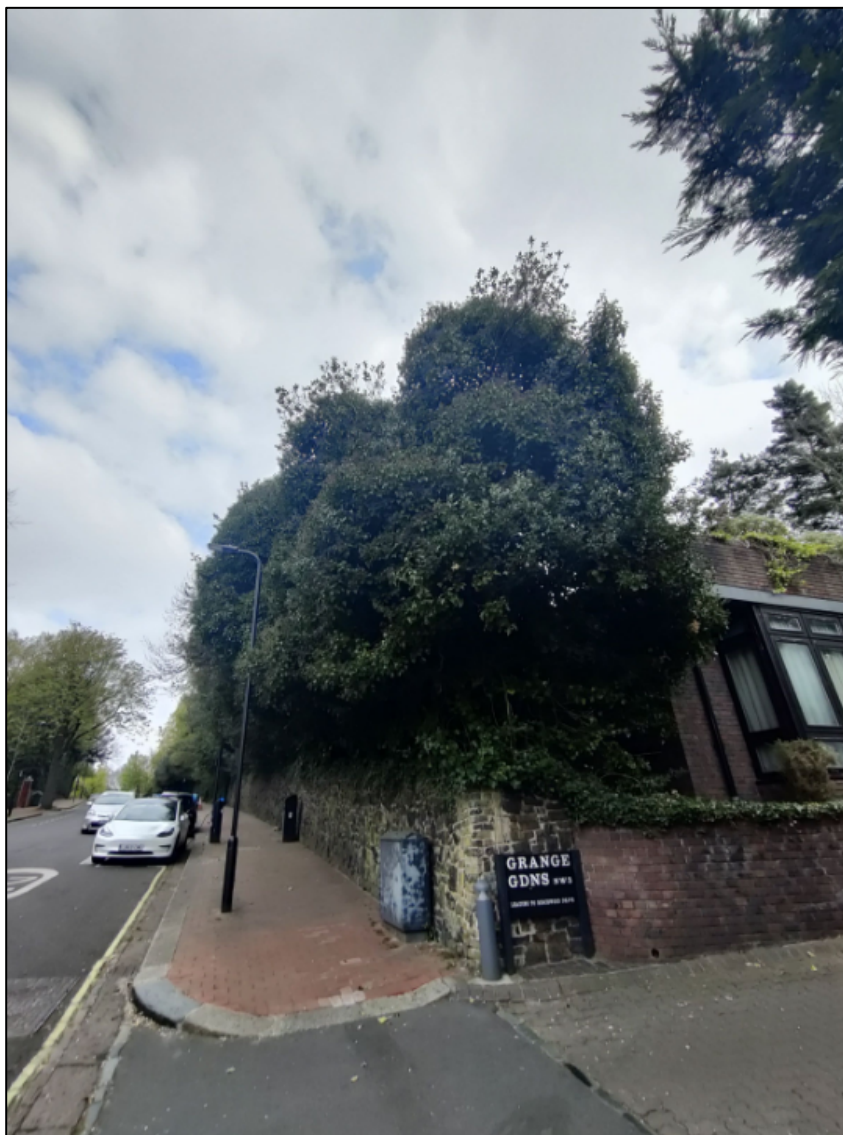
| 3.3.5 | There are recommended works for G1 and T11. These are listed in Appendix 2. |

Photograph 3: G1 encroaching on annex

Tree No.	English Name	Height	Crown Spread				Ground Clearance	B.S. Cat	Comments	Preliminary Recommendations
G1	Holly,Elder,Yew	6	2	2	2	2	0	C2	Mixed species linear screening hedge. The majority of specimens at the southern extent of group are ivy covered. Some small dead trees within	Fell any dead stems at southern end of group - RH2
11	Yew	7.5	1	1.5	1.5	2	0.5	C2	Bifurcated from 1.50m, South western stem is dead, with dead cambium strip running down to base. Crown beginning to show uniform thinning	Remove dead stem - RH2

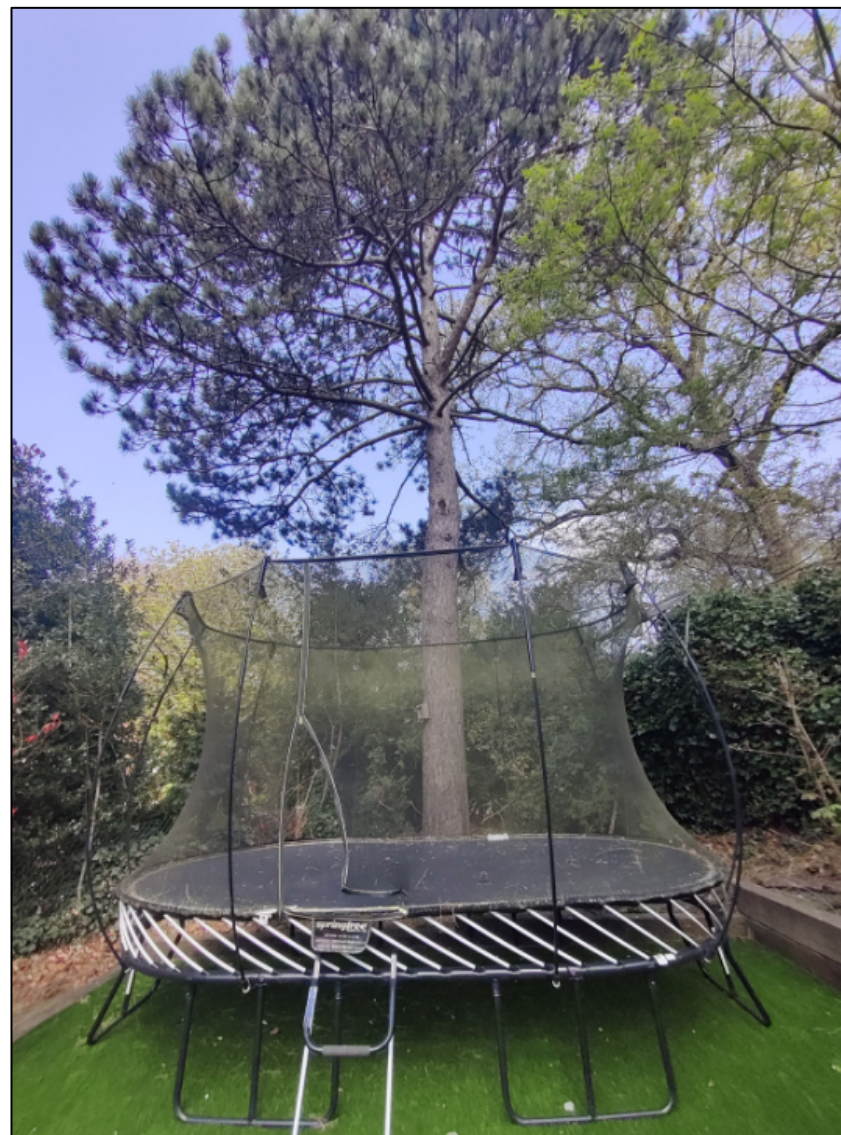
| 3.1.3 | We understand that T2 is subject to a Tree Preservation Order, it is a criminal offence to prune, damage or fell such trees without permission from the local authority. We do though understand that the site stands outside any Conservation Area. |

Photograph 4: Protected pine T2

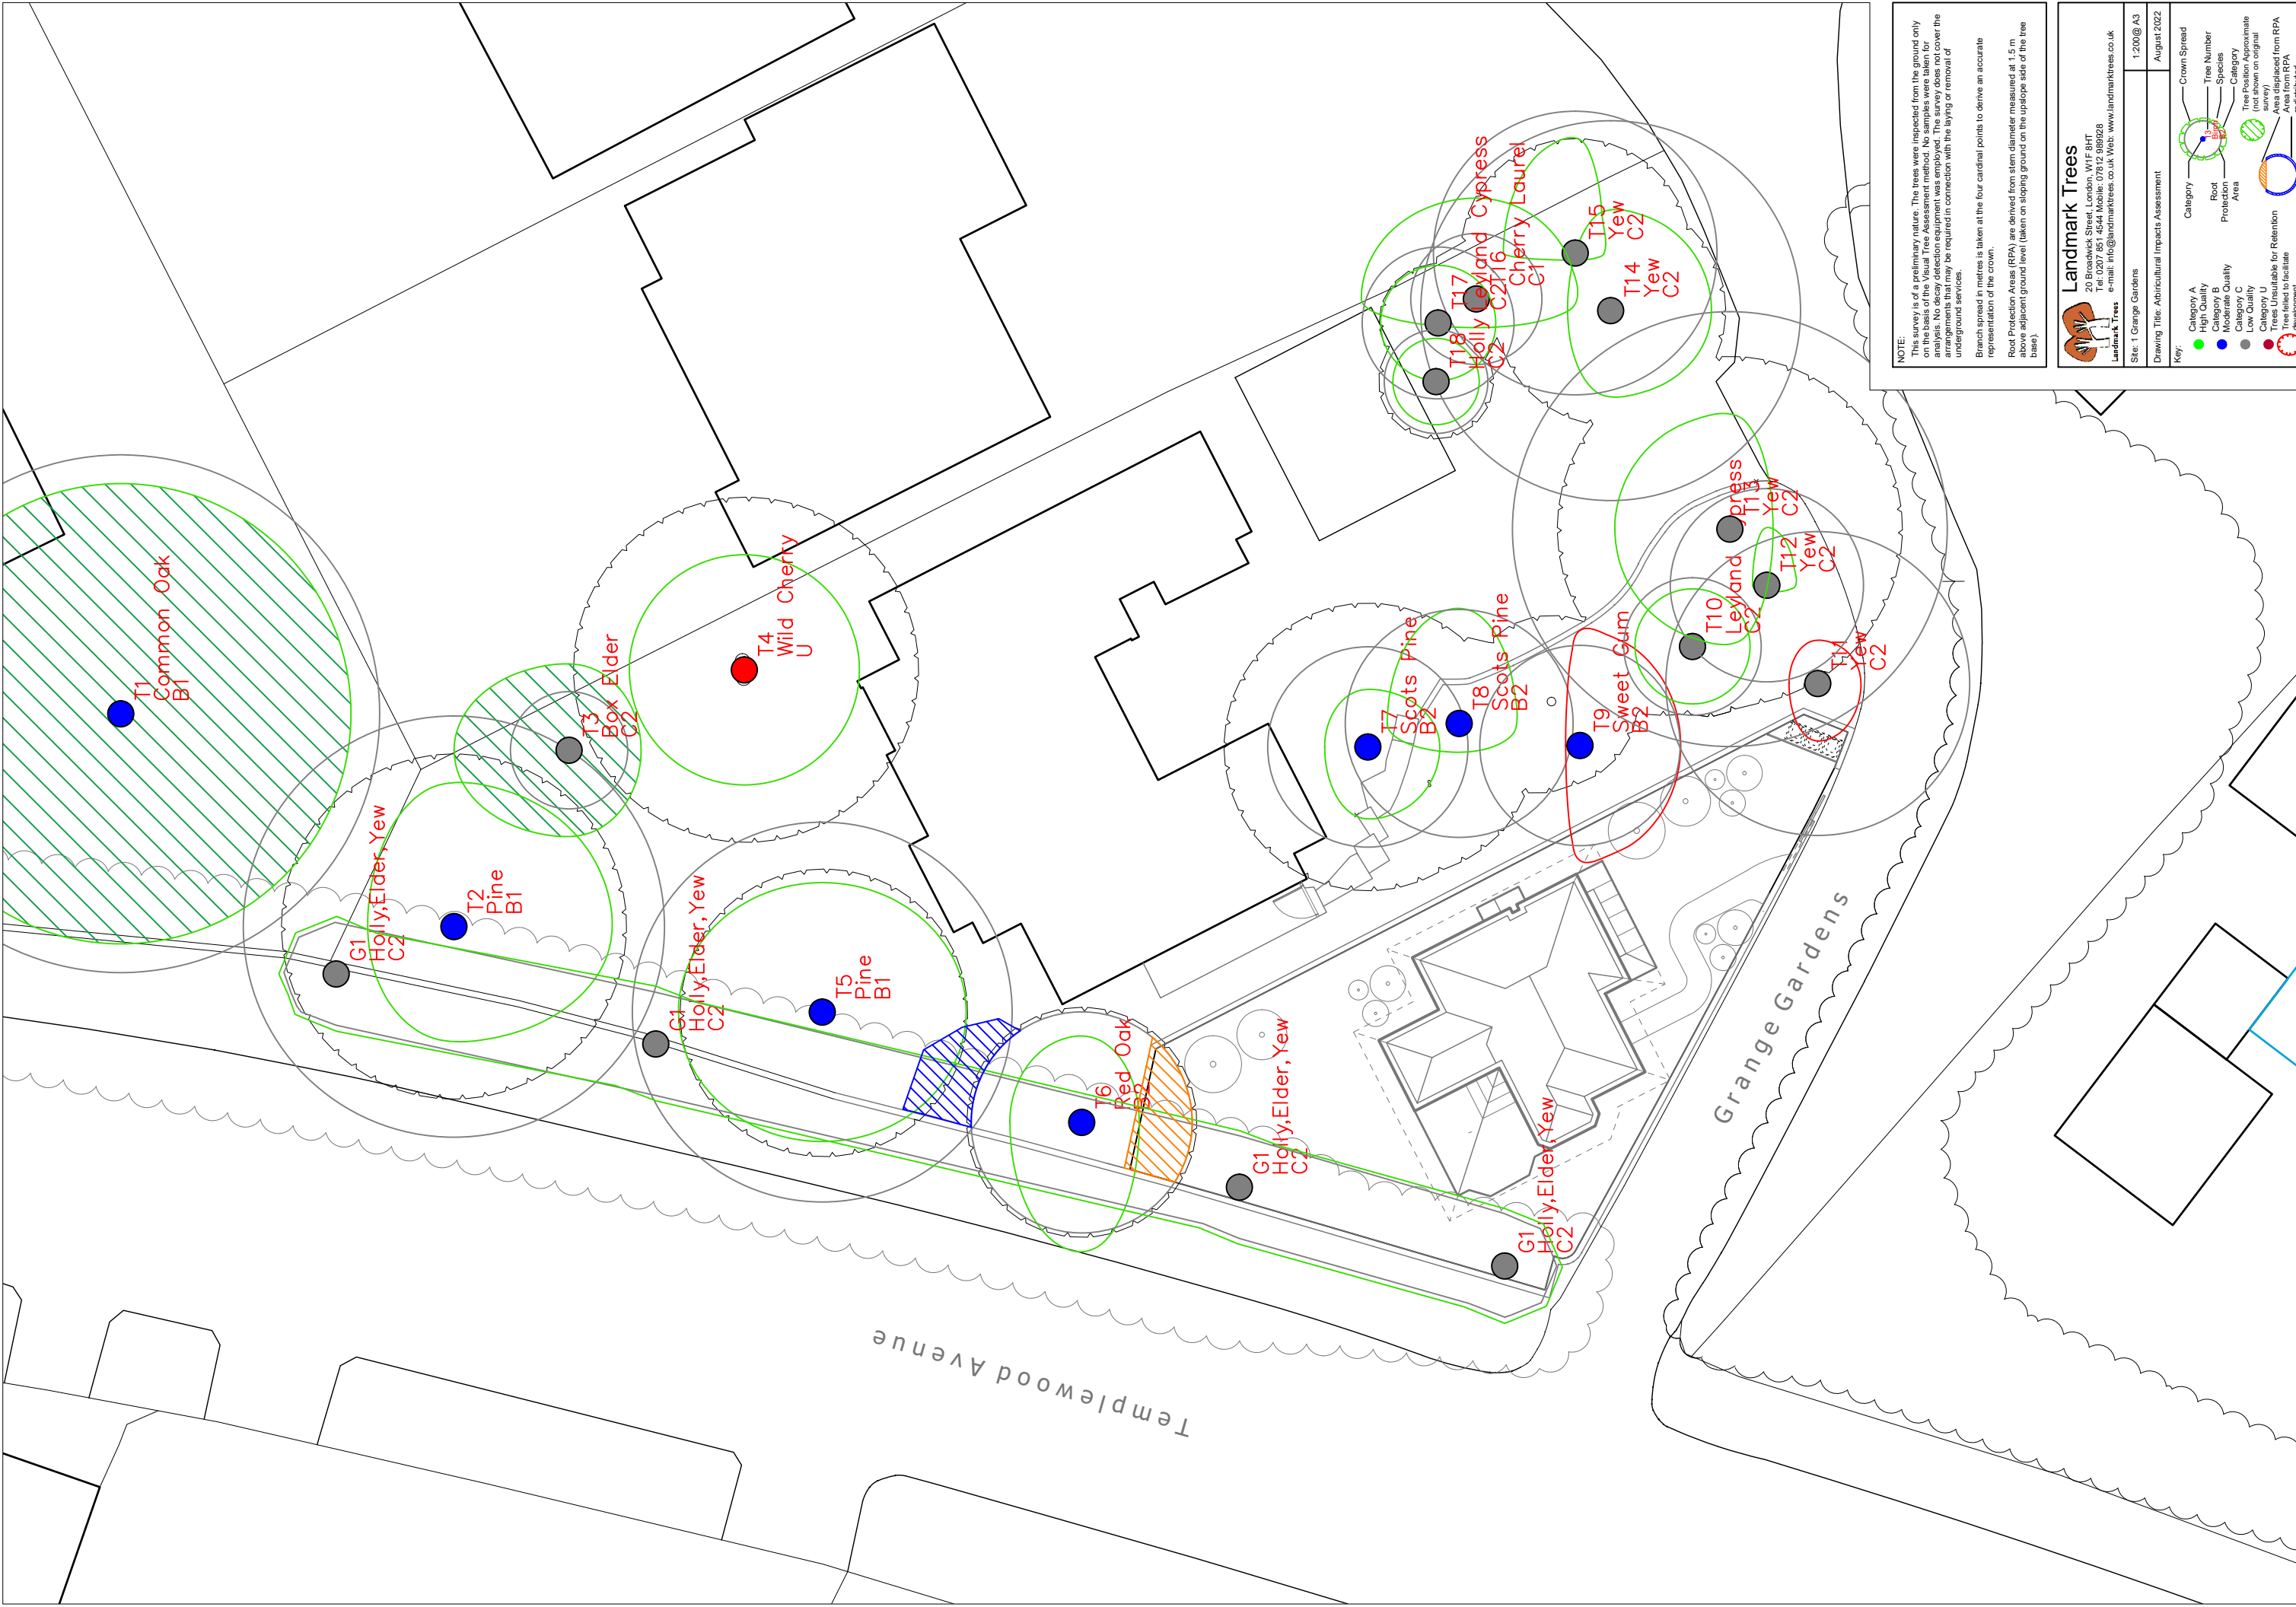
**PLAN 2****ARBORICULTURAL IMPACT ASSESSMENT PLAN (S)**

- 6.1.7 As per BS5837 recommendations (at 5.3.a), the above assessment demonstrates that the tree(s) can remain viable and as per the equivalent hatching in Plan 2 of the Appendices that the area(s) lost to encroachment can be compensated for elsewhere. The guide also recommends (at 5.3.b) the arboriculturalist propose a series of mitigation measures (to improve the soil environment that is used by the tree for growth). These are provided at 6.3 below.

| 6.3.2 | RPA encroachments are shown in Plan 2 compensated for elsewhere on contiguous land, it will be noted that the use of discontinuous foundations for the boundary wall is assumed and as such, only the wall's footprint is deemed to encroach within the RPA of T6. Soft ground within the remaining RPAs of these trees will be treated with a 75mm layer of mulch which will be maintained in place throughout the duration of construction activities. |

| 6.3.4 | The wall encroachments will require the use of specialised foundation techniques, such as discontinuous piles and above ground beam. The foundation pits within the RPA should be trial-excavated by hand using a double-headed spade ("shove-holer") or similar to minimise breadth of hole required for inspection. |
