**20 WELL ROAD  
WINDOWS -  
DESIGN AND ACCESS STATEMENT**

07th September 2022

**BAYNESANDMITCHELLARCHITECTS**

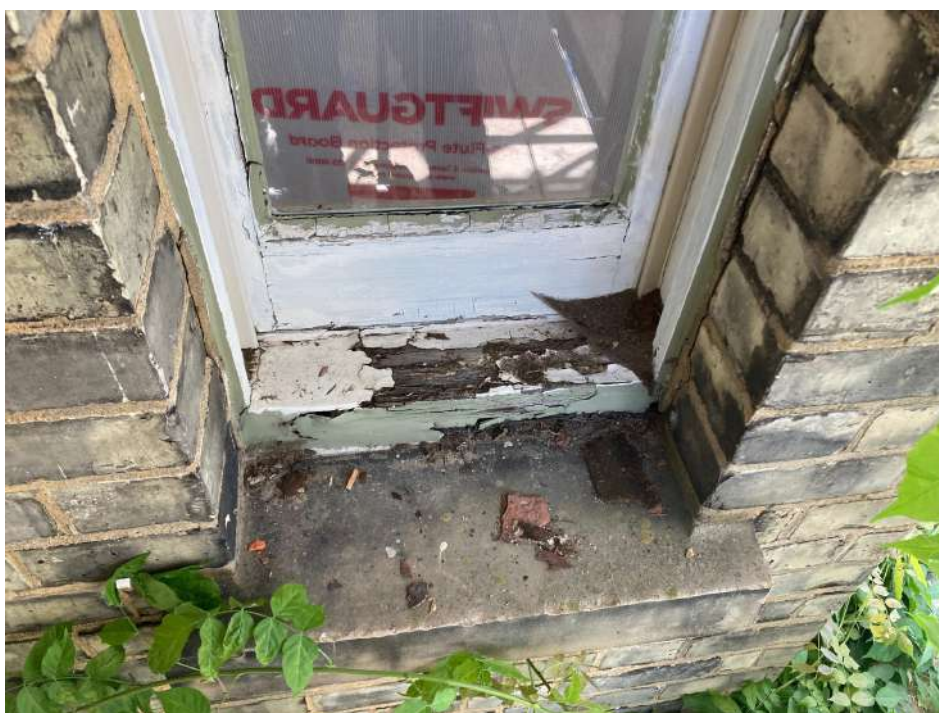
- 3.3 All windows are in a serious state of decay and are in need of replacement. Many of the rotten sills have been lined with lead sheet in an attempt to slow down the deterioration (see pictures).

WINDOWS ARE IN A SERIOUS STATE OF DECAY

- 5.2 The current windows have reached the end of their life cycle and are no longer fit for purpose. They have already had a number of remedial works carried out and a full replacement is now necessary.

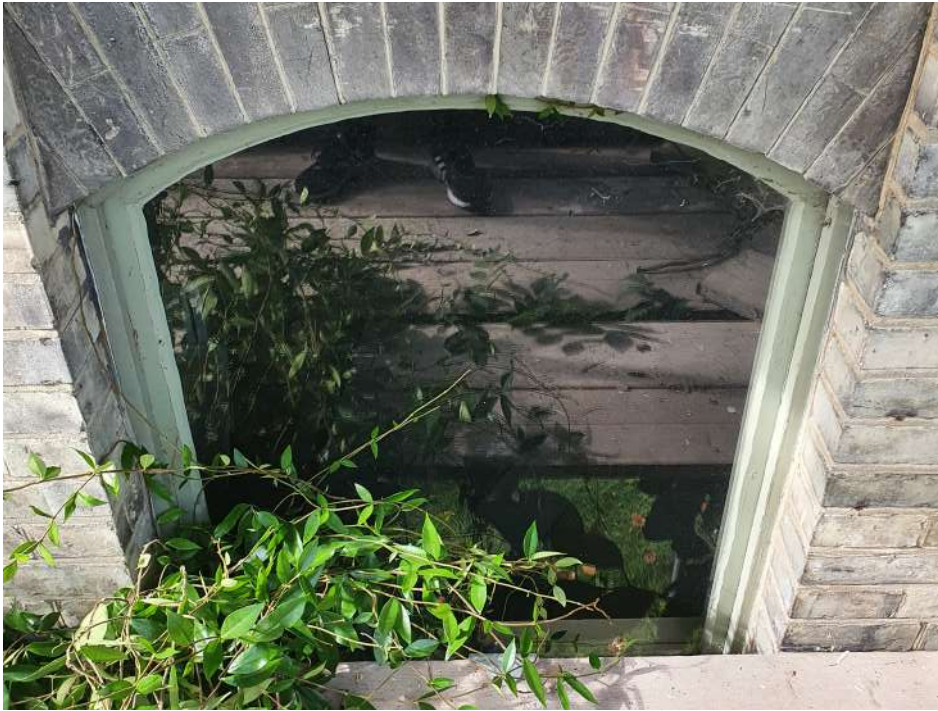
THERE WILL BE NO CHANGES MADE TO THE STRUCTURAL OPENINGS

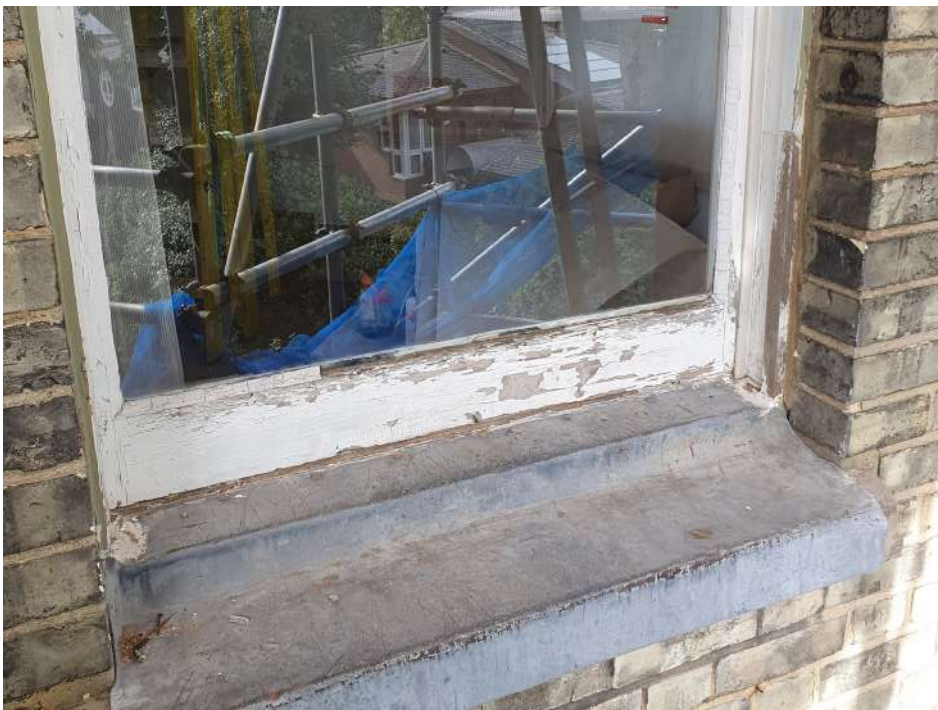
MANY OF THE ROTTEN SILLS HAVE BEEN LINED WITH LEAD SHEET IN ORDER TO SAVE THEM FROM FURTHER DECAY

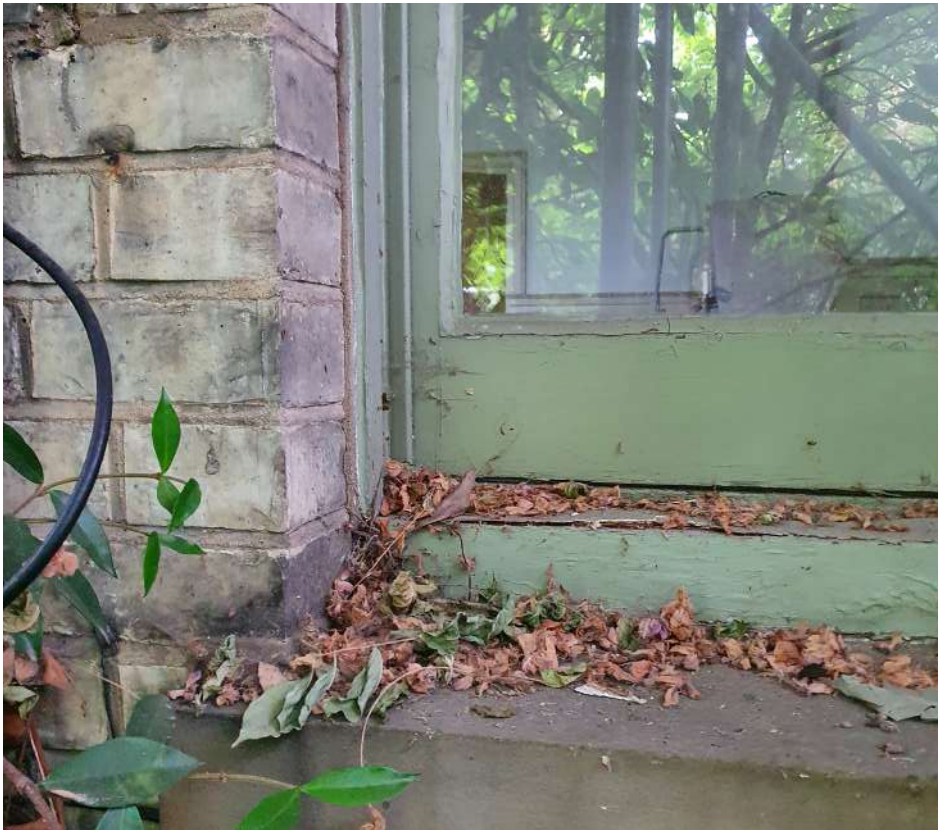
STONE SILLS BENEATH WINDOWS APPEAR TO BE IN GOOD CONDITION AND WILL BE REPAIRED AS NECESSARY AND RETAINED.

- 3.6 There will be no changes made to the structural openings. Stone sills beneath windows appear to be in good condition and would be repaired as necessary and retained.
