BS 5837 Arboricultural Report

**15 Holly Lodge Gardens
London
N6 6AA**

Arboricultural Report to BS 5837: 2012 for: Paul Archer Design Ltd

Crown Ref: 10889

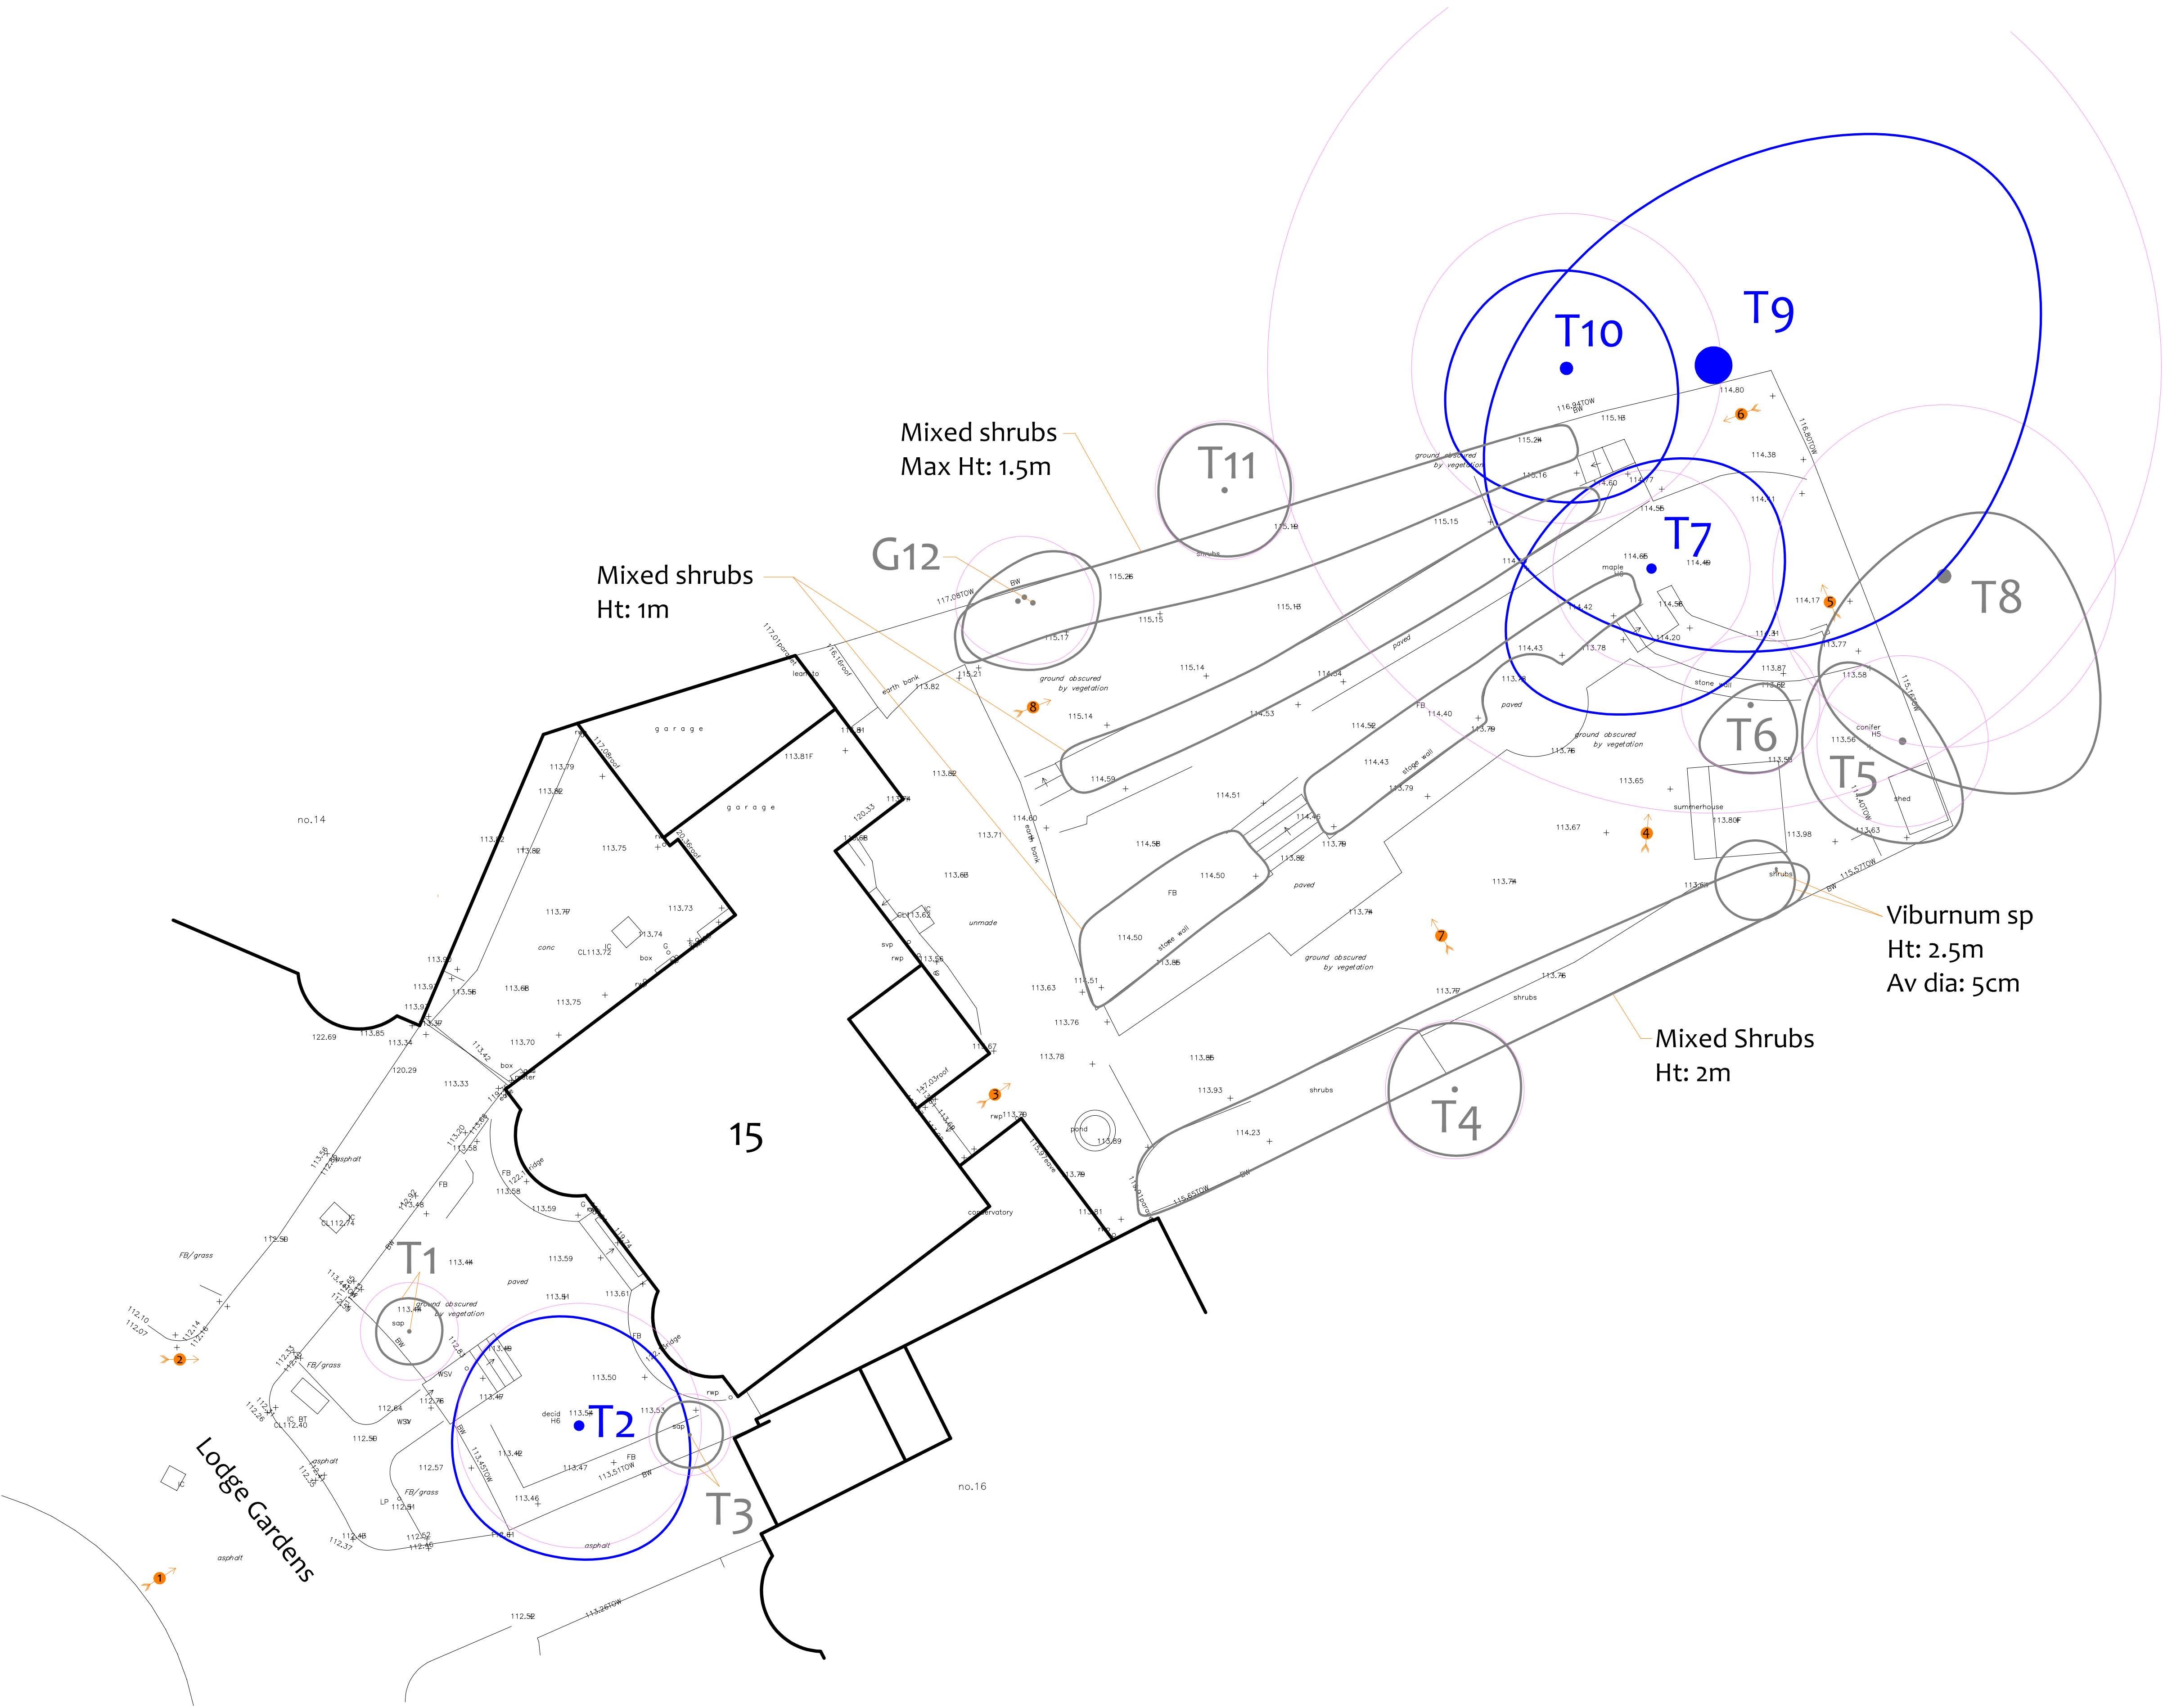
Tree Constraints Plan (Existing Layout)

A small portion of T11, a Retention Category C Elder, shall be affected by proposed building foundations.

The boundary wall foundations are likely to influence the rooting activity of T9, T10 & T11 such that their roots are less likely to proliferate at shallow depths within the site.
