1 Existing - Basement Floor Plan

3 Existing - Section AA'

RIBA CHARTERED PRACTICE T: +44(0)7438 46 23 51 M: alex@iungostudio.com W: www.iungostudio.com	figured dimensions only to be taken from this drawing. All dimensions are to be checked on site before any work is put in hand If in doubt, ask.
075	Medburn St	31 Medburn St, London NW1 1RH		Existing Basement/Section					
Revision	Client	Author	Checked	Drawing No		Date			
	Ms Alina Gerasimenko & Mr Caspar Bartscherer	AC	OB	075(P)031		28/07/2022

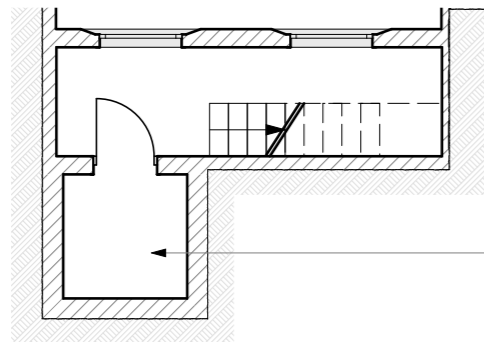
EXISTING COAL VAULT IS DAMAGED FROM WATER INGRESS

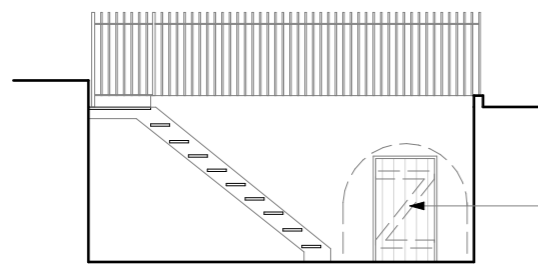
2 Existing - Basement Elevation

EXISTING PINE DOOR IS DAMAGED FROM LACK OF MAINTENANCE AND PROLONGED EXPOSURE TO DAMP

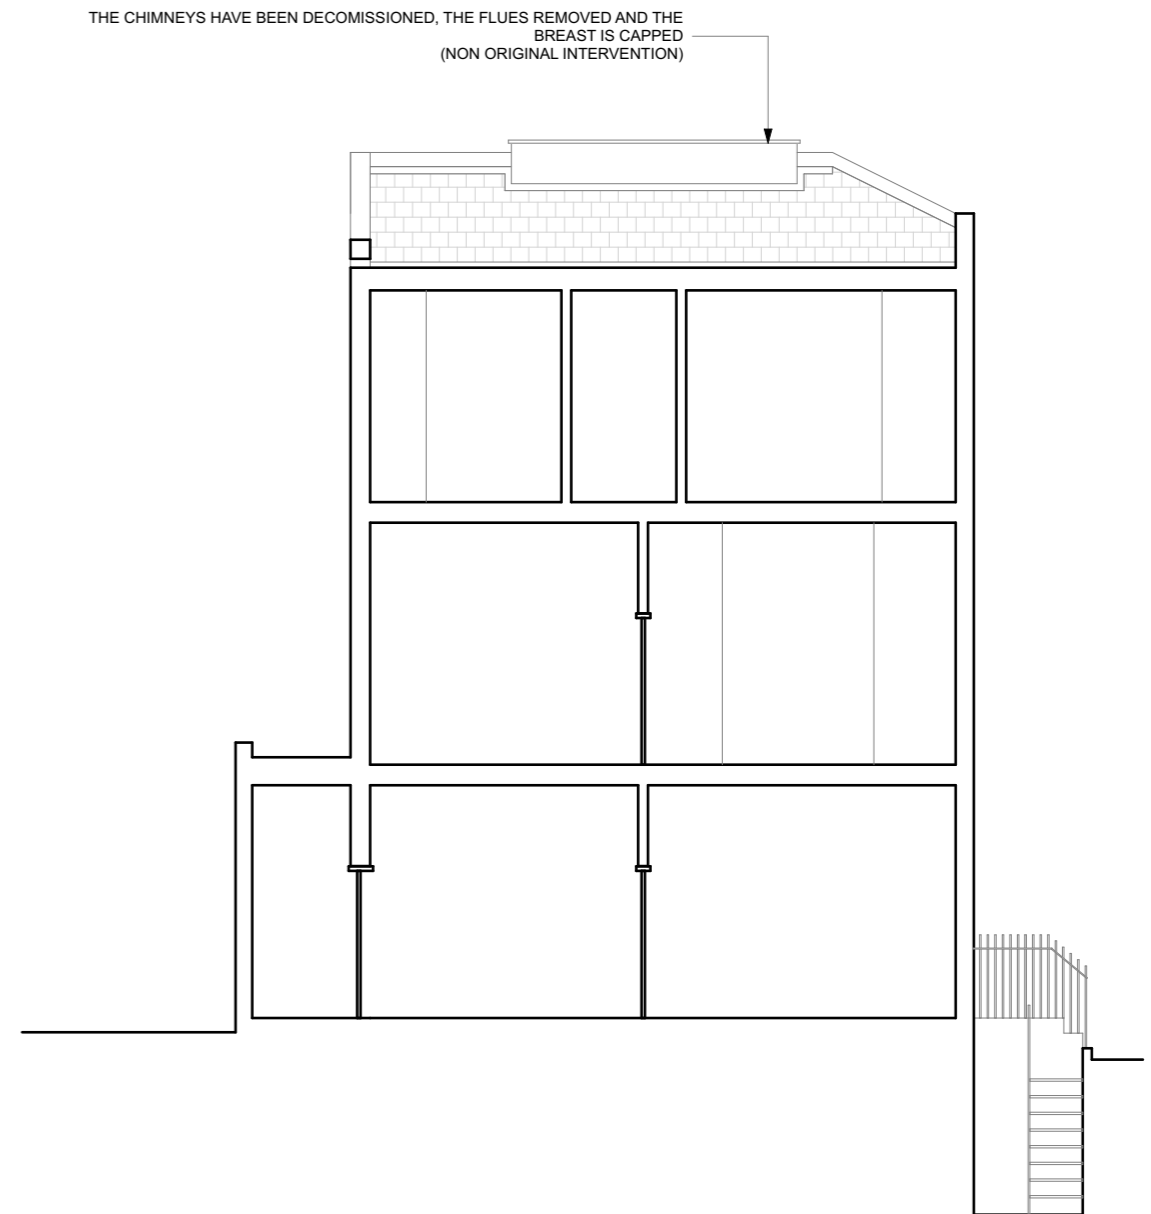
THE CHIMNEYS HAVE BEEN DECOMMISSIONED, THE FLUES REMOVED AND THE BREAST IS CAPPED (NON ORIGINAL INTERVENTION)
