TREE SURVEY, ARBORICULTURAL IMPACT ASSESSMENT AND TREE PROTECTION PLAN

A report to accompany a planning application for the demolition of an existing garage, relocation of site access and development of a two-storey extension and basement level at 4 Frognal Rise, London, NW3 6RD

Report by Dr Martin Dobson

5 June 2015

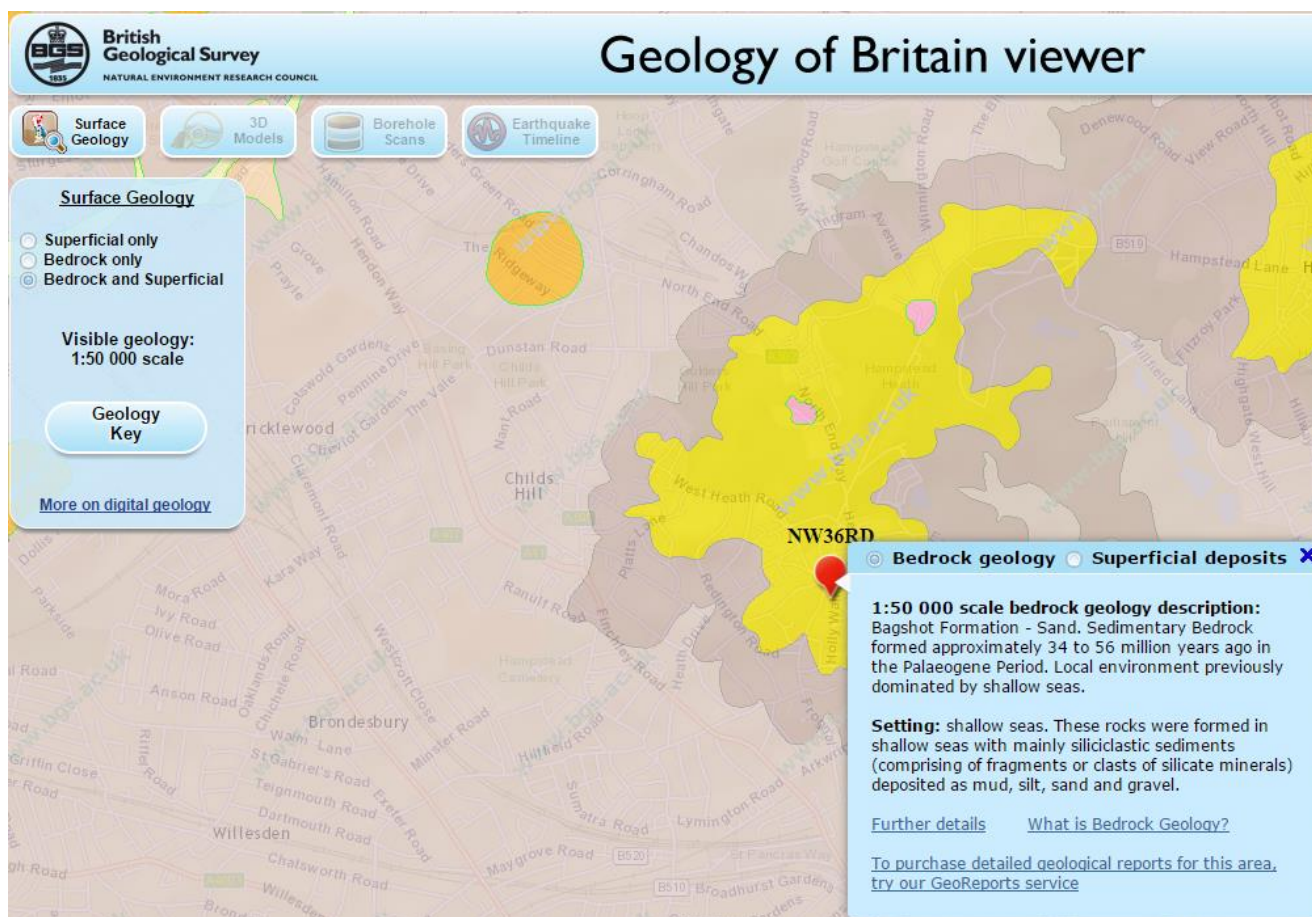
- 3.2 The British Geological Survey 1: 50,000 scale map indicates that the underlying geology of the site is non-shrinkable Bagshot Formation - Sand (Figure 1). This suggests that foundations should not need to be deepened to take account of trees. However, the geological maps indicates that highly shrinkable London clay is close by and therefore if site specific investigations detect shrinkable clay then foundations must be designed with reference to the National House Building Council's Standards Chapter 4.2 *Building near trees*. Cypress and oak are high water demand species, ash, birch and sycamore are moderate water demand species and beech is low water demand.

Figure 1. British Geological Survey 1: 50,000 scale showing that the site is underlain by the Bagshot Formation - Sand.

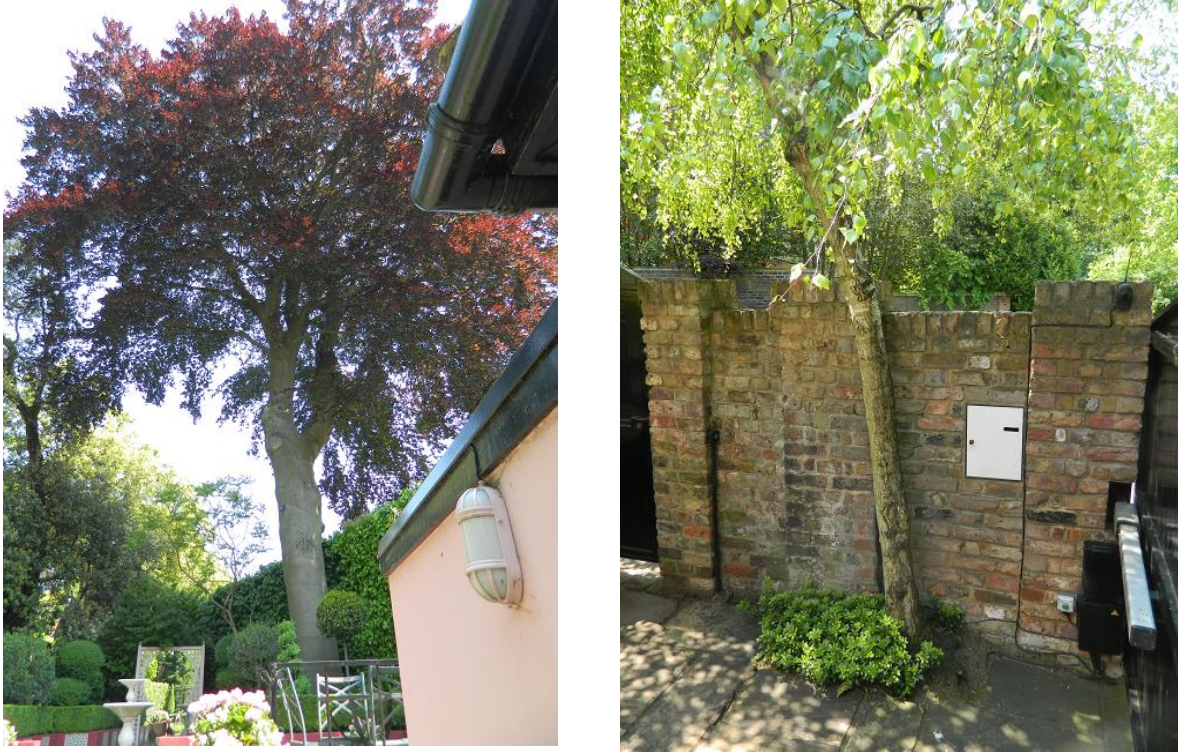
- 4.1 The tree survey identified three trees within the curtilage of the property, a fine category A copper beech (T1) to the rear, a small category C birch causing damage to the front boundary wall (Figure 2) and a category B holm oak in the rear left corner of the garden (Figure 3)

Figure 2. Beech T1 (left) and birch T12 (right)

- 4.8 A low value category C birch (T12) is growing very close to the front boundary wall and has caused direct damage to it. The tree is not in a sustainable location and it is proposed to remove and replace it. The tree is small enough that its amenity value will easily be restored by planting a replacement tree (shown on proposed plans).

T9	Cypress	8	300	2	2	2	2	2	MA	Good	Fair	20-40	C	Part of boundary screen - topped winter 2012/3
T10	Sycamore	16	500	3	3	3	3	8	MA	Good	Good	40+	B	
T11	Holm oak	16	450	4	8	4	6	4	MA	Good	Good	40+	B	Very close to boundary retaining wall.
T12	Birch	4	180	2	2	3	1	2	Y	Good	Good	<10	C	Too close to boundary wall. Damage occurring already and will worsen

- 5.14 One category C birch tree is to be removed as part of these proposals. The tree will be removed as part of preliminary works. This will be carried out by suitably qualified arboriculturists to the standards set out in BS3998: 2010 *Tree works – recommendations*.

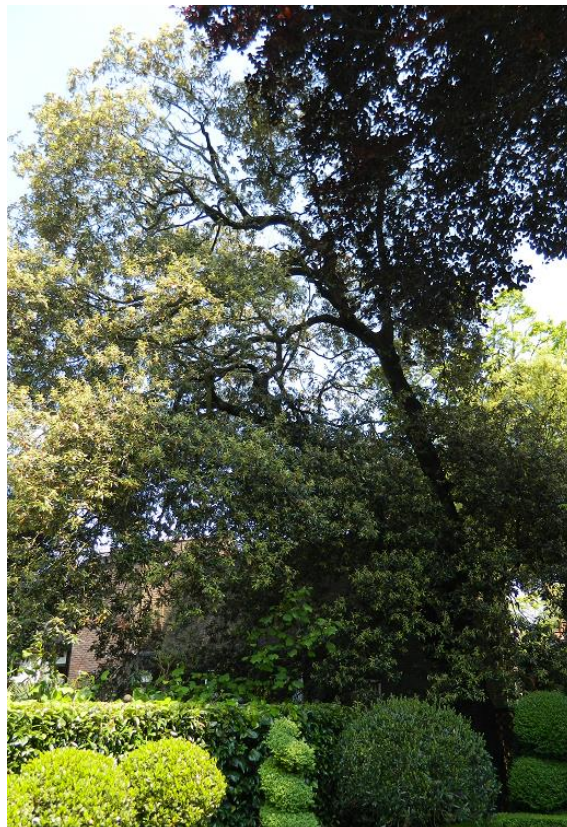
Figure 3. Holm oak (T11) – in the shadow of the beech T1 and suppressed by it.

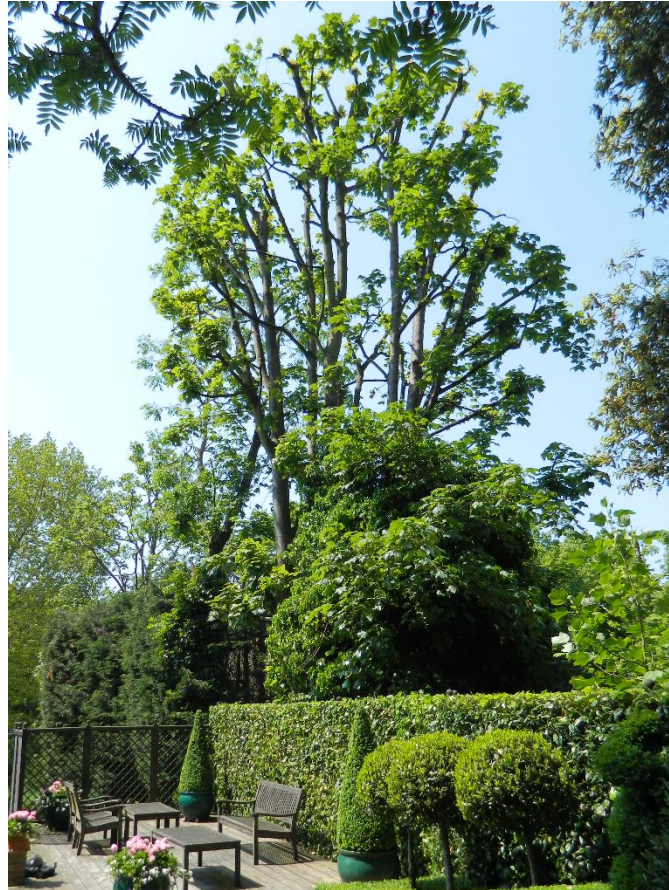
- 4.2 The remaining trees are to be found in a row adjacent to the boundary in the neighbouring garden to the left (Figure 4) and comprise a line of cypresses topped and maintained as a boundary screen (T3 – T4 and T6 – T9) with a young ash (T5) growing amongst the cypresses and two sycamores (T2 and T10) at either end of the cypresses. T2 is the larger of the two sycamores and was significantly crown reduced in 2012/13.

Figure 4. Photograph of trees near to the boundary taken from the rear garden of 4 Frognal Rise

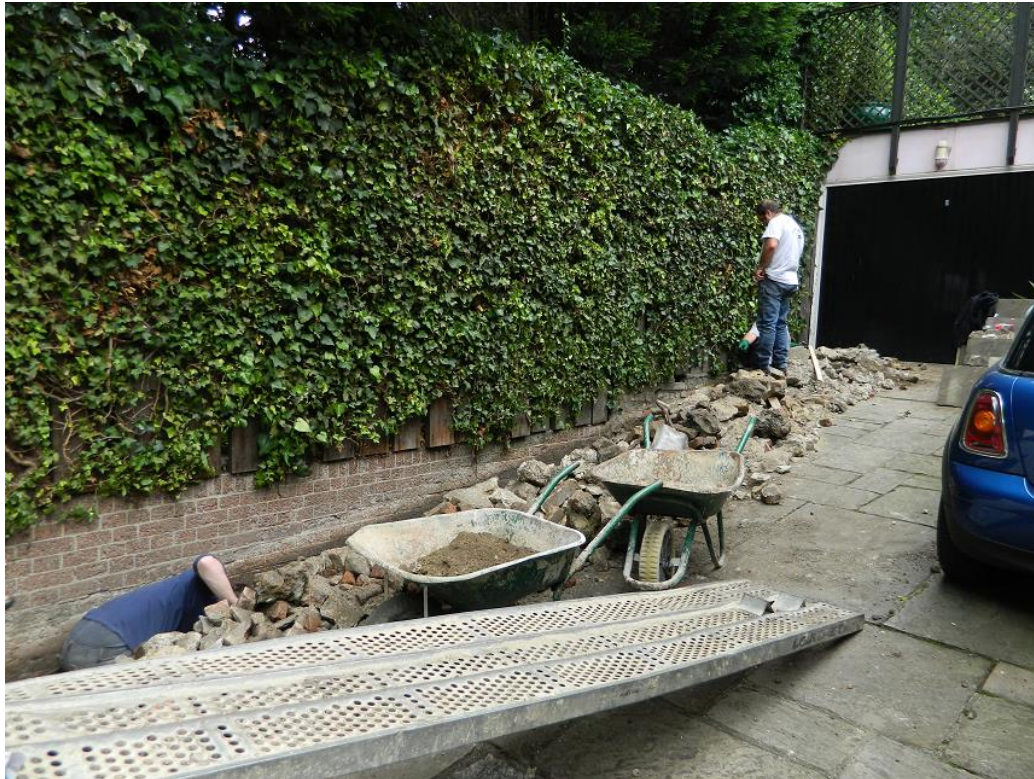
- 4.3 In anticipation of the possibility that roots from the neighbouring trees might cross the boundary a 10 m long trench was dug adjacent to the boundary wall from the front entrance up to the garage (Figure 5) on 15 August 2013. The trench was dug to a maximum depth of 1100 mm (i.e. below the depth where larger woody roots might be expected). The brick footings of the garage extended to 800 mm below ground level and the concrete foundation must have been deeper than this, but excavations were not deep enough to reveal it. The base of the boundary wall was at 1100 mm below ground level and was on a brick rubble foundation. No roots were seen to be penetrating through the brickwork or rubble. A single woody root of about 20 mm diameter was growing along the face of the foundation at a depth of about 400 mm. It appeared to be a conifer root and had apparently grown around the end of the boundary wall, under the pavement, and turned to grow towards the garage along the drive. It is considered that the root is not significant to the overall health of the conifer it originated from.

Figure 5. Exploratory trench 1.1 m deep by 10 m long hand-dug adjacent to the boundary wall to determine whether tree roots were present.

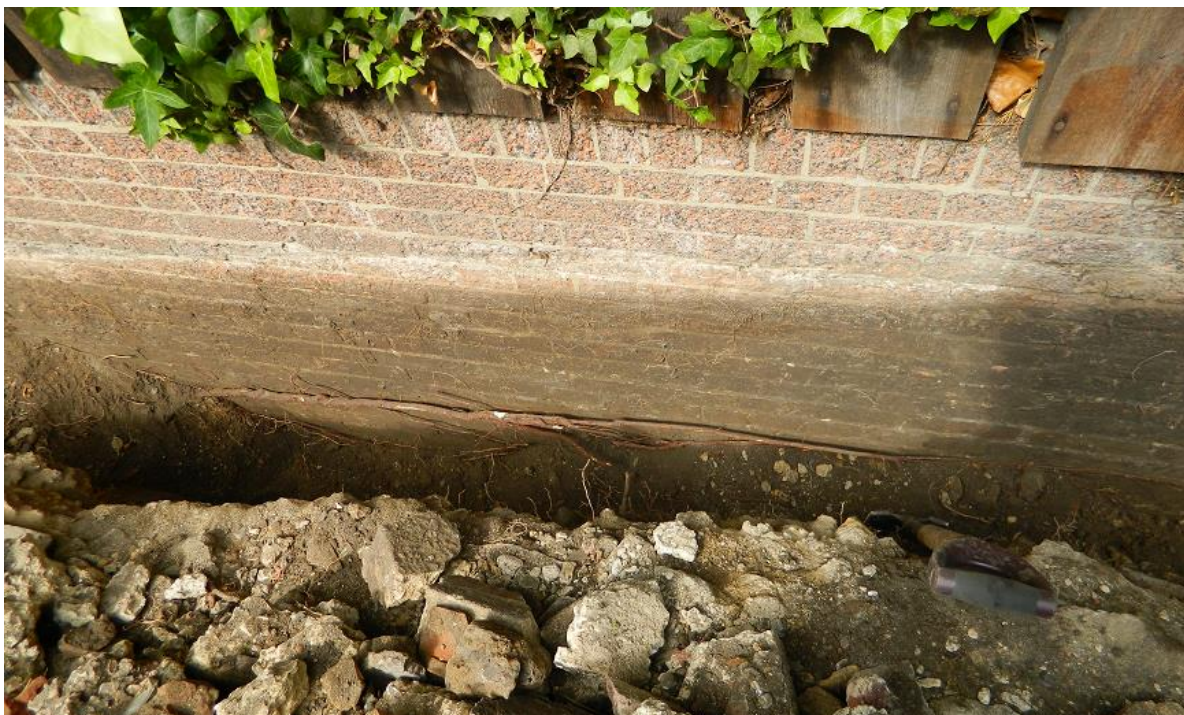
Figure 6. Root thought to be from the neighbour's cypress growing along face of boundary wall foundations.

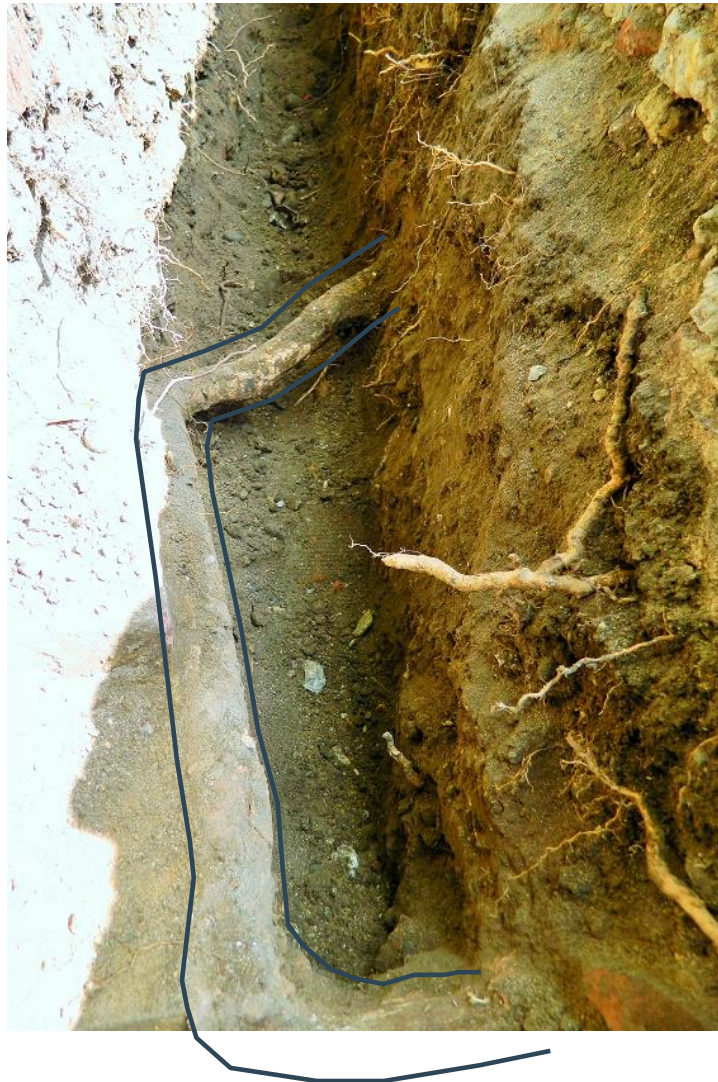
- 4.4 A second, larger, root of 50 mm diameter emerged from the face of the trench (on the house side) at a depth of about 600 mm below ground level and about 2.3 m away from the garage. About 200 mm from the face of the trench the root turned at right angles because of a large piece of masonry in its way and continued in a straight line towards the front boundary for about 1 m before turning at right angles again away from the boundary wall (Figure 6). A side shoot from the root was sampled and sent to Richardson's Botanical Identifications and was identified as being *Fraxinus* – ash. It seems likely therefore that the root was from the young ash tree T5 in the neighbour's garden. How the root came to be in the location it was discovered in is something of a mystery. It didn't grow under the boundary wall in the excavated area and it

seems unlikely that it grew under the relatively deep foundations of the garage, the brick footings of which were in excess of 800 mm deep and there was probably a further 500 mm of concrete below the footings. A root 50 mm diameter is not, in my experience, likely to grow to a depth of 1300 mm and therefore, as improbable as it sounds, the root had probably grown around the rear end of the garage and then grown back down its right hand flank wall. Whilst the root is in close proximity to the trunk of its parent tree T5 (approximately 2 m) it may have travelled 20 m to get there.

Figure 7. Ash root 50 mm diameter growing out of house-side of exploratory trench and back into the side wall of the trench after 1 m.

- 4.6 It is considered that removal of the 50 mm diameter ash root will not have any implications for the health of T5. The root, strictly speaking, is also outside the theoretical root protection area of the ash as it has travelled significantly more than 3.6 m away from the parent trunk. The young age of the ash combined with the relatively small size of the root means that, in my opinion, it may be removed without harm to T5.

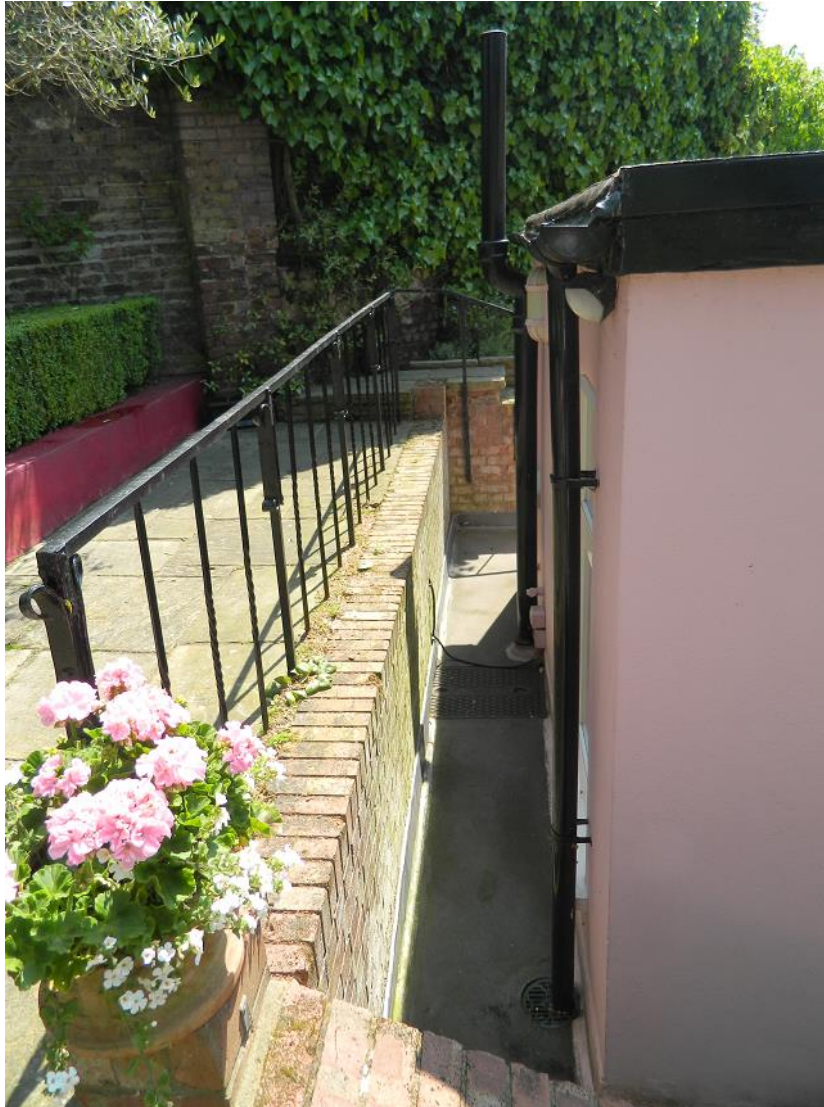
- 4.7 The development is theoretically within the root protection area of the beech T1 but the proposals do not extend beyond the footprint of the existing development. A retaining wall to the rear of the property (Figure 8) marks the edge of development. It is highly improbable that any roots of the beech (which tends to be shallow rooting) will grow beneath the retaining wall.

Figure 8. Retaining wall to the rear of the property which marks the edge of proposed development which will act as a root barrier.
