**PLANNING STATEMENT**

**CAPITAL WORKS PLANNING**

**29- 31 SWINTON STREET & 1-4 SWINTON PLACE**  
**CAMDEN LONDON**  
**WC1X 9NW / WC1X 9NF**

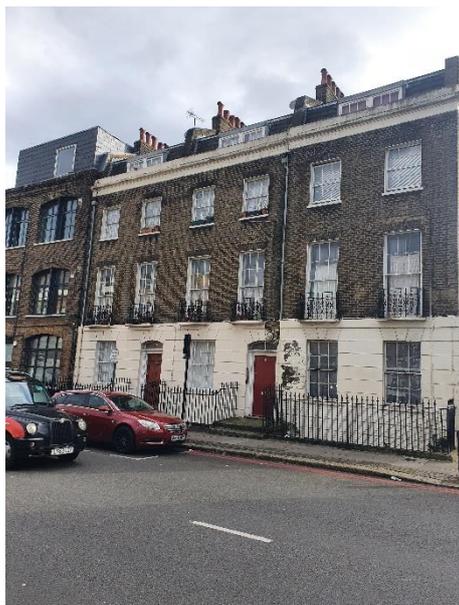
The external painted elements including windows, cills and cornice details on both the front and rear elevation have deteriorated over time with visible cracks evident. These elements are painted in magnolia and white. The brickwork also has visible damage, and they are in poor condition in some areas of the buildings. The proposed work includes for these to be repaired. Currently, both the yellow stock brickwork to upper storey's and the stucco render are affected by how busy the road is, with a layer of soot having discoloured the bricks and render over the years.

Figure 2: Existing painted section on front and side elevation

It is proposed that all previously painted surfaces will be improved by redecorating with a magnolia and/or white colour in a suitable paint considering the materials (as below). Where necessary we will be carrying out masonry repairs to brickwork and rendered sections to prevent further deterioration, which will be completed by a specialist contractor. Mortar repairs will be completed in accordance with the below material list, to ensure suitability for the scenario to be used.

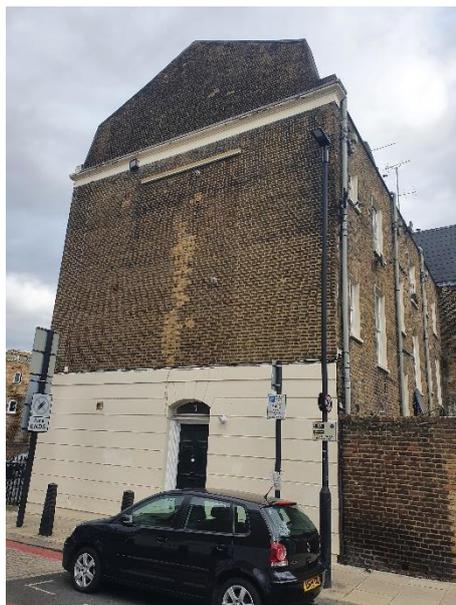
Figure 3: Existing brickwork sections on rear elevation

- Mortar Repairs – All brickwork mortar repairs will use a 3:1 lime-based mix as follows: 2 (Building Sand) : 1 (Sharp Sand) : 1 Lime. The lime part of the mix will be NHL 2.5 for lower level, less exposed areas, and NHL 5 for higher areas of the elevations and exposed areas.

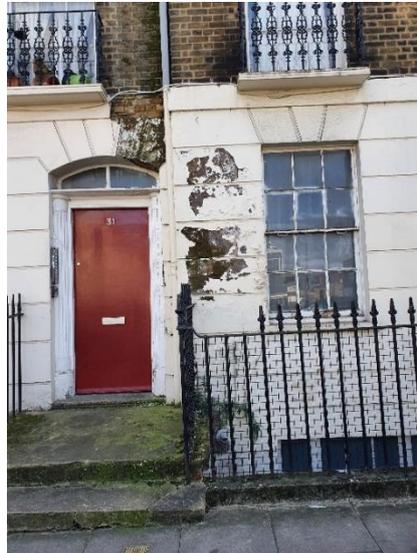
The properties currently have front entrance steps constructed up to the ground floor entrance that requires waterproofing. They are in very poor condition with visible cracks and splits. It is proposed, to retain the existing, suitably cleaned and repaired with concrete fillers. If other finishes, such as tiles or bitumen, have been applied, these may be removed.

Figure 4: Existing front entrance steps
