THIRD FLOOR PLAN

AS EXISTING

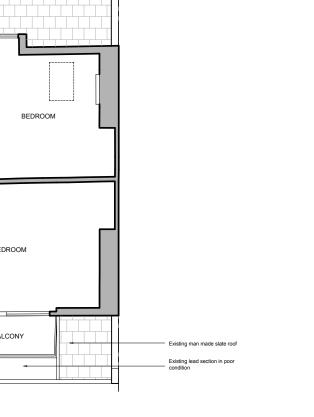
Existing lead dormer in poor condition Existing poor quality roof lights Existing lead section in poor condition
