—The British Museum  
King Edward Building  
Window Replacement  
Design & Access Statement

22 November 2022

# Design & Access Statement

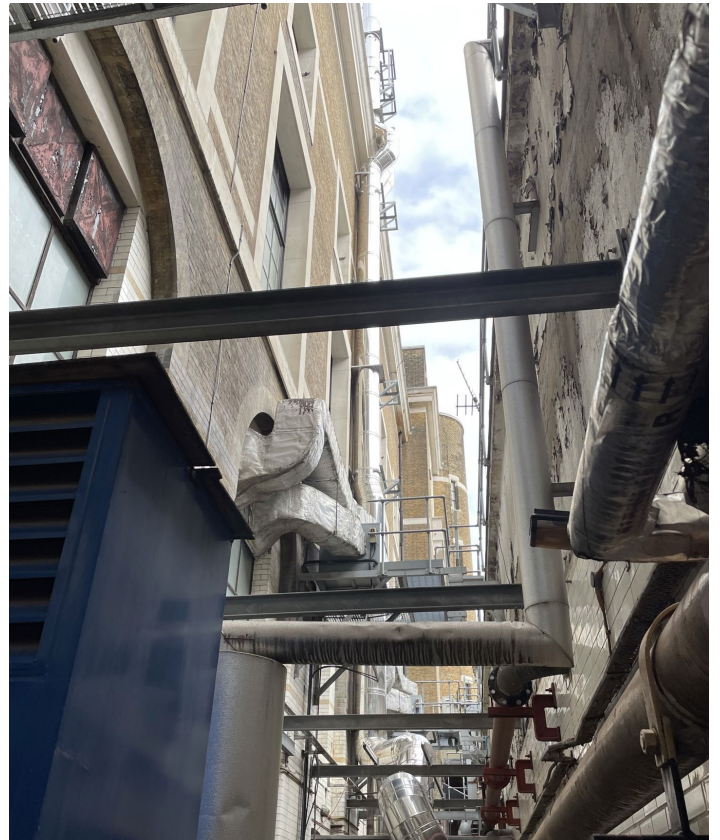
1. Photo of existing mechanical ducting on the south east elevation above the window

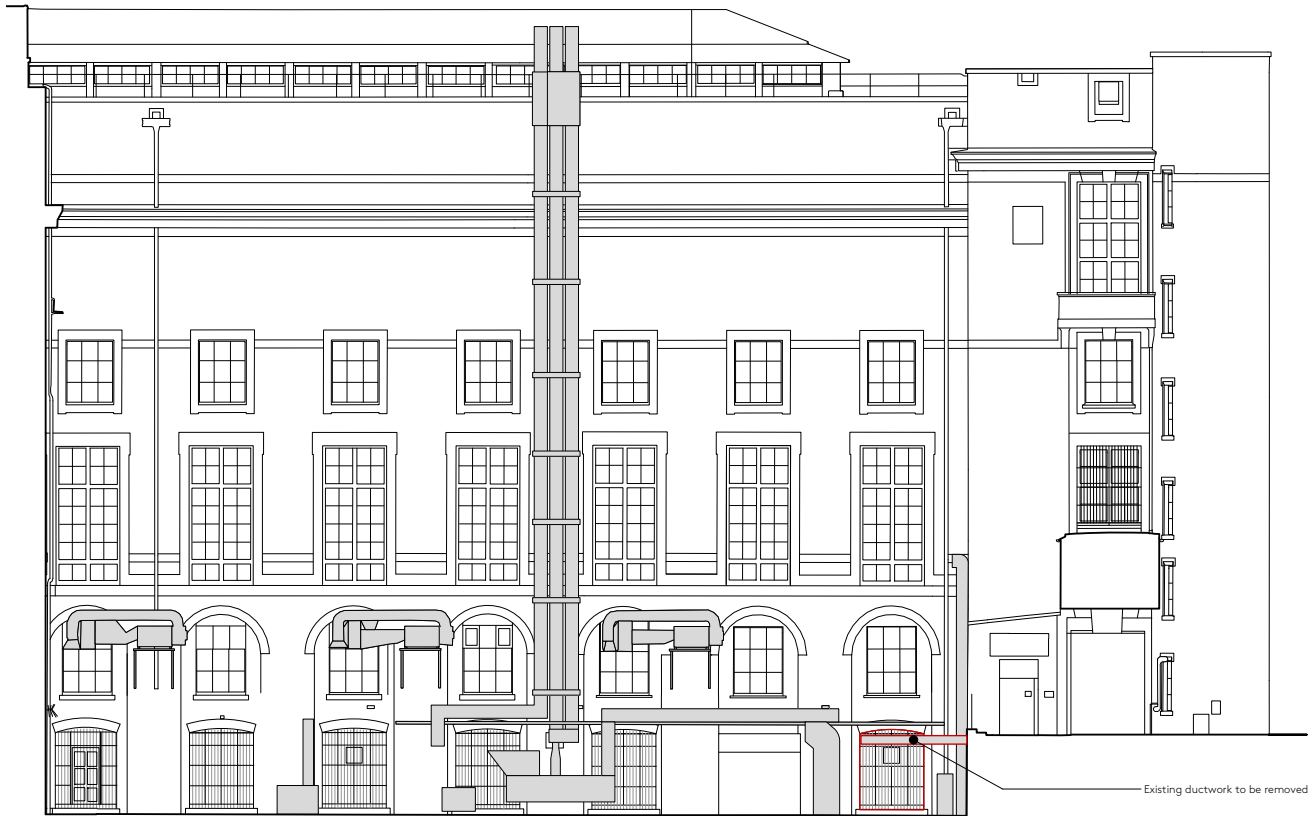
Southeast elevation of the KEB showing the window to be replaced, and the duct that is proposed to be removed.

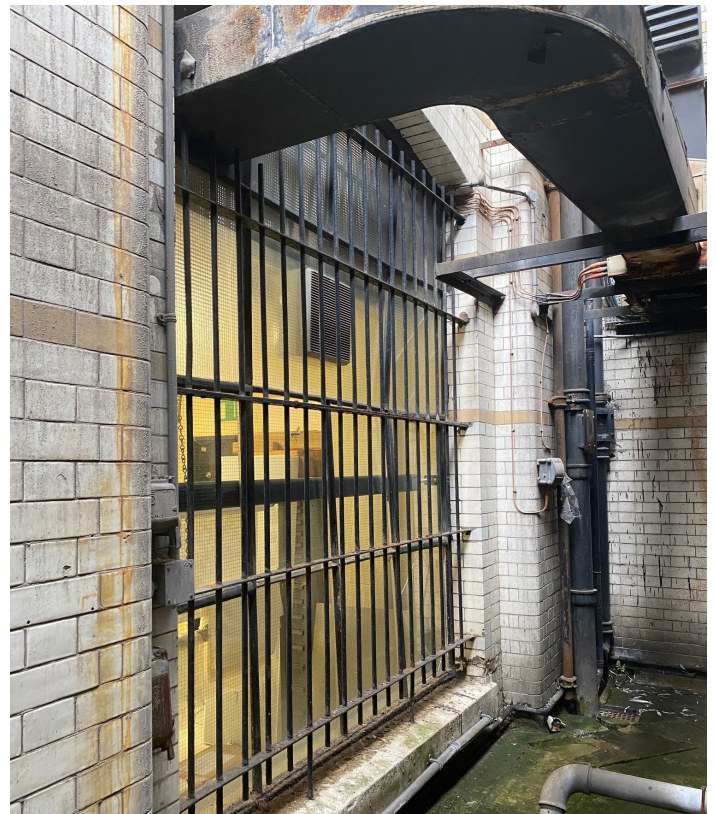
During a building inspection in June 2022, it was noted that a window onto the level 0 photography workshop has suffered from extensive corrosion in sections of its steel frame.

Photo of the window to be replaced

This proposal seeks permission for the removal of the warped window and installation of a like-for-like new replacement steel framed 'Crittall' type window. Cracks to the sill will be repaired with a conservation appropriate treatment. Redundant duct work will also be removed to offer a heritage benefit.

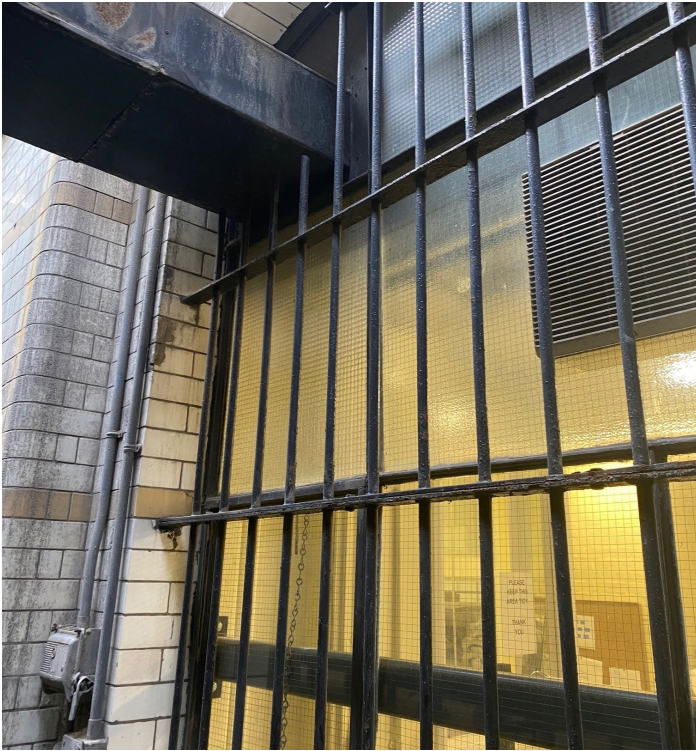
Photo of window showing redundant duct work and vents that may be removed on top left.

Redundant mechanical ventilation ducts should be removed and the fixed permanent vent can be replaced with an operable windows similar to the opening sections in the other windows in the facade. Glazing will be replaced with a similar obscure wired 'Georgian' glass replacement.

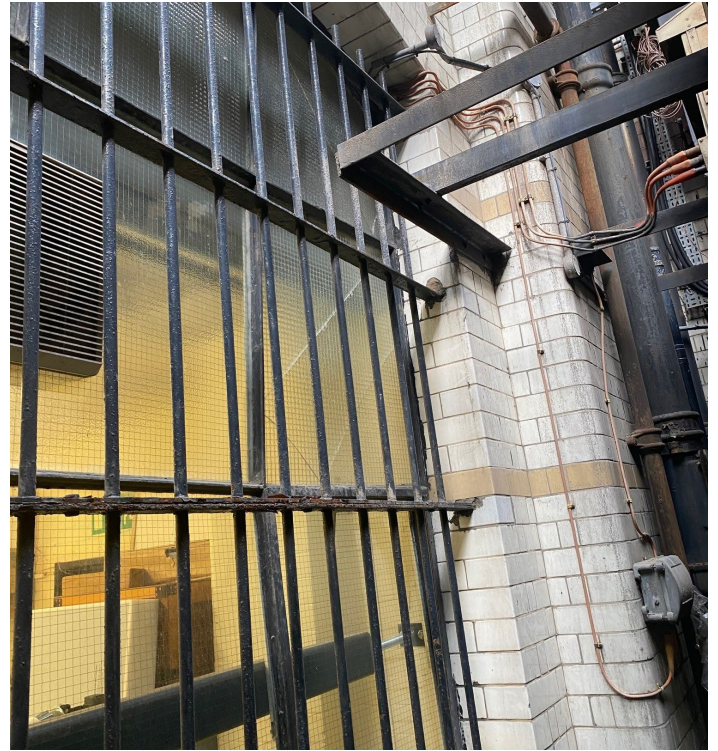
The corrosion has resulted in significant bowing of the window frame and cracking of glazing panels. Warping has become so pronounced that the window has become a safety hazard and it was temporarily boarded to protect occupants in September 2022.

Photo of window showing warping of steel frame and cracking of wired glass.

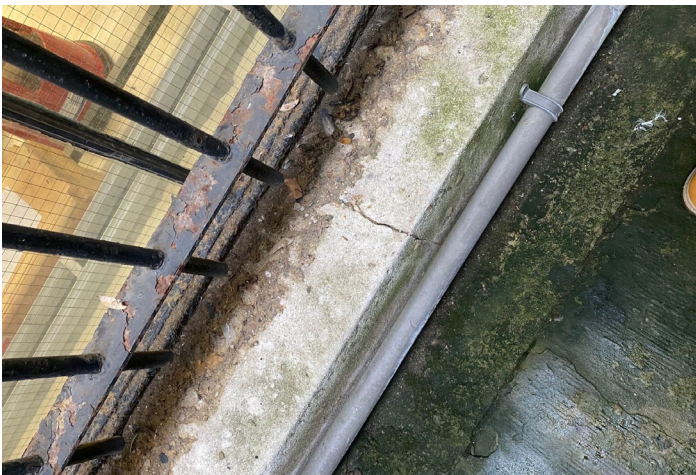
The warping of the frame and decay has also led to some water ingress into the space and possibly contributed to cracking of the lower sill. The surrounding fabric will continue to deteriorate if the condition of the frame is not addressed.

Photo of window showing corrosion of window frame and cracking of sill.

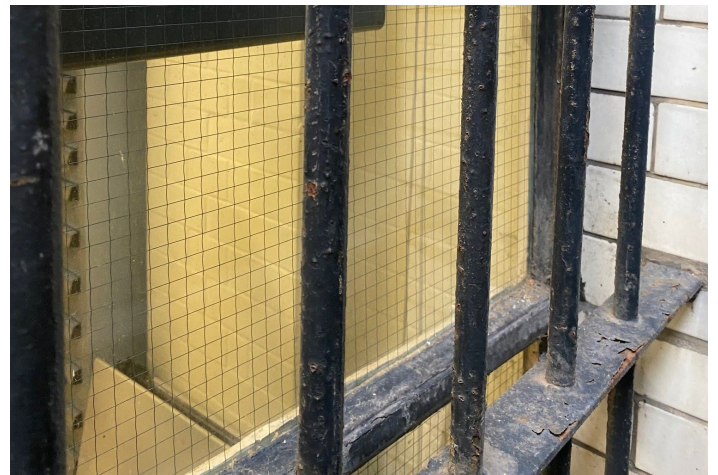
In addition to warping, sections of frame show significant corrosion due to the fact that they do not have a galvanisation primer coat. Sections of frame exhibit jacking and delamination from oxidation making repair unfeasible.

Photo corrosion of window frame at jamb.
