20th December 2022

Catalpa and Malus trees on frontage of St Mary's Church

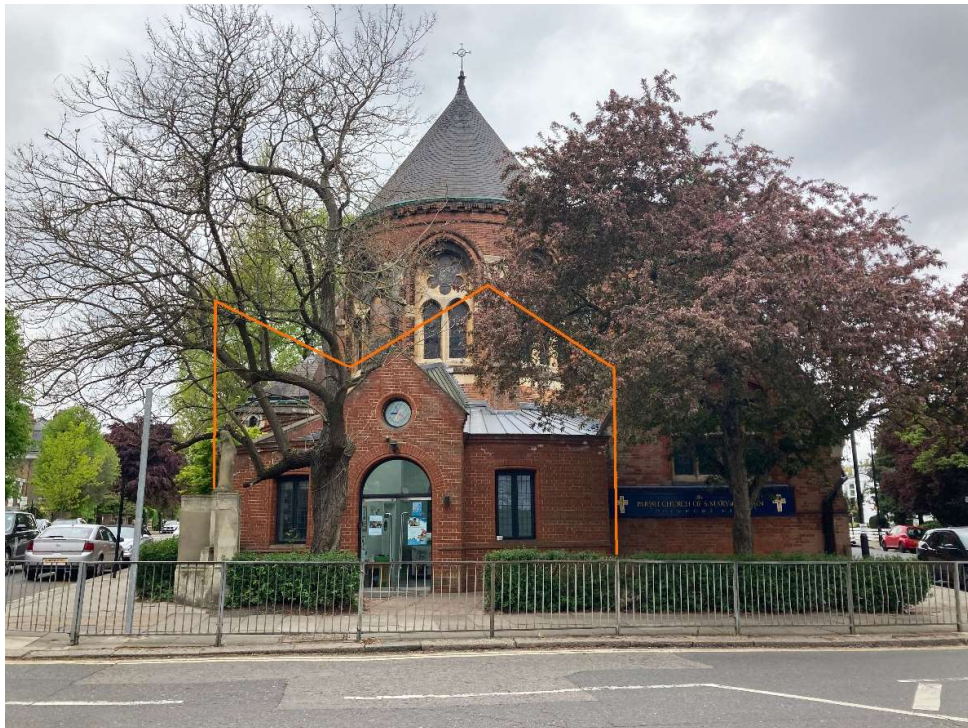
2. Photo of East Elevation with estimated roof line

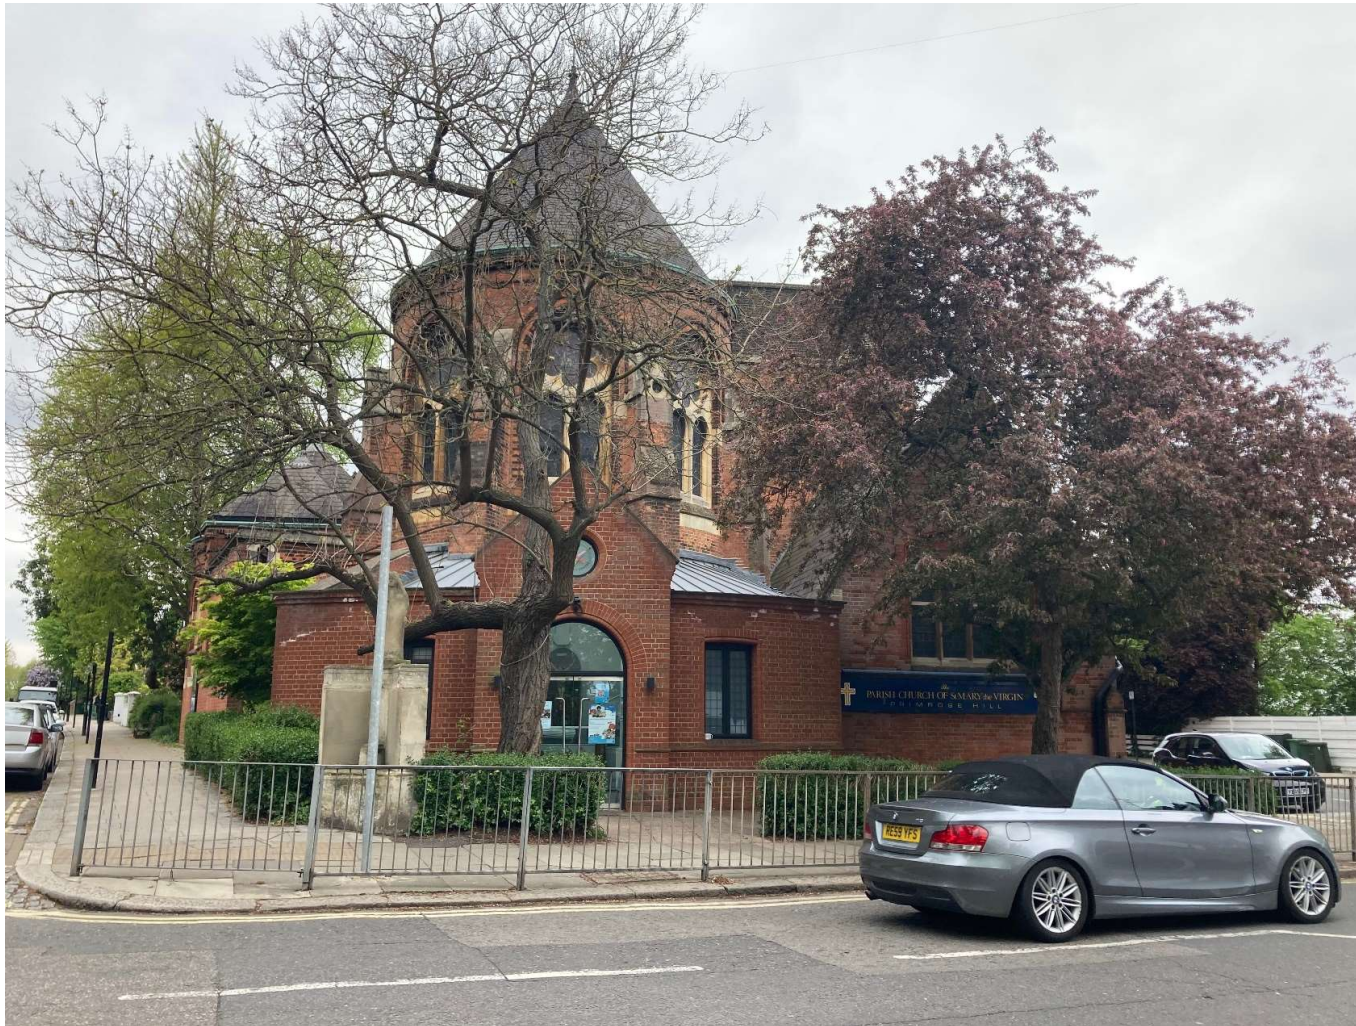
3. Catalpa Left and Malus right Viewed from the East

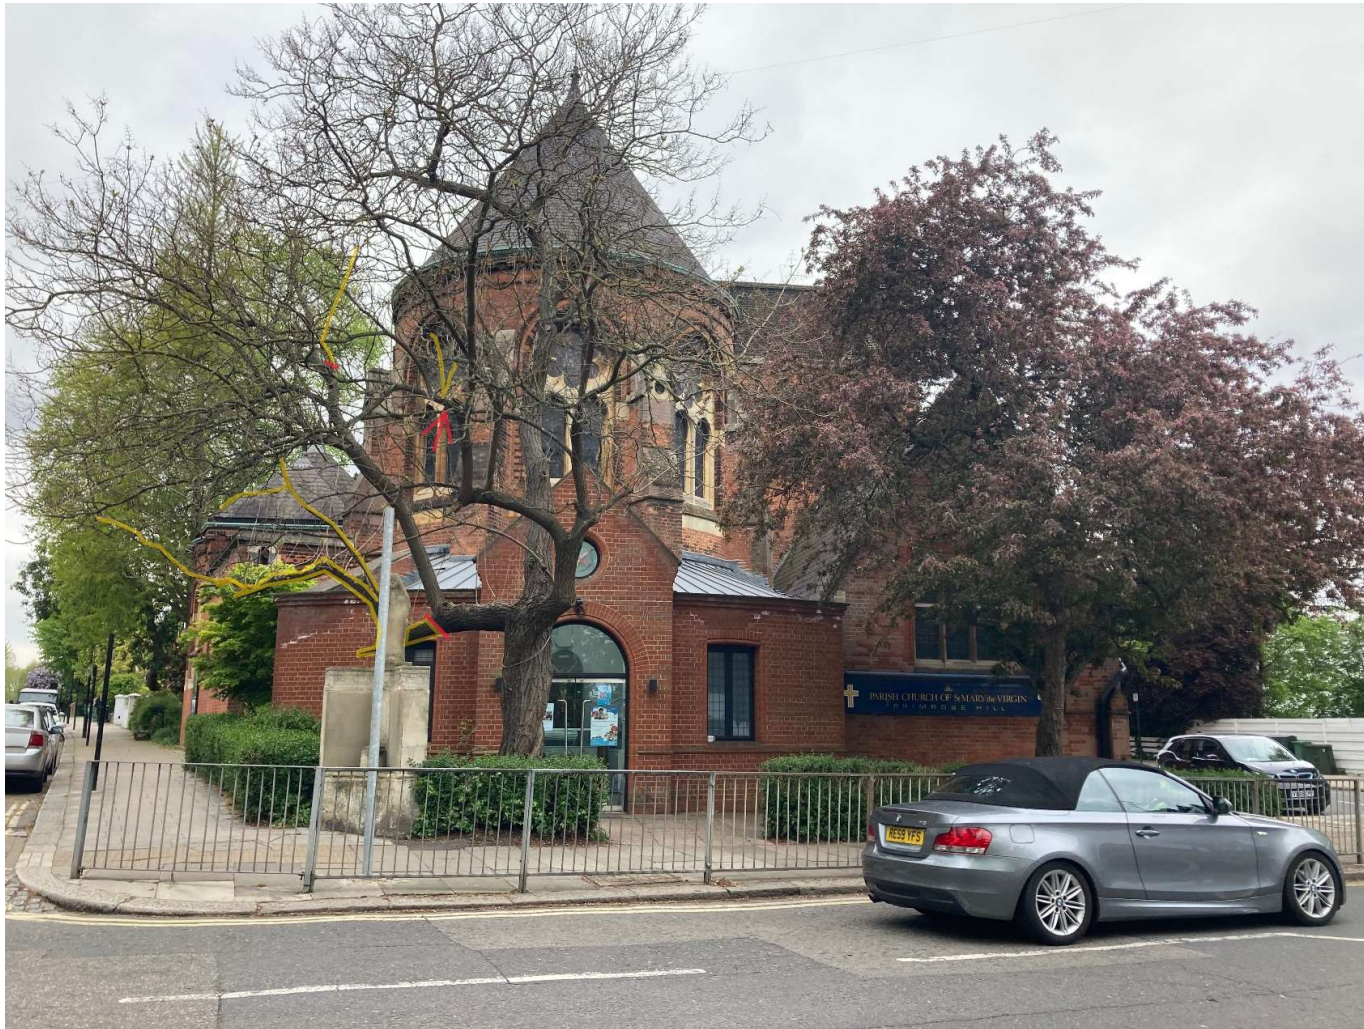
4. Catalpa pruning estimated the remains of the lower branch (large dogleg on the lower left) must be retained within any scaffolding.

There will be some additional pruning that is too small to show in the photographs, consisting of small branches and twigs. Wherever possible branches will be tied and pulled away to provide working space. The basic pruning indicated in the photographs can take place prior to scaffold erection. Further minor pruning of small branches and twigs may be necessary once scaffold is erected but a tree surgeon should be on hand to prune or tie back limbs to minimise damage and pruning.

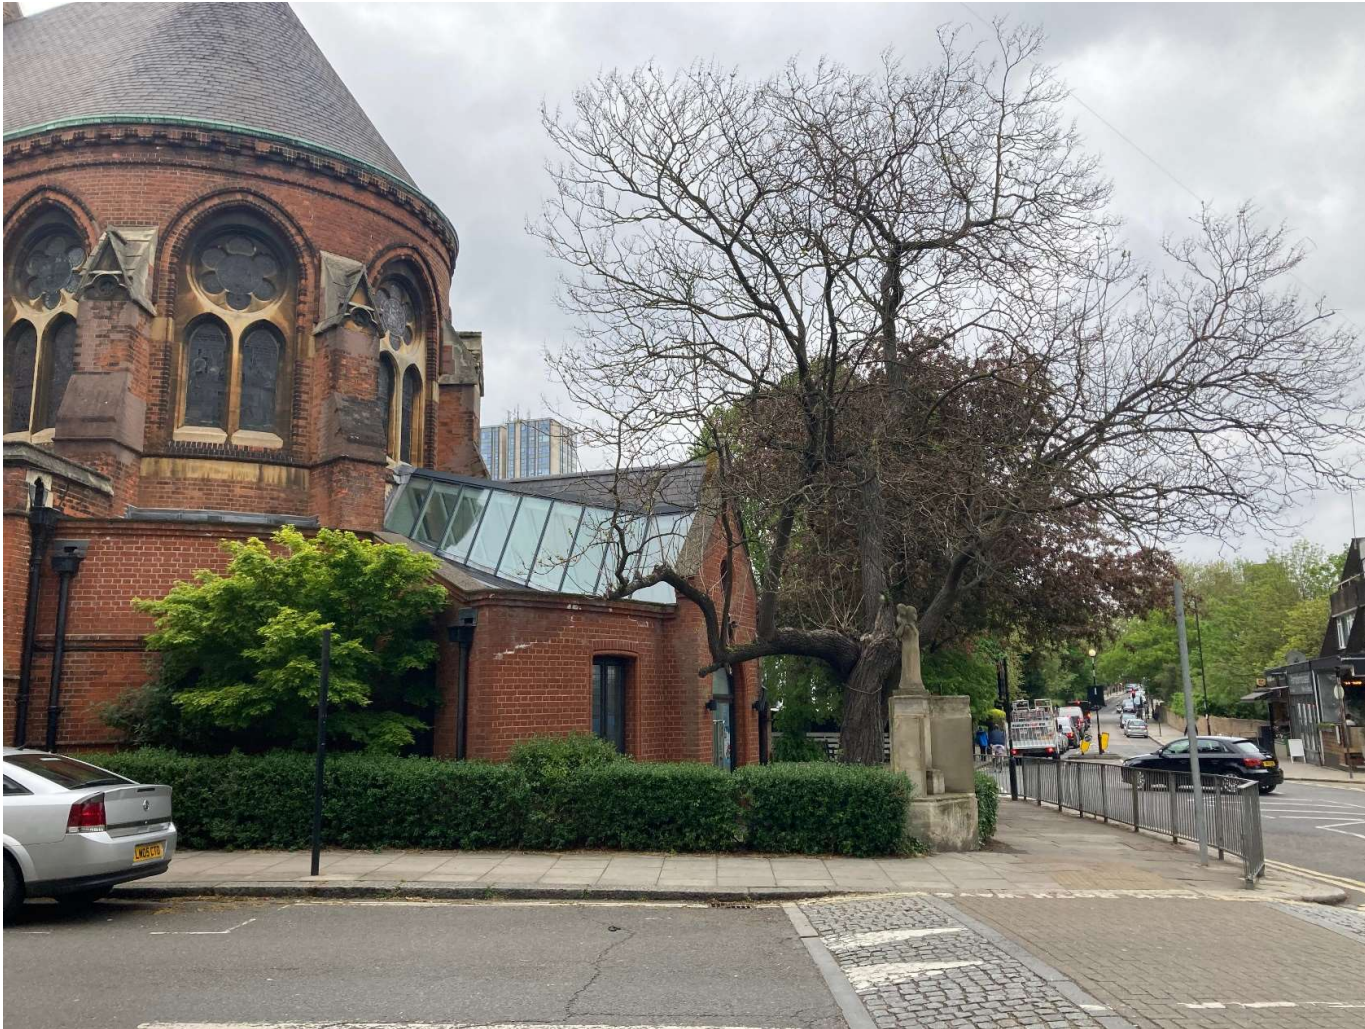
5. Catalpa viewed from south side.

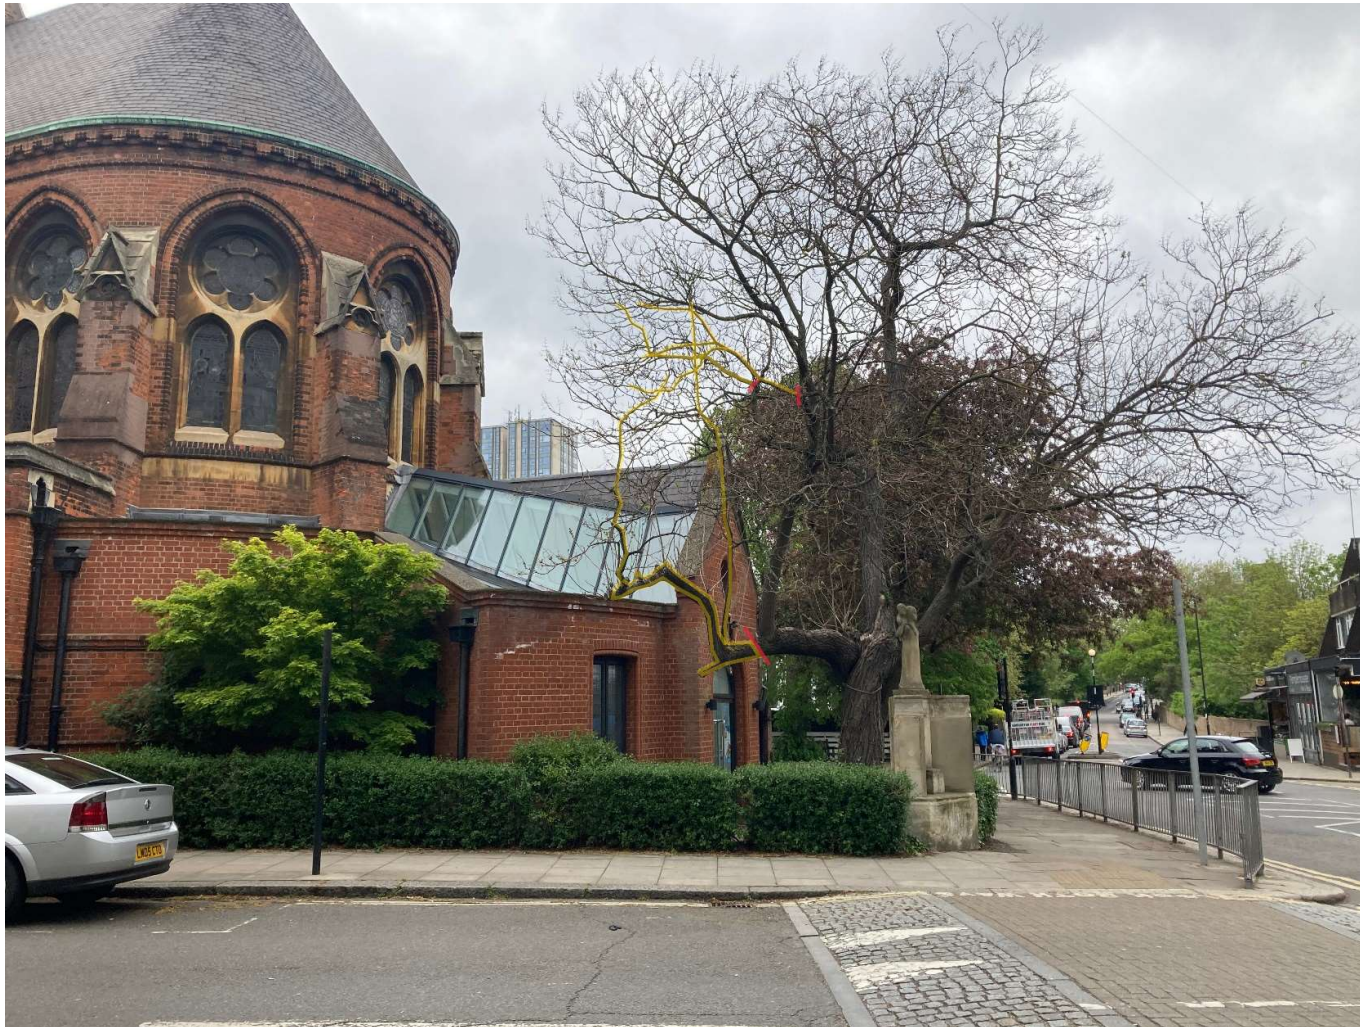
6. Catalpa estimated Pruning (Same branches as Photo 4)

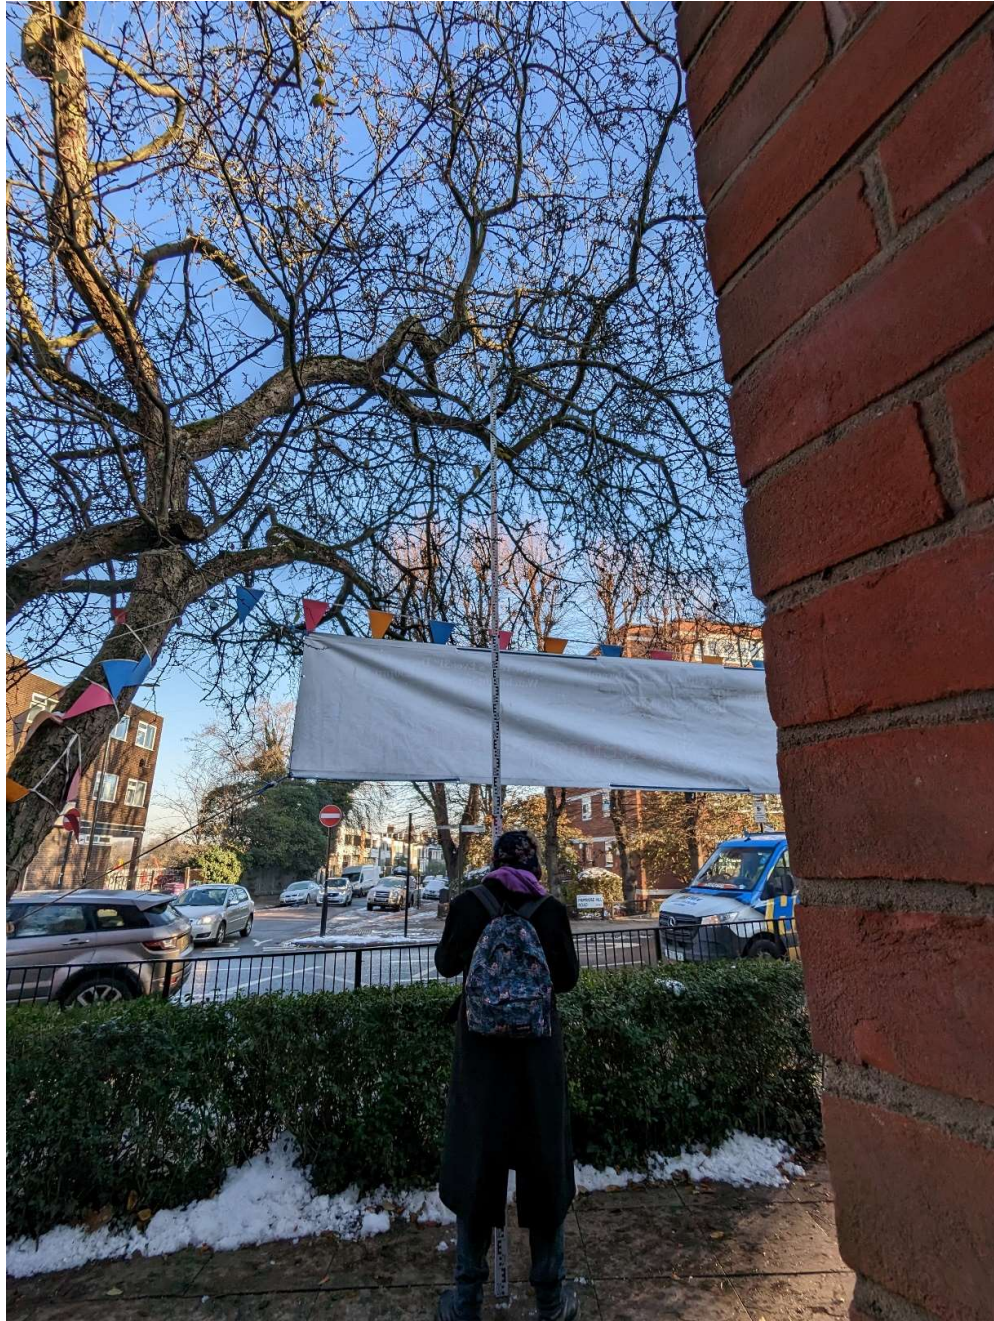
7. Ranging pole at 5m shows the north-east corner of the extension. The eaves are approximately 6m high here.

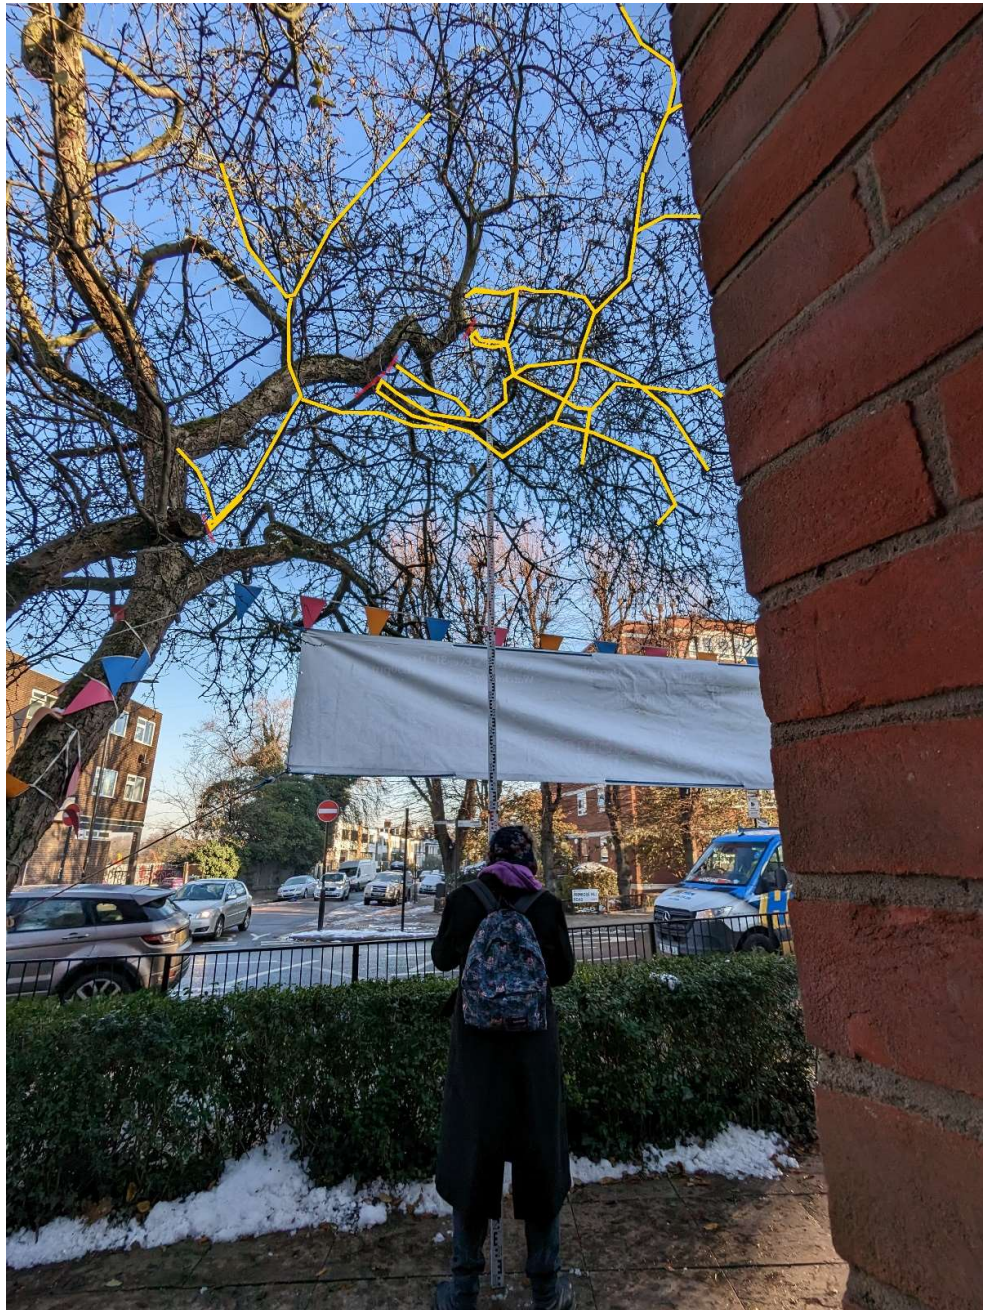
8. Estimated pruning of Malus tree.

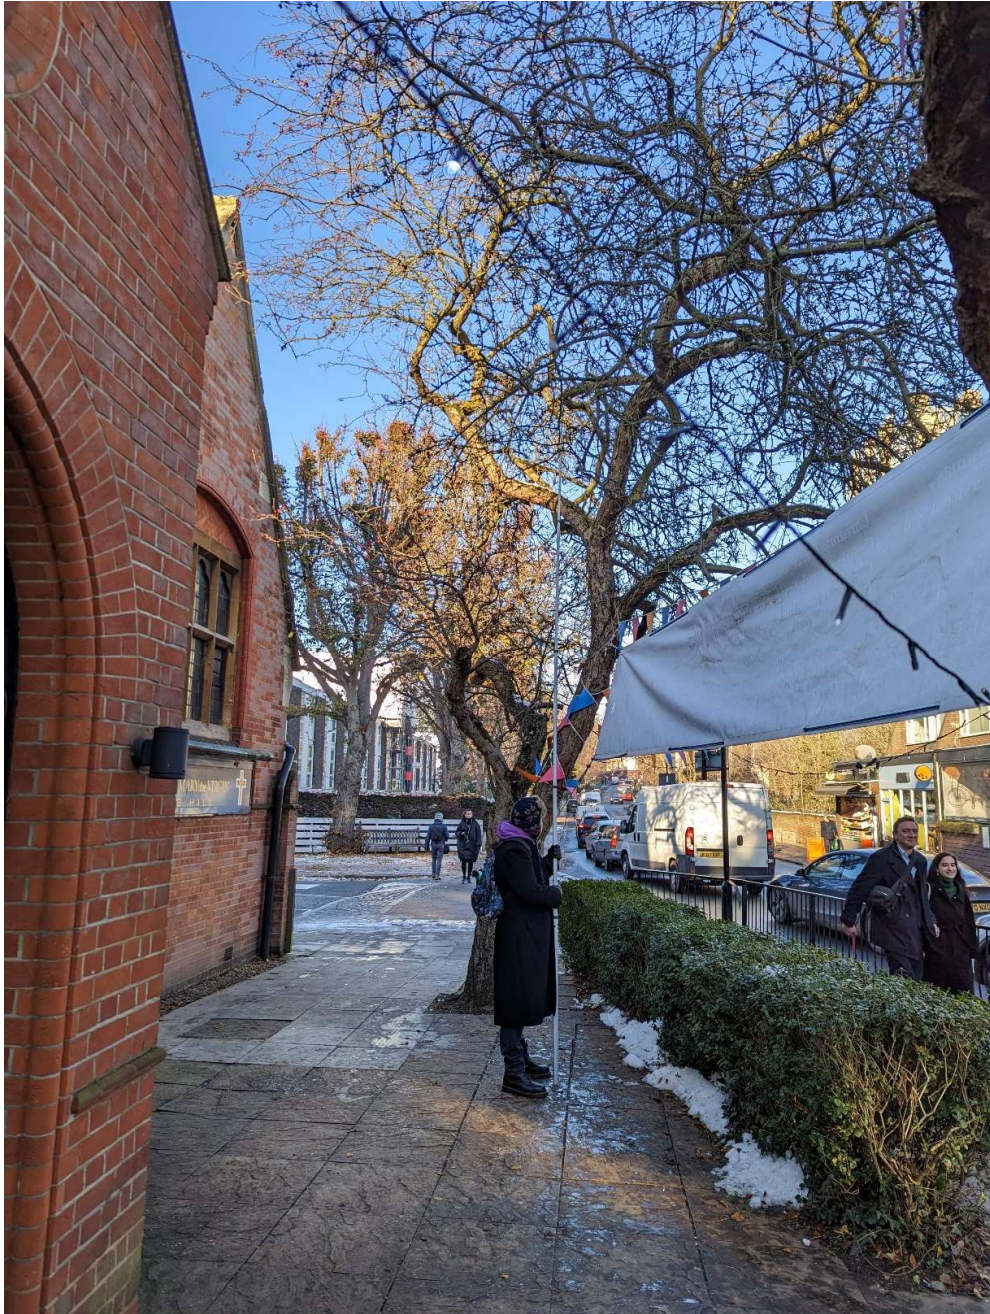
9. Northeast corner of extension marked with ranging pole - viewed from south
(eaves are 6m high here)

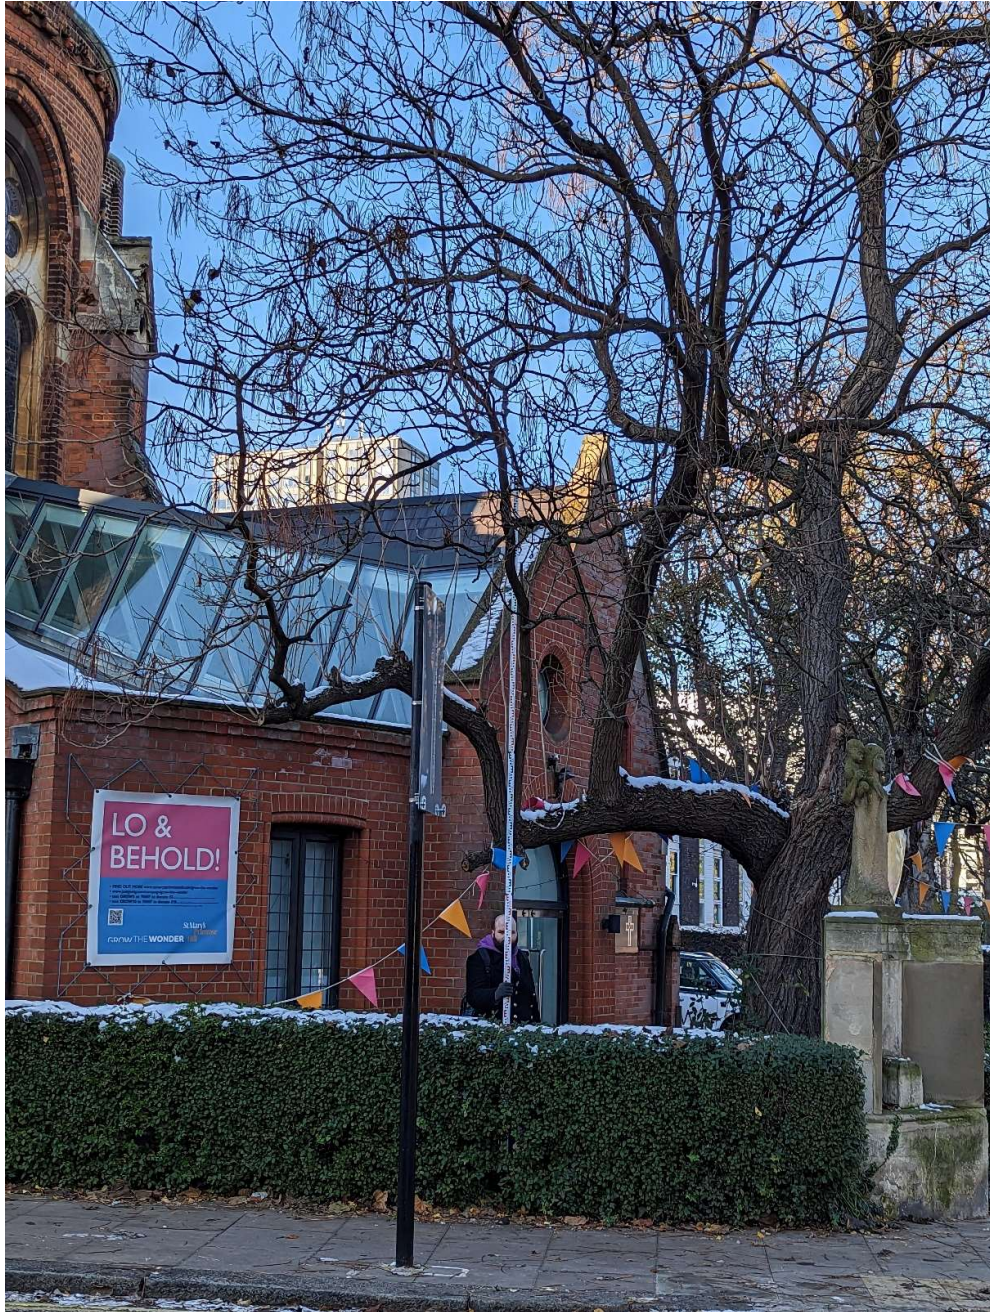
10. Southeast corner of extension marked with ranging pole – view from south (eaves are 7m here)

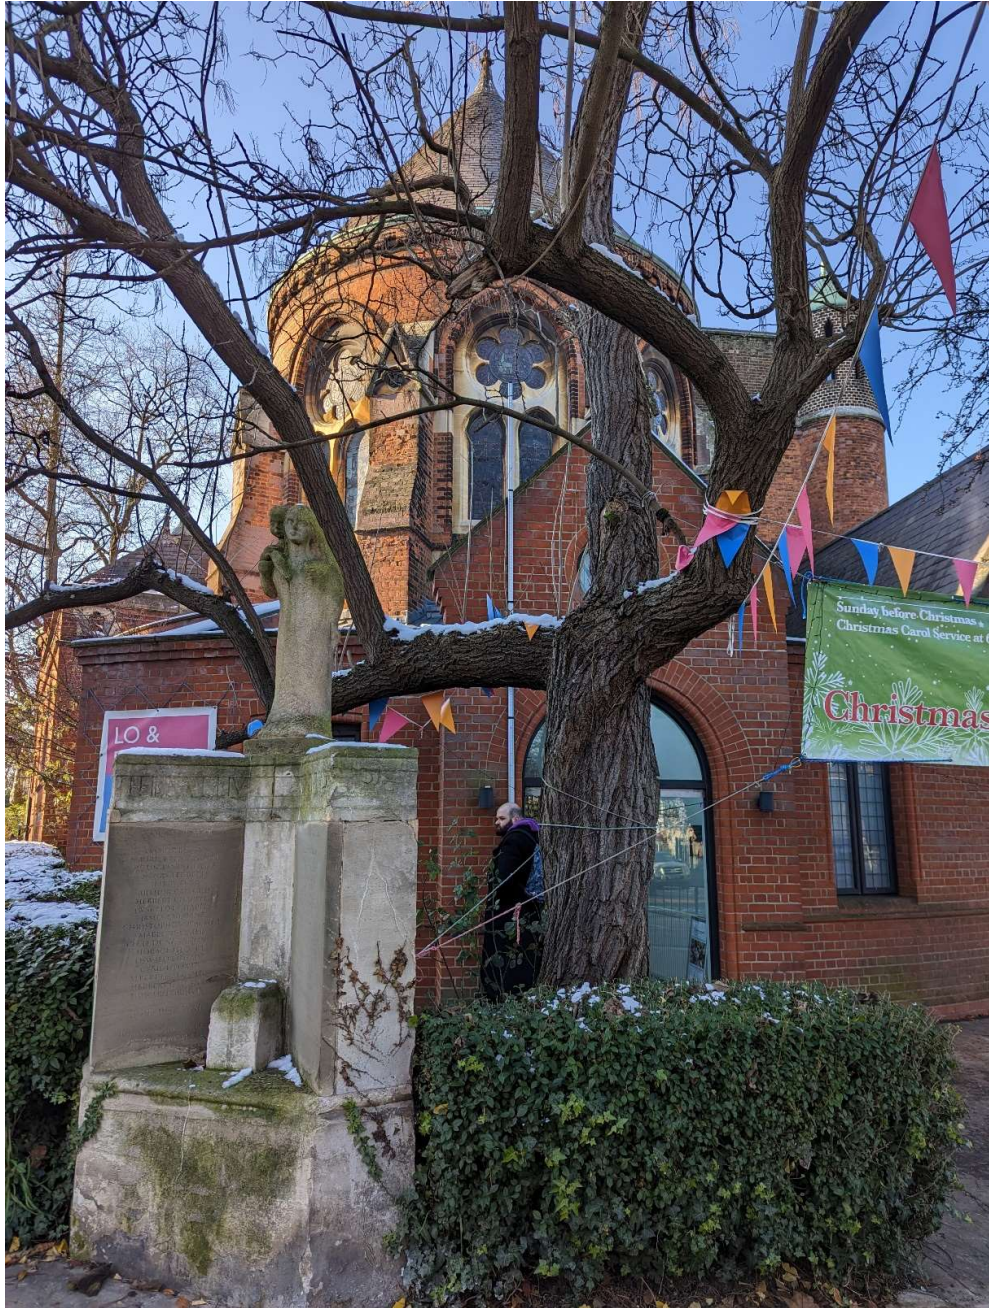
11. Ranging pole showing height of roof valley by Catalpa (5.6m pole base at 0.6m)

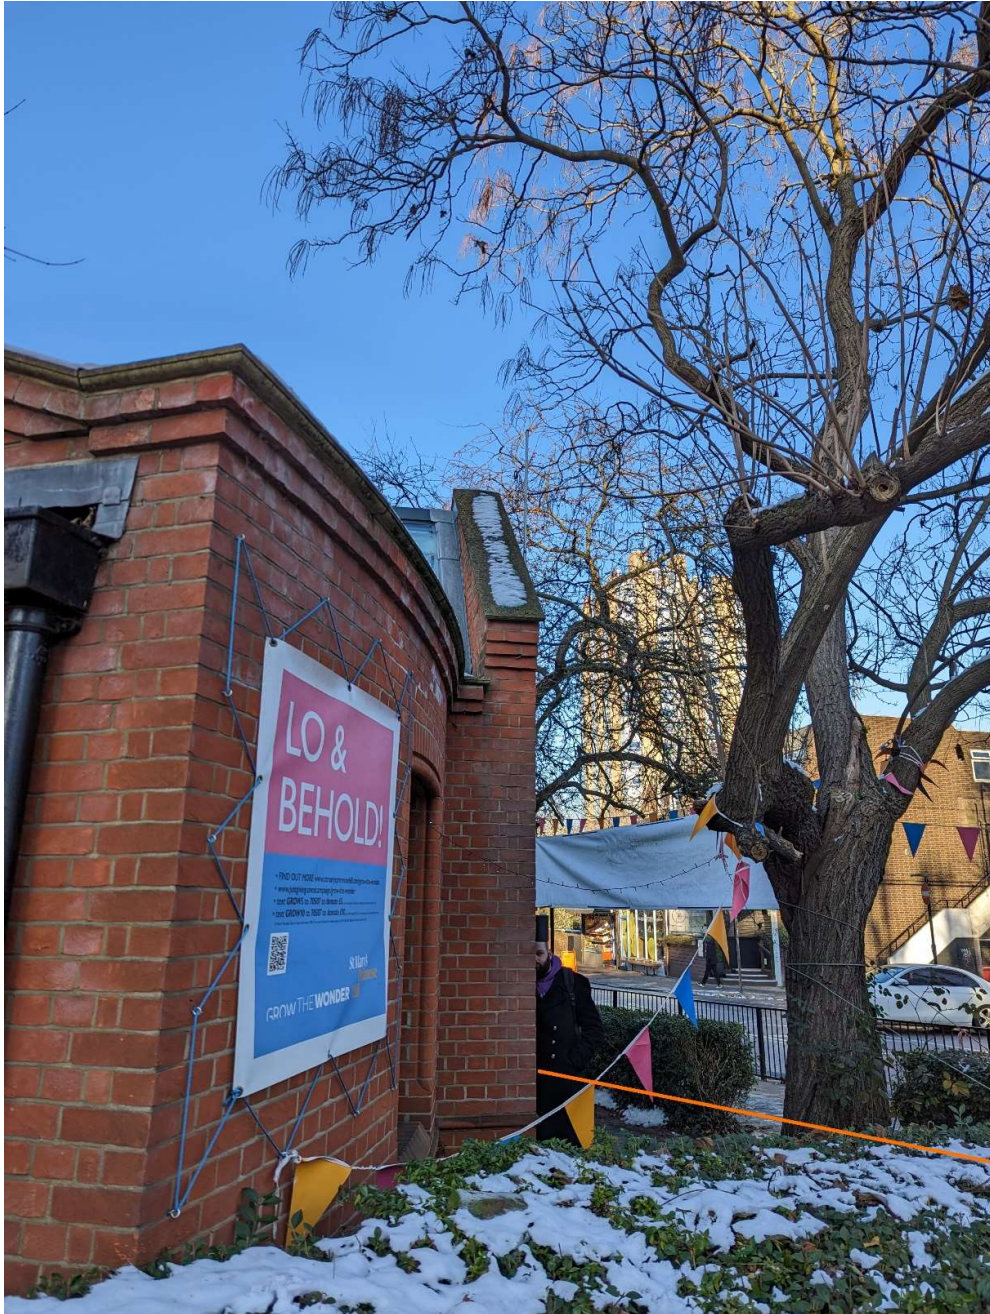
12. View of Catalpa with approximate building line of front elevation (orange)
