Landmark Trees

ARBORICULTURAL IMPACT ASSESSMENT REPORT FOR:

The Hoo
17 Lyndhurst Gardens
Hampstead
NW3 5NU

Ref: JDL/17LDG/AIA/03a

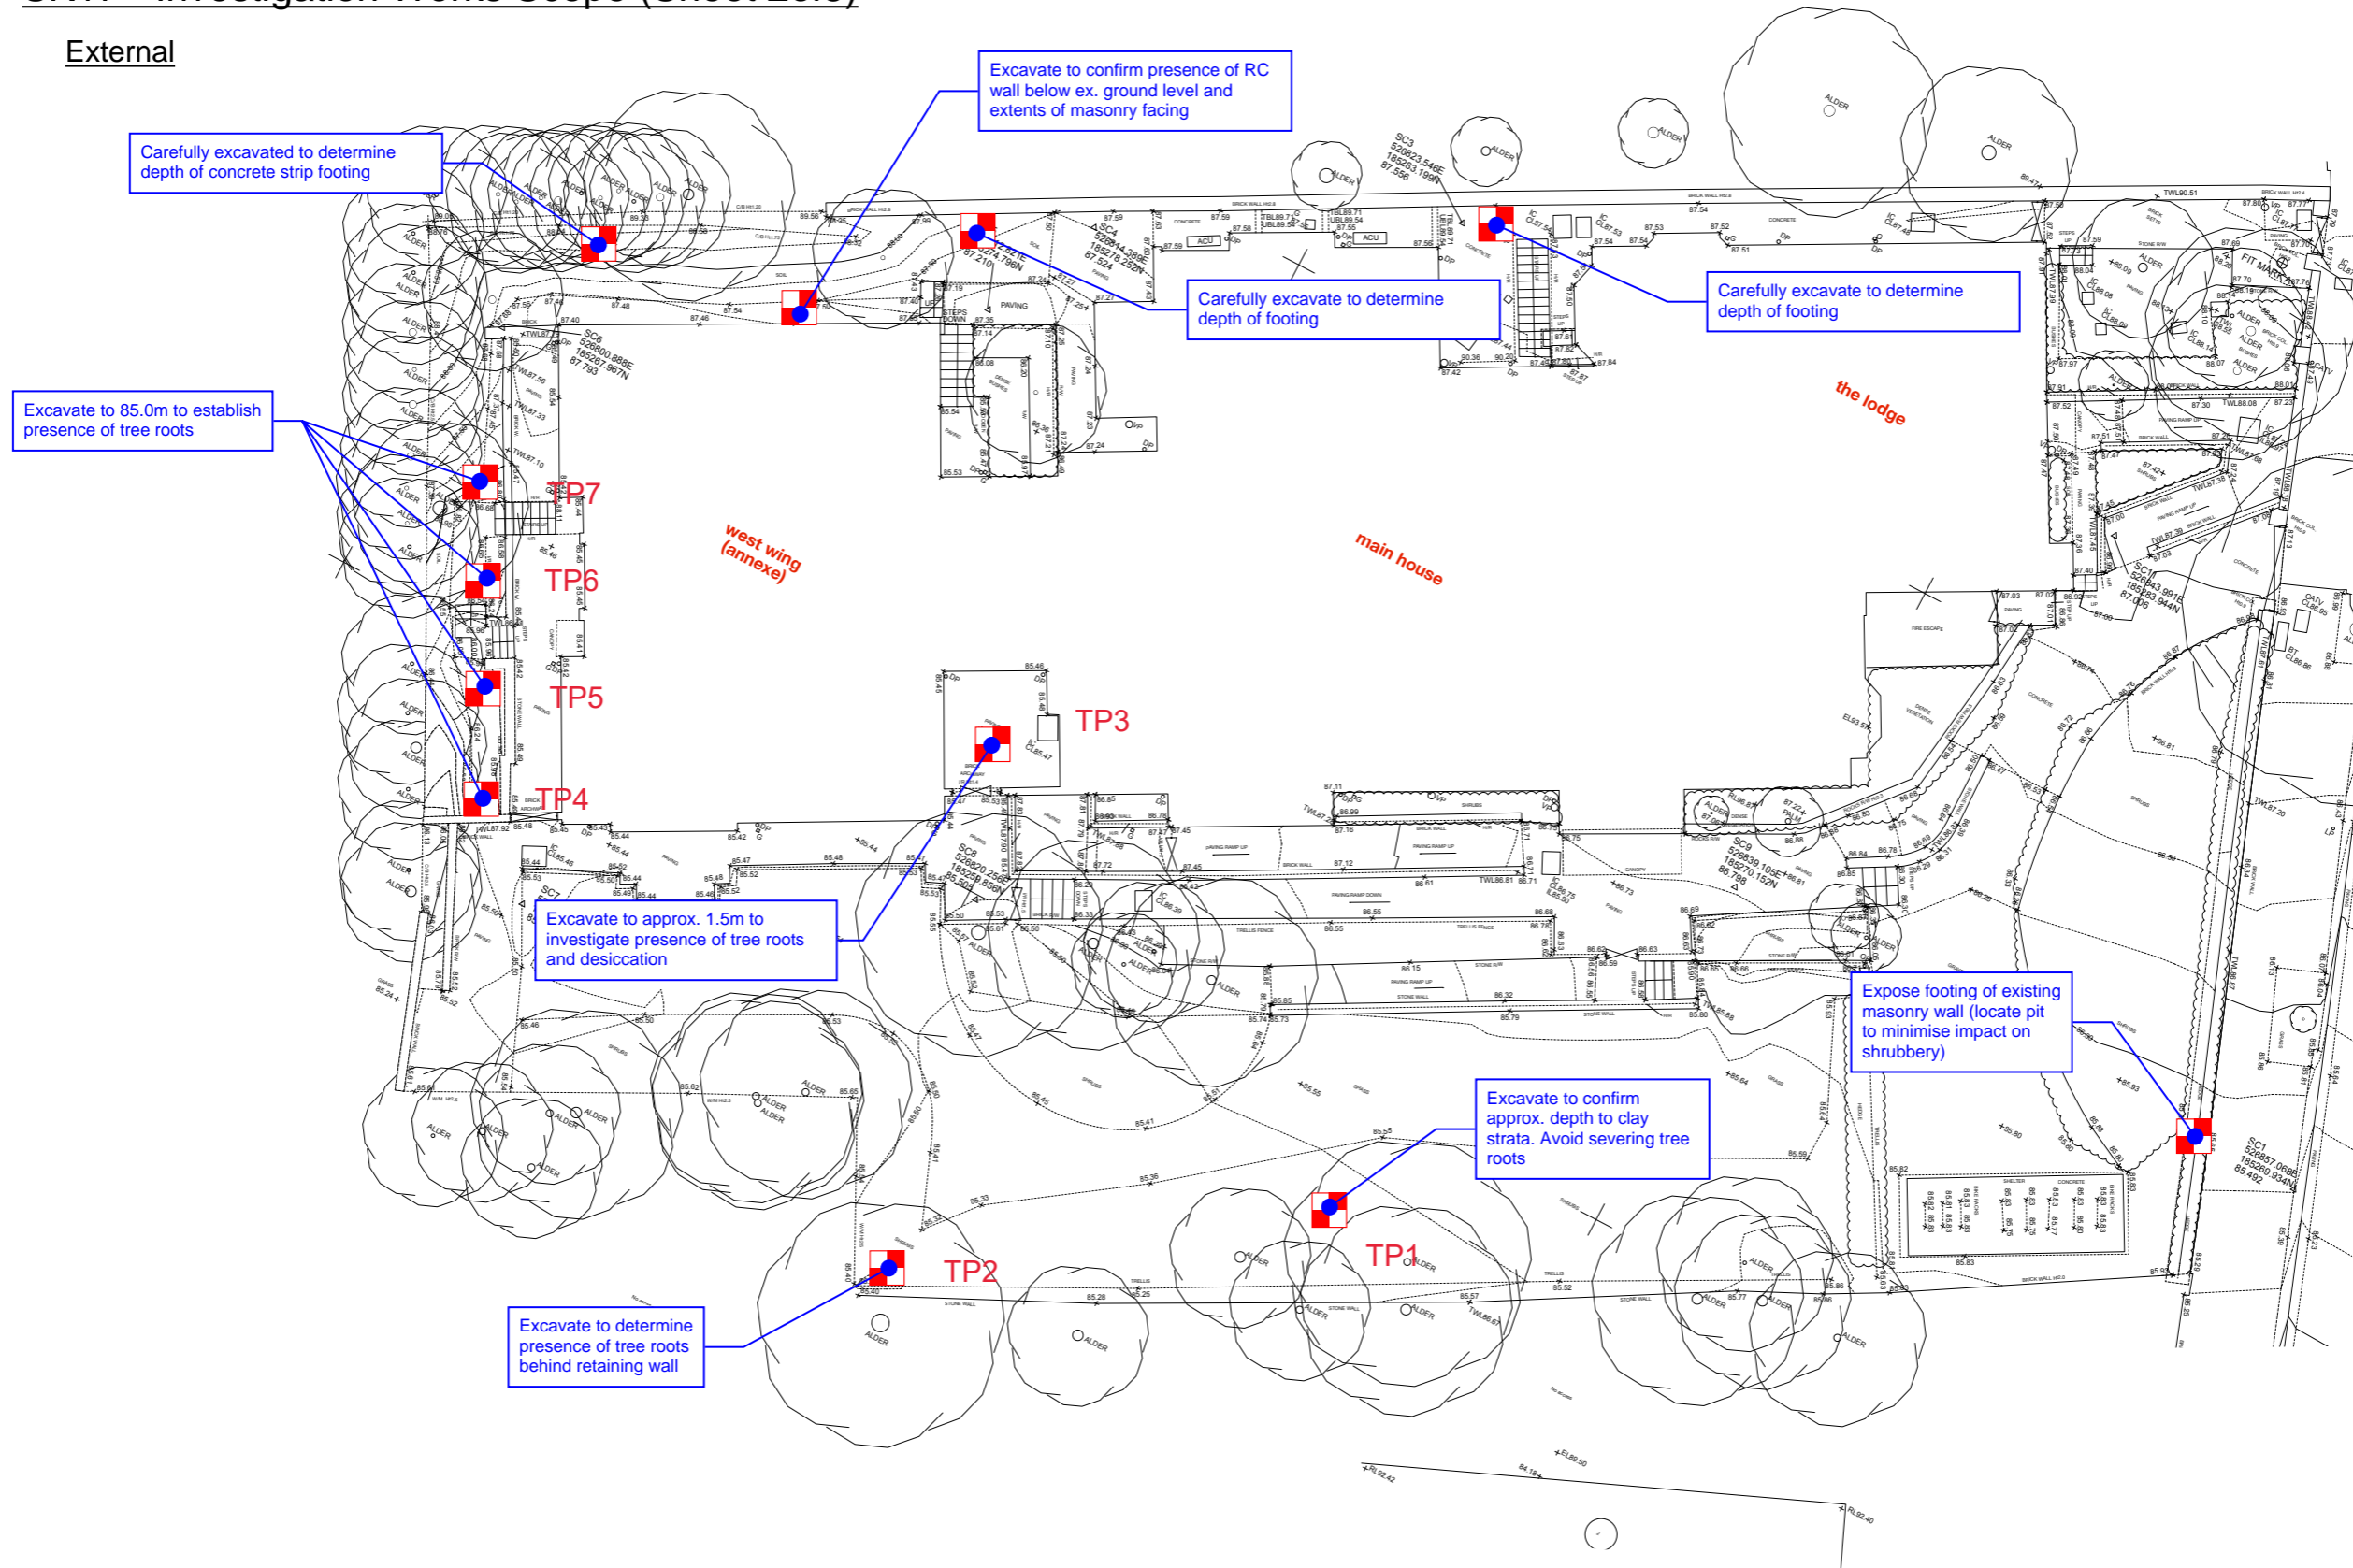
SK17 - Investigation Works Scope (Sheet 2 of 5)

TP1 – Mixed brick rubble to approx. 100mm depth; potentially old paving. Soil beneath. Frequent fibrous roots observed <10mm dia. Single severed root of 18mm dia

TP2 – Mixed brick rubble to approx. 100mm depth; potentially old paving. Soil beneath. Frequent fibrous roots <10mm dia. 3 x severed roots of 20mm dia, 20mm dia and 35mm dia. All expected to originate from G11 Lime.

TP6 – Concrete to approx. 100mm depth then soil below. Single root observed approx. 100mm dia, infrequent fibrous roots. All expected to originate from adjacent cypress H8

TP7 – No pit found/dug at location

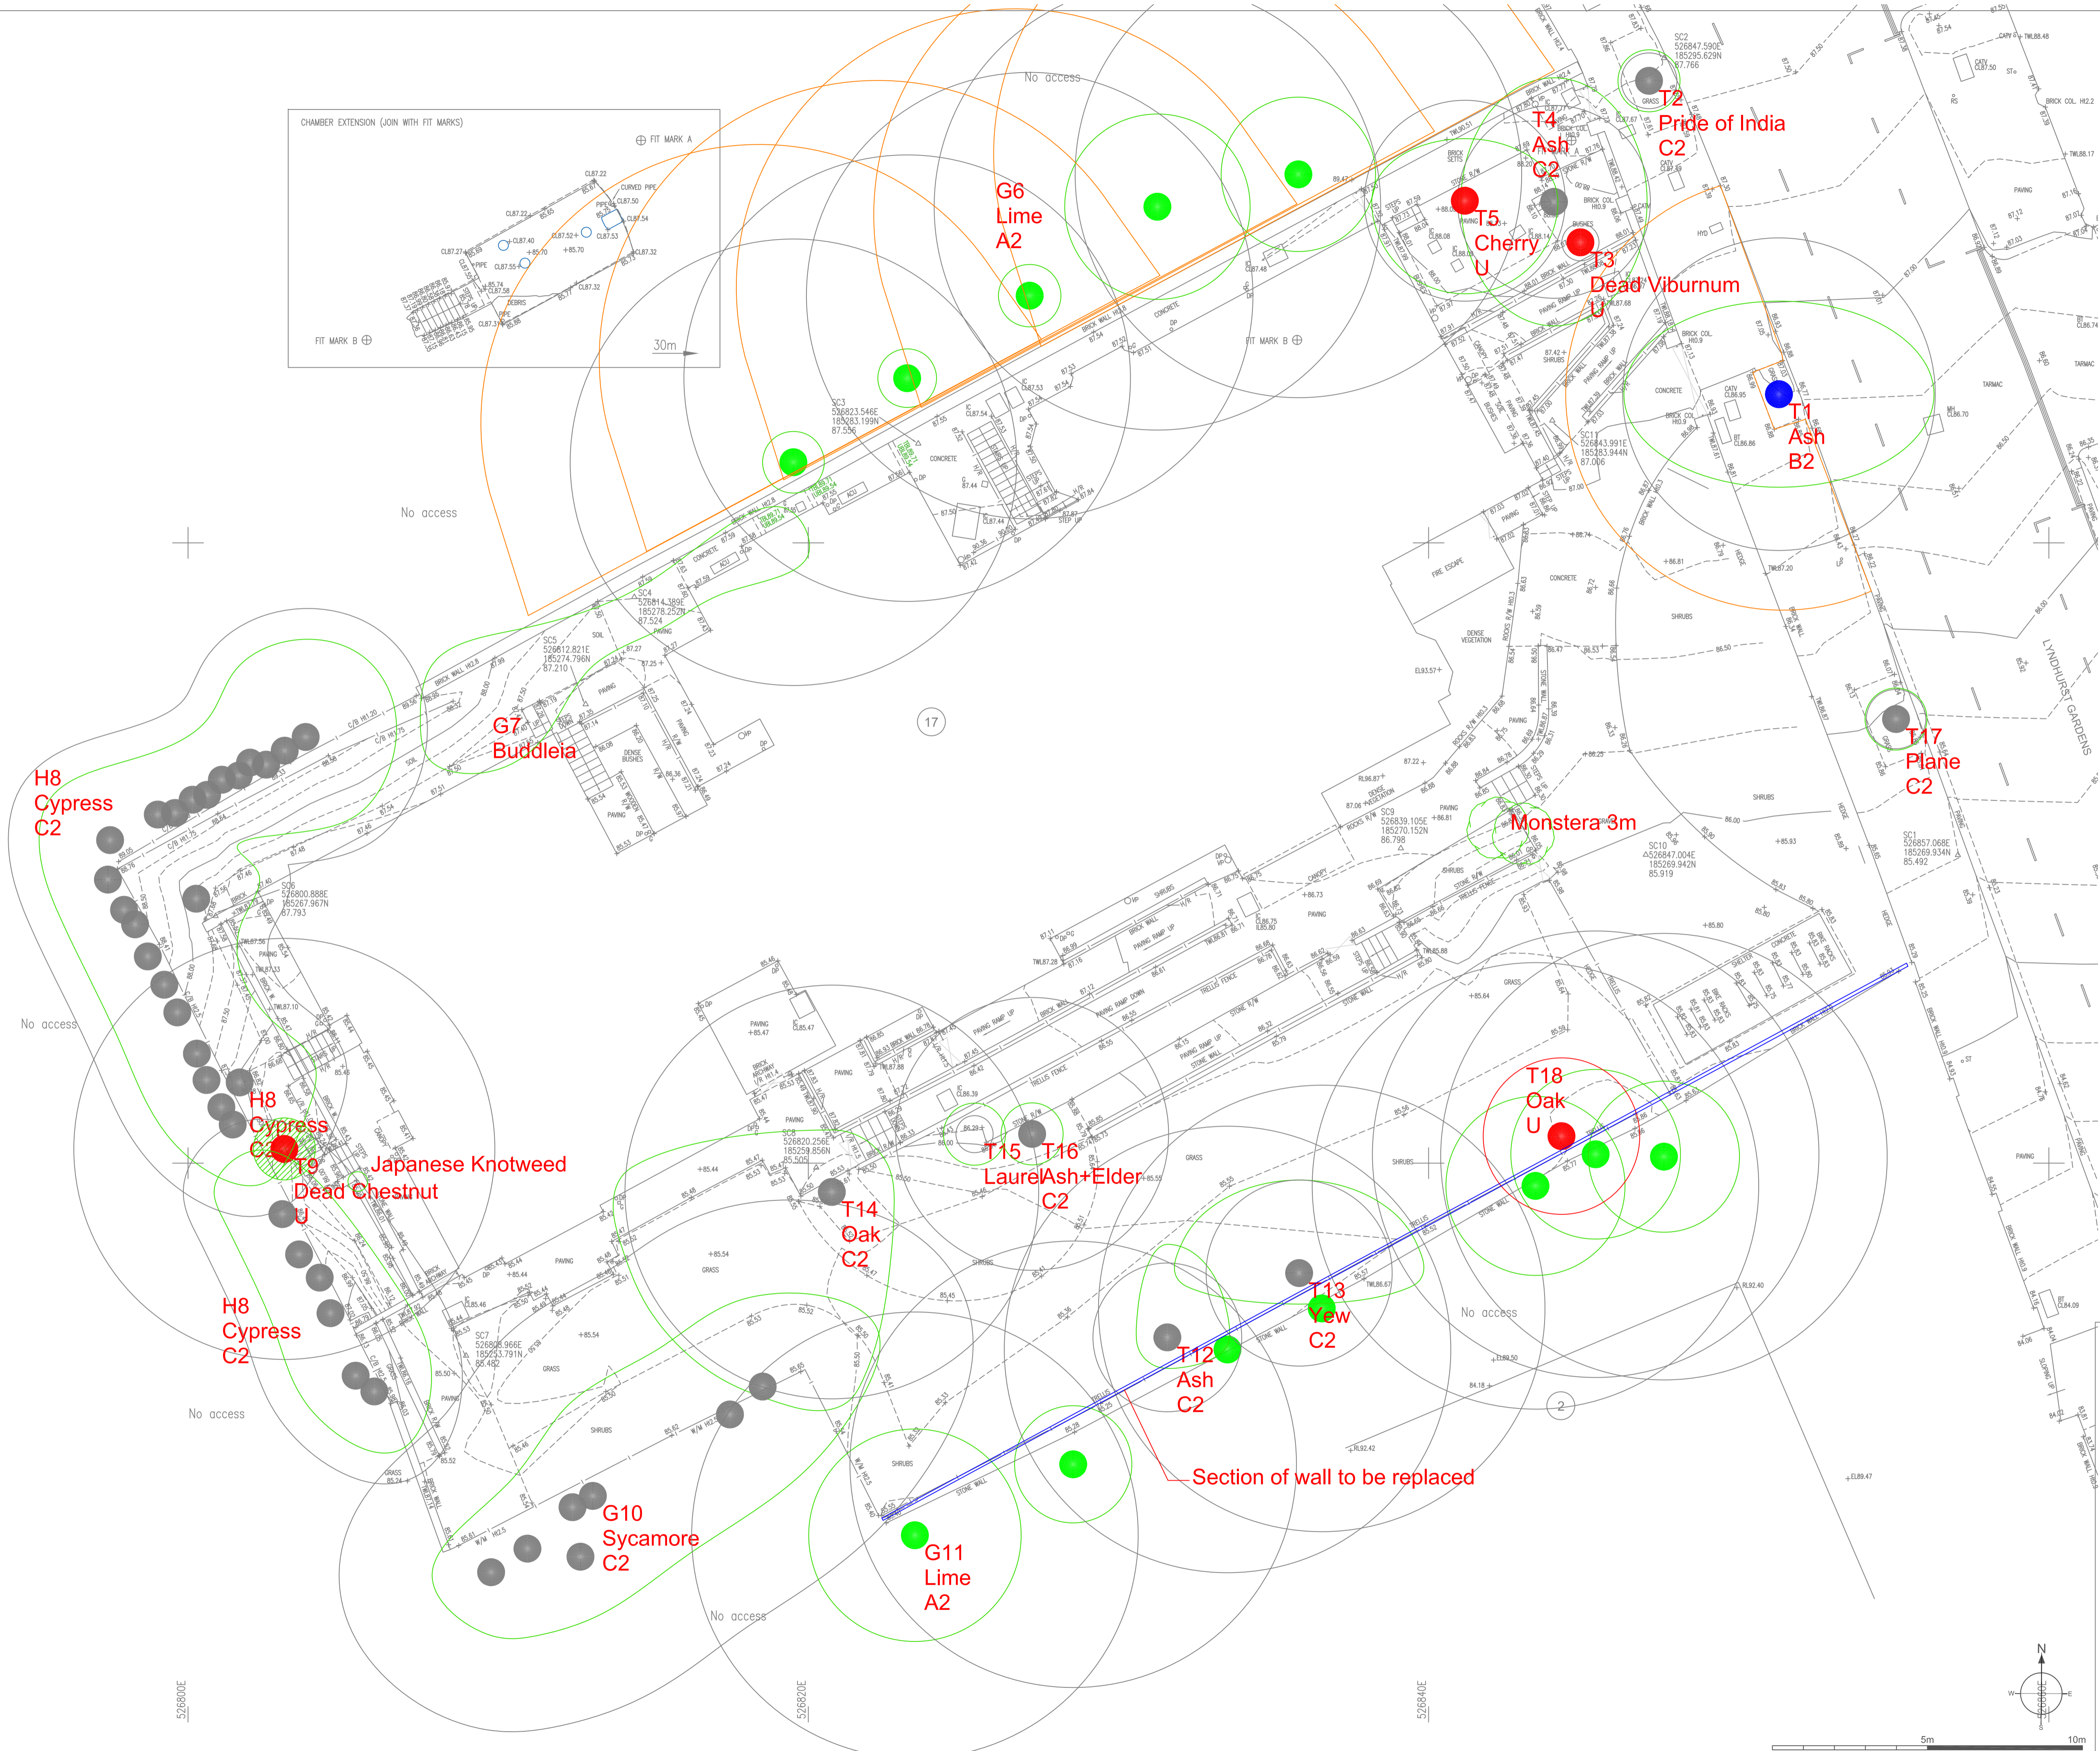
ARBORICULTURAL IMPACT ASSESSMENT PLAN (S)

B.S. Cat.	Tree No.	Species	Impact	Tree / RPA Affected	Age	Growth Vitality	Species Tolerance	Impact on Tree Rating	Impact on Site Rating	Mitigation
A	11	Lime, Common	Retaining Wall Replacement adjacent to RPA	m ² N/A %	Mature	Normal	Good	Very Low	Very Low	Low-invasive foundation design

6.3.1 The existing wall will be broken out using hand tools only. The replacement wall will be founded on 200mm diameter mini-piles inserted between any significant roots that may undermine the existing wall. These piles will be linked by a concrete pile cap installed so that its lower edge is above the highest root encountered. A reinforced concrete retaining wall will be built off this cap. The concrete reinforced retaining wall will be clad to the south in a single leaf of skin of facing brickwork to match the existing, up to the level of The Hoo's garden. The rebuilt boundary wall in 9-inch brick would sit about this. This will be laid in a Flemish Garden wall bond and topped by a saddleback coping, as existing.

6.3.2 Provided the owners of the property in which G11 stands acquiesce, a compost tea will be applied to the soft ground between G11 and the existing wall to improve rooting conditions therein.
