<b>LDC Report</b>	<b>05/12/2022</b>
<b>Officer</b>	<b>Application Number</b>
Fast Track Team	2021/5438/P
<b>Application Address</b>	<b>Recommendation</b>
Flat 2nd And 3rd Floor 58 Parliament Hill London NW3 2TL	Refuse Certificate of Lawfulness (existing) and warning of enforcement action.
<b>1<sup>st</sup> Signature</b>	<b>2<sup>nd</sup> Signature (if refusal)</b>
<b>Proposal</b>	
To confirm the existing fencing around a roof terrace ('the Development'), on the third floor of the building are lawful.	
<b>Assessment</b>	
<b>Application site</b>	
<p>The application site is a four-storey semi-detached building, located on the eastern side of Parliament Hill road. The certificate application is in relation to the 2<sup>nd</sup> and 3<sup>rd</sup> floor flat of the property. The building is not listed and is located in the South Hill Park Conservation Area and it is covered by Hampstead Neighbourhood Plan.</p> <p>The application site has a roof terrace in situ for more than four years. Different types of enclosure have been installed along the years as shown in Image 1 below; red is the front boundary fence, pink the southern boundary fence, blue the one surrounding rear and part of nor

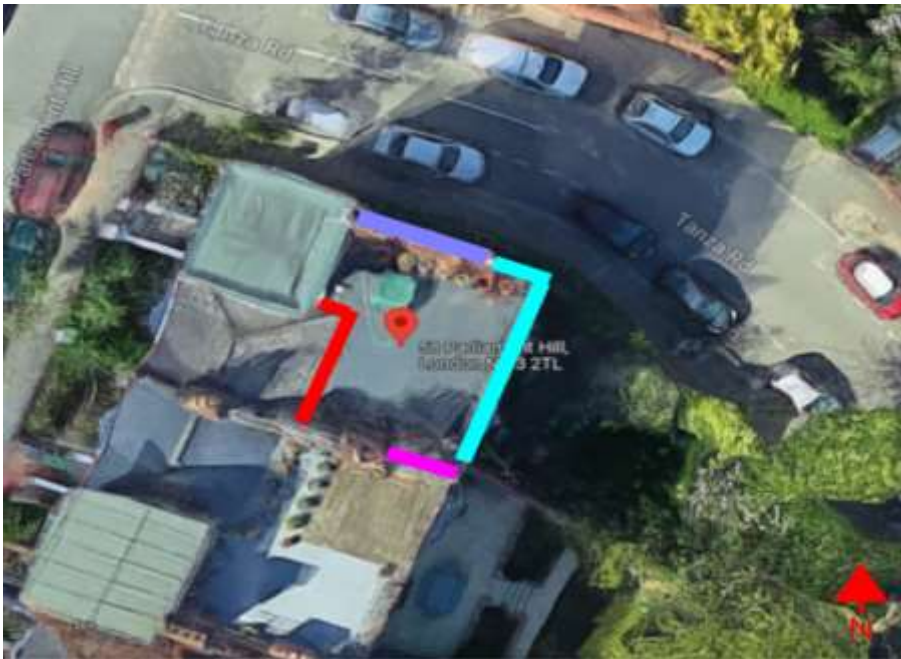
<b>Image 01.</b>

In relation to the other boundary alterations, installation of solid boundary surrounding the terrace, rebuilding of chimney, brickwork infill with fence of top, as indicated with light blue and purple in Image 1, and shown in photos D1)-D4), insufficient information has been provided to demonstrate these have been undertaken more than 4 years prior to the submission of the application. . Google streetview images clearly show the property in 2019-2021 without fencing along the northern elevation. It shows the alterations to the chimney and the raising of the brick parapet wall and addition of the solid fence in 2022.

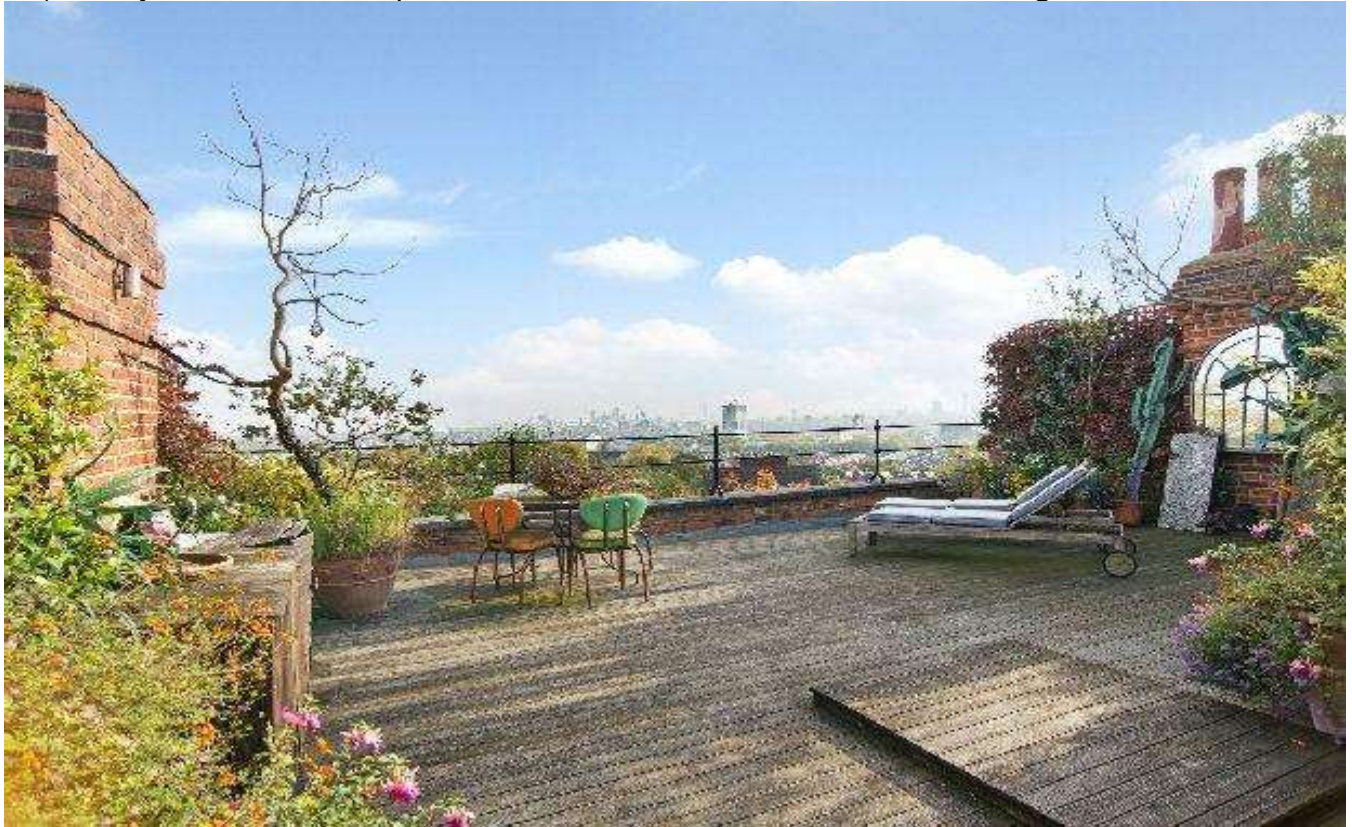
A1) Four years or more old photo before commencement of works looking south-west

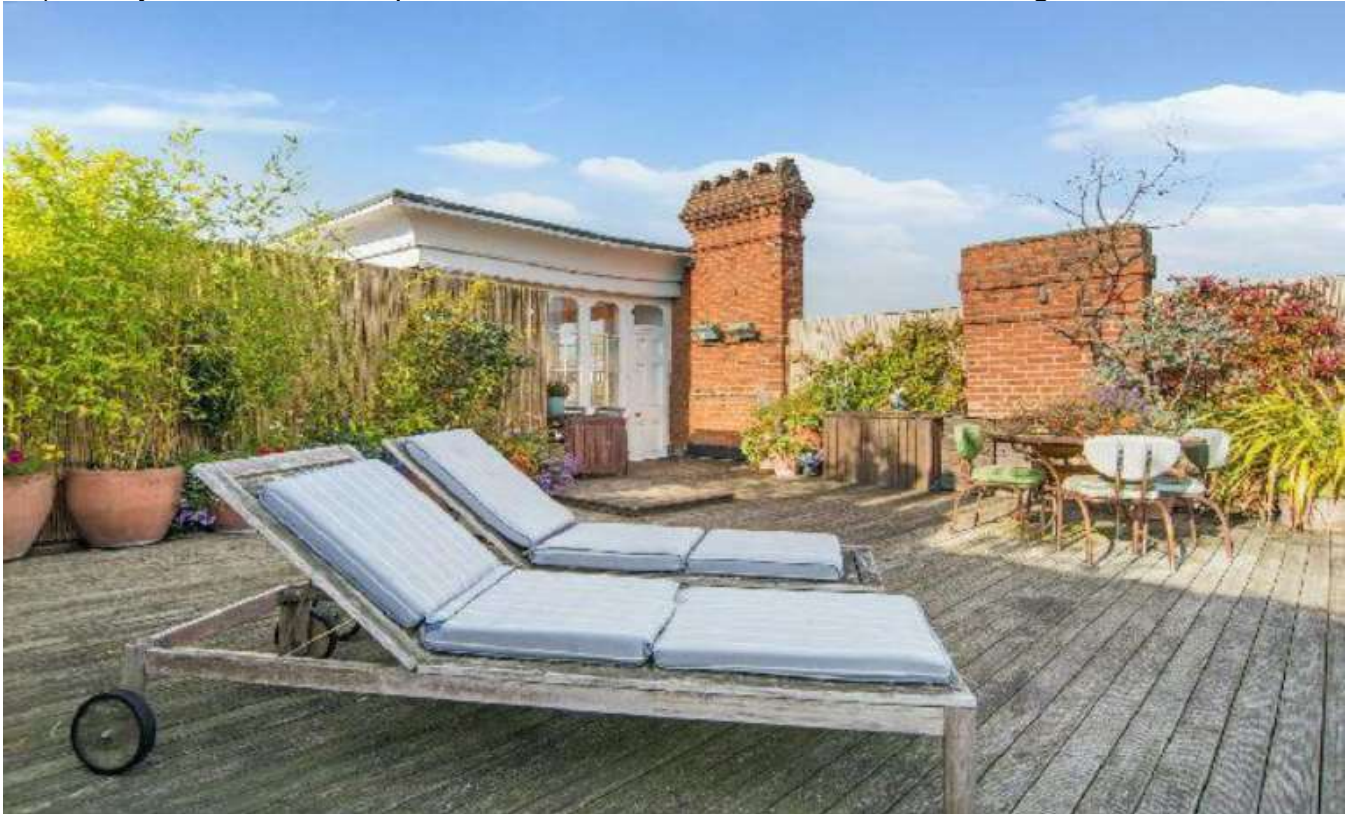
A2) Four years or more old photo before commencement of works looking north-west.

In photo A2 from the applicant, a structure covered in planting appears on the southern boundary of the roof, to be in situ for more than 4 years. This is indicated with pink on Image 02.

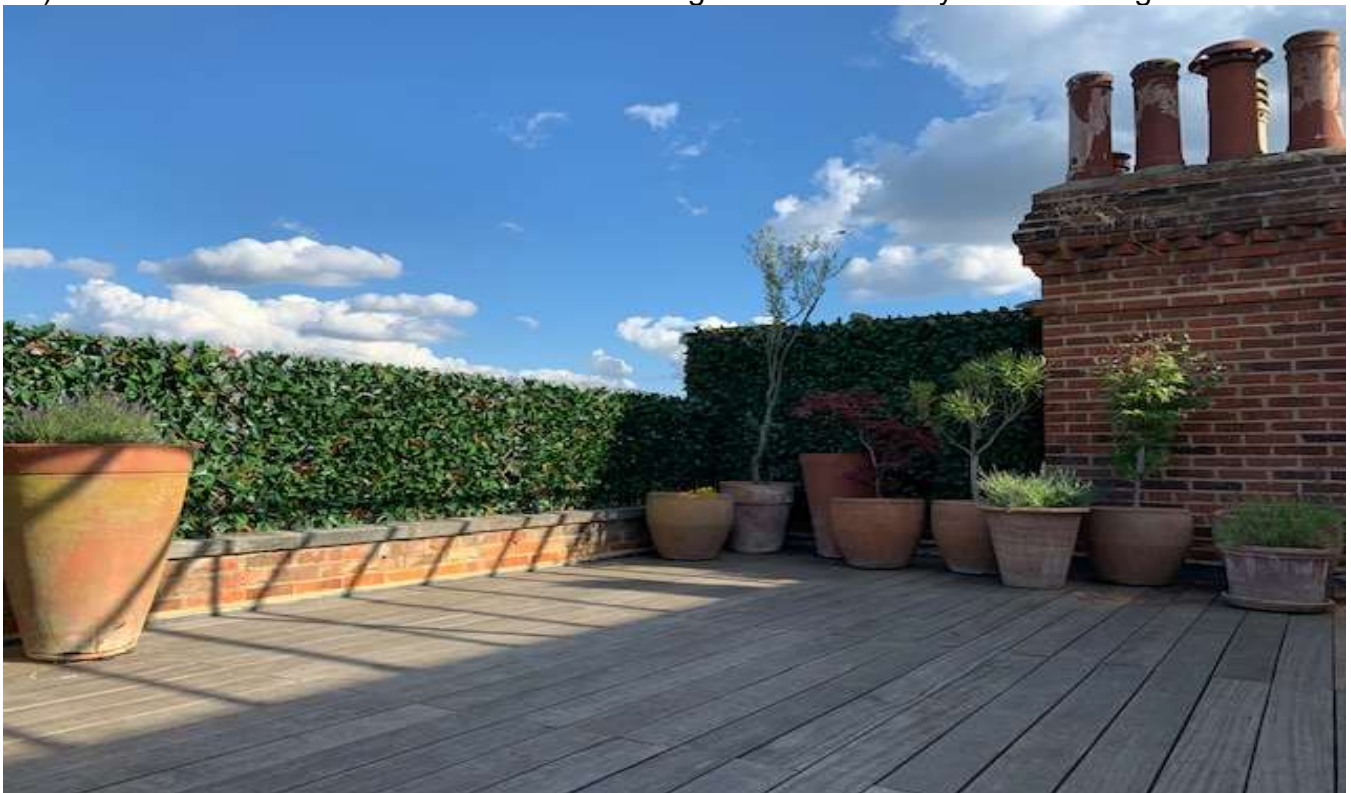
B1) Post commencement of works - Current image of the boundary fence looking south-west

Recent photos from the applicant, photo B1, shows the structure replaced with a new one and covered in artificial planting. As this structure would have been in situ for more than four years, its replacement with a similar structure of similar height is considered lawful.

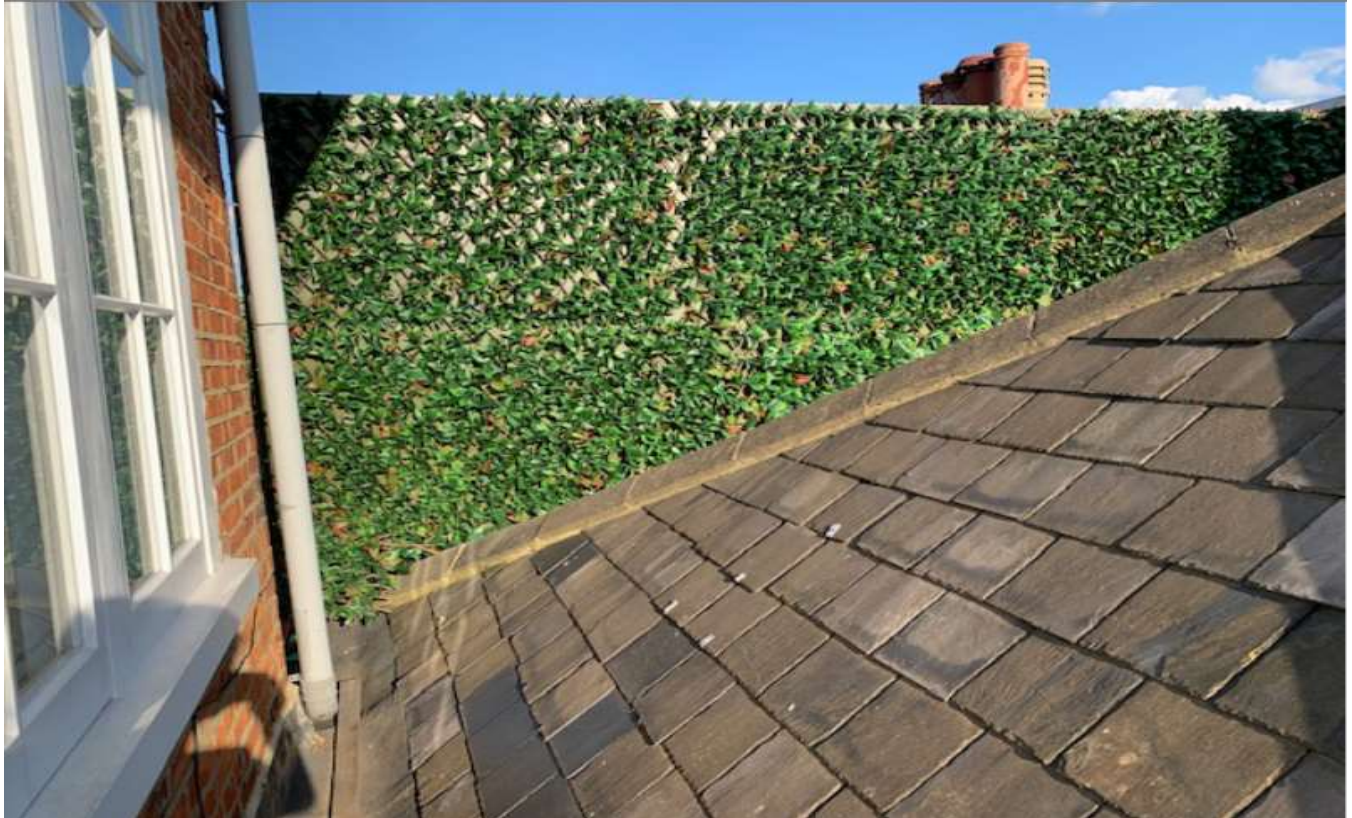
B2) Current image 2022 – looking north

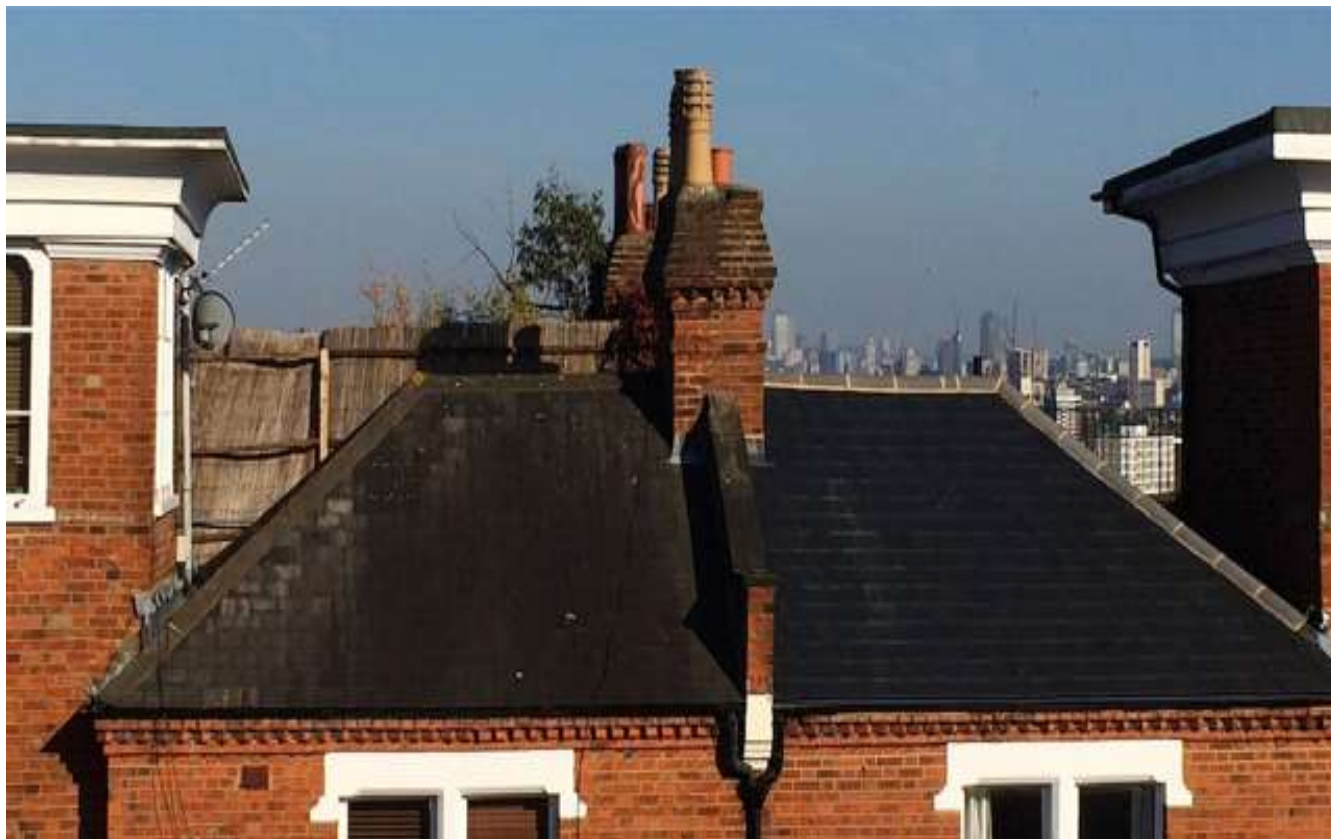
C2) The fence at the front is established, pic dating from 2007 below (from complainant EN15/1167). (nb this fence is also visible in the 2007 aerial pic above).

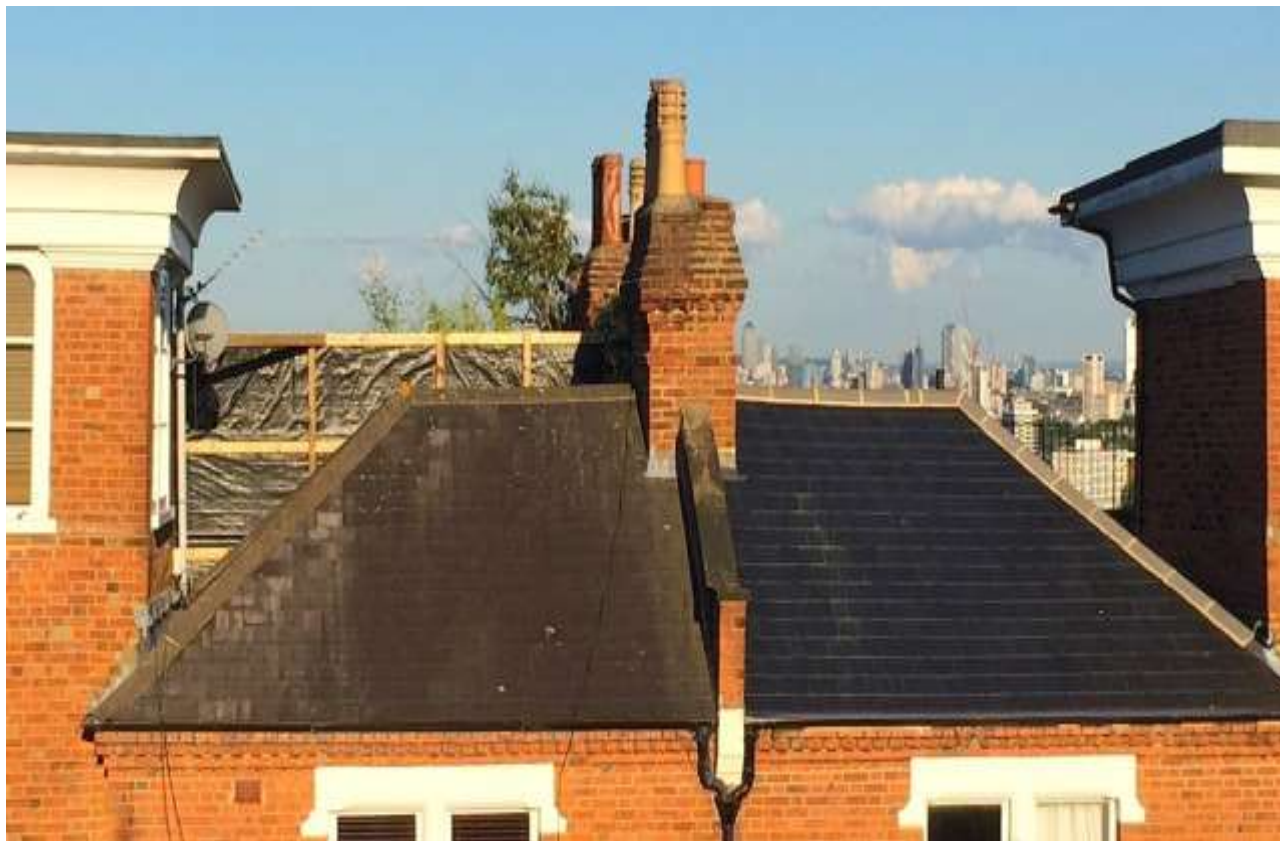
C3) The fence was rebuilt in 2015 after damage, see image below.

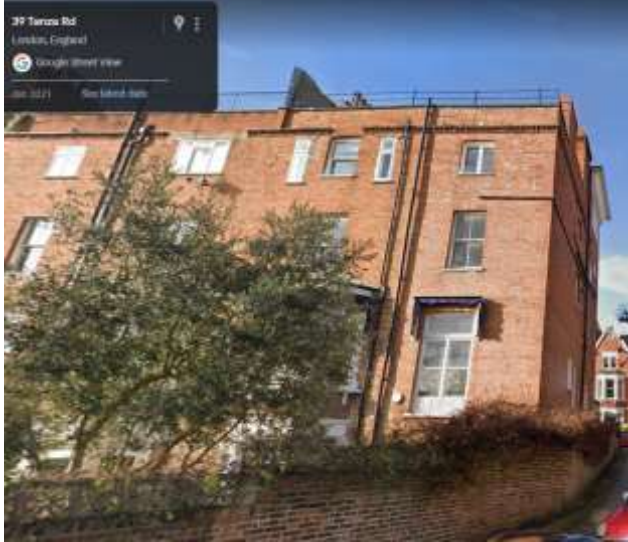
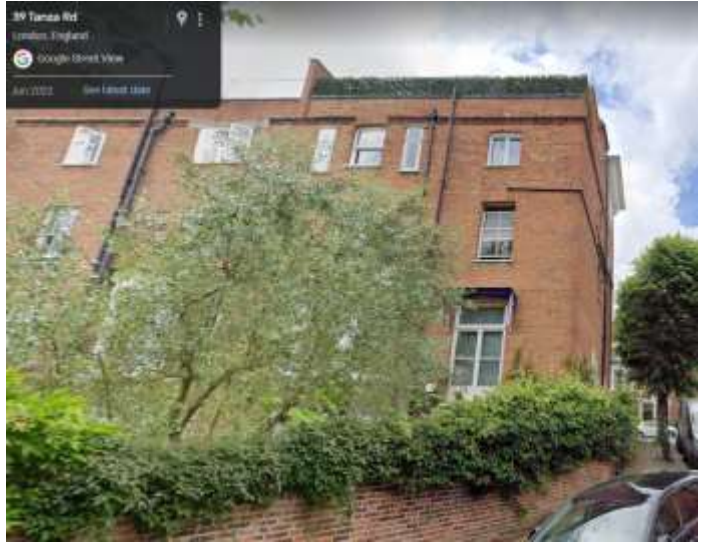
D1) Left - rear of the property 2021 showing railings at roof level; Right – rear of the property 2022 showing solid enclosure at roof level.

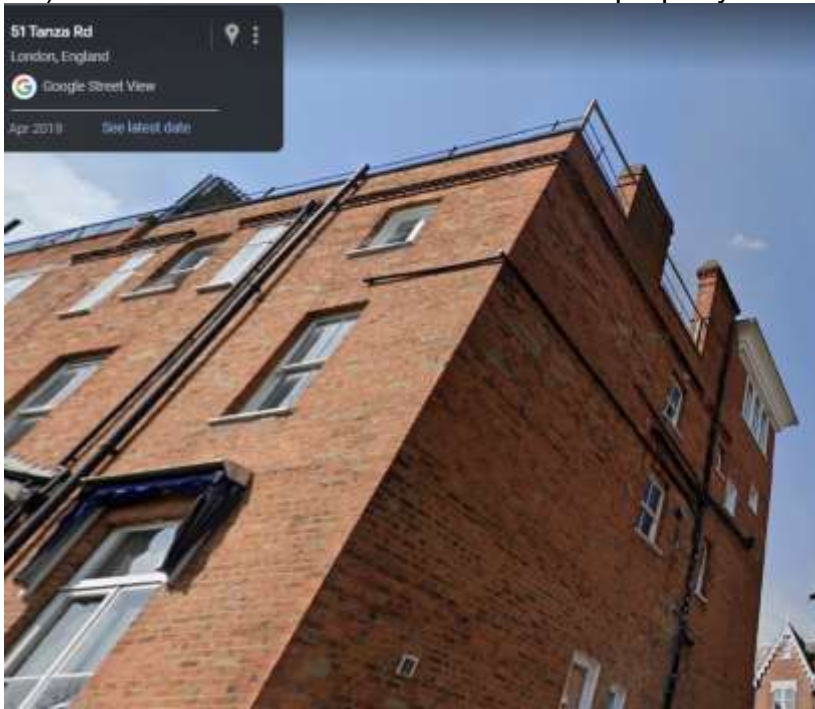
D2) 2019 - Rear and side elevations of the property showing railings at roof level

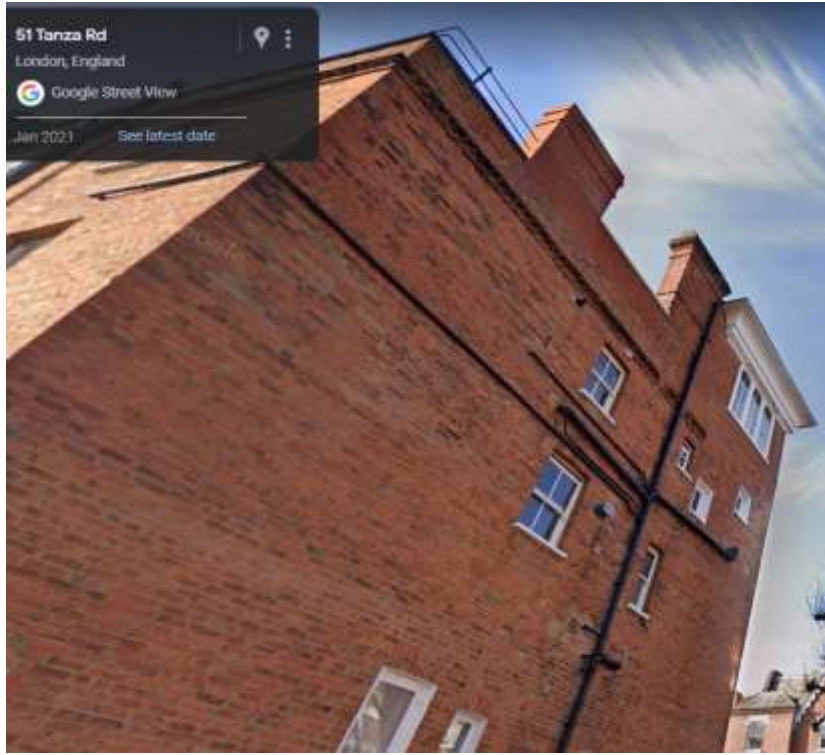
D3) 2021 - Rear and side elevations of the property showing wider chimney rebuilt and new brick infill to which a fence is later added.

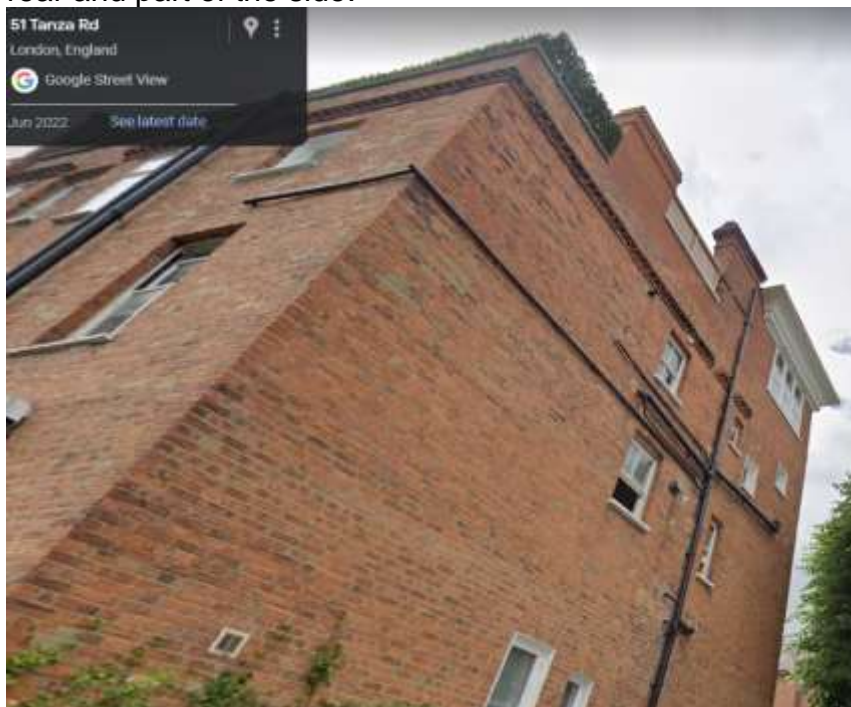
D4) 2022 - Rear and side elevation of the property showing the wider chimney rebuilt, brick infill and additional timber fence over towards the front of the building and green mesh panels along rear and part of the side.

Due to their nature, size and location they do not benefit from permitted development rights. Furthermore, given their recent installation they do not benefit from lawfulness by the passage of time. Whilst a fence was previous in place prior to 2019, given the significant gap between its removal, the fact it was higher than the fence it replaced, it is would be considered development for which planning permission is required. The information from the applicant clearly shows the unlawful installation of the solid boundary to the terrace currently in situ.
