ARBORICULTURAL IMPACT ASSESSMENT

St Paul's CE Primary School, Elsworthy Road, NW3 3DS

Reference: MDJAC-22.137-AIA-01A

Revision: A – 16 January 2023

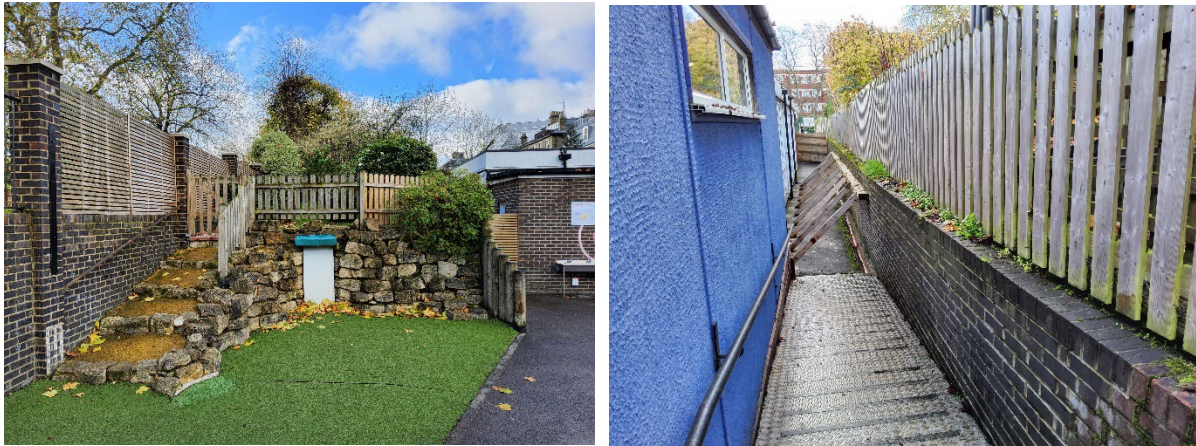
4.2.2 A narrow strip of land along the southern boundary has, in the past, been segregated from the remainder of the school site, to provide a gated, raised 'wilderness' area for outdoor education and recreational activities during the school day.

Photographs 1 and 2: showing the rockery steps leading from the playground to the wilderness area (above left), and the retaining wall along the northern boundary of the wilderness area (above right).

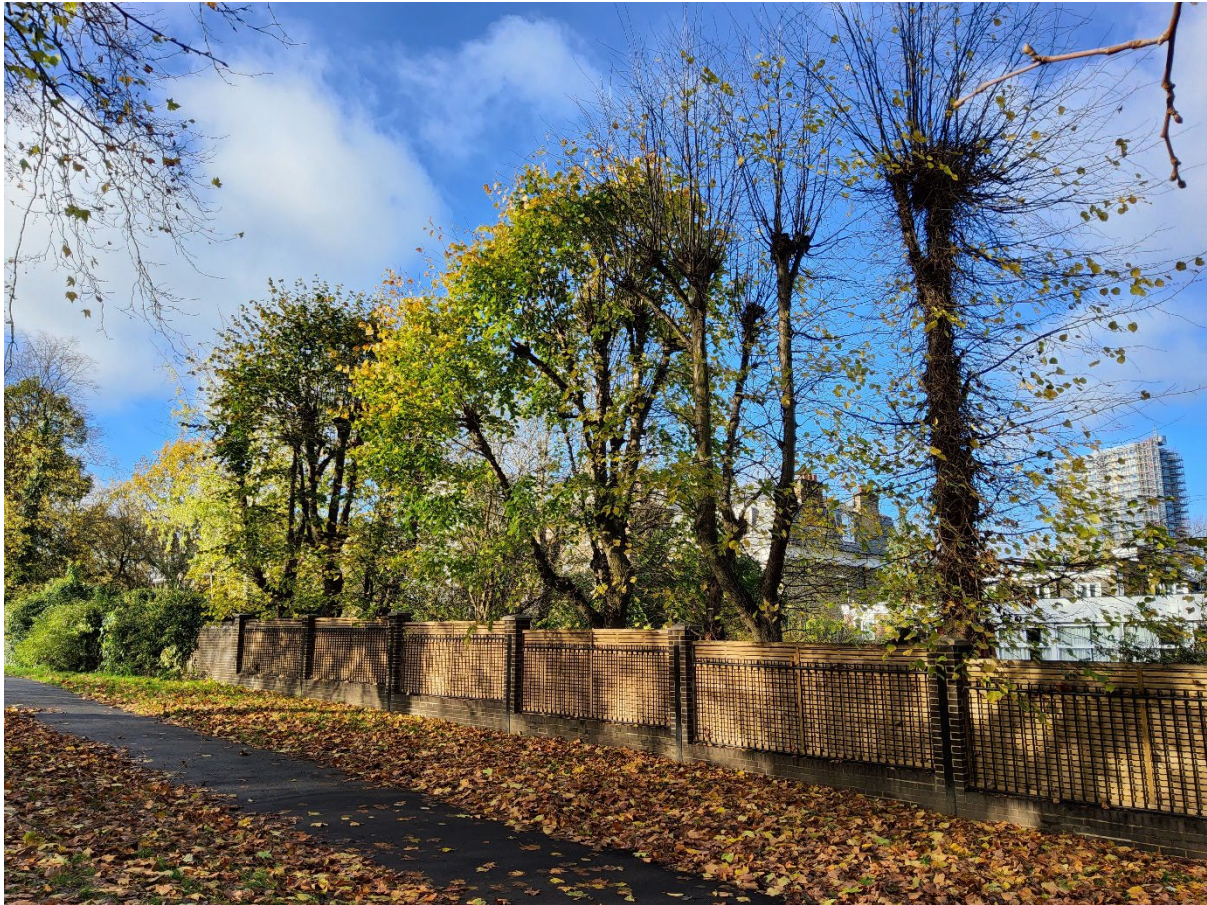
5.1.3 The trees to be removed collectively form a belt along the southern boundary, predominantly comprising lime specimens which were pollarded some time ago and have since been re-pollarded annually. This degree of intensive proactive management has been necessary in the interests of risk mitigation owing to the lime species' propensity to develop deadwood within their canopies, which might otherwise pose an unacceptable risk to school staff and pupils, and users of the adjacent Primrose Hill Park footway.

5.1.4 As a result of this management, the trees are of limited height and stature within the landscape on an individual basis but do provide an element of amenity value on a collective basis, as shown below. Their position upon elevated ground, which is in keeping with the ground levels within

Photograph 3: showing the group of mostly lime trees to be removed in views from Primrose Hill Park to the south of the school.

1. Remove the trees identified for as such as part of a planning application to re-develop the site in the interests of preventing and mitigating damage to the existing boundary wall; and
2. Ensure that replacement tree planting is secured to progressively mitigate the loss of the existing specimens.

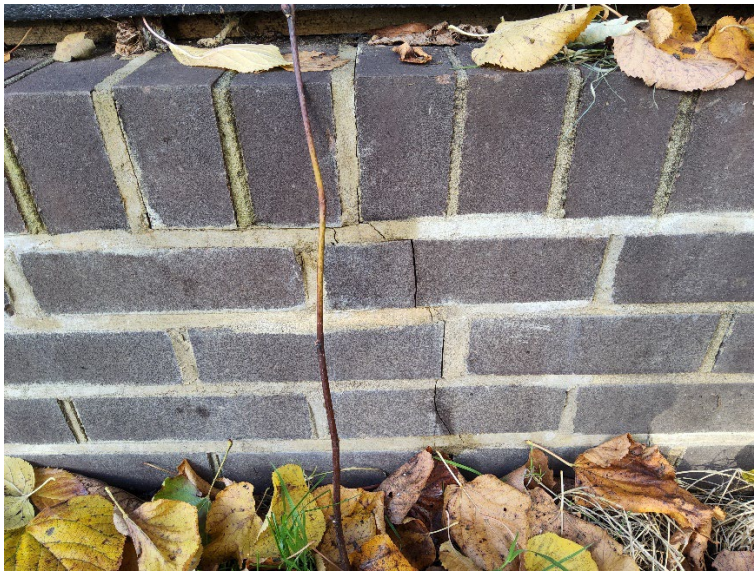
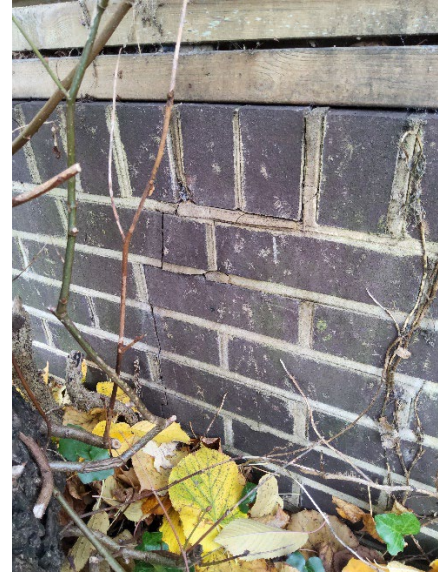
5.1.5 Despite the trees' relative amenity value, assessment of the condition of the existing boundary wall that extends along the southern boundary, shows evidence of tree-related damage. Whilst this damage, in the form of cracking as a result of continued root growth near the base of T5, is isolated to one location at present, the retention of these trees for the longer-term is likely to result in additional areas of damage along the length of the wall, particularly given the uniform size and distribution of trees.

5.1.6 Tree's are able to cause damage to structures in two principal ways. Direct damage occurs through the continued incremental growth of roots resulting in an increase in diameter, which can forcibly move and distort sections of the wall. The second damage type is indirect and can be caused by the extraction of water from the soil solution by tree roots at significant depths, which can lead to areas of desiccation within the soil and associated volumetric shrinkage in the summer months.

Photographs 4 and 5: showing the damage adjacent to the base of a common lime (T5) from Primrose Hill Park (above left) and from within the school grounds (above right).

5.1.7 As part of my assessment I have considered the likely soil properties underlying the site. The site is located atop an area of London Clay Formation (British Geology Society, 2022), which is highly susceptible to volumetric changes as a result of moisture extraction, particularly from tree roots. This is further corroborated by the number of insurance claims made for such damages throughout the Greater London area, and in particular, within the London Borough of Camden (Dobson, 2022).

5.1.8 Based on the above assessments, I conclude that the removal of the lime tree(s) is likely to become necessary in the short-to-medium-term to prevent further damage to the boundary wall, irrespective of the proposed re-development. However, their proactive removal as part of the re-development and associated planning application will likely prevent further damage to the wall and provide the local planning authority with an element of control over the works via collaboration with the applicant.
