Arboricultural Report

for planning purposes

Chester Terrace
London
NW1 4ND

220928-PD-11b

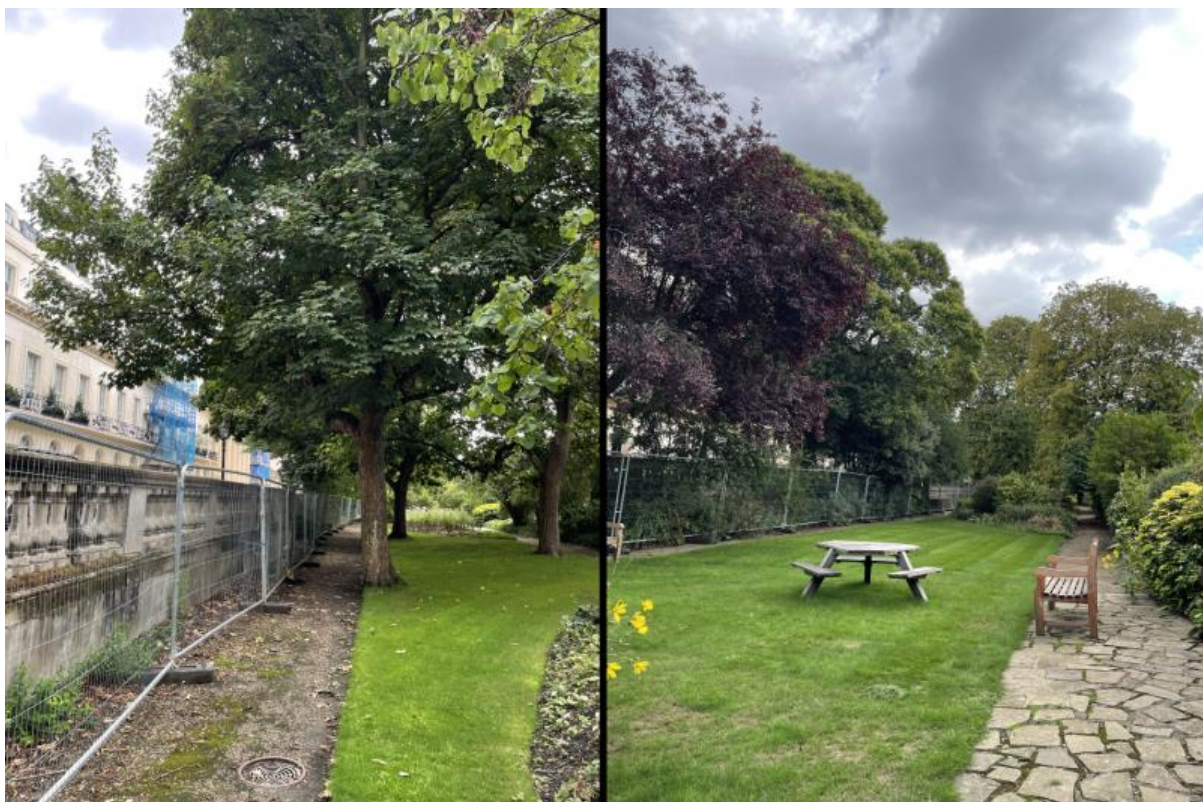
Photo 3 (left) & Photo 4 (right): Looking south towards T223 (left) and looking south along the western edge of the Site from adjacent to T221 (right).

Tree T223	1 Acer pseudoplatanus (Sycamore)	13.0	53	1	4.0		7.5		7.0		5.5		2.5		Mature	Structural condition Fair. Physiological condition Fair. Buttresses / buttress roots - Major adaptive growth / strong development. Crown reduction - Historic. Die-back - Throughout crown. Decay / structural defect in crown limb / limbs - Open cavity / cavities. Deadwood - Major. Fork - Suspected structurally sound. Pollard - Lapsed / Mature stems. Pruning wounds - Decayed. Stems - Co-dominant. Stems - Heavy principal stems. Unbalanced crown - Minor.	12/09/2022	127.1	6.4	40+	B1/B2
Tree T224	1 Ilex aquifolium (Holly)	7.0	28 COM	13	3.5		3.5		3.0		3.5		2.0		Mature	Structural condition Fair. Physiological condition Fair. Arboricultural work - Recent. Buttresses / buttress roots - Major adaptive growth / strong development. Epicormic growth - Base. Multi-stemmed. Stem diameter estimated average of stems. Position estimated - not plotted on the topographical survey.	12/09/2022	37.6	3.5	40+	B1/B2

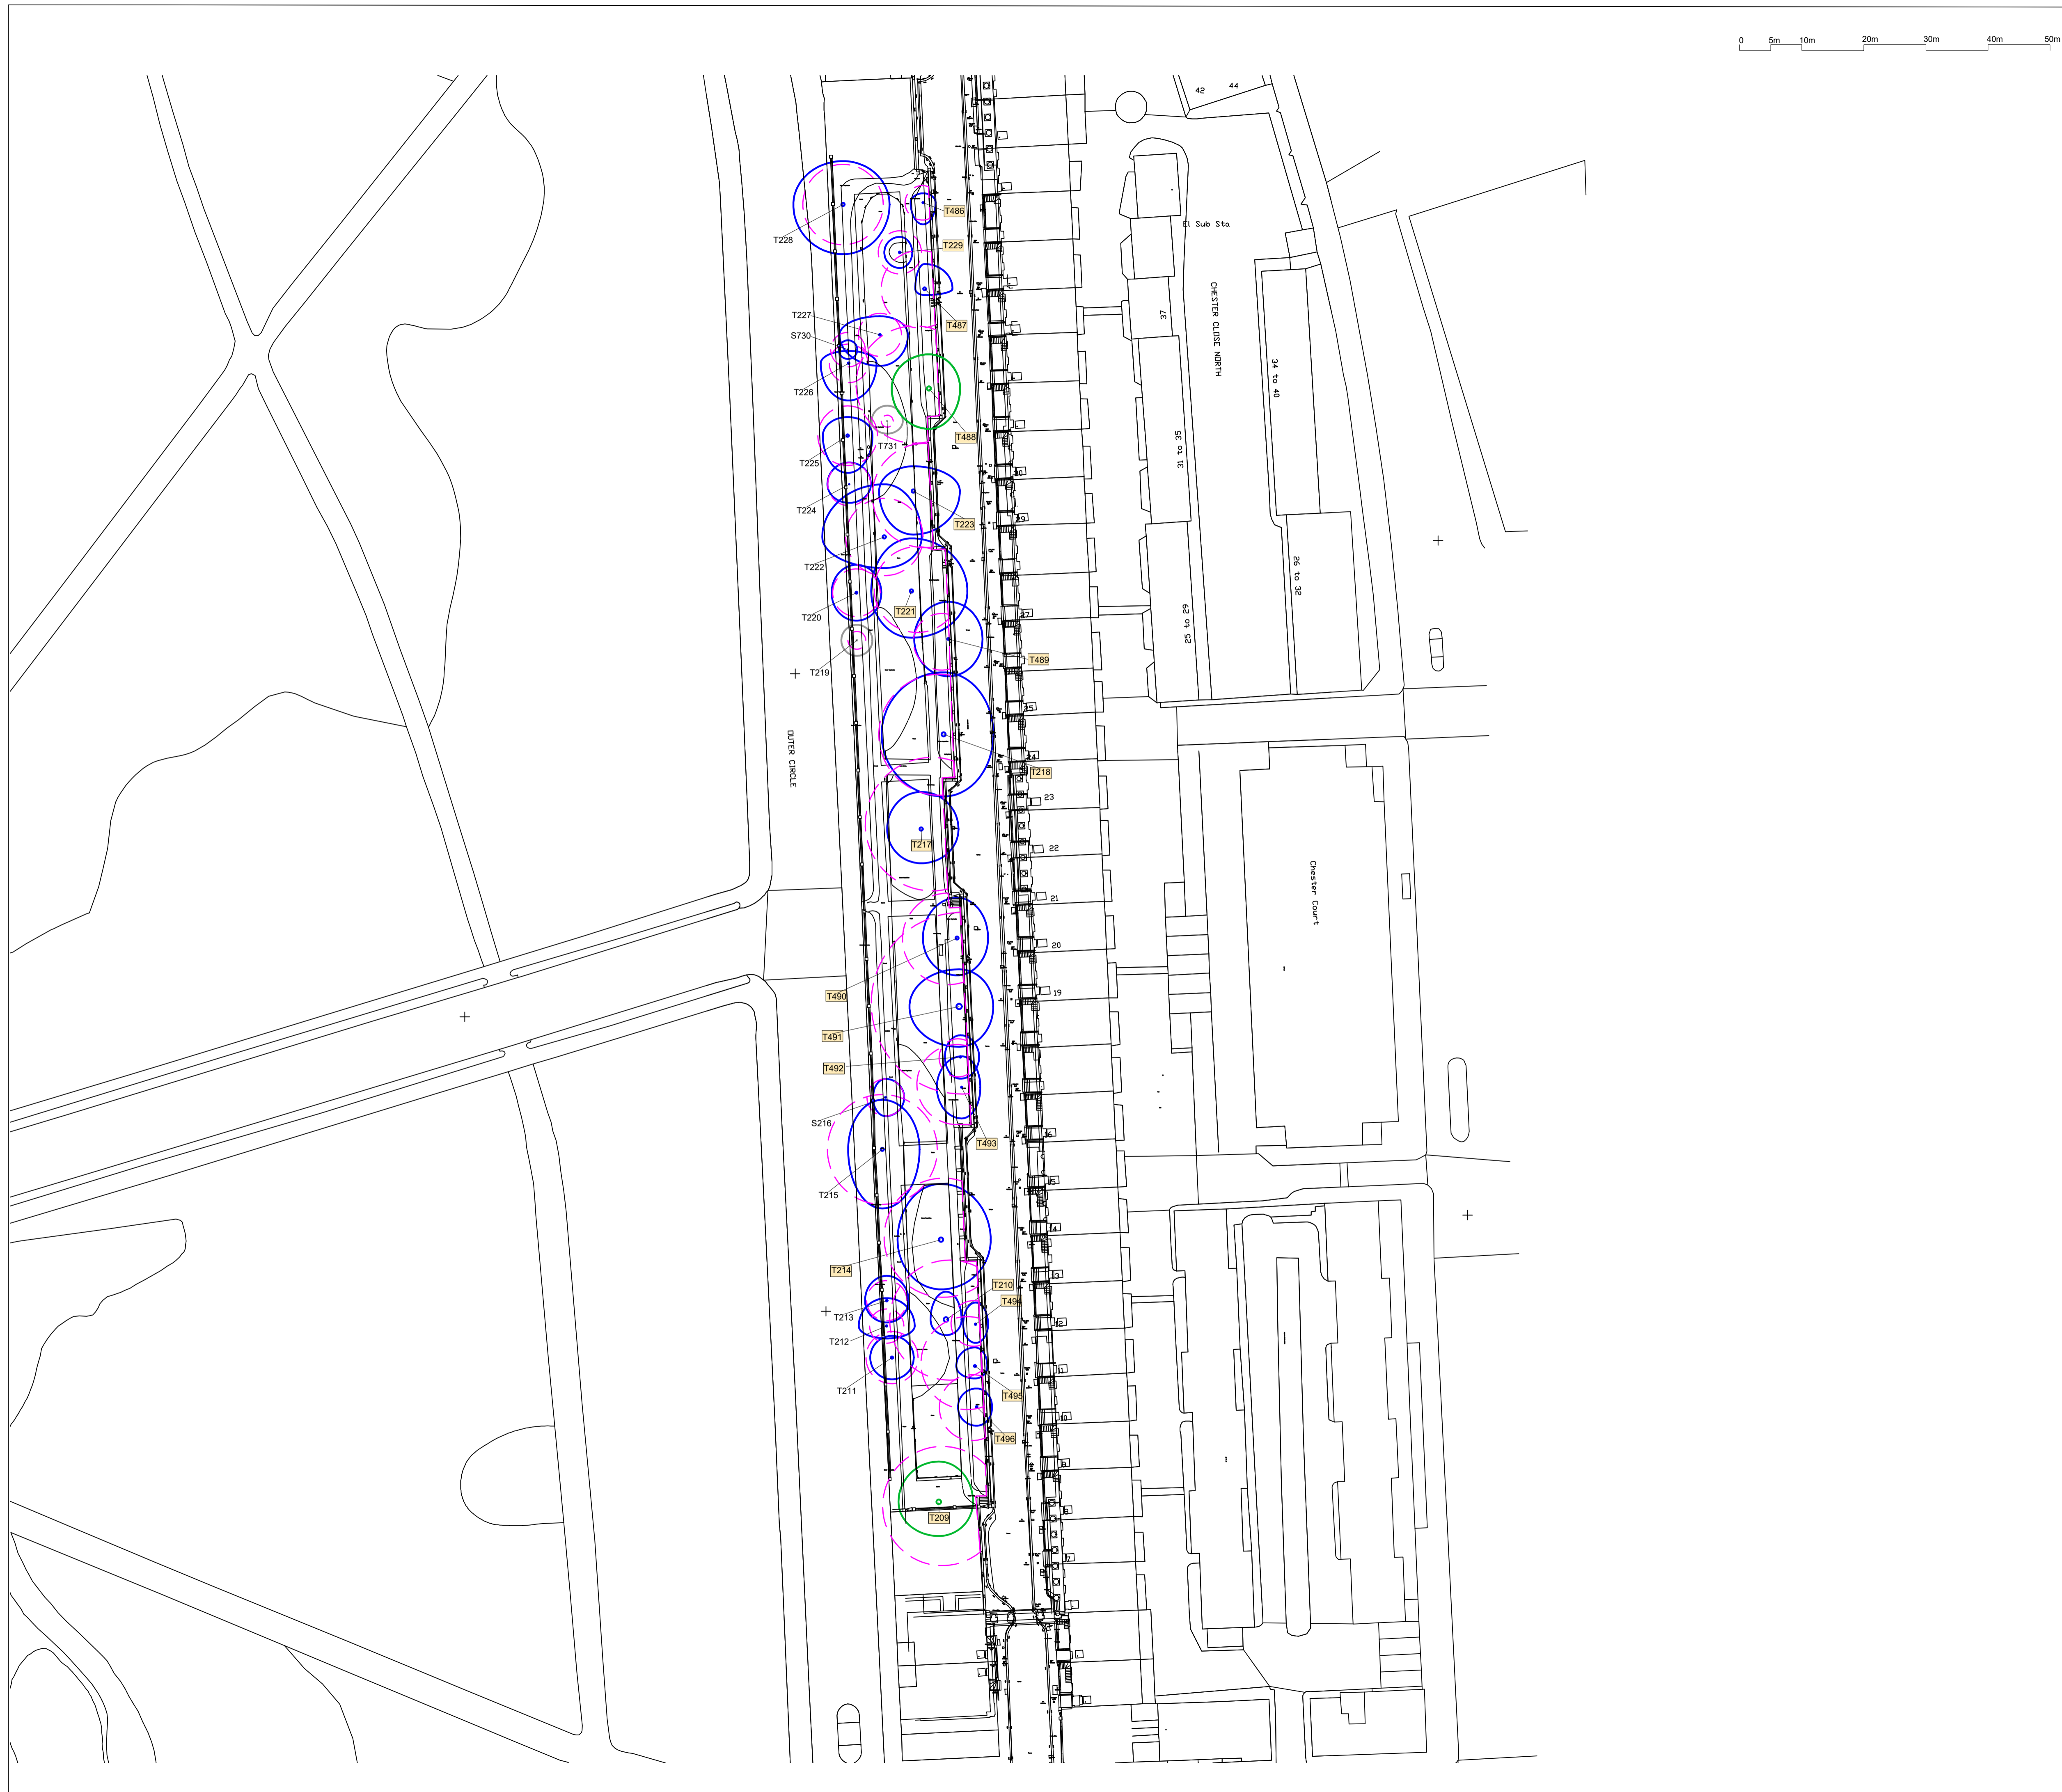
rev	date	description	drawn by
Base Drawing:	OSMAP and TOPO		
Title			
Tree Survey			
Client			
Crown Estates Paving Commission			
Project			
Chester Terrace, London, NW1 4RU			
Date	19.10.2022	Drawn by	HR
		Authorised	CW
Drawing No	211130-P-10	Rev	-
		Scale	1:500@A1

**T33** The RPAs of affected trees have been off-set, due to the presence of existing roads.

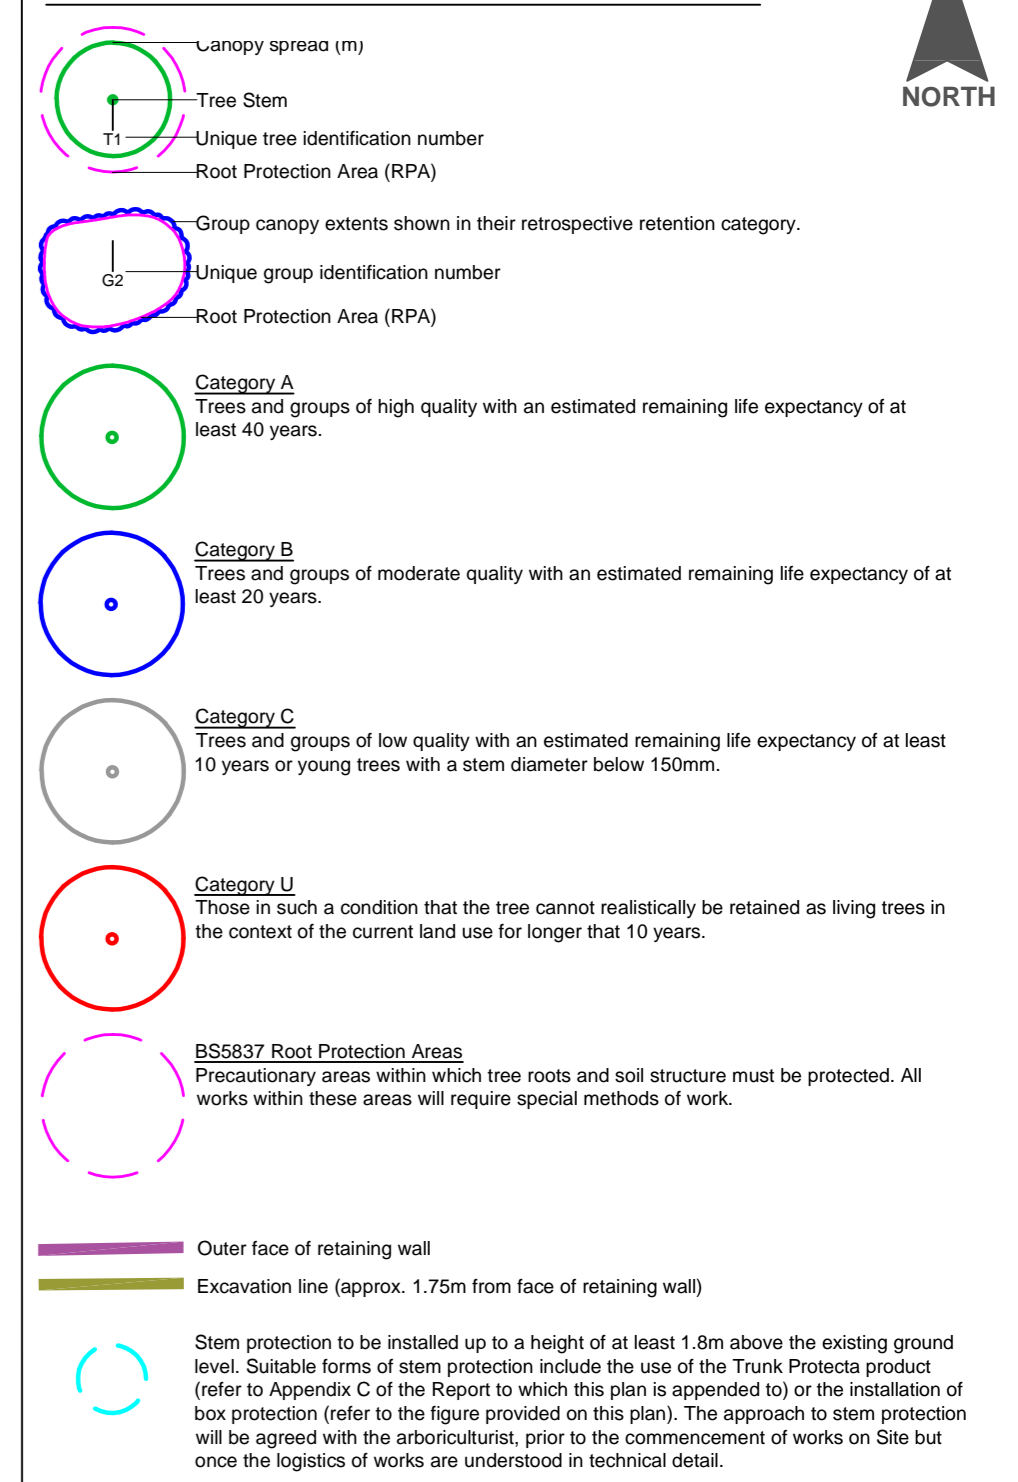
Drawing No	211130-P-12	Rev	b	Scale	1:500@A1
------------	-------------	-----	---	-------	----------

Areas to be protected with a suitable combination of barrier and ground protection. The approach to tree protection will be agreed with the arboriculturist, prior to the commencement of works on Site but once the logistics of works are understood in technical detail. Where barrier protection (to the specification as provided on this plan) is not able to fully protect RPAs within the Site, ground protection will be installed over the remaining existing surfaces to a specification that fully accommodates the gross applied loads to prevent significant ground damage and compaction - nominally, this will comprise a 150mm-thick layer of woodchip laid upon a geotextile membrane over which heavy-duty ground mats will be laid.
