Arboricultural Report

Client: Nicky Kay

Site: 15 Dartmouth Park Avenue, London NW5 1JL

Survey undertaken: Trees in relation to design, demolition and construction – Recommendations.

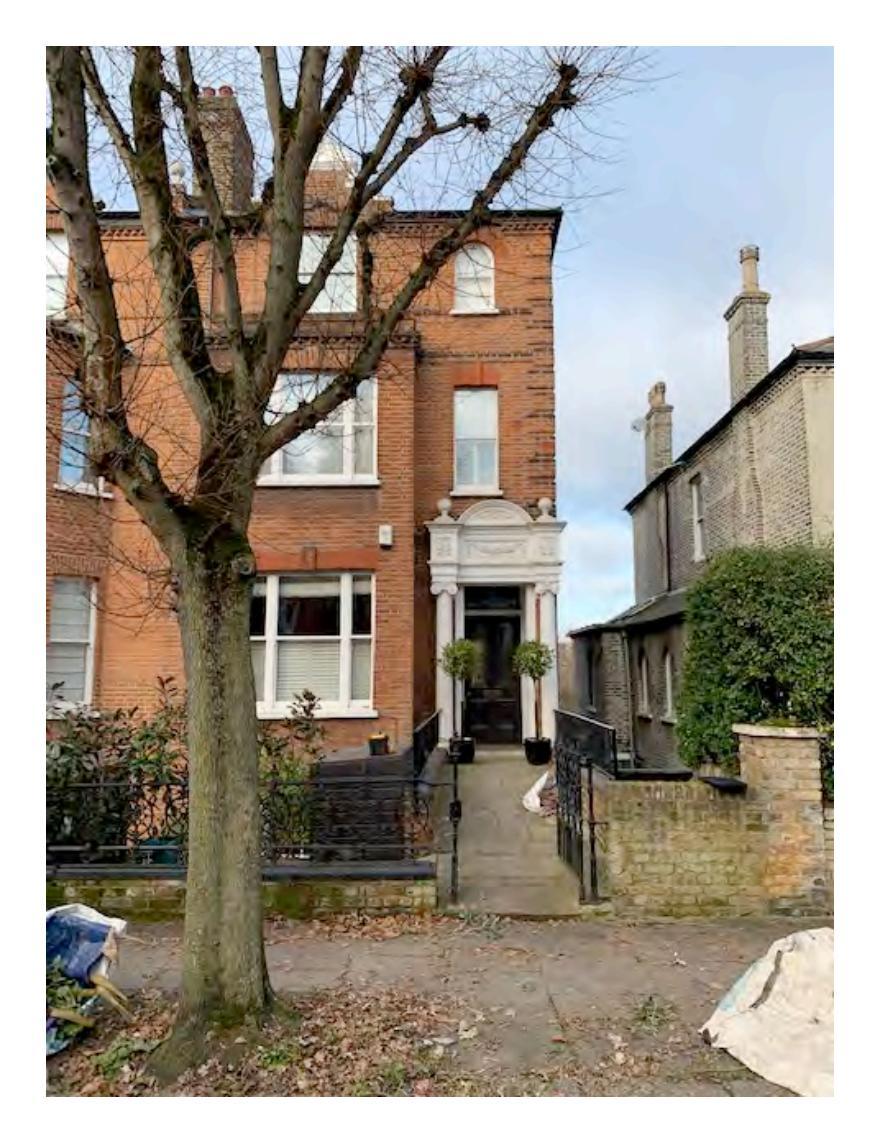
T3 – Field Maple is a street tree growing directly outside front garden of number 15. The tree has been reduced to contain the spread in the past two years. Although the roots of this tree are clearly not within the area proposed for development I have included this tree to ensure it is considered during the project with regards to construction traffic and unloading activities. Skip

Photo 1: Front of number 15 Dartmouth park Avenue with access down the side return to rear garden. T3 Field Maple grows outside in close proximity to site entrance. Tree stem hoarding would mitigate mechanical wounding from construction traffic for duration of project.

lorries or HIAB lorries can cause mechanical damage to the stem or canopy as it grows in close proximity to the front garden access. Materials would need to be unloaded away from this tree. It would be prudent to erect hoarding around the stem to ensure mechanical damage doesn't occur and materials are not stored in the tree-planting pit.

T3 – RPA not affected by proposed development. No pruning required. Installation of protective hoarding around main stem to prevent mechanical damage by construction traffic is recommended (2.5m in height and to incorporate dimensions of the planting pit)

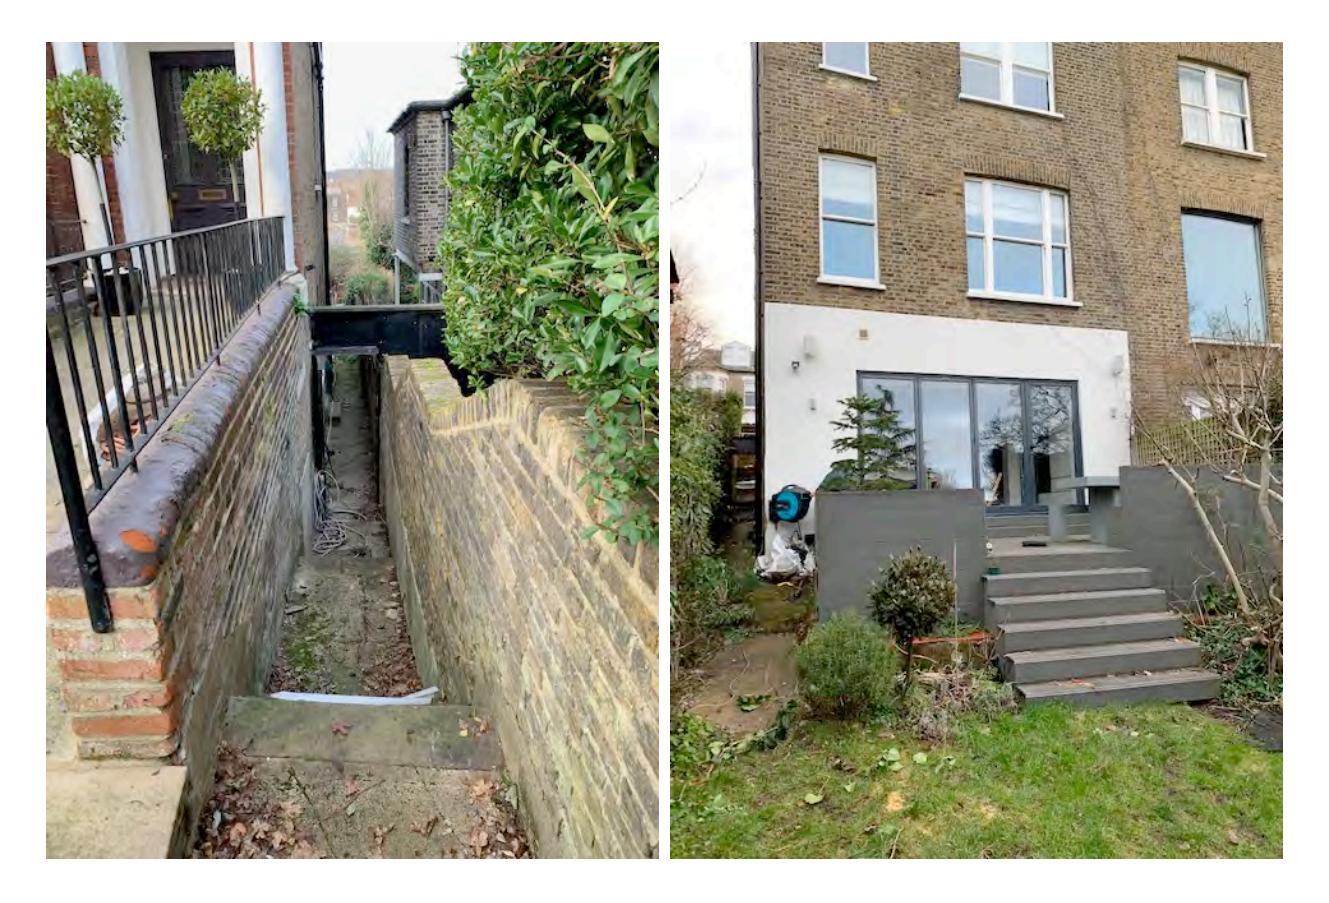
Photo 2: Left, denotes side access considerations, such as narrow width and steps down to rear garden. The proposed project would not permit heavy machinery on site due the access considerations therefore soil compaction in the rear garden would not occur.

Photo 3: Right, illustrates lower ground floor level proposed for extension. Existing decking would need to be removed for foundations and build space. There is adequate space in the immediate vicinity of the rear garden for storage and mixing of materials without having to utilize the rear section vegetable growing areas.

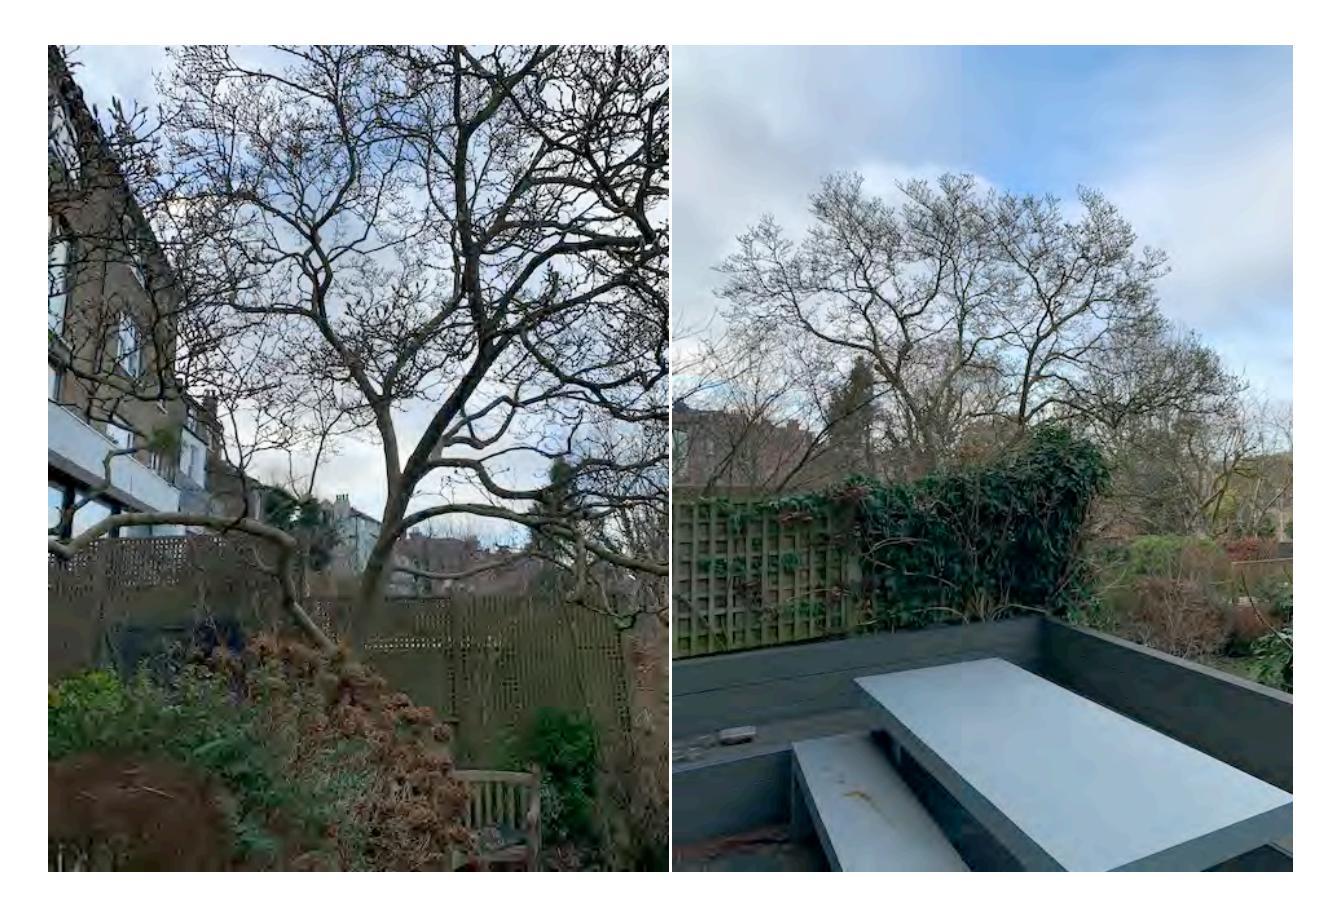
T1 – Magnolia has been recorded category A in the BS tree quality assessment. It has a medium landscape contribution and the most significant tree in the immediate vicinity of the proposed extension. The stem grows on the opposite boundary to number 15 so approximately 5m away from the shared wall. The rooting area has been calculated at 2.7m and therefore is not likely to be impacted by the proposed development. The canopy is largely untouched and has a natural free flowing form that does not extend into number 15.

Photo 4 & 5: T1. Magnolia grows in number 13 clearly visible and enjoyed from the existing terrace. The Tree grows an acceptable distance away for its roots not to be disturbed during proposed excavations for foundations. The canopy has a natural form free of water shoots and provides high amenity value to the surrounding gardens. The canopy does not extend into the rear of number 15. Therefore no pruning would be required to facilitate the proposed project.

T1 – Magnolia: RPA not affected by proposed development, no pruning required.

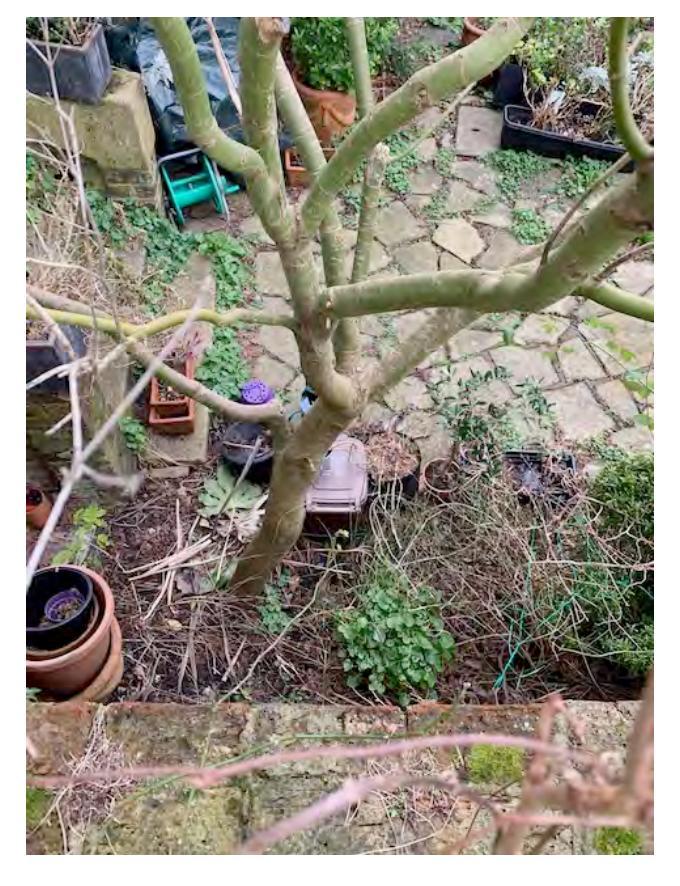
Photo 6:

T2 – Japanese Maple is less than 1m away from the shared boundary wall, the lateral spread of the canopy extends into number 15 marginally (by 300mm) however if the boundary wall is proposed to be dismantled then suitable tree protection measures should be put in place to ensure the roots and canopy are not damaged by construction activities. Due to the current size of the tree one solution may be to transplant the tree prior to any work commencing and then replant post construction.

T2. Japanese Maple growing in close proximity to the boundary wall shared with 15 and 13. The canopy does extend into the area proposed for extension and light pruning would be required to facilitate the project to ensure no damage arises from construction activities. If all work can be contained within boundaries of 15 then pruning may be a solution.

However if build space encroaches into number 13 then the tree would be impacted due to its delicate form. The Maples' DBH is 90mm so protected under conservation area orders. The tree is established in its position but could be potentially transplanted with a high degree of survival if it was under threat.

The project engineers would need to draw up foundation plans along the shared boundary and then we can re assess the potential impact on this tree and come to a suitable solution to preserve it.

T2 – Japanese maple: RPA marginally affected by proposed development. Professional transplanting to a different location temporarily would eliminate necessity to prune canopy and ensure roots were not damaged during boundary wall reconstruction. (TBC once foundation design has been submitted)

T2 will require lateral pruning of secondary branches that extend over the boundary line of no.15. However if the tree owner would prefer the tree to be transplanted for the duration of the project no pruning would be required.
