## Heritage Statement

Holborn Bars, 138 - 142  
Holborn, London EC1N 2ST

Date: 03 March 2023

Reference: 119351-100/30/HM/STB

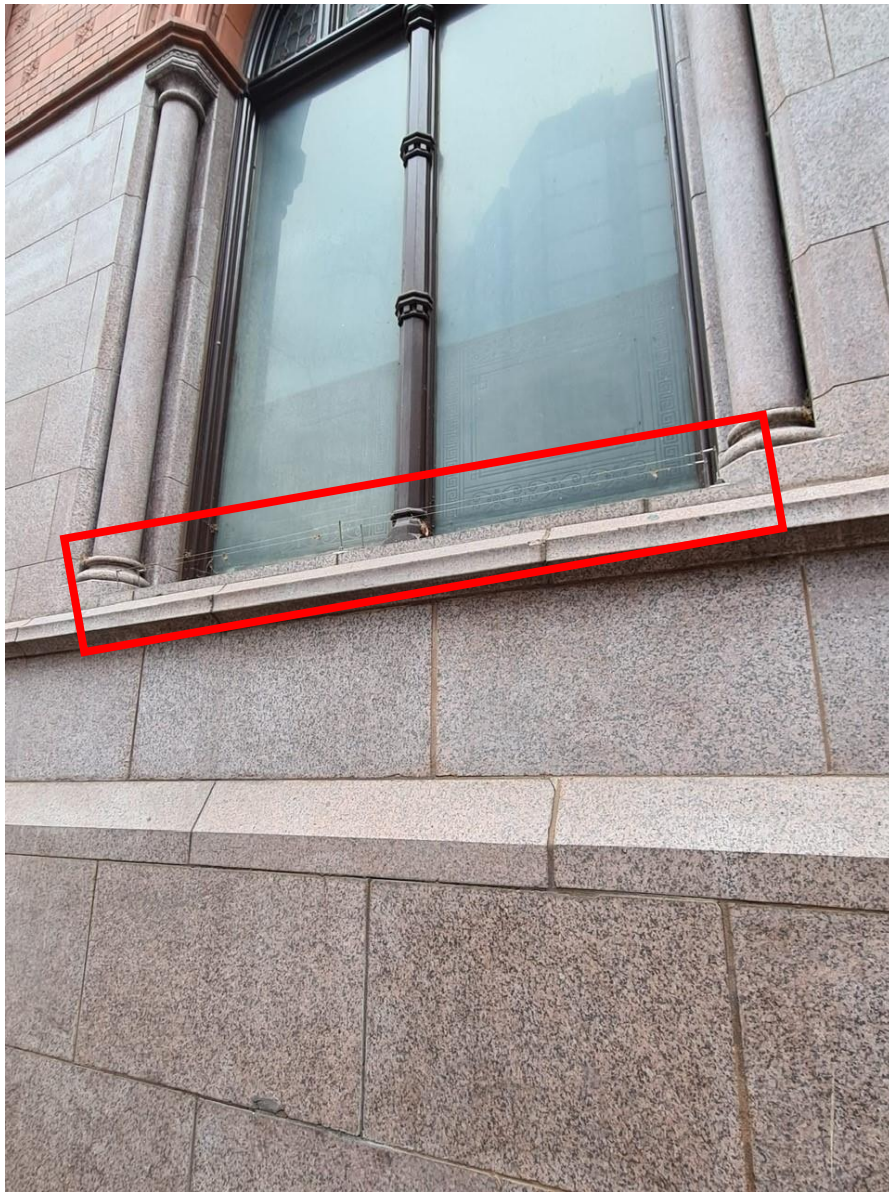
1.1.2. The main reason behind the listed building consent application is to introduce overflow chutes to three parapet gutters due to a recent bout of internal water ingress which has caused aesthetic and physical damage internally within the property. Furthermore, the addition of more pigeon spring tension wire has been proposed due to areas that have significant build up of pigeon guano.

Existing pigeon wire installation to be replicated under this proposal.

Ref.	Pigeon spring tension wire
2.0	<ul style="list-style-type: none"> <li>▪ Via a mobile elevated work platform or abseilers.</li> <li>▪ Drill small holes at intervals of c. 1.50m and install 25mm masonry rivets for the stainless steel posts to be inserted into and grouted into place. Enough room is to be left at either end of the runs for an anchor point, c. 115mm.</li> <li>▪ Install the anchor point via a small drill hole and again, a 25mm masonry rivet.</li> <li>▪ <b>Install the bird wire as per the manufacturer's guidance.</b></li> </ul>

- 5.1.4. Varying types of pigeon deterrent were reviewed, including surface mounted spikes and tension wire. The surface mounted spikes were discounted as the spikes are much more visible from ground level as opposed to thin wire, not easily visible from a distance. As for the surface mounting, this will require some form of glue/adhesive which, if at a later stage becomes loose, it may take away some of the surface of the terracotta, leading to freeze-thaw defects with the terracotta or loss of fire skin. For this reason, a more robust solution of dowelled-in posts which are held in place with grouting that will match the colour of the terracotta blocks is proposed, and is also in keeping with other installations on the elevations. The spring tension wire galvanised posts will protrude c. 100mm vertically from the terracotta sills.

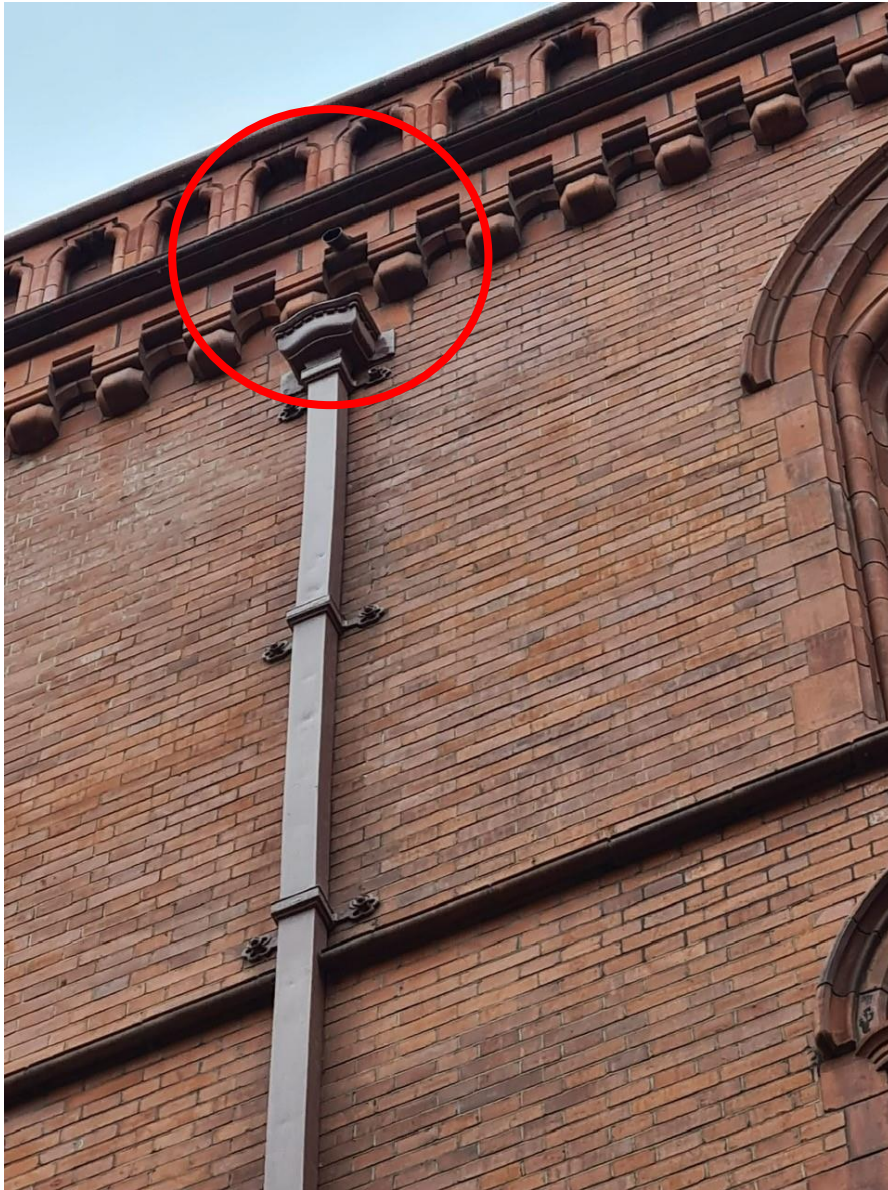
5.1.2. Due to more frequent periods of heavy rainfall, which are a likely side effect of global warming, the parapet gutters have been breached and the water is entering the internal fabric of the building. The lead-lined parapet gutters are known to be water-tight as they were reviewed as part of the larger external restoration project which completed in December 2020, but they have minimal falls and have a limited capacity due to their size. The steep roof slopes shed rainwater quickly with the slate providing a small amount of friction, especially since they were cleaned as part of the previous restoration works. This means that in heavy down pours, the gutters fill up quickly and are often overwhelmed. In the first instance, the on-site maintenance team have increased the amount of cleaning cycles undertaken to the gutters but the problem has persisted.

Existing overflow chute to be replicated under this proposal.

Ref.	Overflow Chutes
1.0	<ul style="list-style-type: none"> <li>▪ Via a mobile elevated work platform and from the eye-bolt anchor points.</li> <li>▪ Core drill of c. 50mm diameter holes from the inside of the parapet gutter through to the external side of the wall.</li> <li>▪ Line the core drilled bore hole with lead and dress into the inside of the parapet.</li> <li>▪ The chute will protrude from the elevation c.50-60mm. The variance will depend on any obstructions below the protrusion point to ensure no water runs down the façade.</li> </ul>

- 5.1.3. The options presented to the client were to increase the height of the lead upstands/flashings or to install additional outlets with downpipes. In order to increase the height of the lead flashings, the slate roof slopes would need to be removed and reinstalled after the leadwork is undertaken. This would be hugely costly and would likely also result in many of the slates becoming damaged or broken, meaning less authentic replacements would be sought. Additionally, by increasing the height of the flashings would simply increase amount of water that may pool within the parapet which could percolate into the interior of the property. Installing additional outlets and downpipes was discounted as an increased amount of penetrations to the fabric would be required to the façade. Furthermore, to replicate the current installations, bore holes of circa 1-2 metres would be required, as the hoppers do not sit on the façade at the same level as the parapets. By installing an overflow chute, this alleviates the amount of water to be evacuated from the gutters by allowing the water to eject from the parapet as opposed to finding its way into the interior of the building. It can also be used as an indicator for the maintenance team to react and check the performance of the outlet for any blockages. An overflow chute has already been installed on the Leather Lane elevation, which retrospective approval is being sought. We believe this installation to be innocuous and any by passers would need to study the elevation in detail to notice it. A picture of this installation is below.
