CROWN ESTATE PAVING COMMISSION

Chester Terrace Management Vision

August 2019

Todd Longstaffe-Gowan
Landscape Design

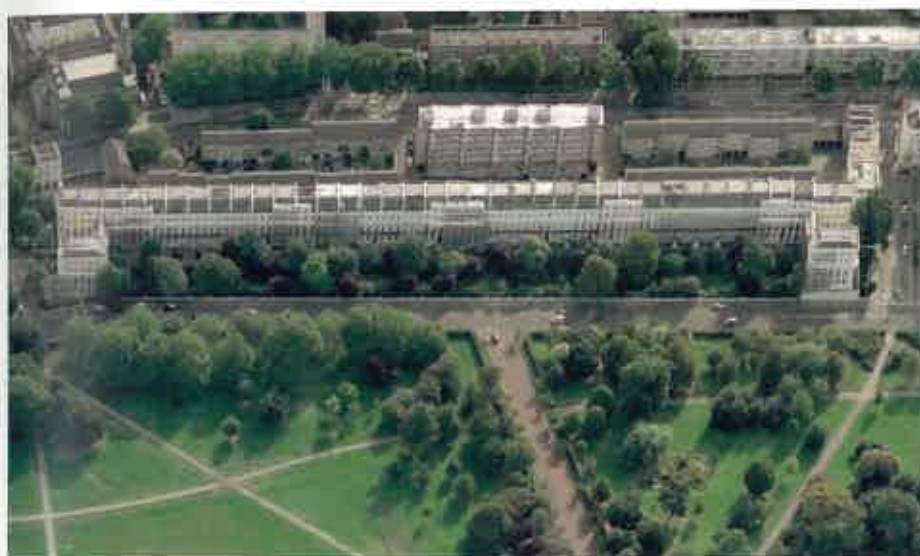
Aerial photograph showing Chester Terrace facing Regent's Park, 2015.

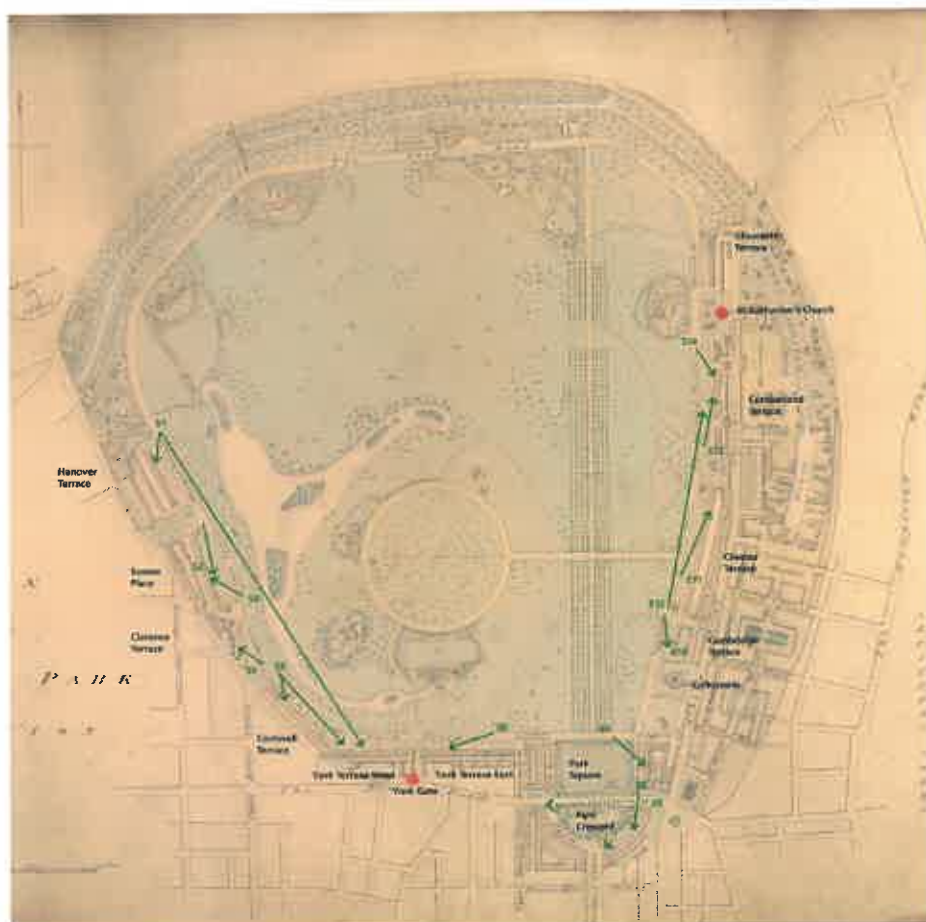
Left: Historic street views from The Outer Circle (superimposed on Mayhew's Plan of 1834-35). Note the view northeast across the facade of Chester Terrace.

The Outer Circle was originally flanked on either side by a broad footway lit with gas-lamps, and planted with trees, which complemented and distinguished the palatial terraces and framed views to and from the interior of the park. As Nash remarked in 1832, his aim was to create 'so many distinct pictures' so that perambulators 'will see a succession of views distinct from each other'.

The layout of the Outer Circle was calculated to satisfy the residents' wish for privacy and the public's desire for public amenity: resident leaseholders enjoyed the benefits of private communal gardens and aerial views from the upper windows of their houses; the visiting public were restricted to street-level views from the public rights of way, but these were nevertheless carefully designed so that a walk or drive took visitors through a series of framed views or living pictures.

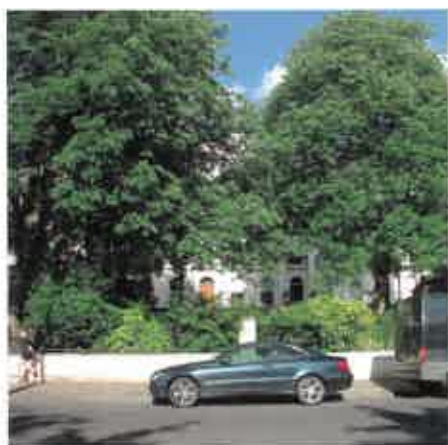
Far left: Views to Chester Terrace from the Outer Circle are completely obscured in places.

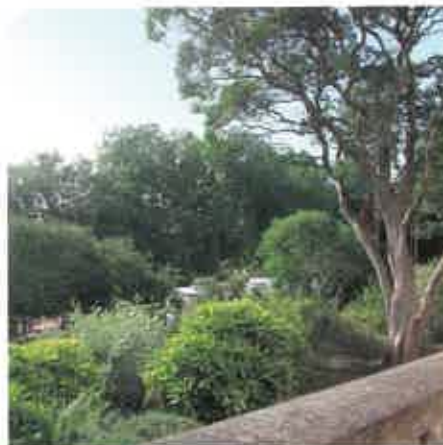
Left: Historic views from the elevated position of Chester Terrace are screened by large trees and shrubs.

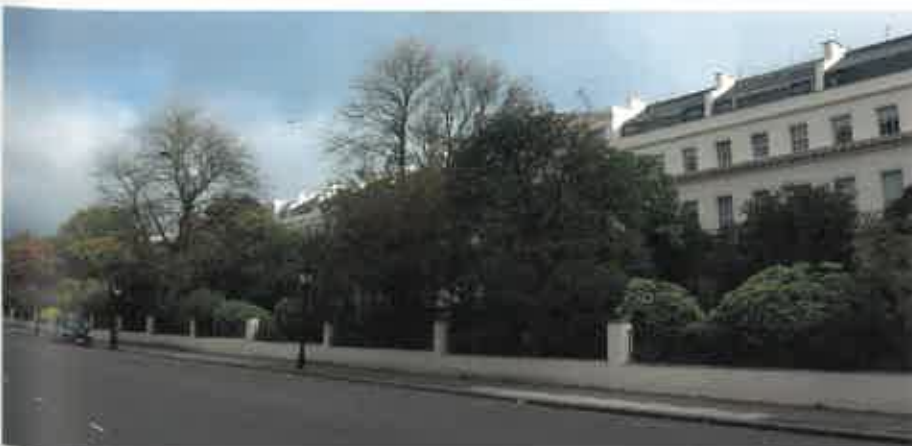
Left: Existing view from the approximate location of the Shepherd drawing above. The majority of the building facade is obscured by trees and shrubs.

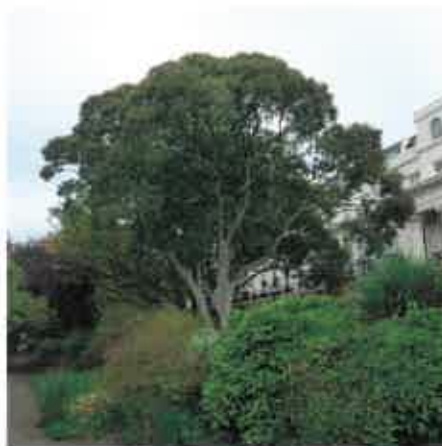
Right: A mature *Ligustrum lucidum* (Chinese privet) is a characterful central feature of the garden, though ~~ill placed~~ for providing views to the building.

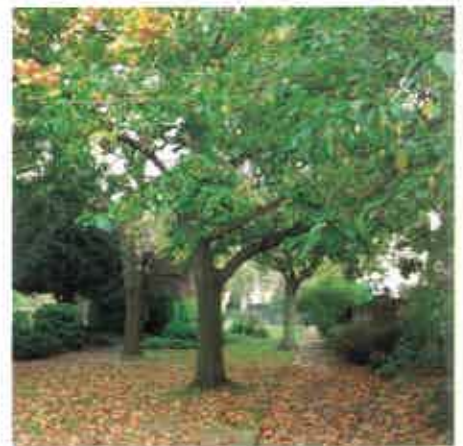
Far Right: two grade B *Acer pseudoplatanus* (sycamore) and a grade B *Catalpa bignonioides* (Indian bean tree) are ~~growing in close proximity to one another~~. The crown of the *Catalpa* is impeded by the adjacent trees, both of which would benefit from its removal.

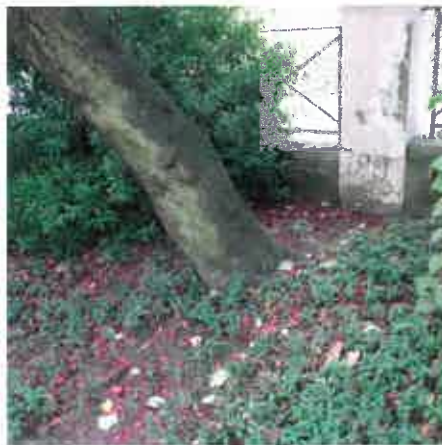
Right: Trees planted along the western boundary place unforeseen stresses on the parapet wall. Many are leaning into the garden, possibly due to an inability to anchor themselves appropriately.

The western boundary contains a high proportion of poor ~~trees that suffer due to being planted too close to the boundary wall~~. Furthermore, the weight of the trees is placing additional pressure on the footing of the structure and therefore compromising its overall strength.

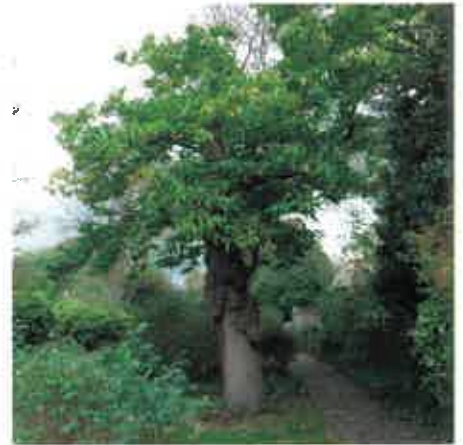
Far Right: The heavily impaired *Castanea sativa* (sweet chestnut) at the south end of the garden should be removed due to decay in the main ☒ stem.

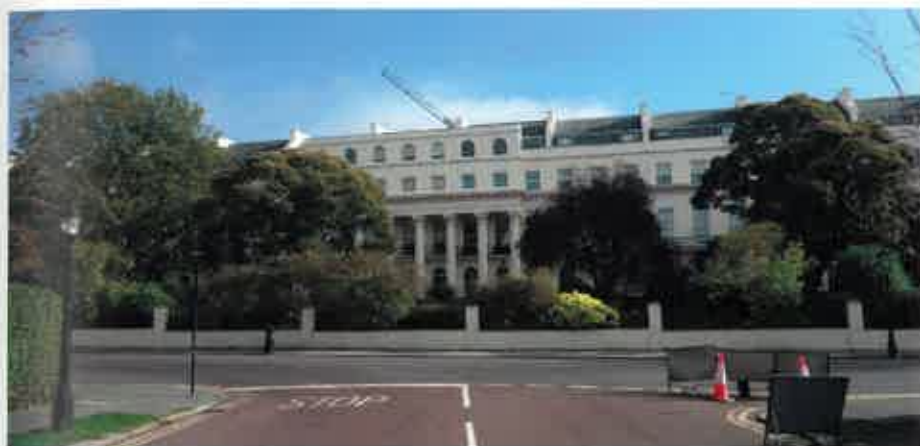
At present, trees obscure a high proportion of views to and from the building.

Left: The view east from Chester road shows partial views to the central set of Corinthian columns, flanked by mature trees.

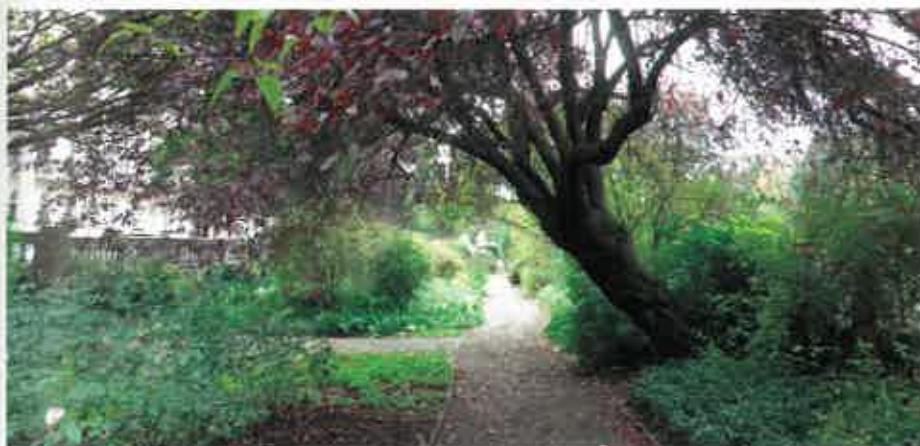
Left: An inward leaning *Prunus cerasifera* 'Pissardii' (cherry plum) that impedes the western path.

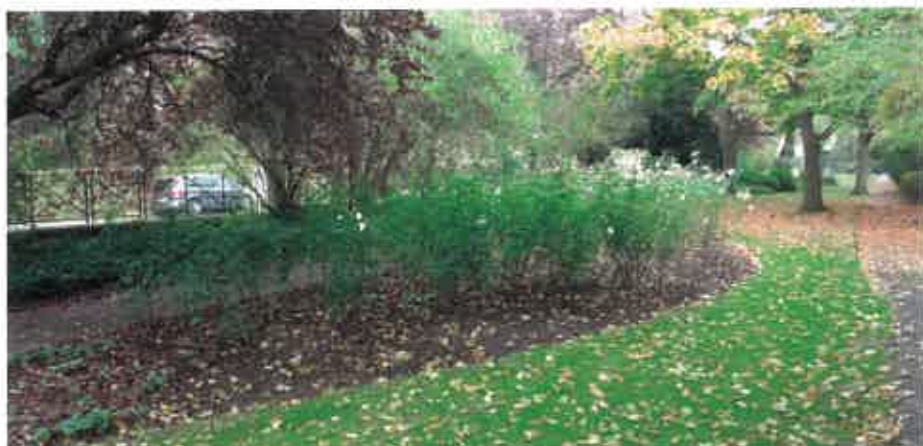
The crescent-shaped planting beds depicted in Mayhew's plans are still present in the garden today, though they have been enlarged over the years.

Right: Shrub and herbaceous planting is mostly well established throughout the garden.

Far Right: Many of the shrubs have become far bigger than they were intended to be, which has resulted in their "leggy" appearance. In such cases, the garden would benefit from the replacement of these shrubs with healthy mature specimens or in some cases, significant pruning to rejuvenate existing shrubs.

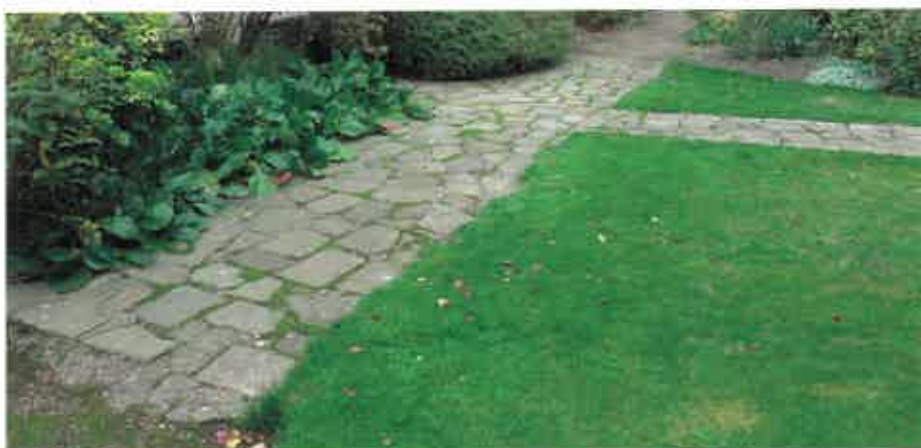
Left: Piecemeal changes to the original gravel paths have resulted in an incongruous mixture of surfaces. Sections of crazy paving are an incongruous addition to the garden that are at odds with the grandeur of the building.

Lengths of path have been replaced in a piecemeal fashion with modern crazy paving, which has resulted in the straightening of the two central crossing paths and an inconsistent surface treatment across the garden.

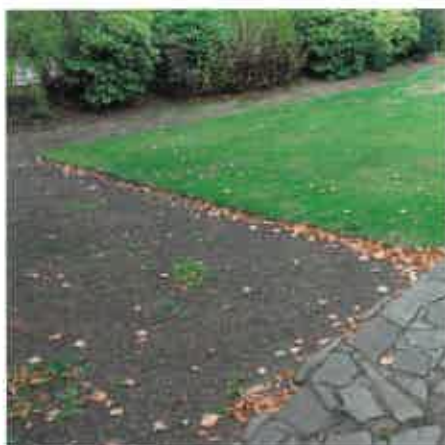
Far left: The existing gravel paths would benefit from resurfacing. Large areas of the path are down to bare earth, which has promoted the encroachment of weeds.

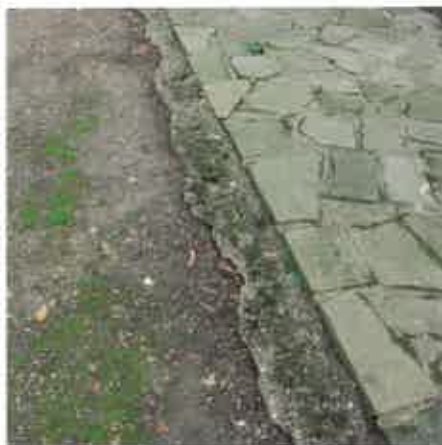
Left: When laid correctly, the gravel surface should cover the haunching to the pavement and form a level threshold to the path surfaces.

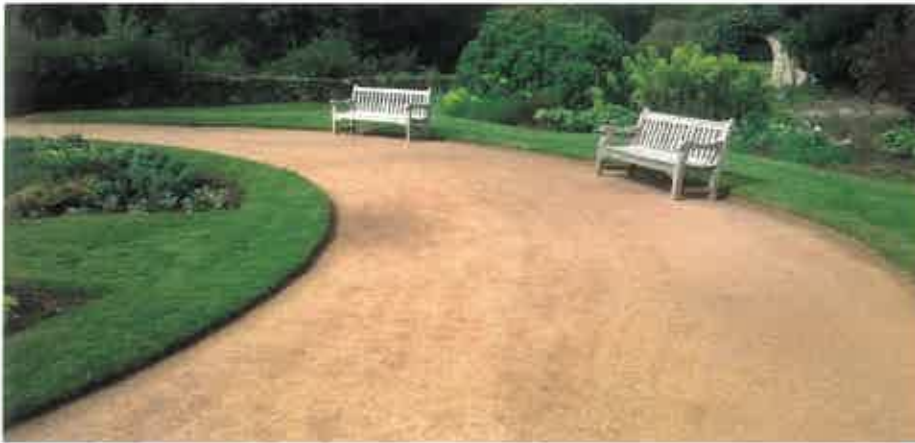
Self-binding gravel (such as that used at Scotney Castle, left) has a low particle size that allows the material to consolidate to form a smooth even surface. It is permeable, though can become less free-draining over time due to the high marl content.

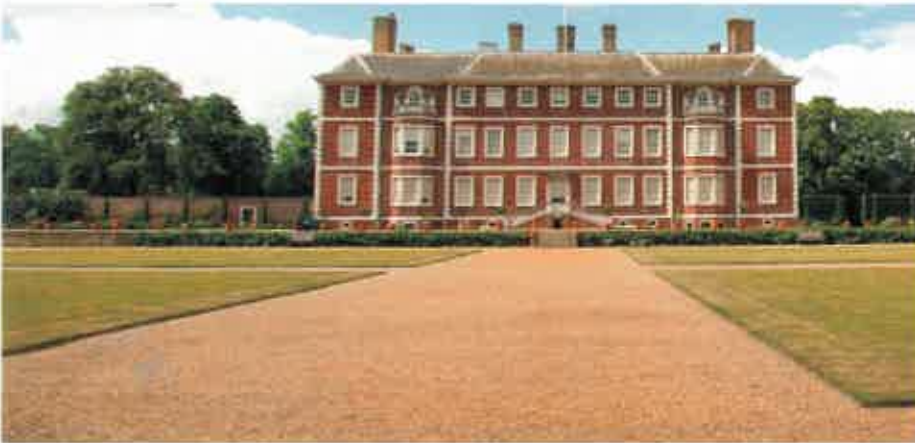
Loose gravel paths (such as those at Ham House, left) are tactile and yielding under foot. Gravel is naturally permeable, and it's drainage properties are more consistent in the long-term than self-binding gravel.

Over time, the underlying sub-base can become exposed, which can be rectified with additional gravel dressing.

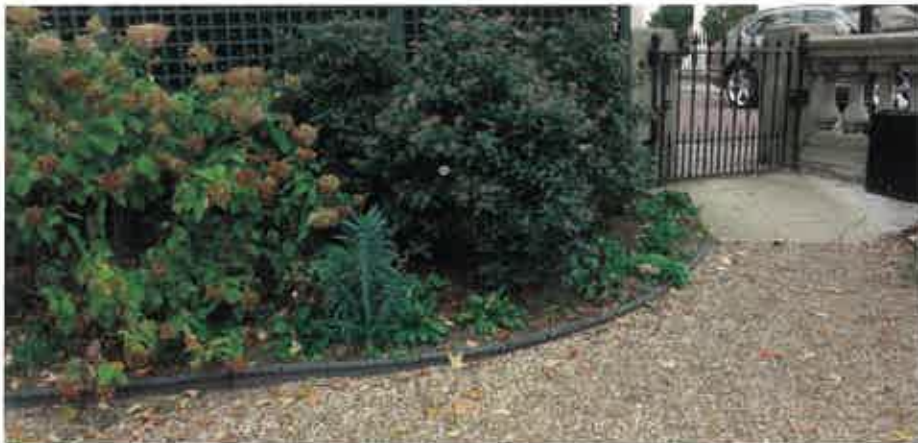
Rope edging is a common feature in most of the terraces and when installed correctly, provides an attractive and practical barrier for vegetation and gravel.

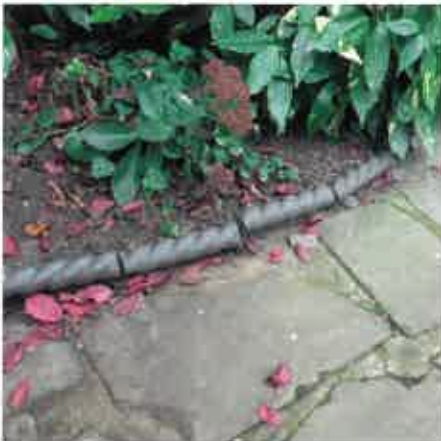
Far Left: Tight curves are hard to achieve using rope edging and therefore it is better suited to straight sections

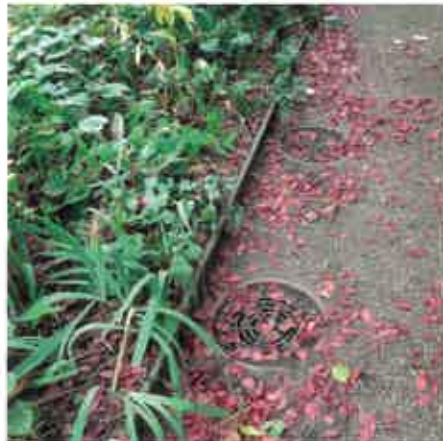
Left: Timber is a low cost option for edging plant beds. Curved sections can be achieved by cutting kerfs into the inside face of the timber to allow the timber to bend.

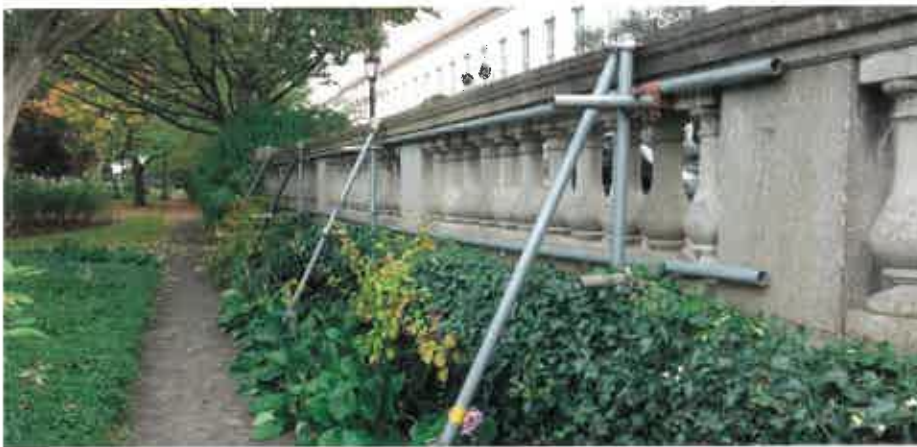
The existing concrete balustrade at Chester Terrace is in a poor state of repair and requires urgent refurbishment to ensure it is structurally sound.

The concrete balustrade on the east side of the garden is at risk of collapse in some sections and as a result a series of temporary scaffolds are in place to strengthen it. Investigations should be carried out into the structural stability of the existing retaining wall to determine the cause of the problems, and ensure there are not further issues effecting the wall itself. There are a number of possible factors effecting the wall, including increased vehicular traffic (and weight) along the carriageway, as well as the possible effect of tree roots on the original foundations.

Following any structural repairs required to the retaining wall, a new composition stone balustrade should be installed that better reflects the original design and materiality. In 2012, a new composition stone balustrade was erected in Cumberland Terrace, which provides a successful precedent for Chester Terrace.

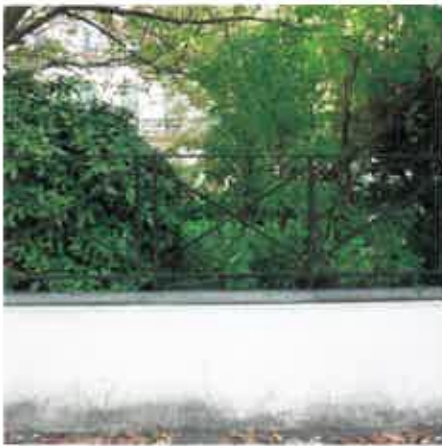
Far Left: The original cast iron railings were replaced in the 1950s with a simple modernist design.

The western edge of the garden is enclosed by a parapet wall and dwarf railings. In the 1950s, the early cast iron railings were removed and replaced with a modern design.

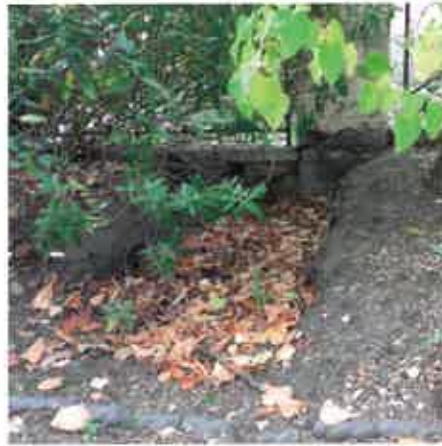
Left: Excavations at the south end of the garden illustrate the original soil level adjacent to the parapet wall.

As the garden has matured, the ground level adjacent to the parapet wall has risen (in part due to soil deposition through new planting). As a result, the boundary wall is now acting as a retaining structure despite not having been designed for this purpose. The additional pressure on the foundations will likely result in structural problems if not addressed.

The soil level on the western boundary wall should be lowered to its original height, which will remove any additional stress currently placed upon it. Following any refurbishment works, new heritage style railings should be installed to match the original railing at the north of the site.

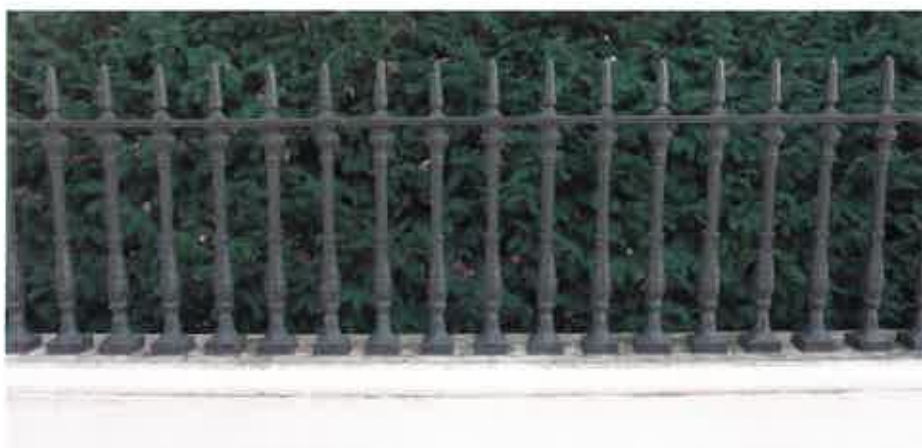
A section of the original dwarf railings are still present at the north end of Chester Terrace.
