Paint Report Revision B

3rd March 2023

GERMAN HISTORICAL INSTITUTE – HISTORIC PAINT INVESTIGATION

ILLUSTRATED PAINT SAMPLE SITES

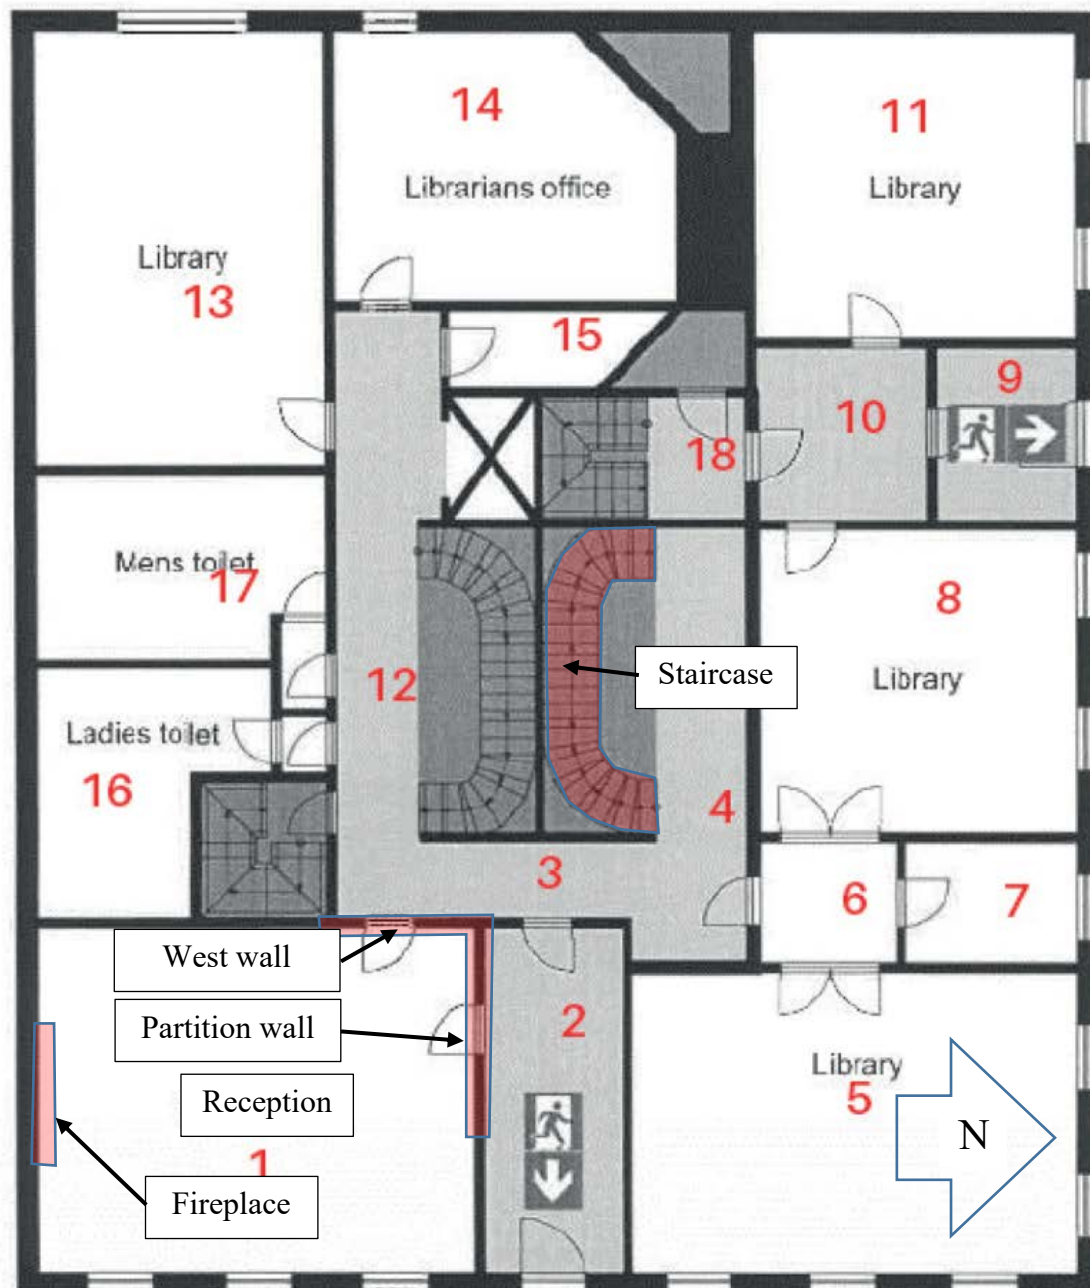
Plan A Ground Floor showing Reception wall and Staircases at the division into two houses

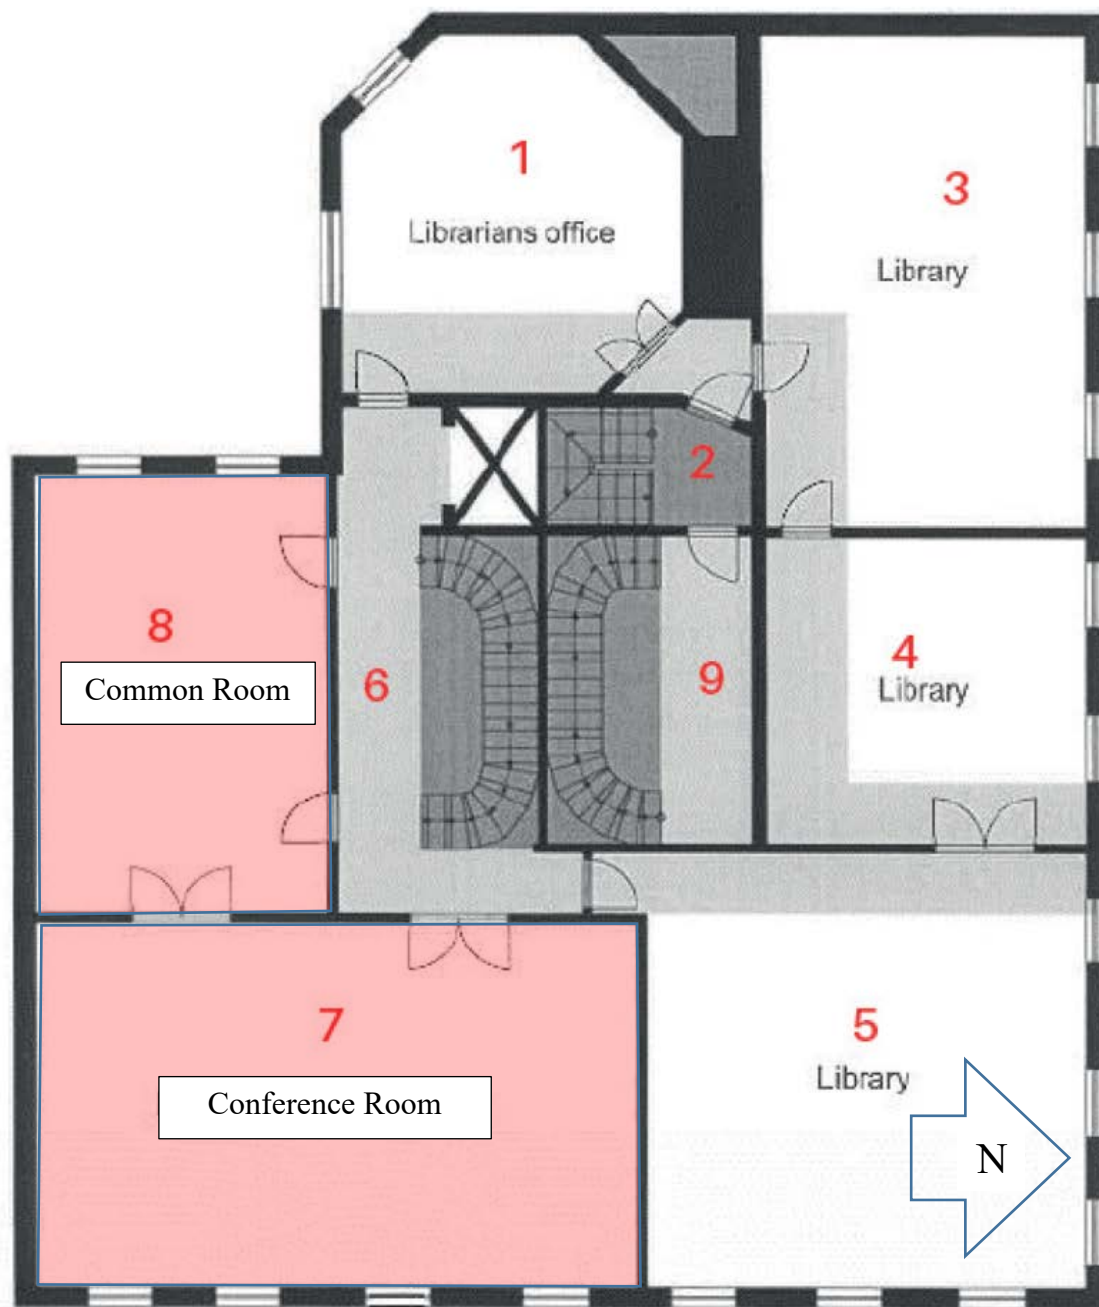
Plan B First Floor showing the two principle rooms of the former southern house.

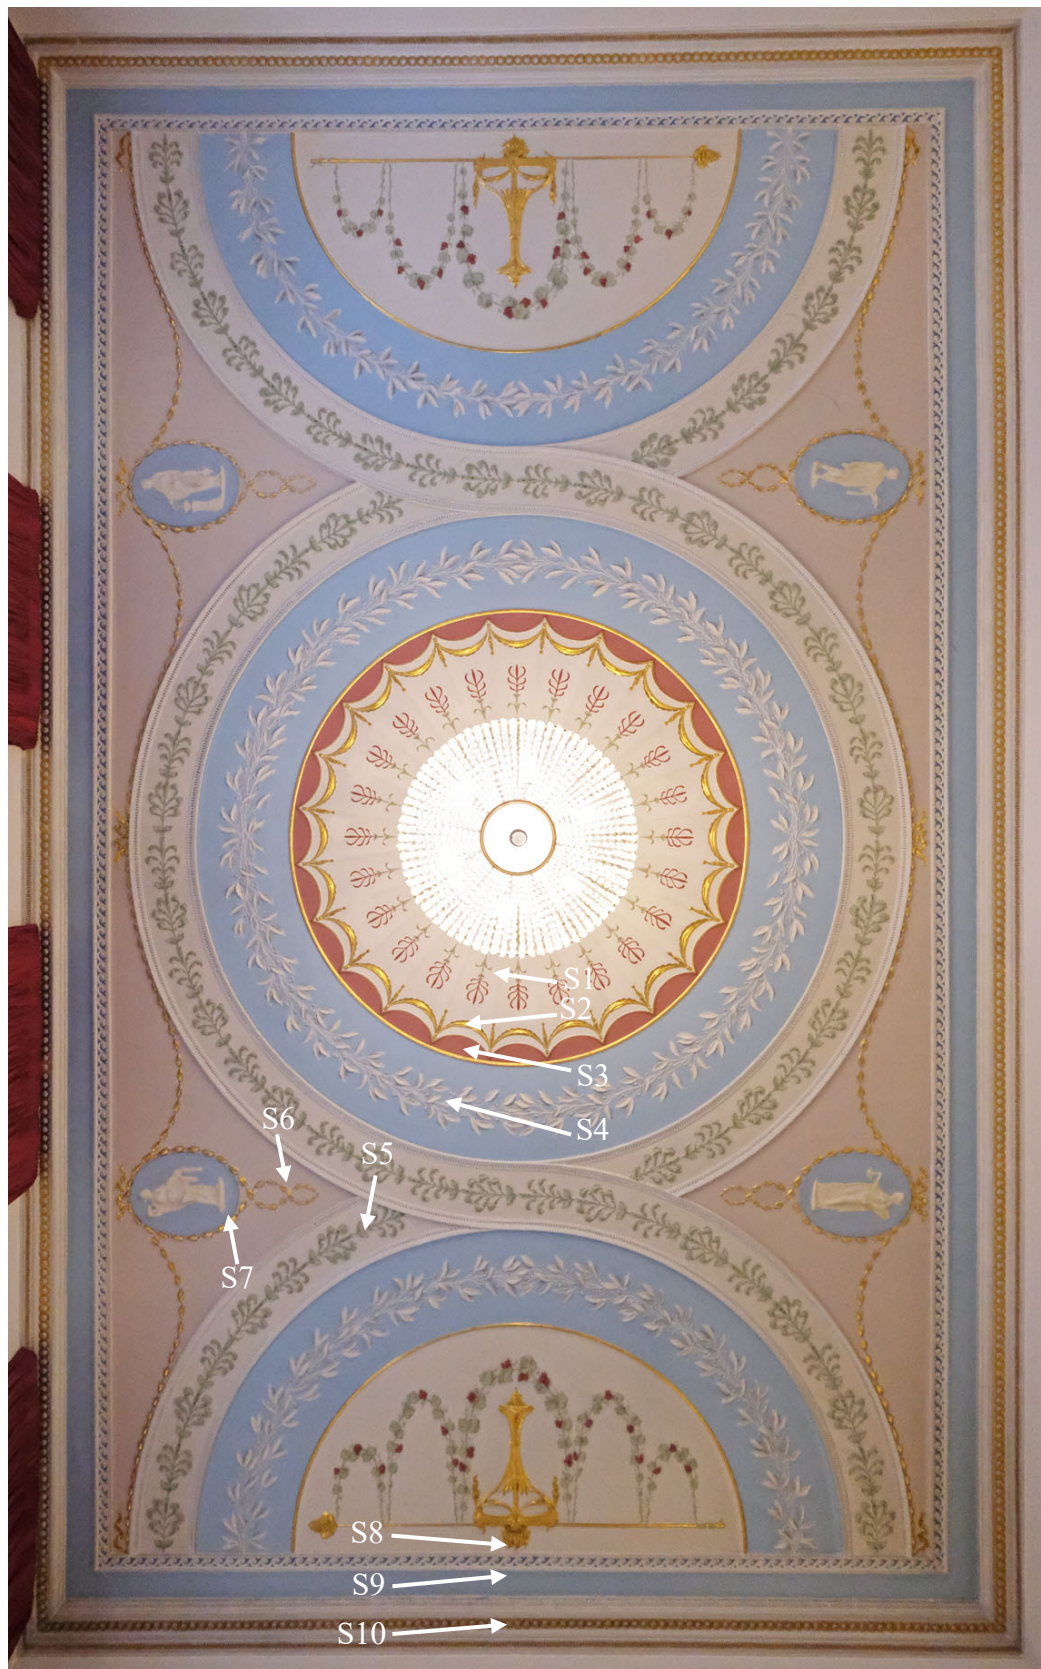
Fig. 01 First Floor Conference Room 1777 decorative plaster ceiling

6.2 Traces were found of the early distemper layers in just one sample S8 caught in a groove of the decorative flame relief. The cross-section shows five or six layers of distemper with one pink scheme and one buff or yellow scheme. (See figs 01, 08)

6.4 No.1: Thinly applied distempers were used to decorate the ceiling with evidence of *white* in S5, S6 and S7 with *Prussian blue* in S8 and S9. (See figs 01, 07, 08)

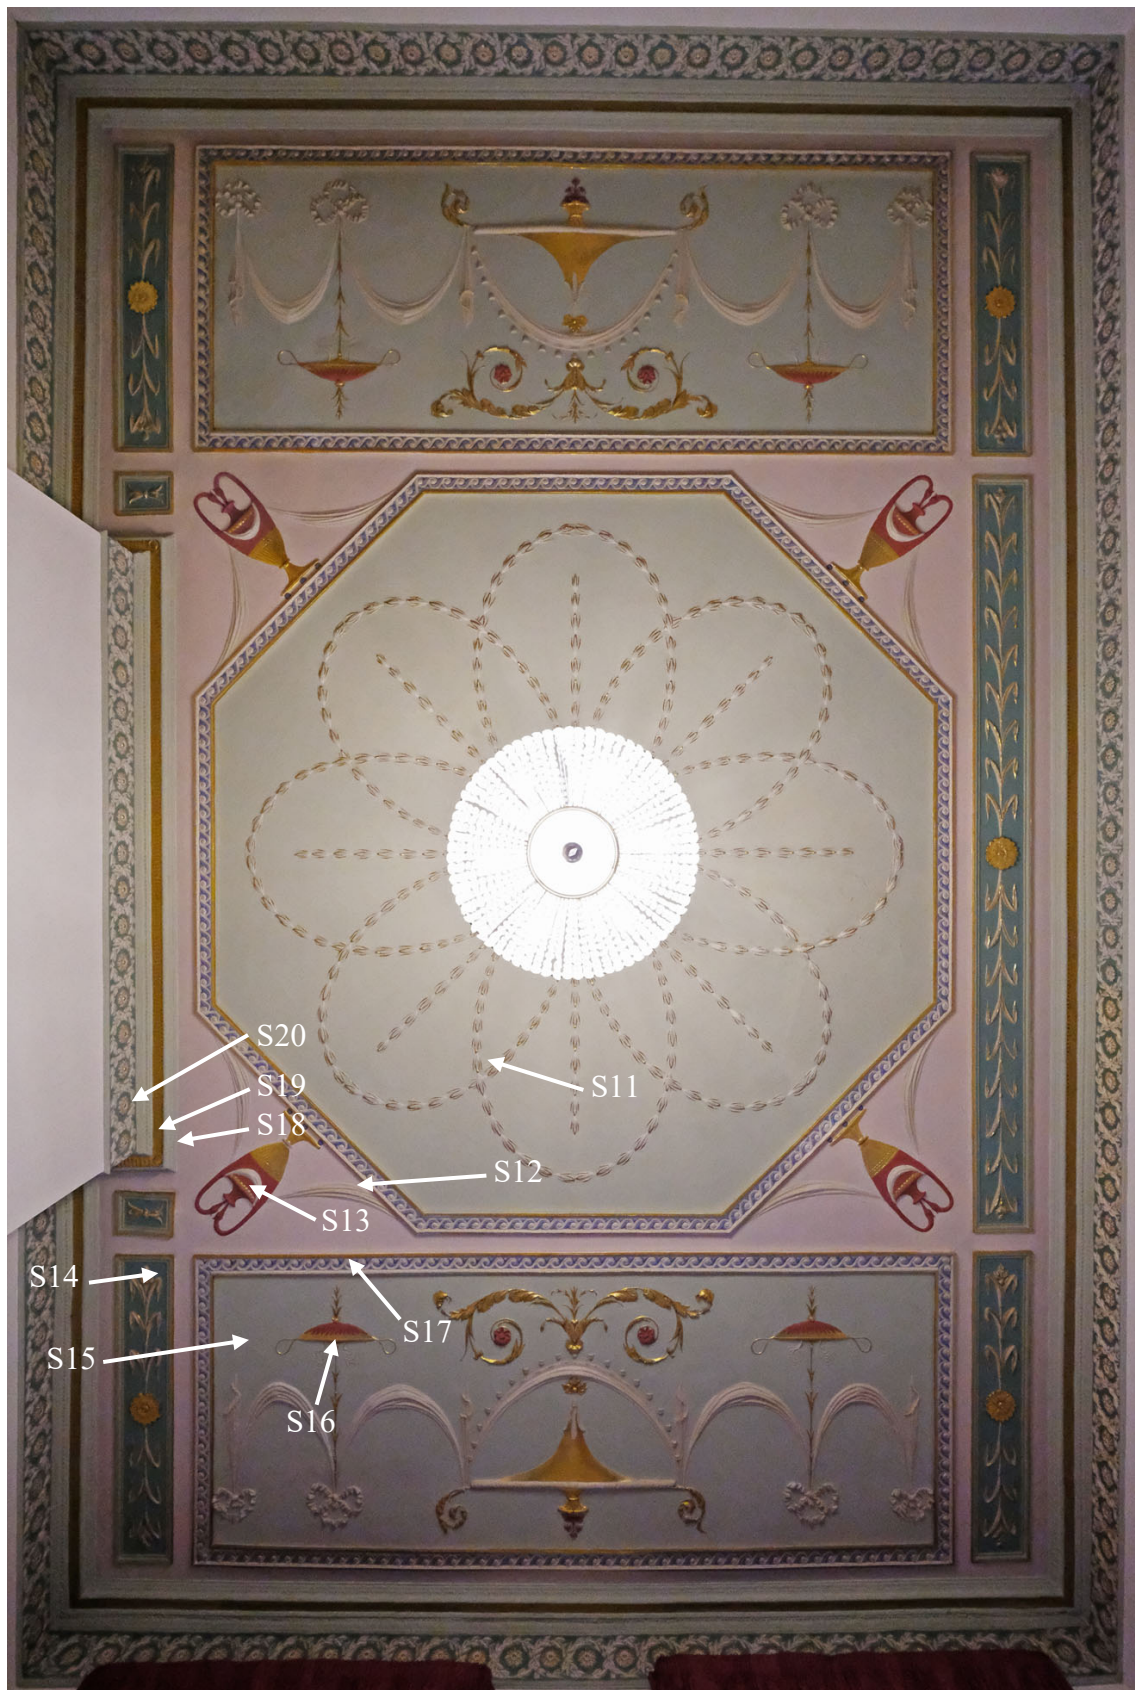
Fig. 02 First Floor Common Room 1777 decorative plaster ceiling

7.3 Remains of distempers were found in several samples most of which were white, but also yellow found in S13. (See figs 02, 13)

7.4 Whites were found in S12, S17, S18, S19. (See figs 02, 12, 17, 18)

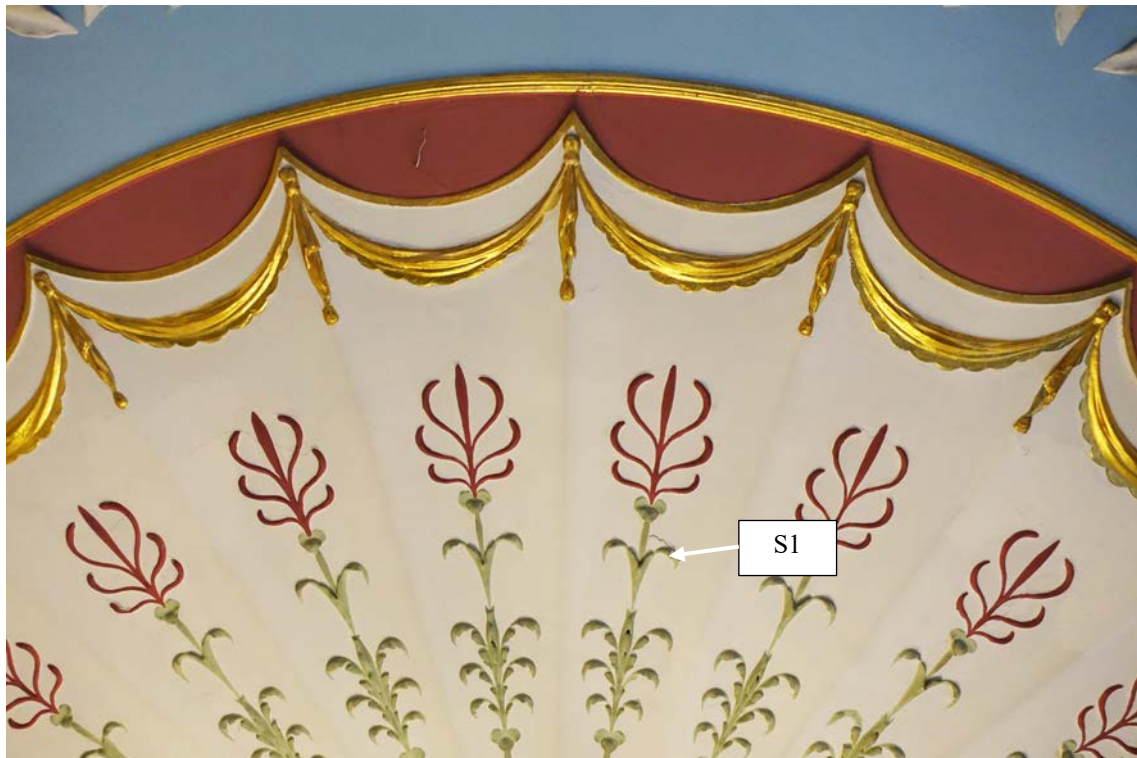
Fig. 05 S1: green leaf and ground

6.6 No.2: A second set of distempers was applied over the first using at least three colours –
Pink tinted with *vermilion* S7 (See figs 01, 07)
Blue tinted with *Prussian blue* S1, S2, S3, S5, S6, S8 (See figs 01, 05-08)
White S4, S9 (See figs 01, 06, 08)

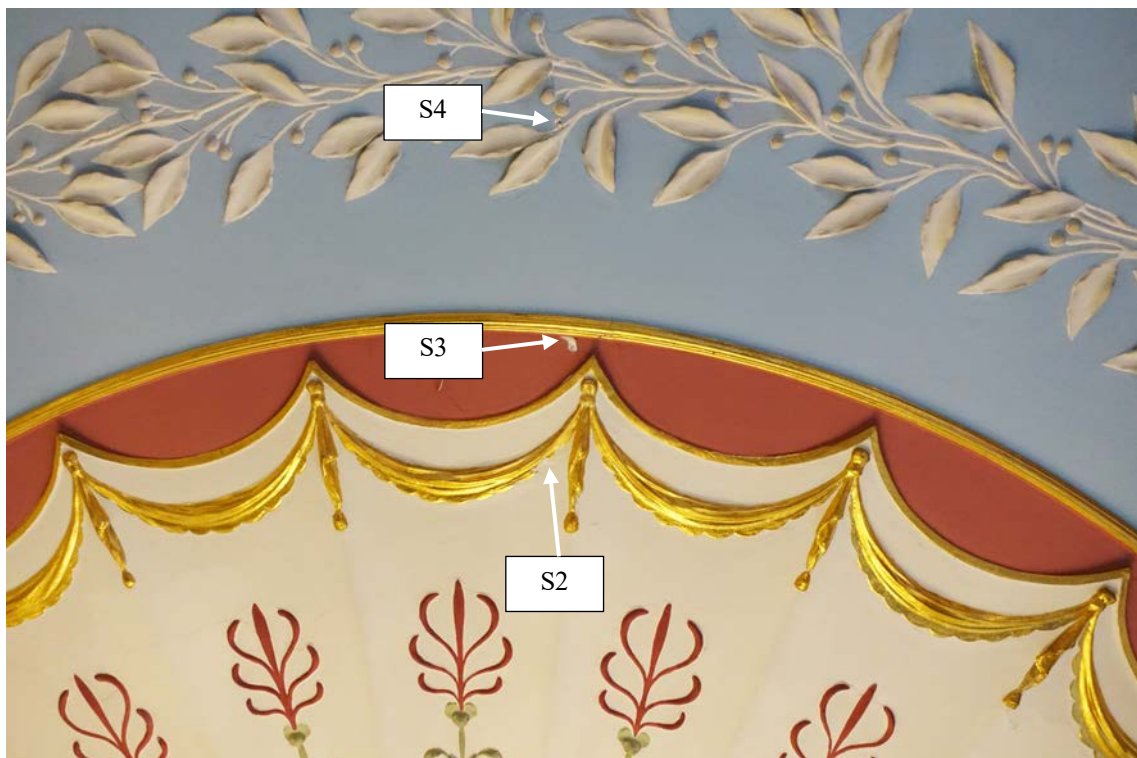
Fig. 06 S2: gilded swag; S3 red ground; S4 leaf stem & blue ground

Change from distemper to oil paints. A pink oil paint tinted with *red oxide* and *red lake* was applied to the whole ceiling S4. (See figs 01, 06)

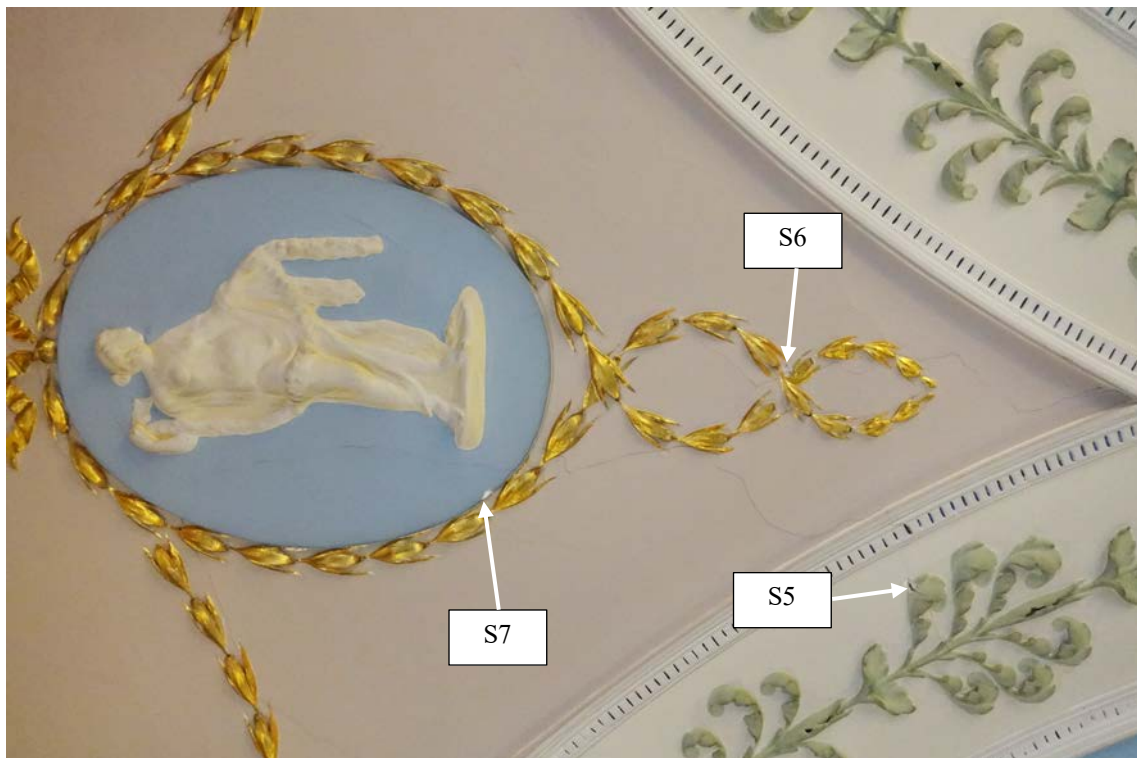
Fig. 07 S6: gilded husk & ground; S5: green leaf & ground; S7: blue medallion edge

6.14 A sealant coat was applied in some areas suggesting instability or loss of some earlier paint layers and then the 1980s scheme was repeated in the same colours. S7 (See figs 01, 07)

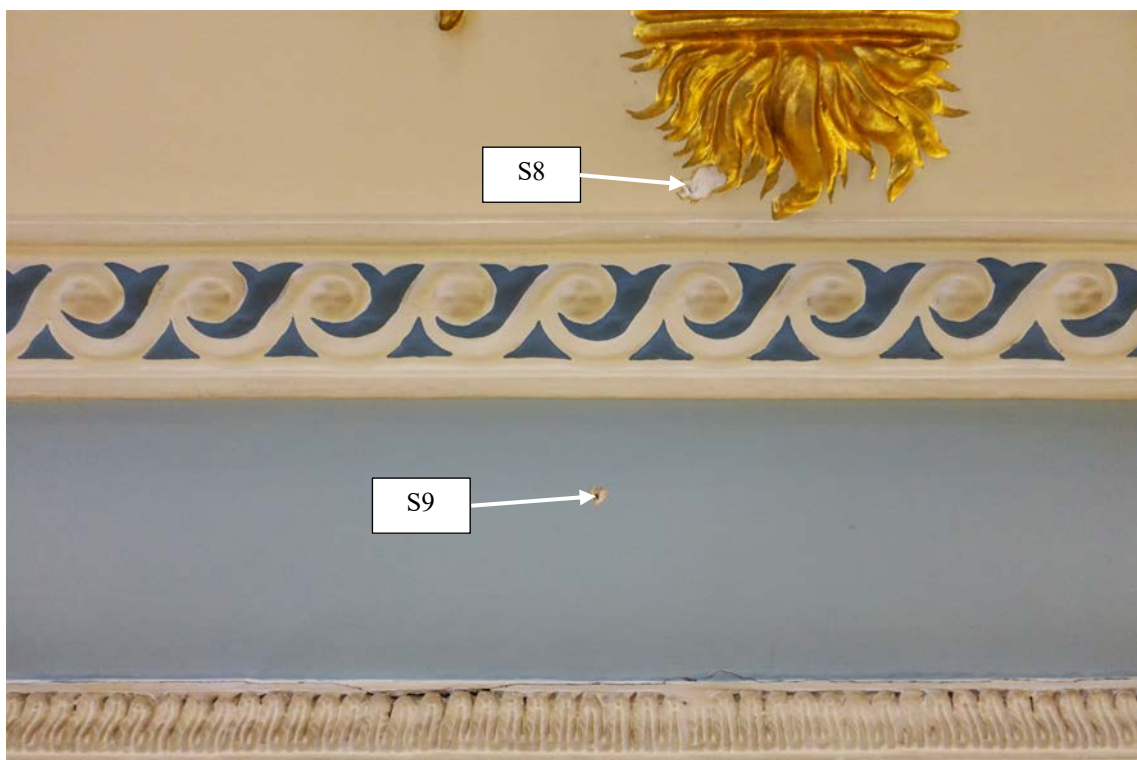
Fig. 08 S8: gilded flame; S9: blue perimeter ground

White oil paint was found on some samples used for the raised moulding. S8, S9 S10.
(See figs (See figs 01, 08-09)

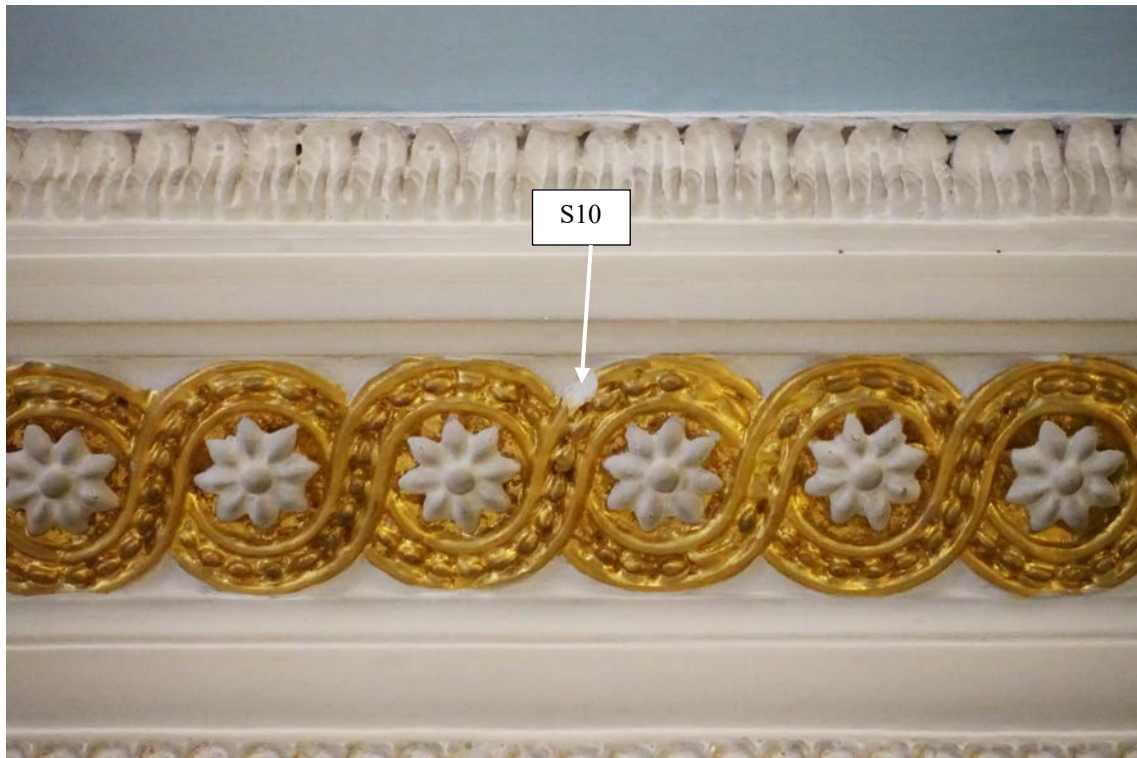
Fig. 09 S10: gilded guilloche band to cornice soffit

6.11 In some areas the earlier paint was cleaned off or lost, S10, but mostly the samples showed a thick layer of cream-coloured alkyd paint containing *titanium dioxide white*. (See figs 01, 09)

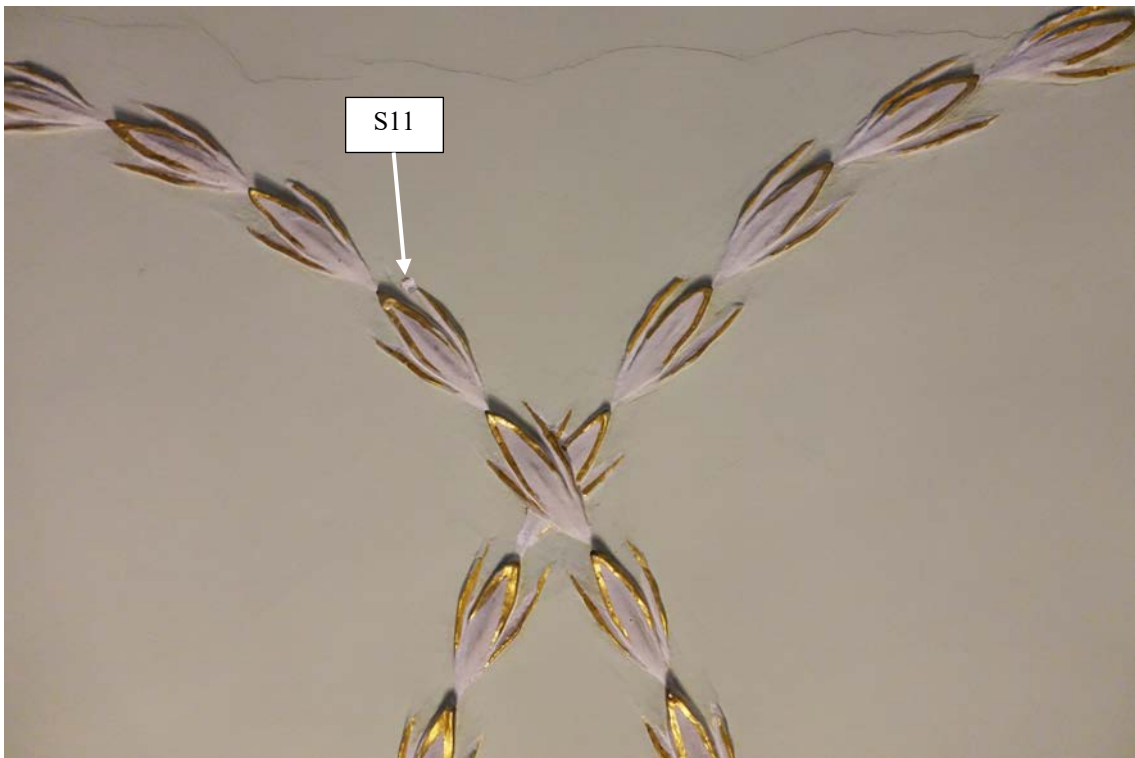
Fig. 11 S11: Husk leaf tip & ground

7.9 White only was found in samples S11, S17, S19 and S20. (See figs 02, 11, 17-18)

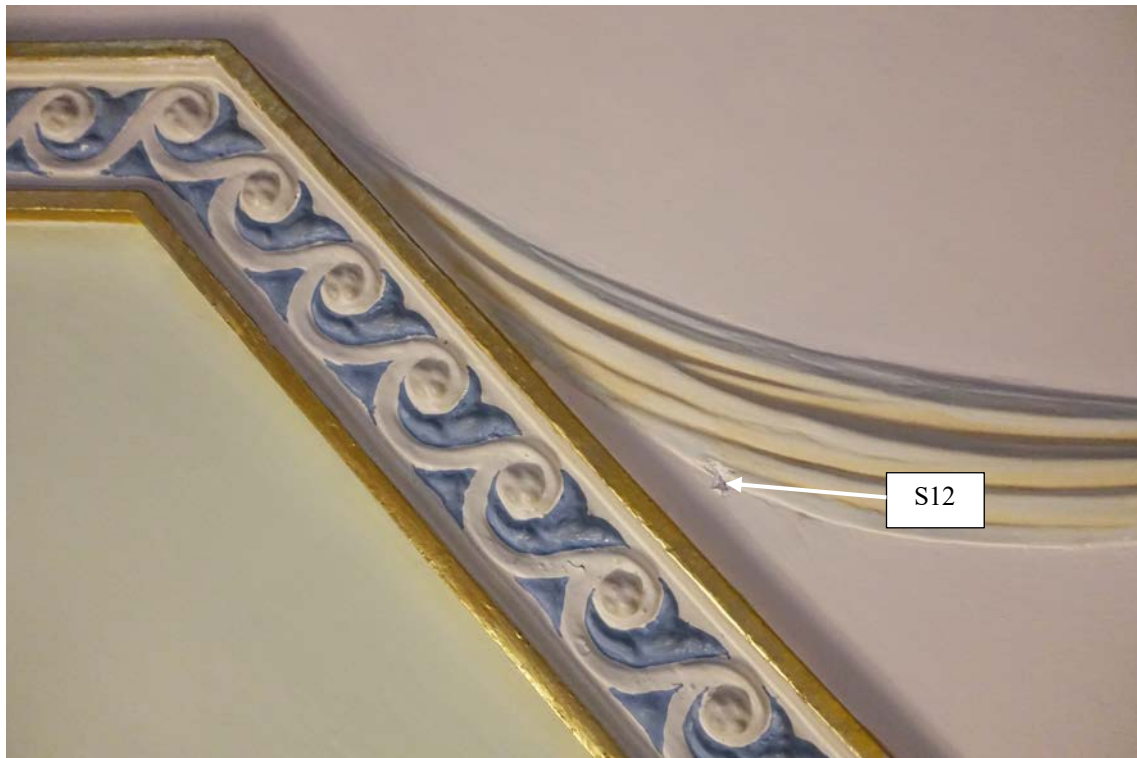
Fig. 12 S12: Swag & ground

7.6 In seven of the ten samples was a *lead white* oil overpaint mixed with *barium sulphate* which was frequently added to *lead white* as an extender in the nineteenth century. It was present in S12, S13, S14, S15, S17, S18, S19. (See figs 02, 12-15, 17-18)

7.8 As in the Conference Room, at some point this ceiling was decorated with distempers. A blue tinted with *Prussian blue* and *carbon black* was found in Samples 12, 13, 14 and 18. (See figs 02, 12-14, 18)

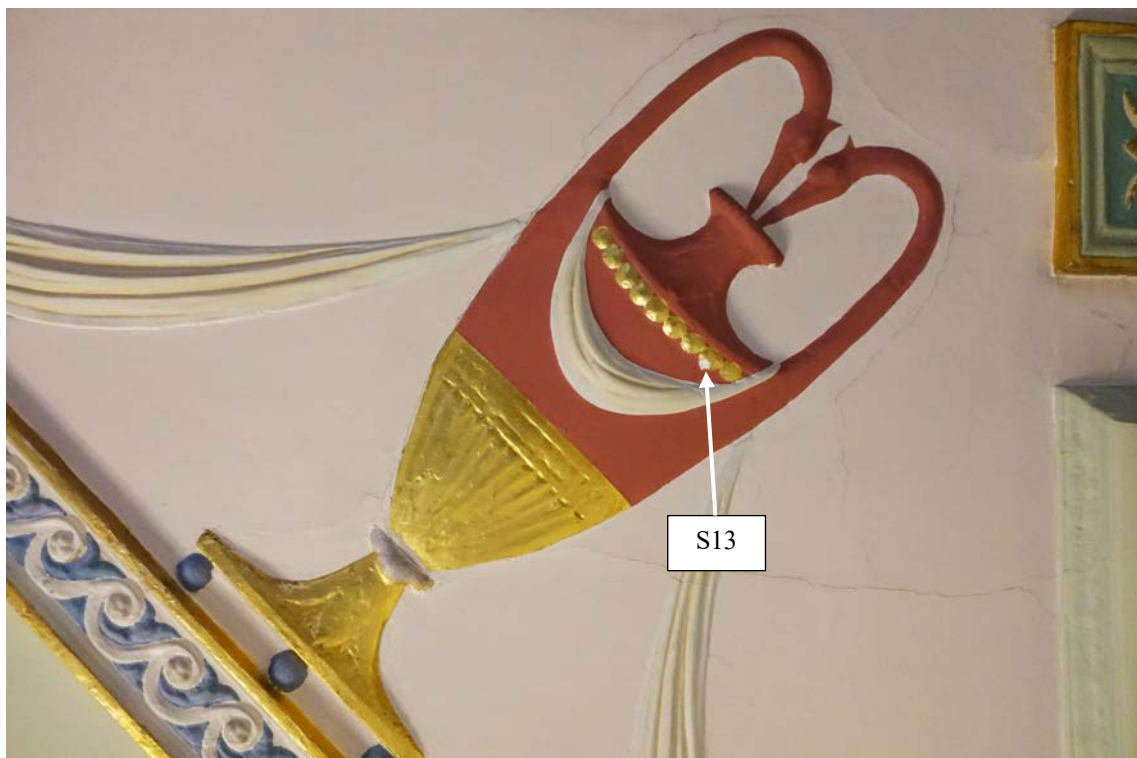
Fig. 13 S13: Amphora gilded bead

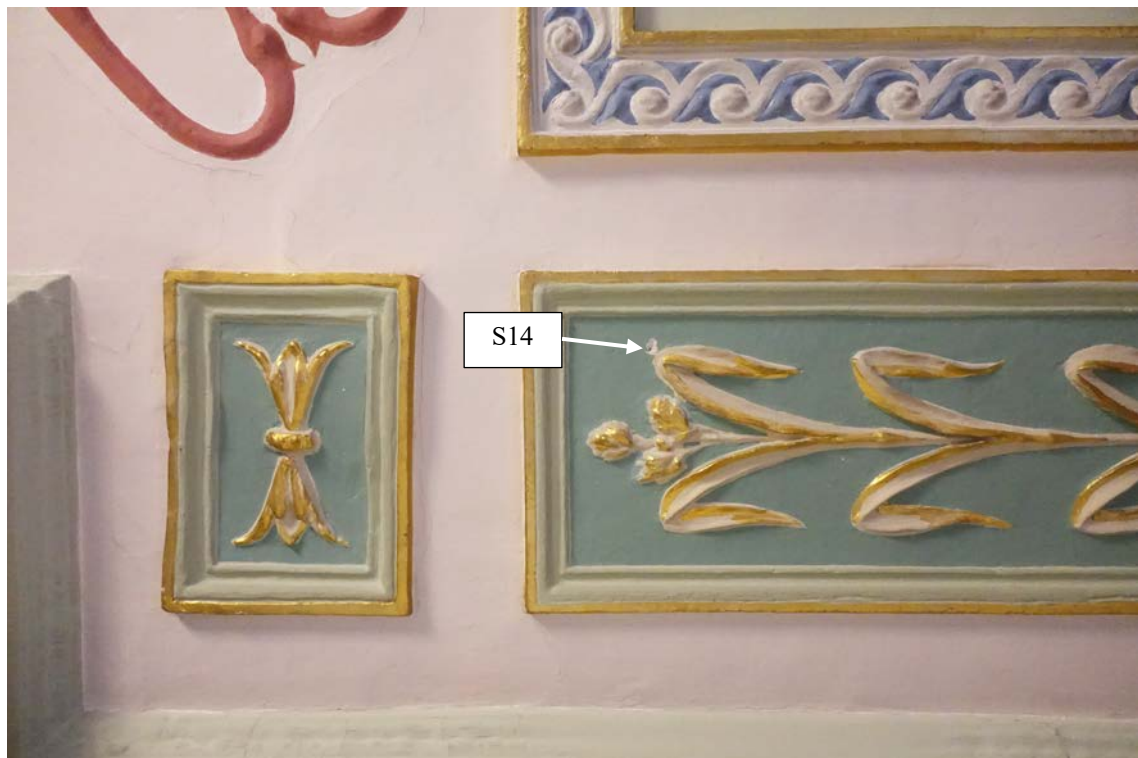
Fig. 14 S14: attenuated panel blue-green ground

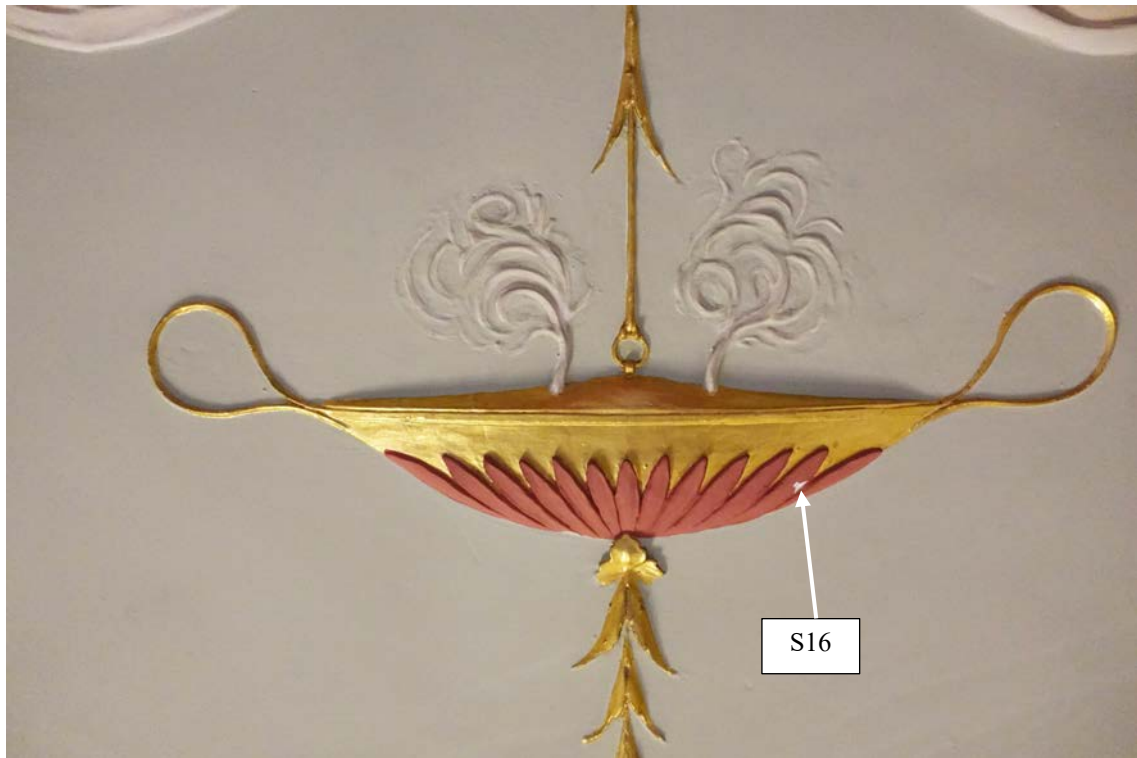
Fig 16 S16: Urn leaf

7.15 In sample S16 there are no earlier paint layers and the late twentieth-century paints sit on gypsum plaster, so in some areas the earlier paints must have been cleaned off.

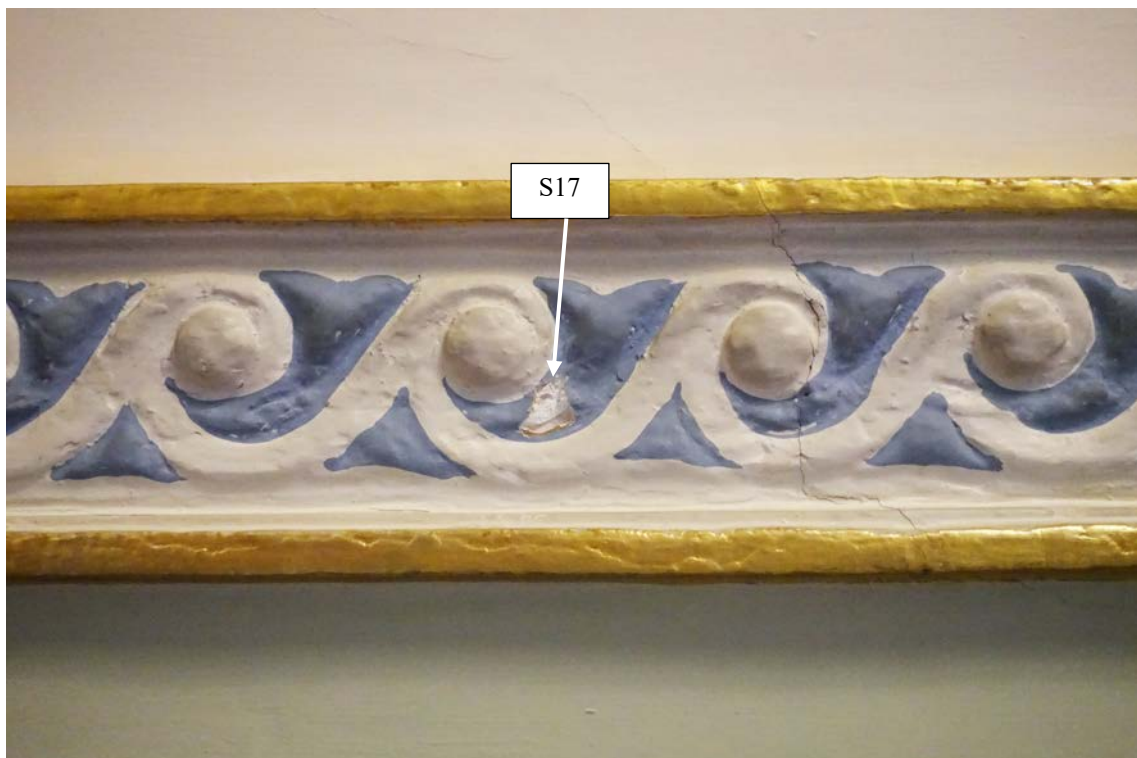
Fig. 17 S17: blue leaf enrichment within Vitruvian scroll

7.11 No.2: In just one sample there is a second coating of white distemper over the first coating S17. (See figs 02, 17)

Traces of a second lot of distemper were found in samples S17 and S19. These may just have been retouching. (See figs 02, 17-18)

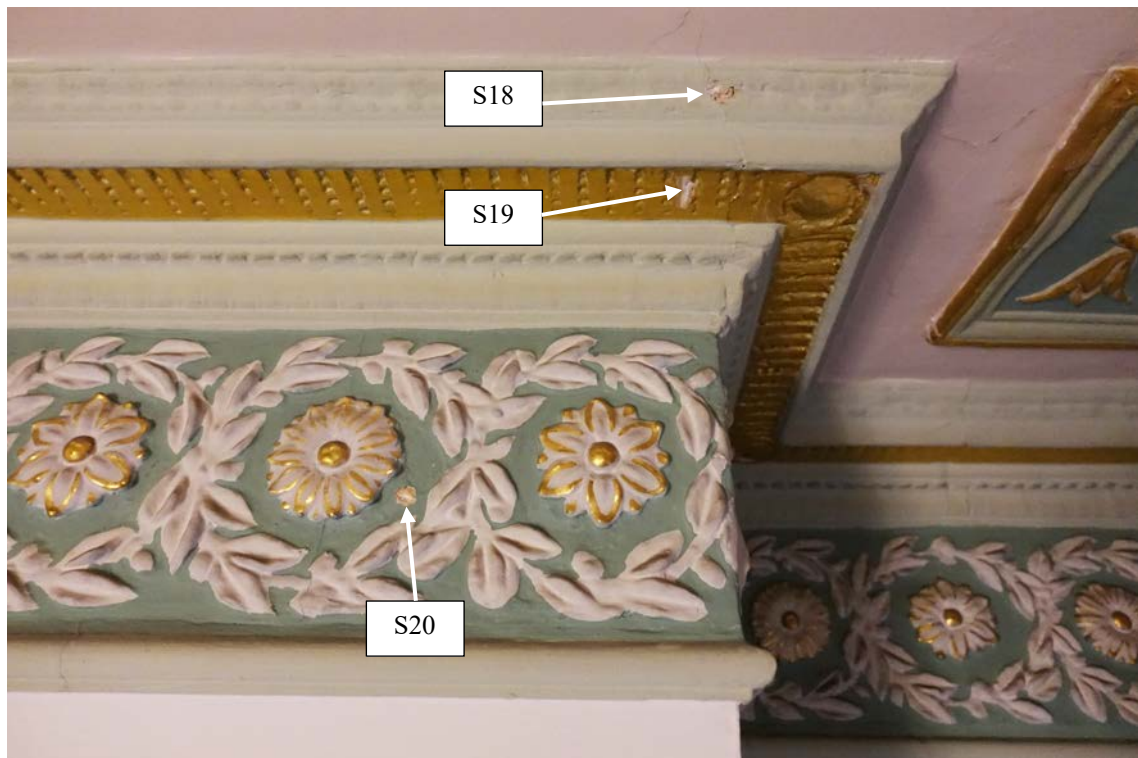
Fig. 18 S18: upper moulding; S19: gilded soffit enrichment; S20: frieze green-blue ground

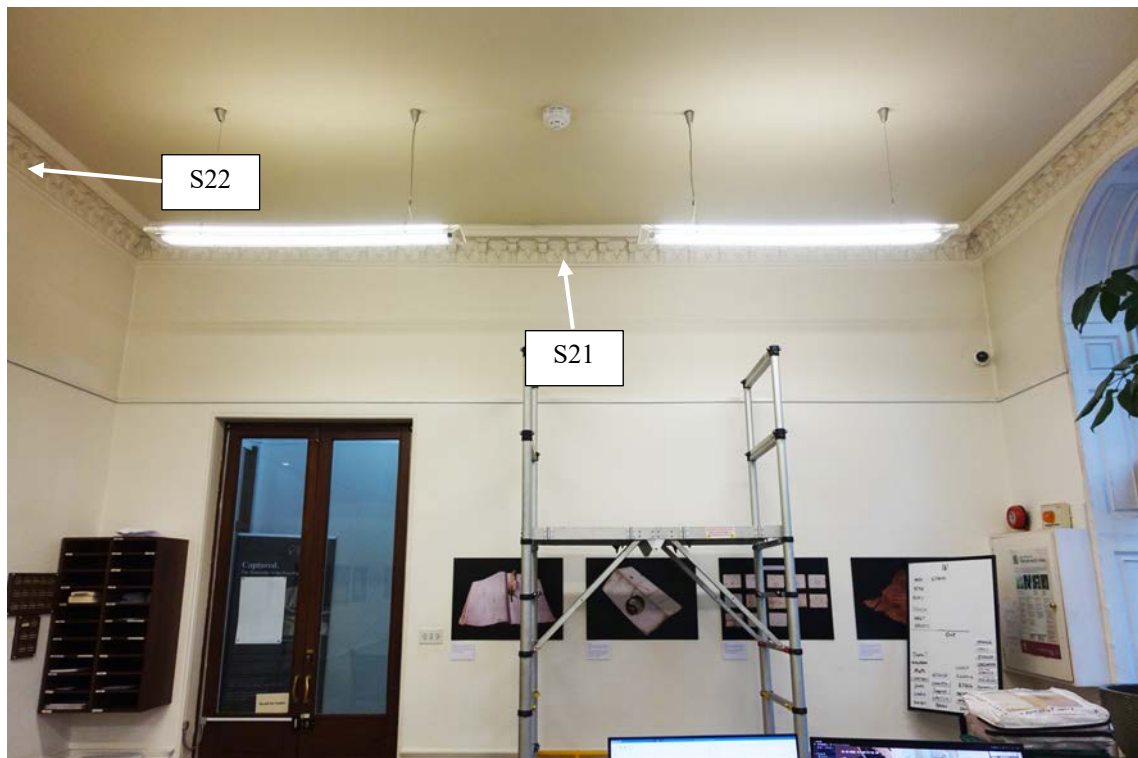
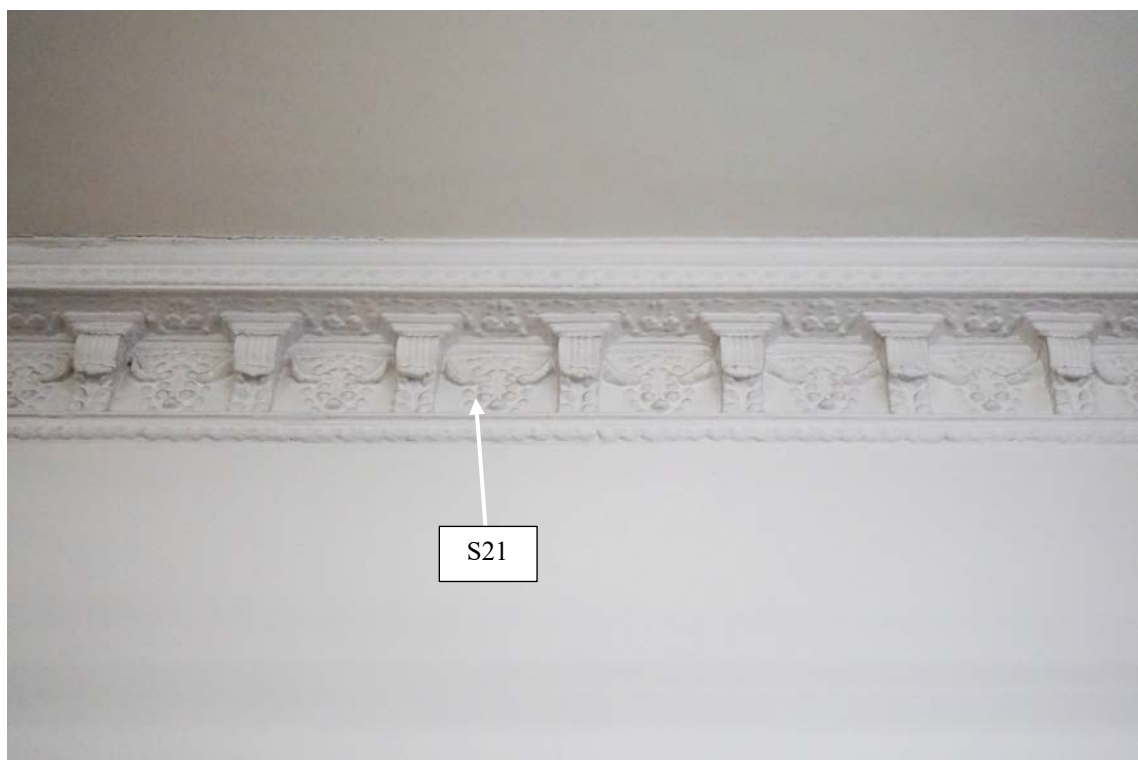
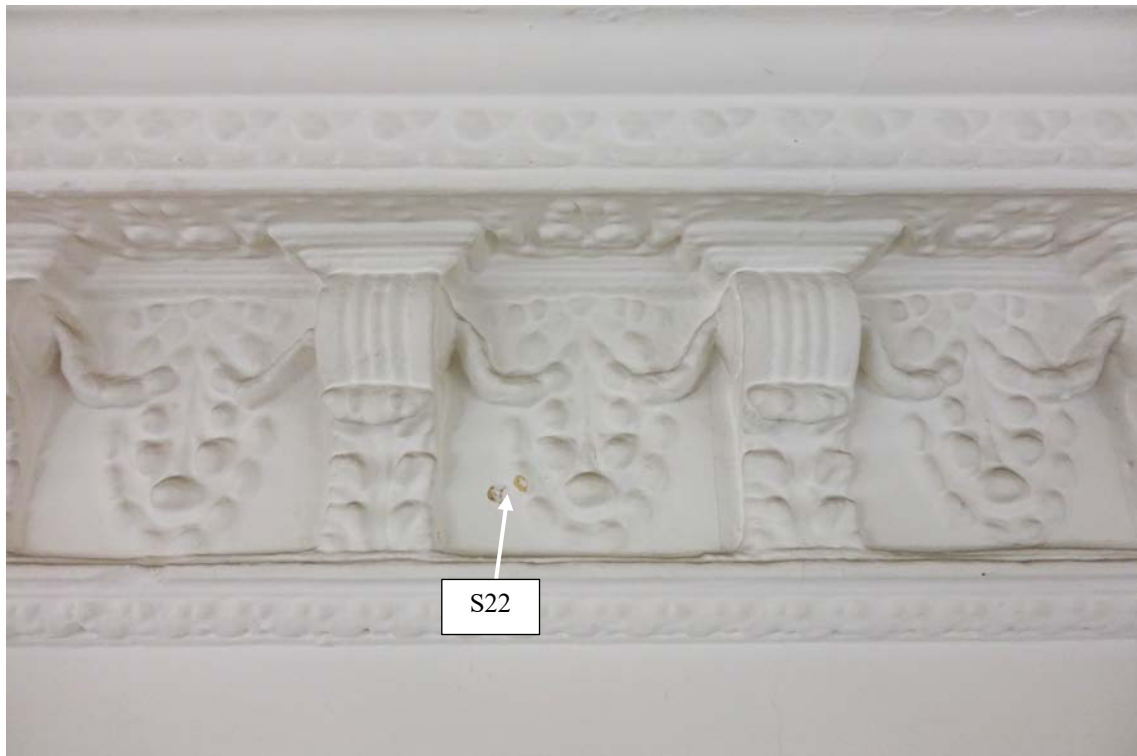
Fig. 19 Ground floor Reception view north towards partition wall

Fig. 20 Entablature on north elevation S21: berry & ground

Fig. 21 Entablature on west elevation S22: berry/ground

8.3 No eighteenth-century layers were found. Exactly the same set of nineteenth and twentieth-century paint layers was present in both samples, so when the north stud wall was inserted, the other wall must have been extant or replastered to match. (See figs 03, 19-21)

8.4 No pre-nineteenth-century paints were present. The earliest two paints in the samples were a pair of green distemper schemes. The first was tinted with a mixture of *Prussian blue* and *chrome yellow*. *Chrome yellow* and *emerald green* were both first available in circa 1814.
