Paint Report Revision B

3rd March 2023

GERMAN HISTORICAL INSTITUTE – HISTORIC PAINT INVESTIGATION

ILLUSTRATED PAINT SAMPLE SITES

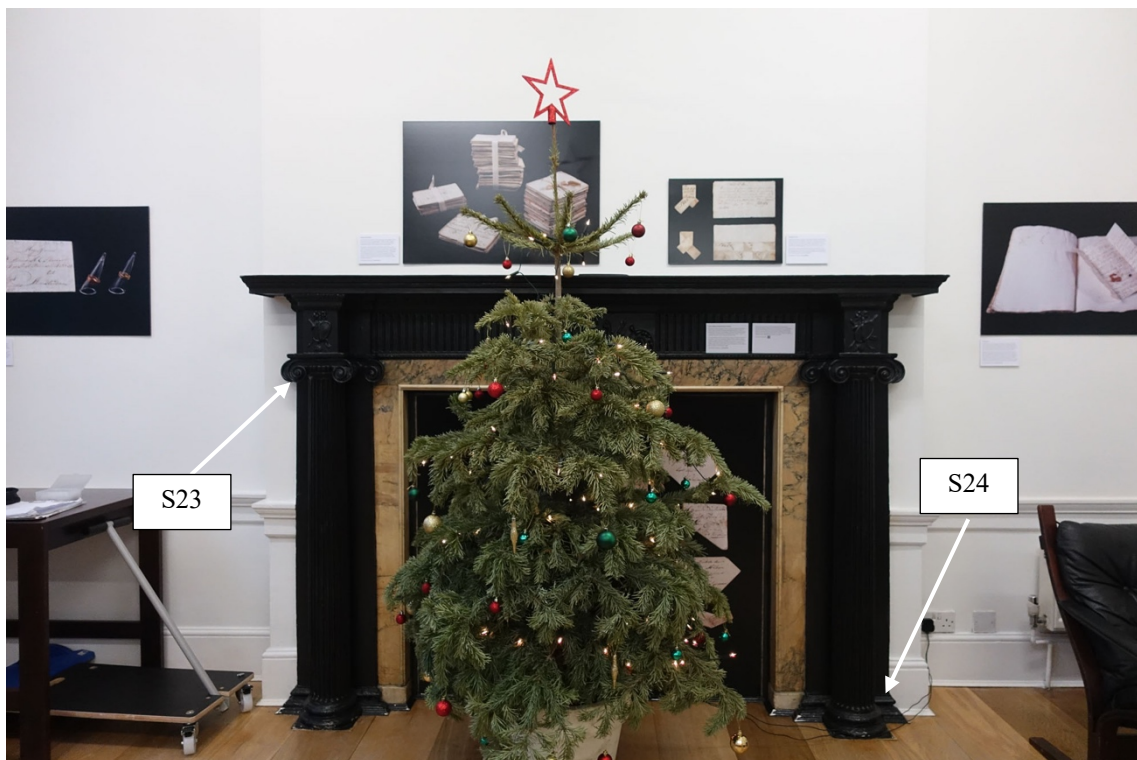
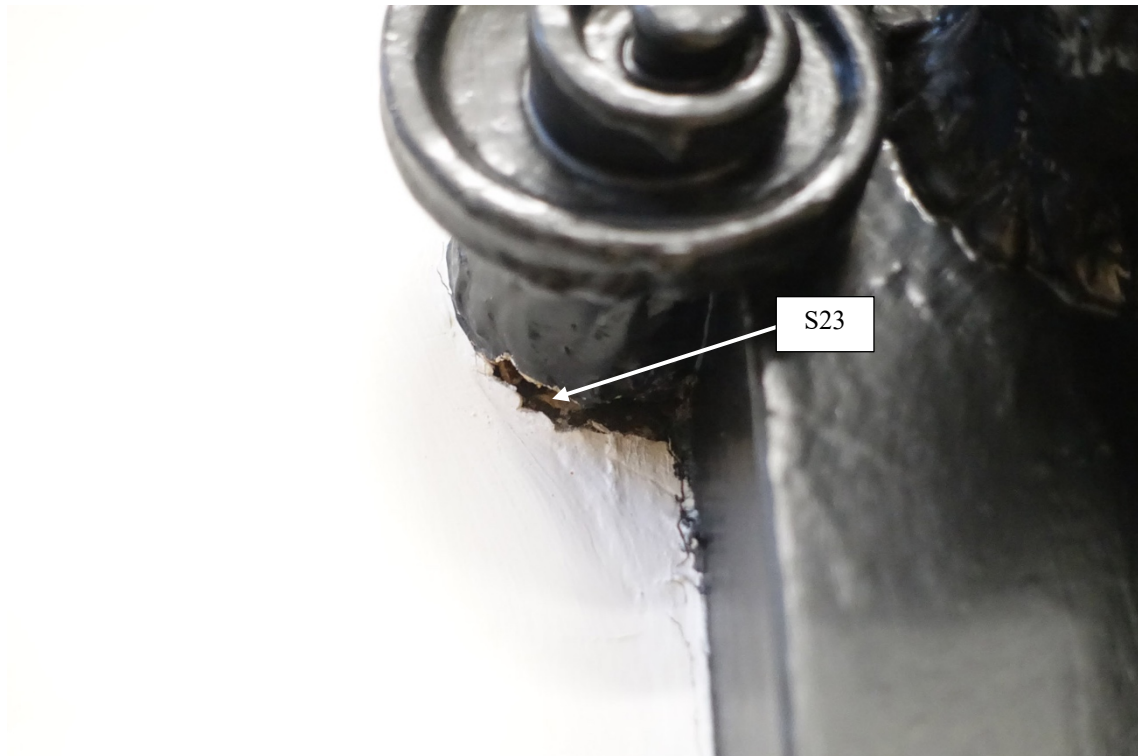
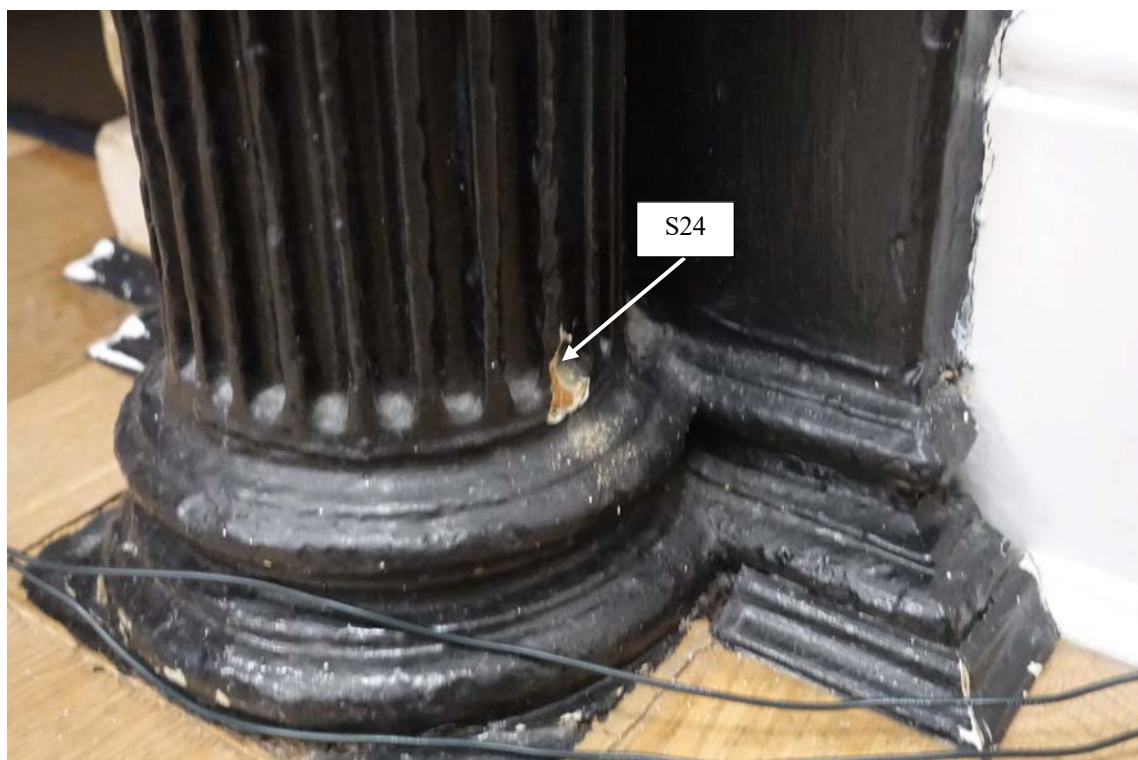
Fig. 22 Fireplace on south elevation of Reception

Fig. 23 Sample from beneath volute of dexter side hard against wall

Fig. 24 Sample from timber fillet

8.6 The wooden fire surround has been painted fifteen times with lead-based oil paint which means it is almost certainly an eighteenth-century feature. If it was installed in 1780, then it was being repainted approximately once every ten years. (See figs 03, 22-24)

8.7 The ninth paint scheme used on this fireplace was a pale green containing particles of *emerald green*. Green using that same pigment was used as a second scheme on the nineteenth-century partition wall. It seems that when the partition was inserted, the room was redecorated and green paint was used for the fireplace as well as for the entablature.

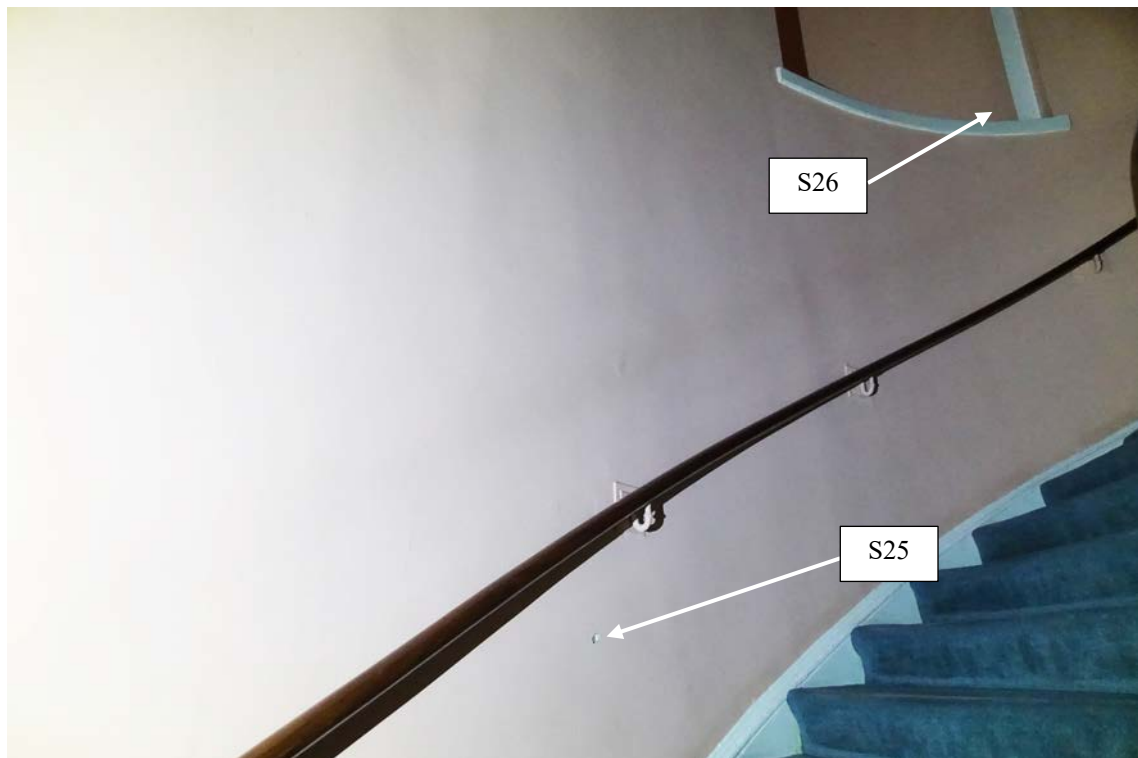
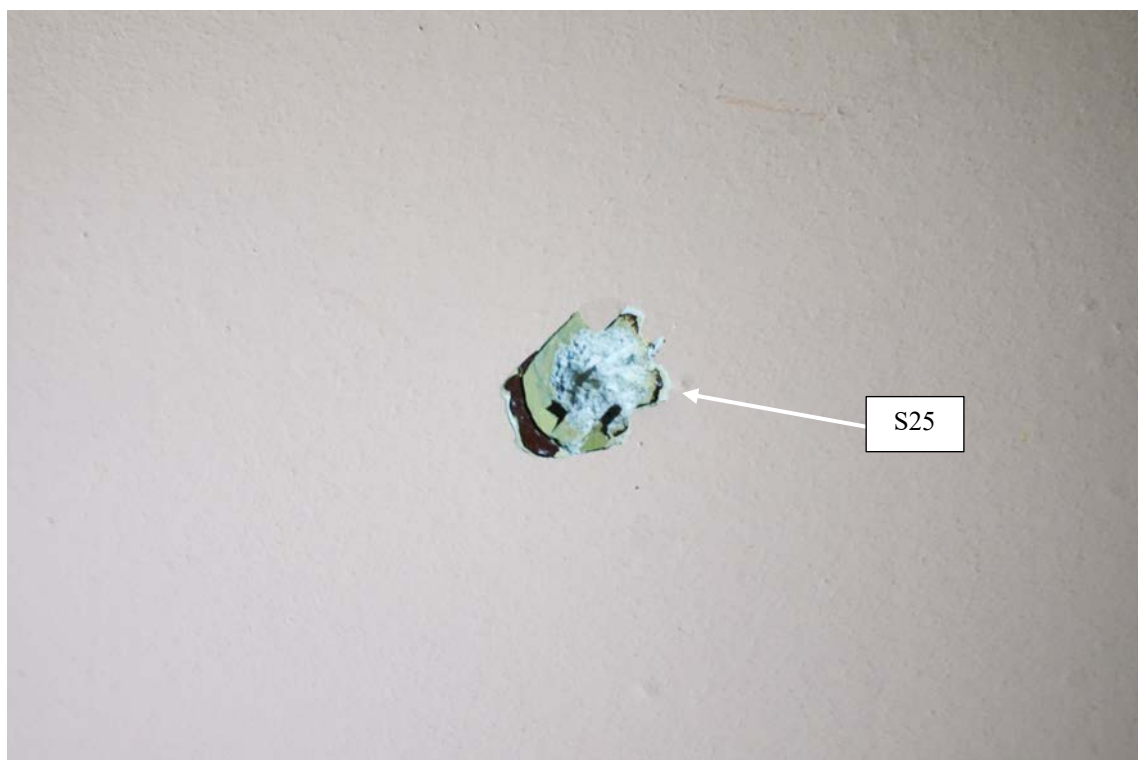
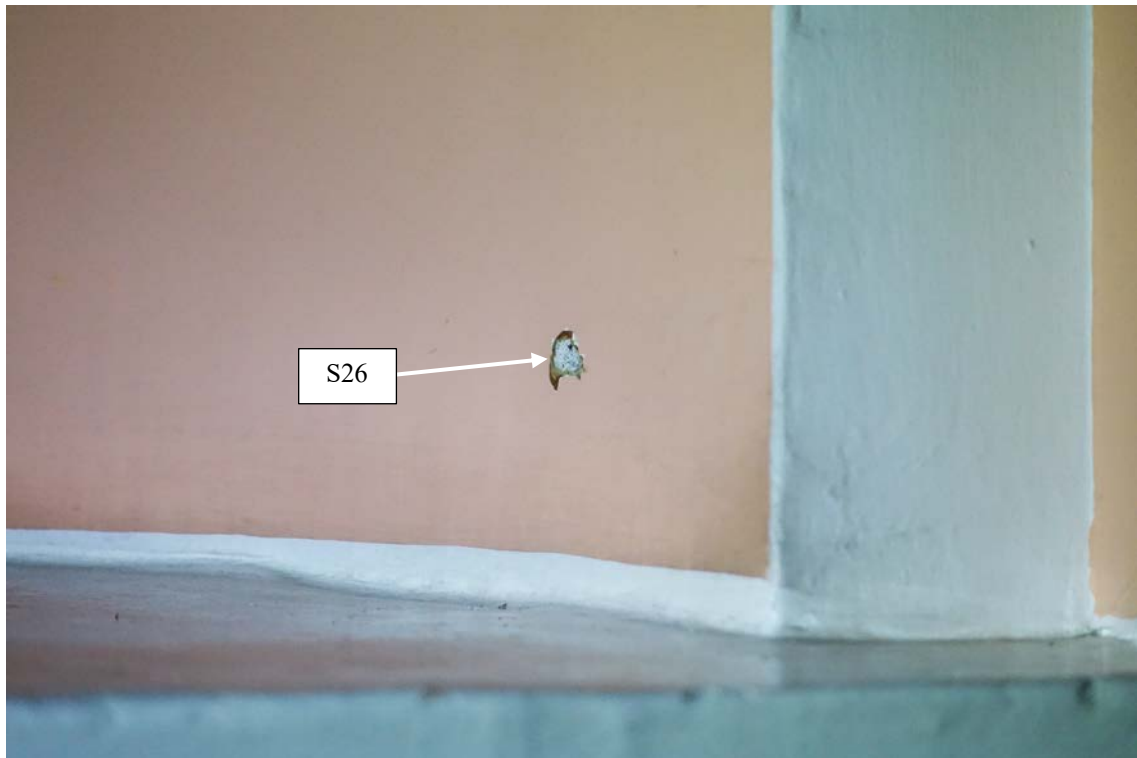
Fig. 25 Cantilevered stairs of former northern house

Fig. 26 S25: from dado included oak graining at a later scheme

Fig. 27 S26: from niche at head of stairs to first floor

9.1 Two samples were taken from the walls of the stairs: one from the back of the niche at the head of the stairs to the first floor, the other from below the present hand rail S25 and S 26. (See figs 25-27)

9.10 No.10: A very dark reddish-brown scheme with varnish on top used for the lower wall, but a paler, pinkish brown used for the back of the niche. Both schemes had varnish over the top and may have been types of graining.⁴

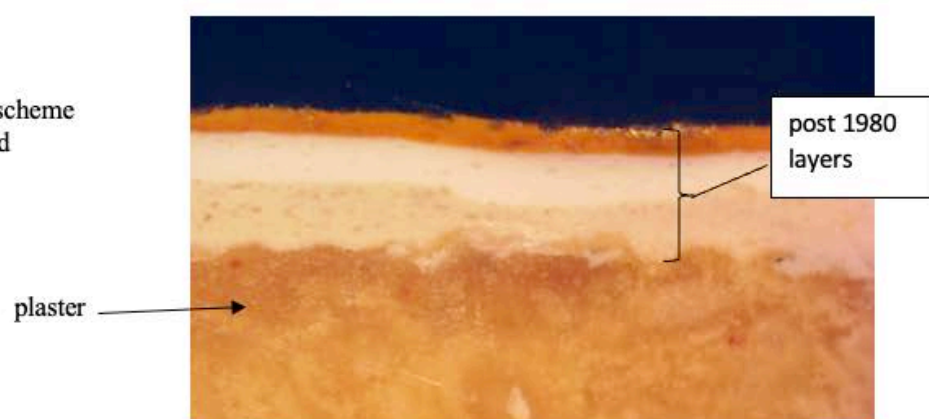
**SAMPLE 10**

The post 1980 gilding scheme rests on bare plaster and all earlier layers have been lost

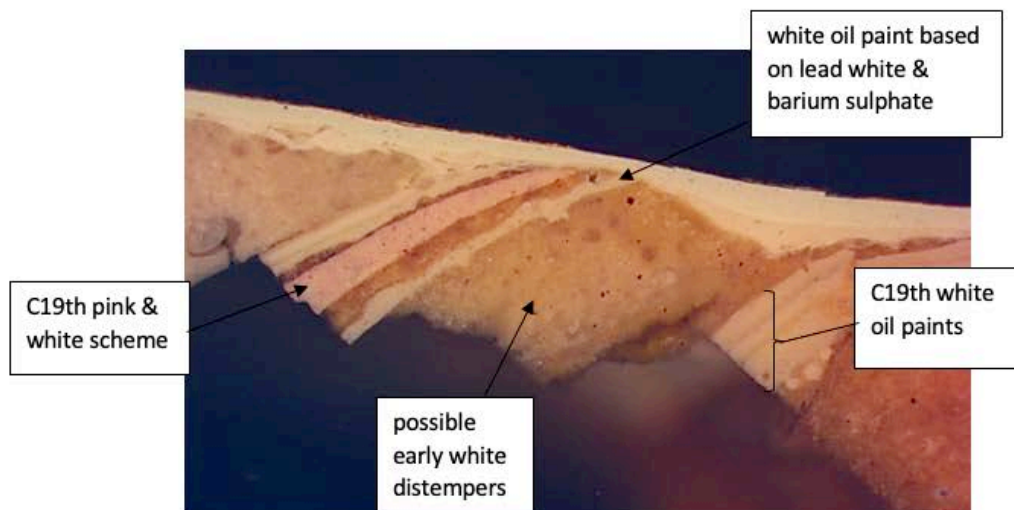
SAMPLE 19

The cross-section shows two loose fragments of C19th layers caught up in the 1980 paint scheme

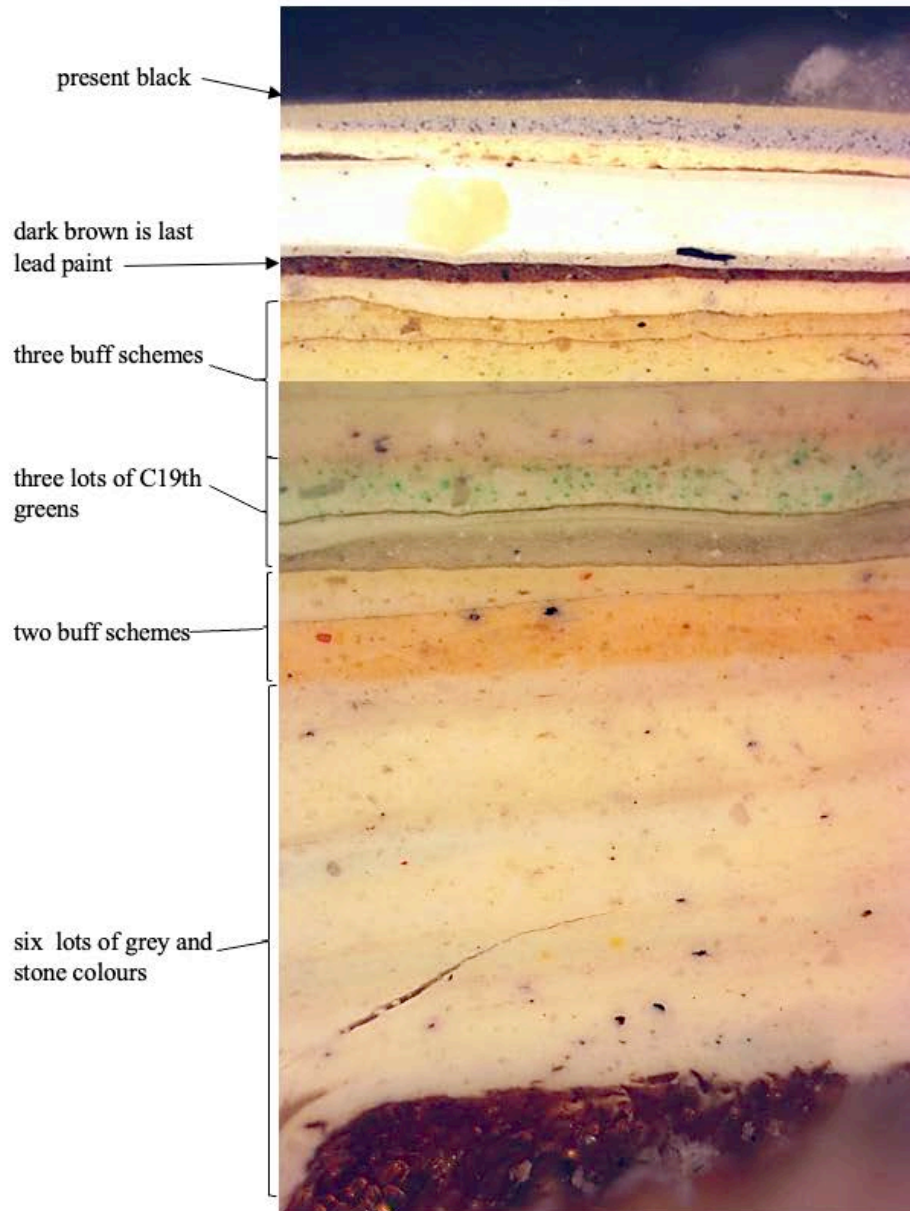
SAMPLE 23

Showing fifteen lots of lead-based oil paint under the modern layers.
