**PLANNING**

PROJECT  
**6 Primrose Hill Studios  
LONDON NW1 8TR**

DRG.TITLE  
**EXISTING & PROPOSED  
FRONT ELEVATION**

DRG.No.	REVISION
BBC-0791-P02	C

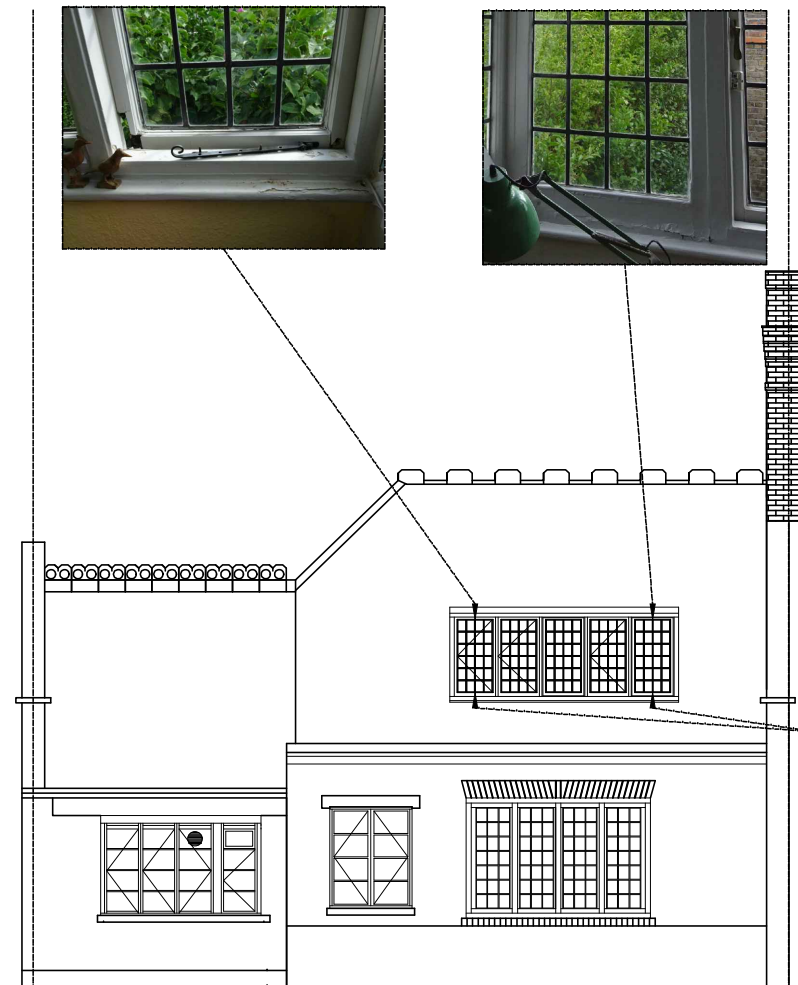
**PROPOSED FRONT ELEVATION  
No. 6 PRIMROSE HILL STUDIOS**

**PROPOSED REMEDIAL  
REPAIRS**

Two rotten timber casements are to be replaced with timber to match with the existing casement. The existing leaded lights are to be retained and installed to the new casements.
