The Hall School Charitable Trust

The Hall Senior School  
Camden

Preliminary Ecological Appraisal review

November 2022

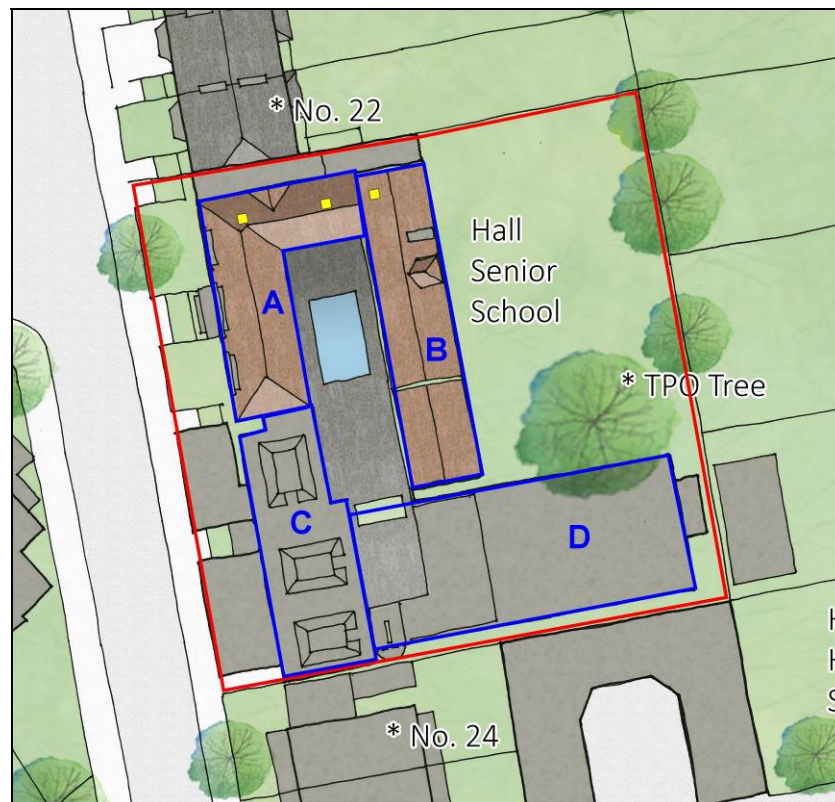
Fig 2 The Hall Senior School site, showing the building layout. The small yellow squares mark the location of the hatches by which the roof voids were accessed.

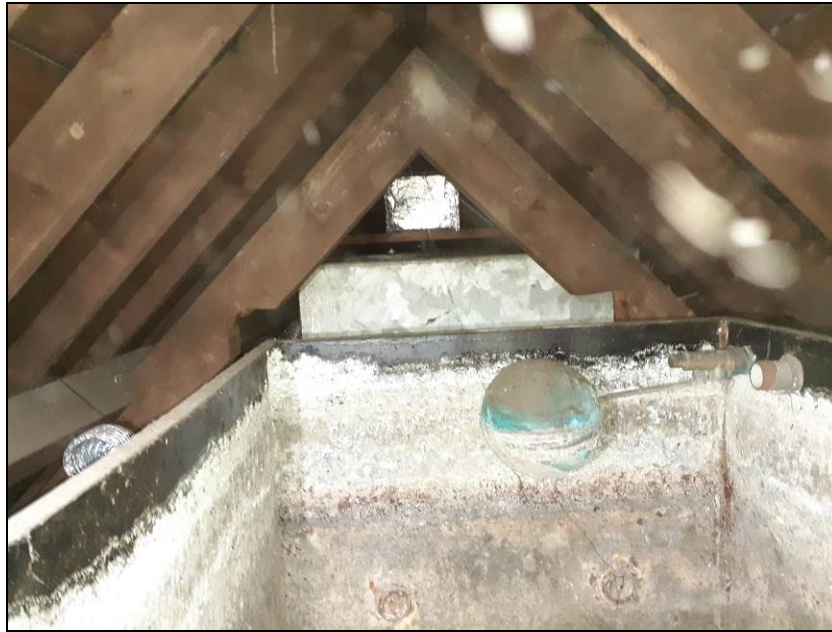
- 3.4. The pitched roof void of Building A was accessed by two hatches at the northern end, and is of sufficient height in which to stand. Despite the presence of water tanks within the northern end (see 2019 PEA, Section 3.5), it was still possible to crawl past the tanks to access the eastern gable end (a typical location for bats to occupy; Fig. 3), and access to the rest of the roof void was possible via a second hatch.

Fig 3 View of roof void within northern part of Building A (looking west from the eastern gable). The water tank in the foreground is empty and showed no evidence of bats

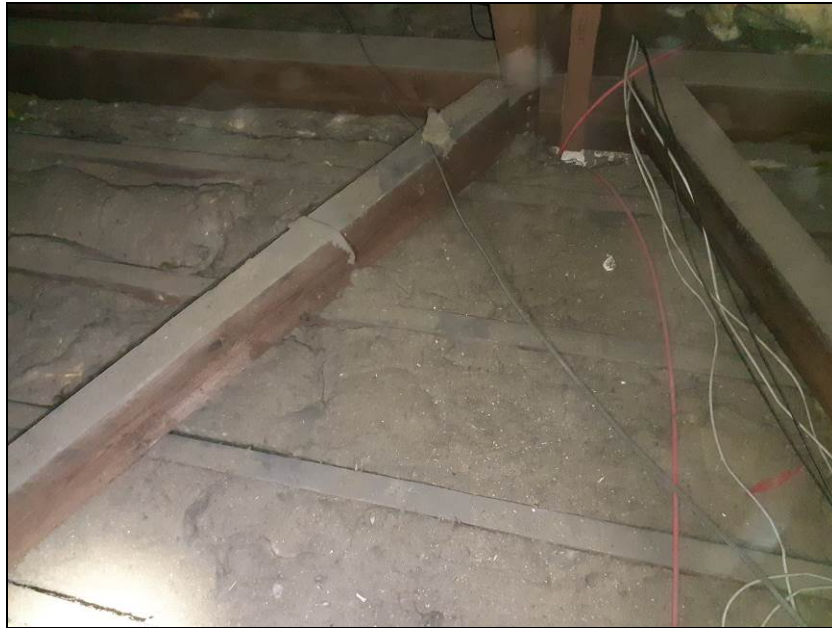
3.5. The state of the roof void was far from conducive for seeking bat droppings or discarded insect wings: The floor of the void (where not obscured by water tanks) was characterised either by the presence of very old fibreglass insulation, had the original lath & plaster ceiling exposed or in places was boarded. In all areas, a substantial layer of dark detritus is present, making it difficult to discern bat evidence (Fig. 4). Nonetheless, although also covered in detritus, the timberwork and tops of the water tanks (or where no cover was present, the dry interior) offered a better opportunity to seek droppings etc. Despite an intensive search, no evidence of bats was found.

Fig 4 Floor of roof void within Building A. As with all the roof voids, characterised by a significant layer of detritus.

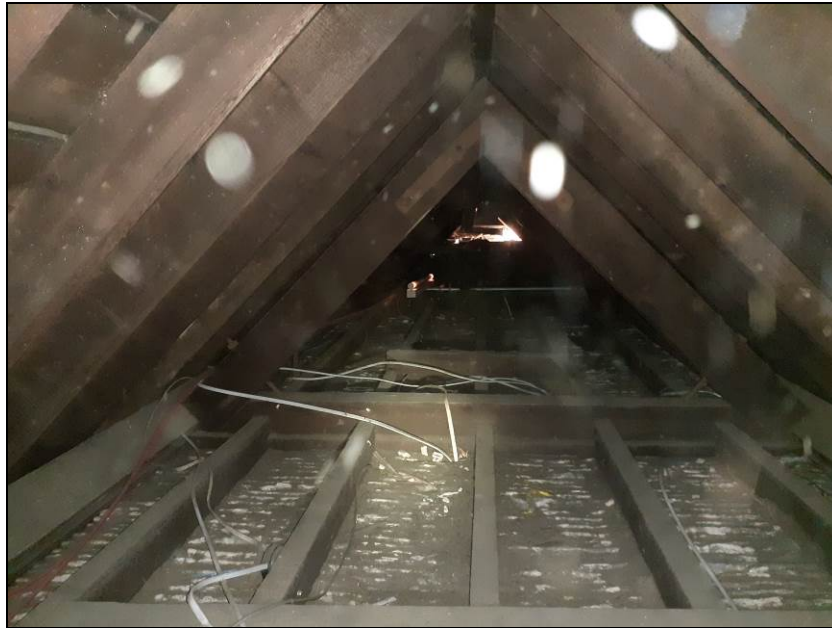
Fig 5 Roof void within Building B (looking north from the southern gable). The lath & plaster ceiling and timberwork are covered in detritus.

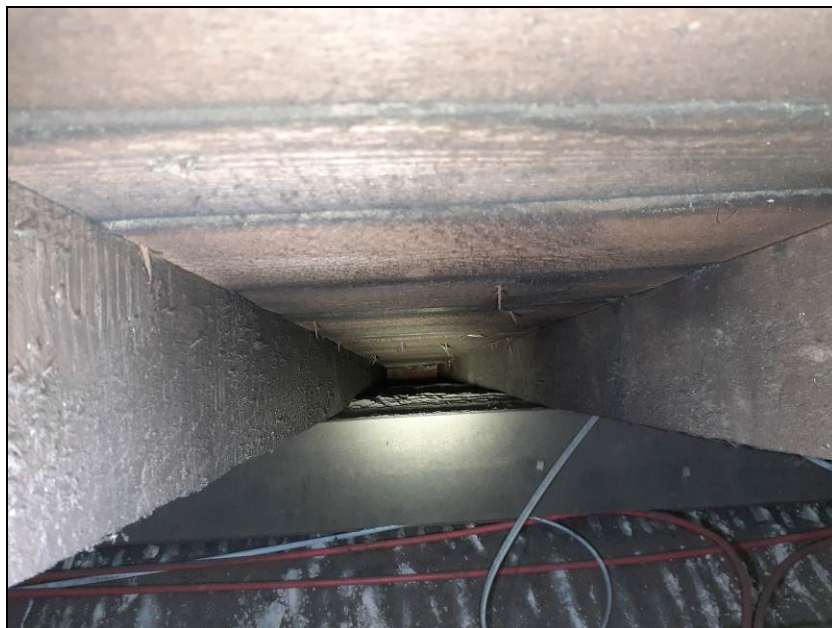
Fig 6 Gap between the sarking-clad pitch and the hip of the roof extending down to the eaves

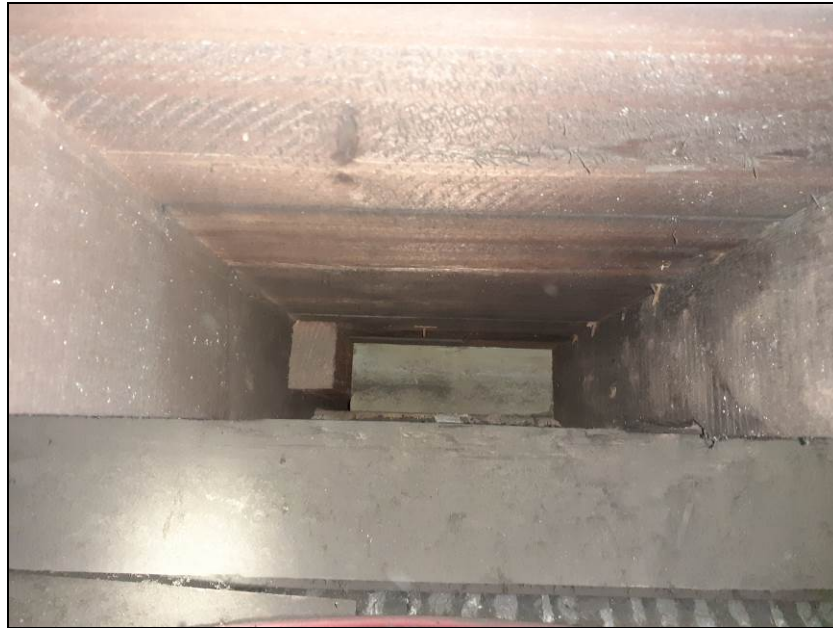
Fig 7 Gap between the sarking-clad pitch and the hip of the roof blocked off before reaching the eaves

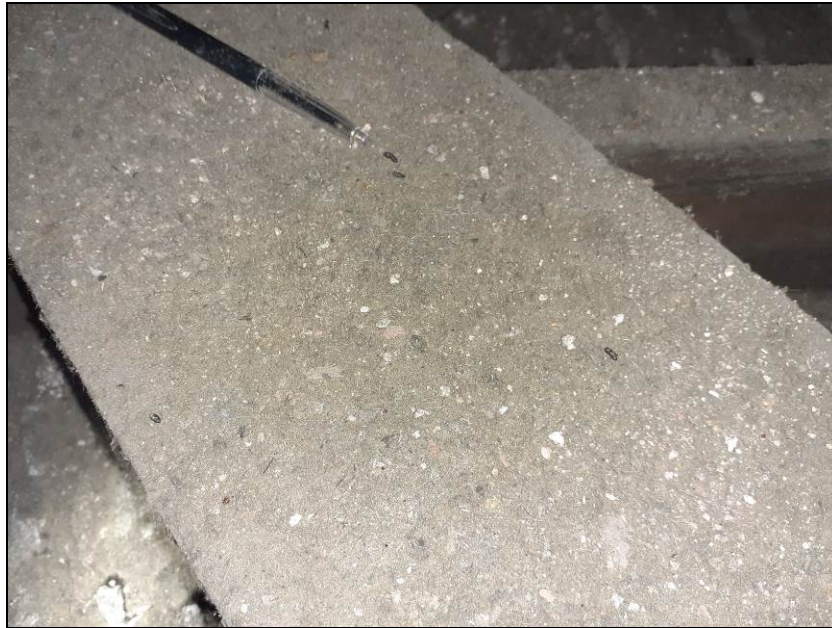
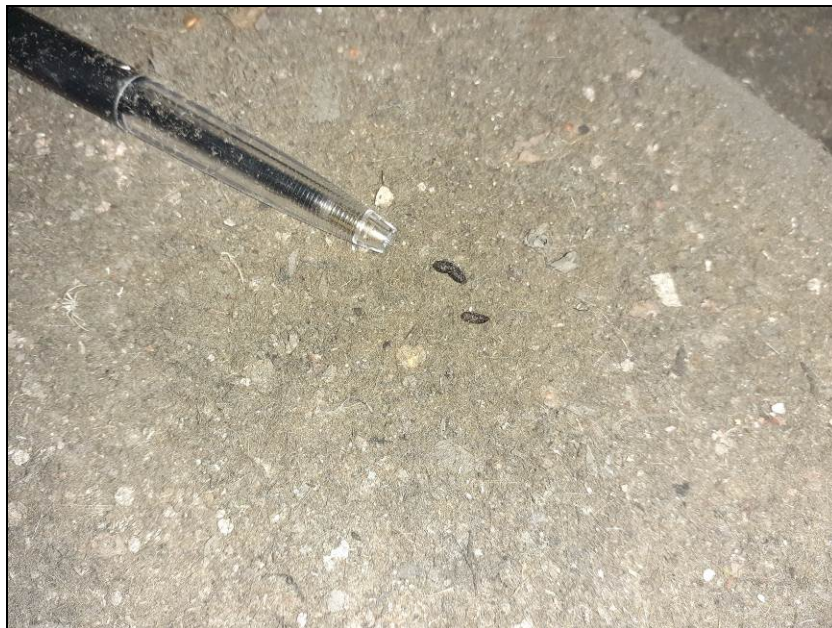
3.8. Close inspection of the timberwork failed to reveal any signs of bats along the length of the void. However, within the dormer present towards the northern end, around 6 brown long eared *Plecotus auritus*<sup>6</sup>. droppings (Figs. 8 & 9), were noted on a loose plank on the ceiling rafters. Locating these resulted in an intensive search of the dormer, with attention paid to the surrounding timber, ceiling and timberwork immediately above (Fig. 10). No further evidence was noted.

Fig 8 Bat droppings on a loose plank in the roof void of the dormer on the east elevation of Building B

Fig 9 Close up of the droppings shown in Fig. 8

- 4.3. Detailed inspection suggests the absence of bat activity in the majority of spaces within the school buildings. The exception to this is the dormer on the east side of Building B. The droppings found were of a condition that suggested they were deposited relatively recently (within the last couple of years). That there were so few with an absence of other signs, and confined to just the one area, suggests an opportunistic visit by a single bat.

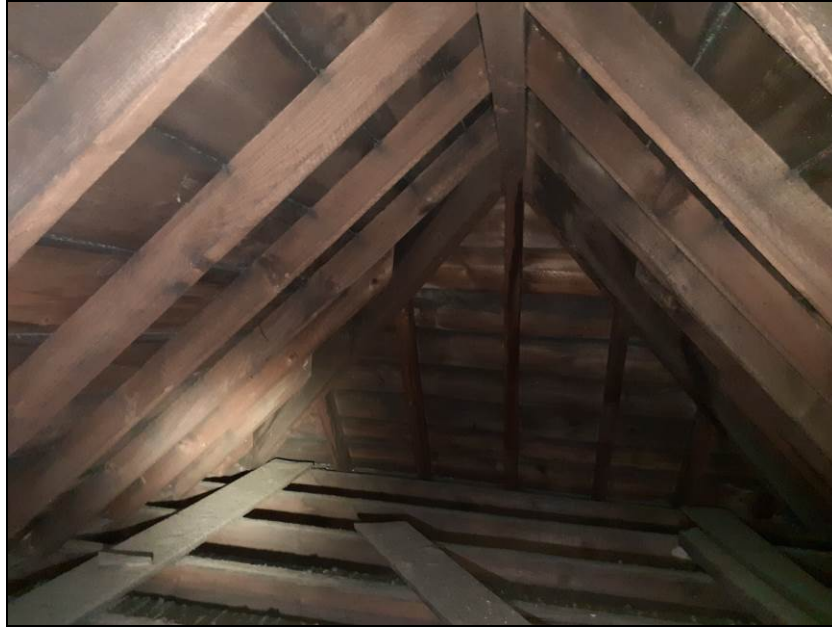
Fig 10 Loose plank of timber within the eastern dormer of Building B. No staining or evidence of roosting was noted associated with the timbers above.

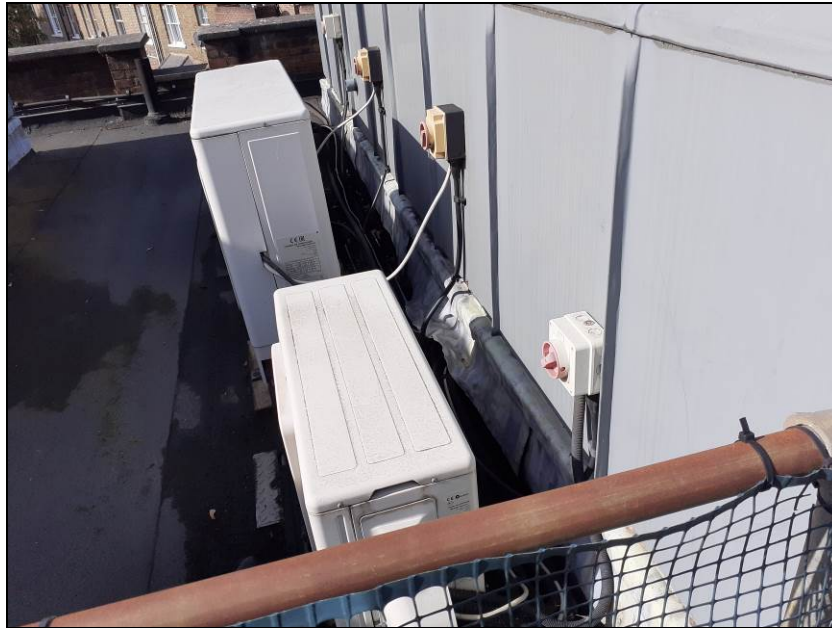
3.9. The 'pods' on the flat roof of **Building C** are of predominately zinc construction and are in good condition, offering little opportunity to accommodate bats. The base of the pods comprise lead flashing where they abut the flat roof. This is mostly intact, but in places is lifting (Fig. 11). However, the aspect of this feature makes it unlikely to be suitable for bats.

Fig 11 Lifting lead flashing (centre of photograph) to the base of the 'pods' on the flat roof of Building C.

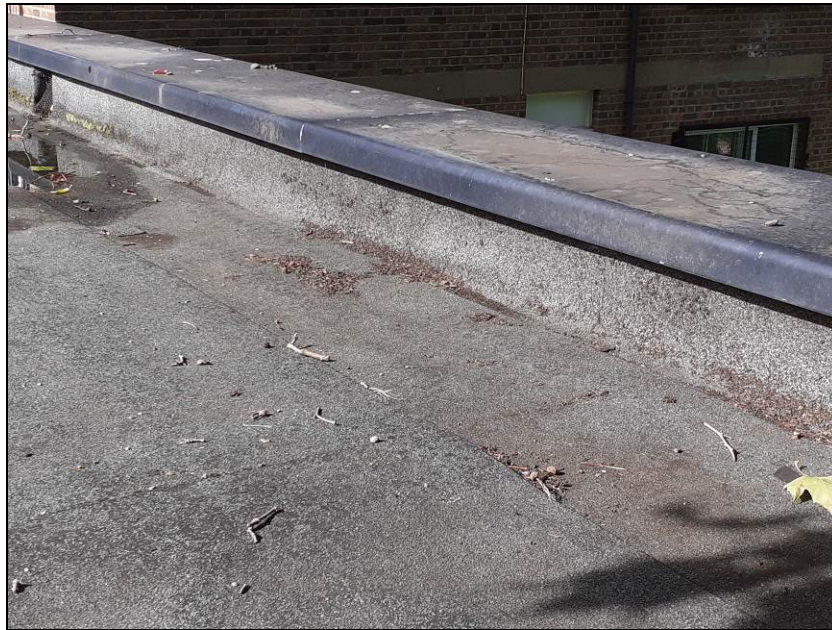
3.11. The felt roof to Wathan Hall (**Building D**) is intact and in sound condition (Fig. 13), offering negligible opportunity to accommodate bats. Beneath the metal coping at the top of the parapet (where the felt laps up), there is a significant gap. The gap is present beneath the coping on both sides of the parapet. Such a structure may be suitable to accommodate bats and/or provide access to within the (assumed) cavity wall of the building.

Fig 13 Roof of Wathan Hall. Felt in sound condition with no gaps. Coping to parapets has a gap along the length under the return, on both sides of the wall.

- 4.6. Overall, the sound condition of Wathen Hall and its low external height would not favour its function as a bat roost, particularly for brown long eared bats (Para 3.8) which favour a more open roost space. However, the gaps beneath the coping may provide access to the cavity walls of the building, and an elevated temperature (favoured by bats during the summer) may be created by the dark finish to the coping. Given that bats are likely to be within the vicinity to a greater or lesser extent (see above), it is recommended that a precautionary approach is taken,

and that a licenced bat worker is present to inspect the cavities when the coping is removed.

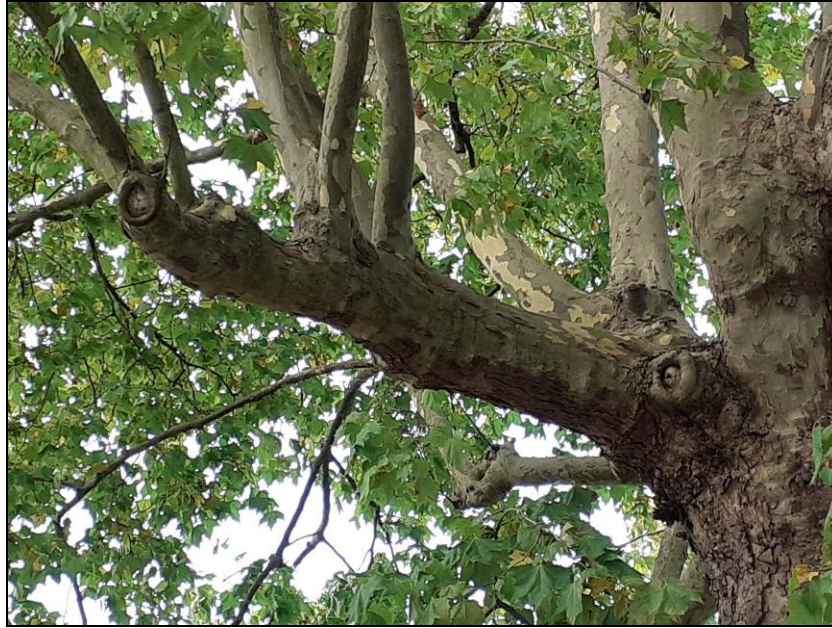
3.12. It is understood that to accommodate the new floor, the London plane will require cutting back, including the removal of at least one large limb. The tree was inspected from the roof of Wathan Hall using binoculars<sup>7</sup>. Several substantial pruning wounds were noted (Fig. 14), but none of them appeared to be associated with any gaps which could accommodate or provide entry points for bats. Likewise, although lifting bark is a ubiquitous feature of the tree, the spaces created appear to be too shallow and of insufficient penetration to accommodate even pipistrelles.

Fig 14 London plane adjacent to Wathan Hall, showing two of the pruning wounds.

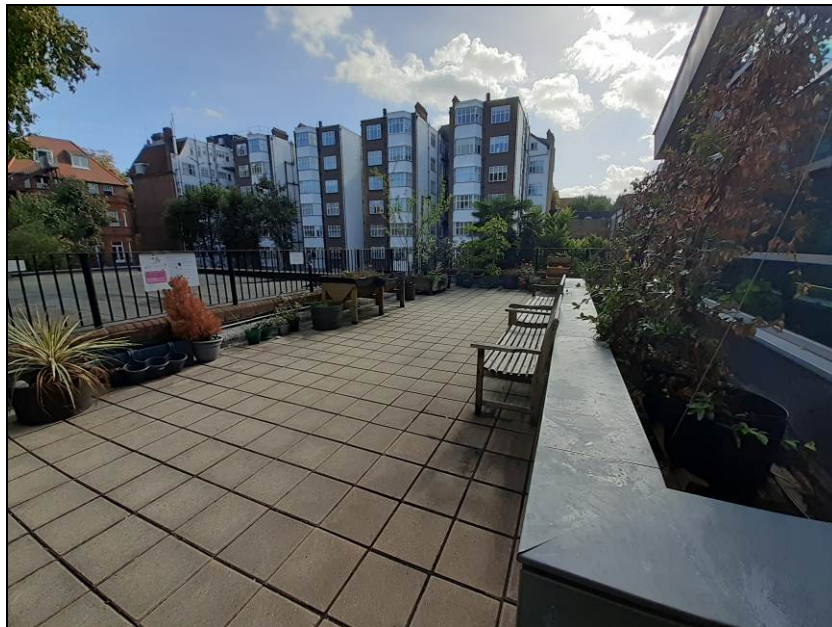
3.13. The 'introduced shrub' on the terrace identified in the 2019 PEA, are all in planters (Fig. 15), and consequently provide only a limited contribution to biodiversity within the site. The beds and young beech at the front of the main entrance (the west of the site), provide a more enhanced resource for invertebrates (and hence possibly bats).

Fig 15 The 'introduced shrub' comprising the terrace planters

- 4.10. In order to ensure that the provision of the green roof demonstrates clear net gain, the loss of the planters on the terrace needs to be compensated. It is suggested that other areas within the application site are planted up and/or incorporate new planters, with native plants, with a view to encouraging insect activity.
