Planning & LBC

Project
 25 Chester Terrace
 London, NW1 4ND
Drawing
 Existing
 Roof Plan

Date	Scale	Drawn
Oct 22	1:50@A3	CS
drwg. no		Rev.
GHV-105		-

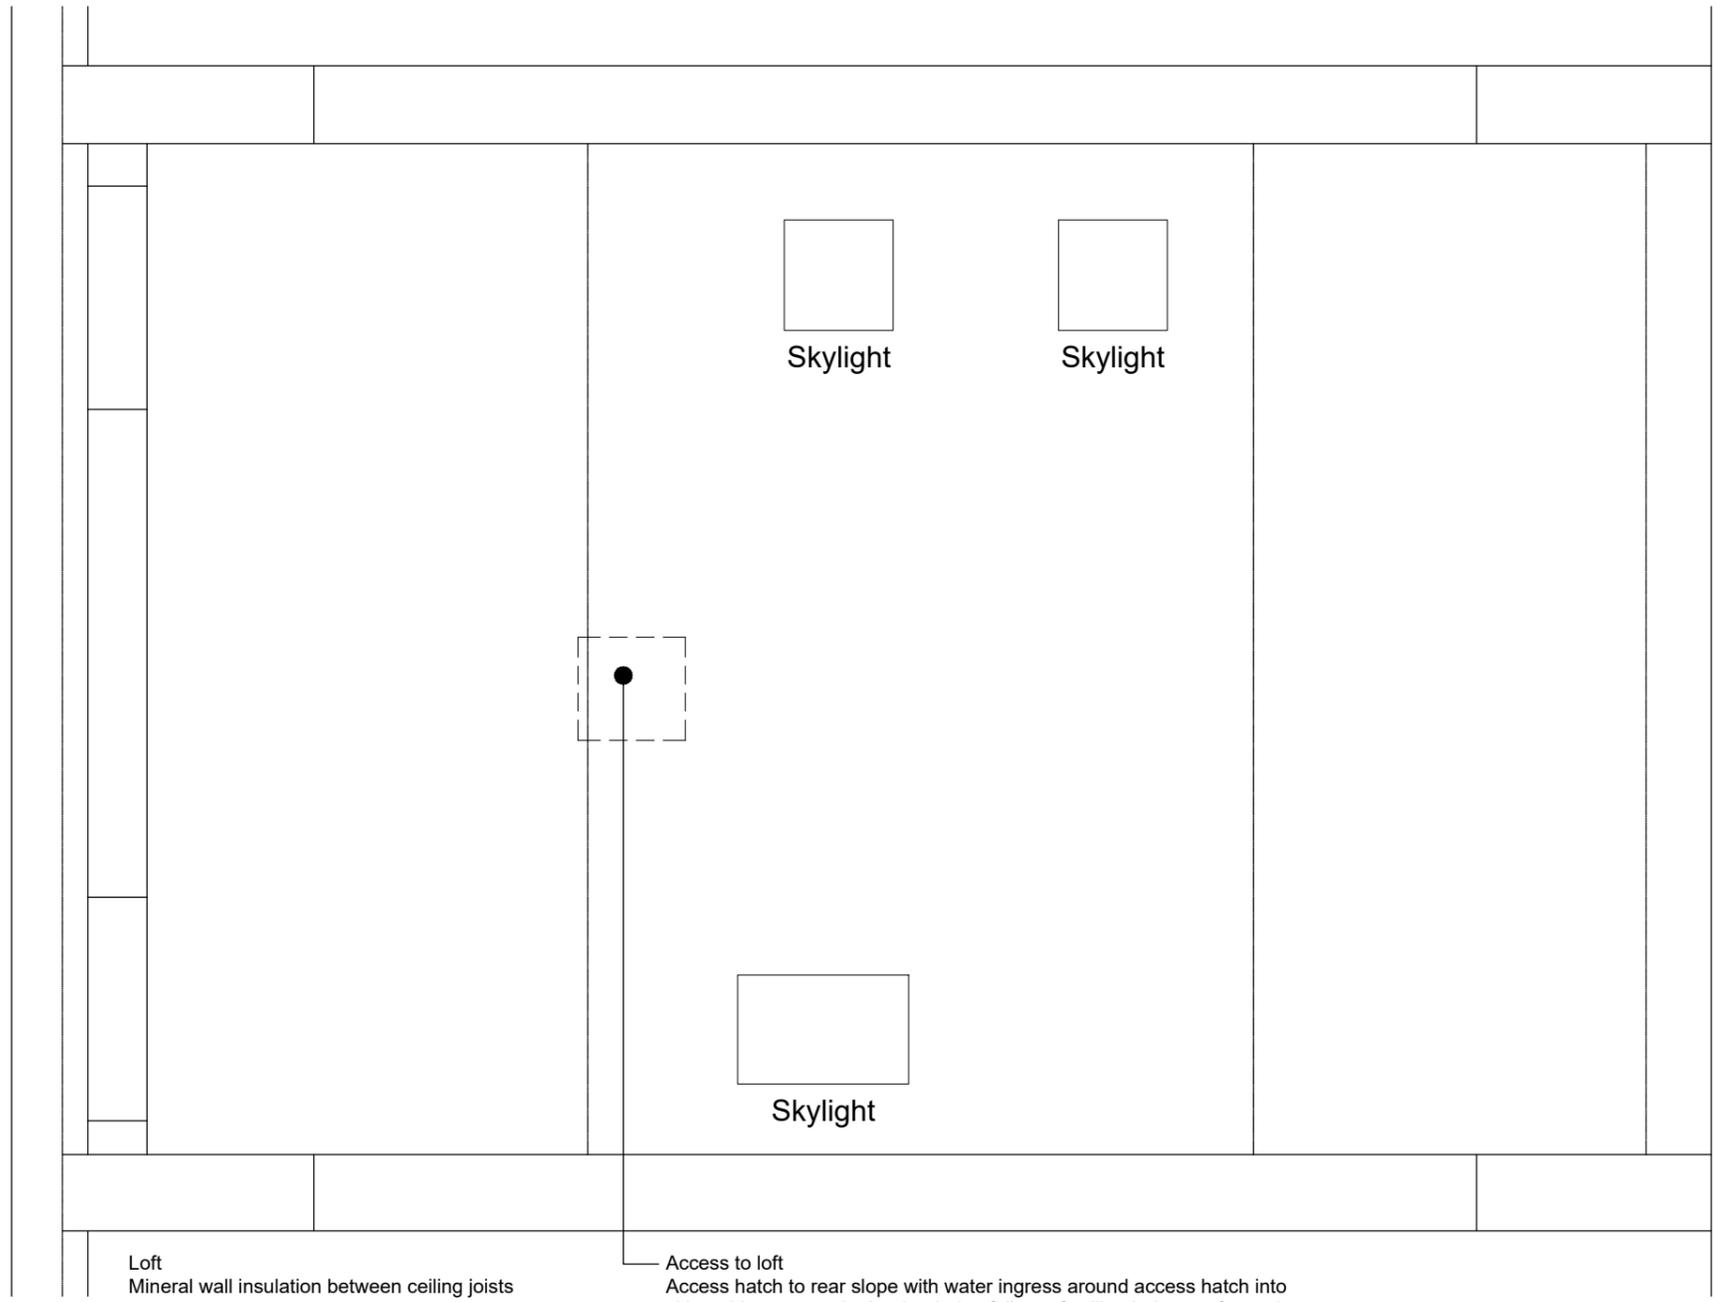
Loft
Mineral wall insulation between ceiling joists

Access to loft
Access hatch to rear slope with water ingress around access hatch into either side assume that's what led to failure of ceiling below roof covering seems to be too hard to determine Seems to be a brittle paperlike material below the actual roof covering ceiling joists are generally boarded flat roof section timber boarded assume lead on top
