4.2 4th Floor Proposal (2022)

5.0 Heritage Management Strategy & Impact

5.2 Evolution of the Central Wing: 4th Floor (1929-2022)

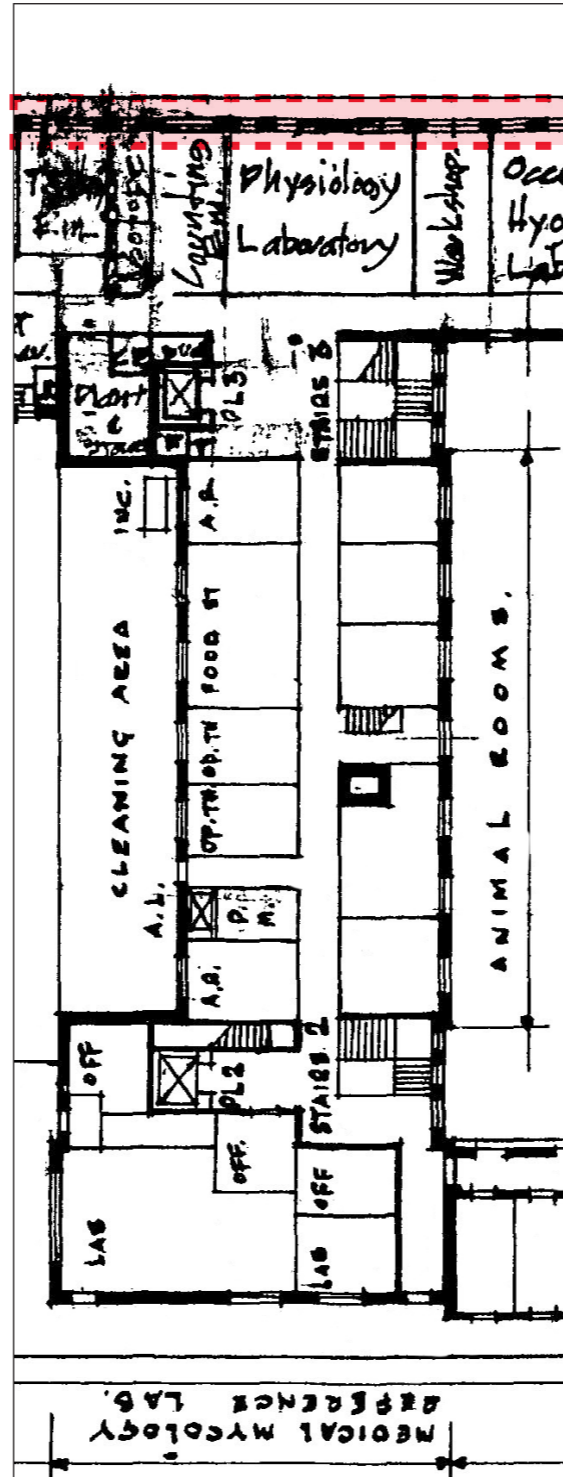
Fourth floor plan, 1977

- Malet Street side has been extended

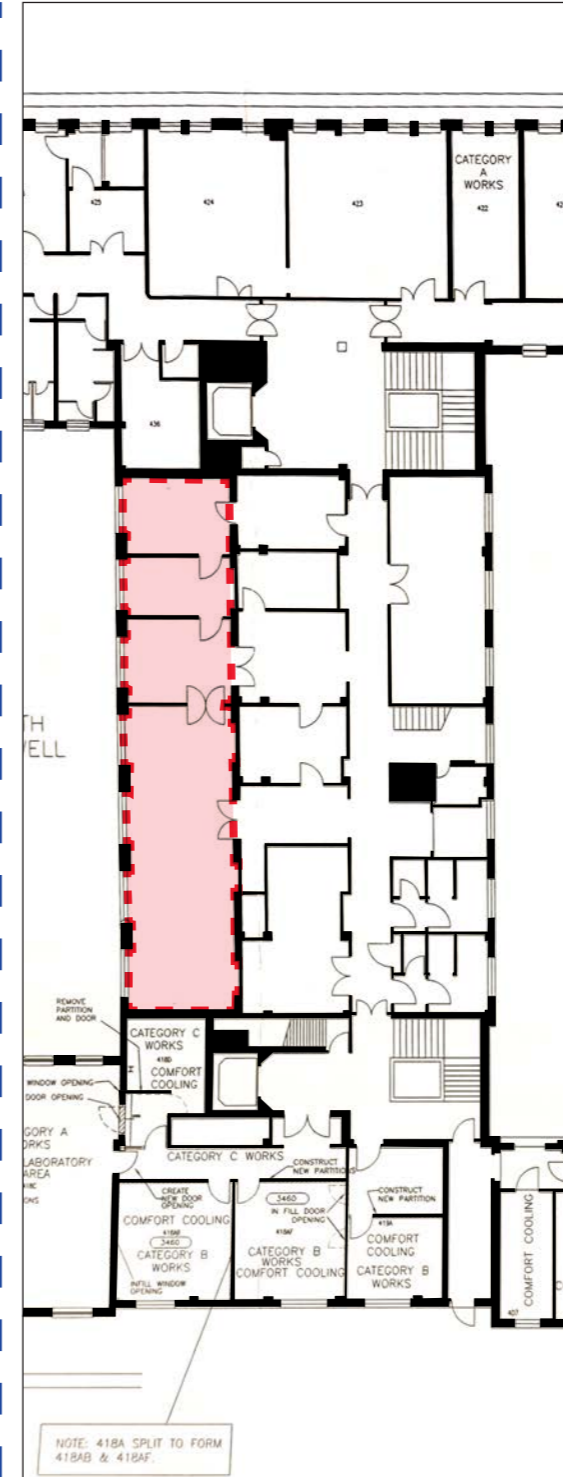
Fourth floor plan, 1998

- The external court has been infilled to give the University more occupable space for labs.

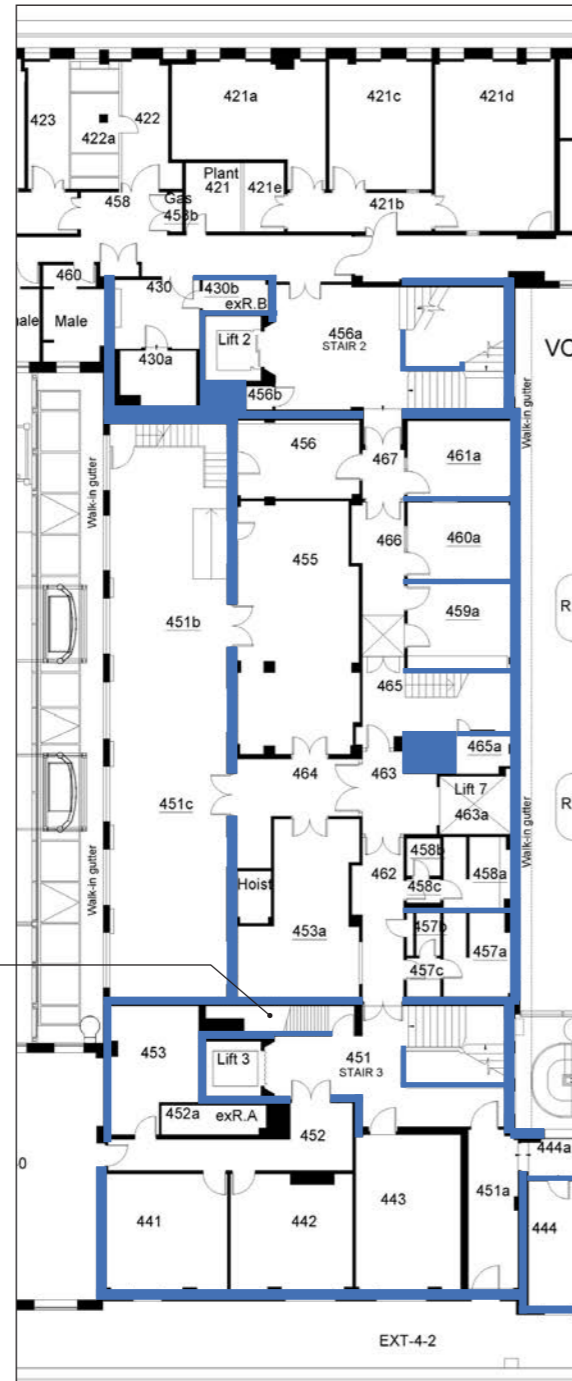
Fire escape between L4-5 to be demolished

Existing 2018 floor plan of Level 4 with blue overlay indicating original walls remaining

The plans to the left show the proposed demolition of the internal original walls to adapt the internal lab spaces to provide LSHTM spaces to meet their current needs.

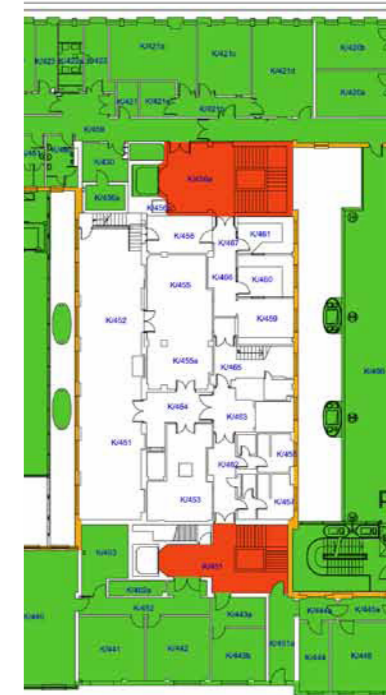
Plan defining Heritage significance from Richard Griffiths Architects Conservation Management Strategy (Appendix C).

The above plan distinguishes the significant areas within the building on Level 4 as being the Malet Street and Gower Street stairwells and lobbies as 'Highly significant' and the building facades as 'Significant'. The footprint of internal lab spaces are not considered key to the heritage of this building.

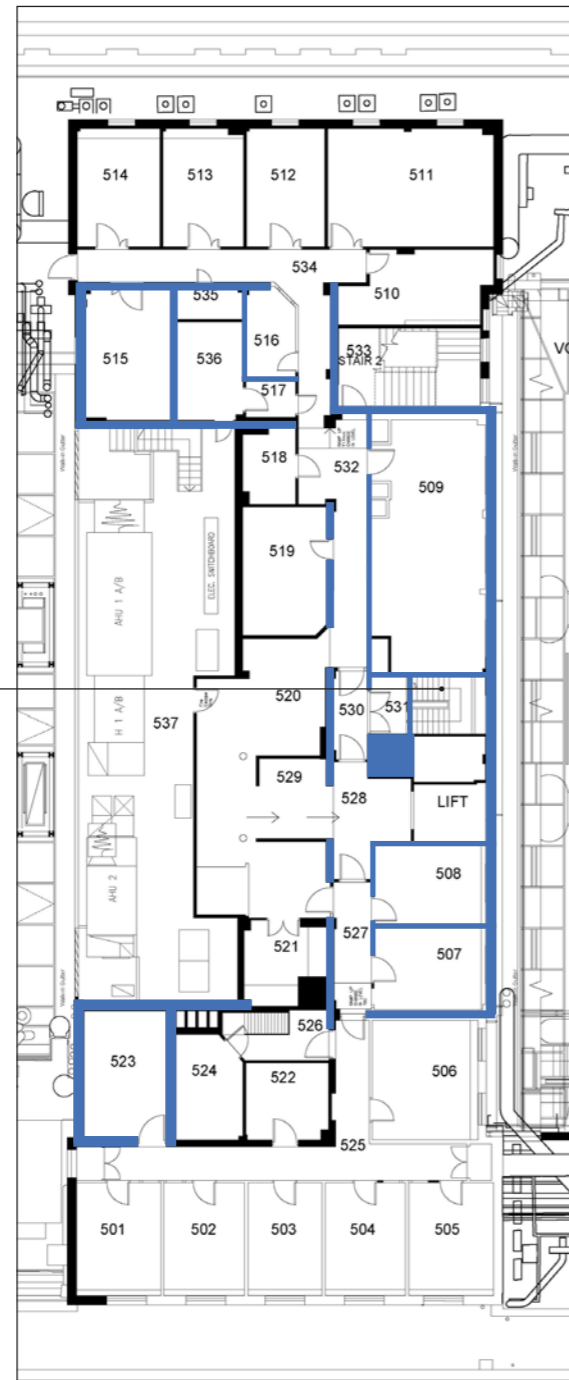
Stair between L4-5 to be demolished

Existing 2018 plan with overlay of original walls left

The plans to the left show the proposed demolition of the internal original walls to adapt the internal lab spaces to provide LSHTM spaces to meet their current needs.

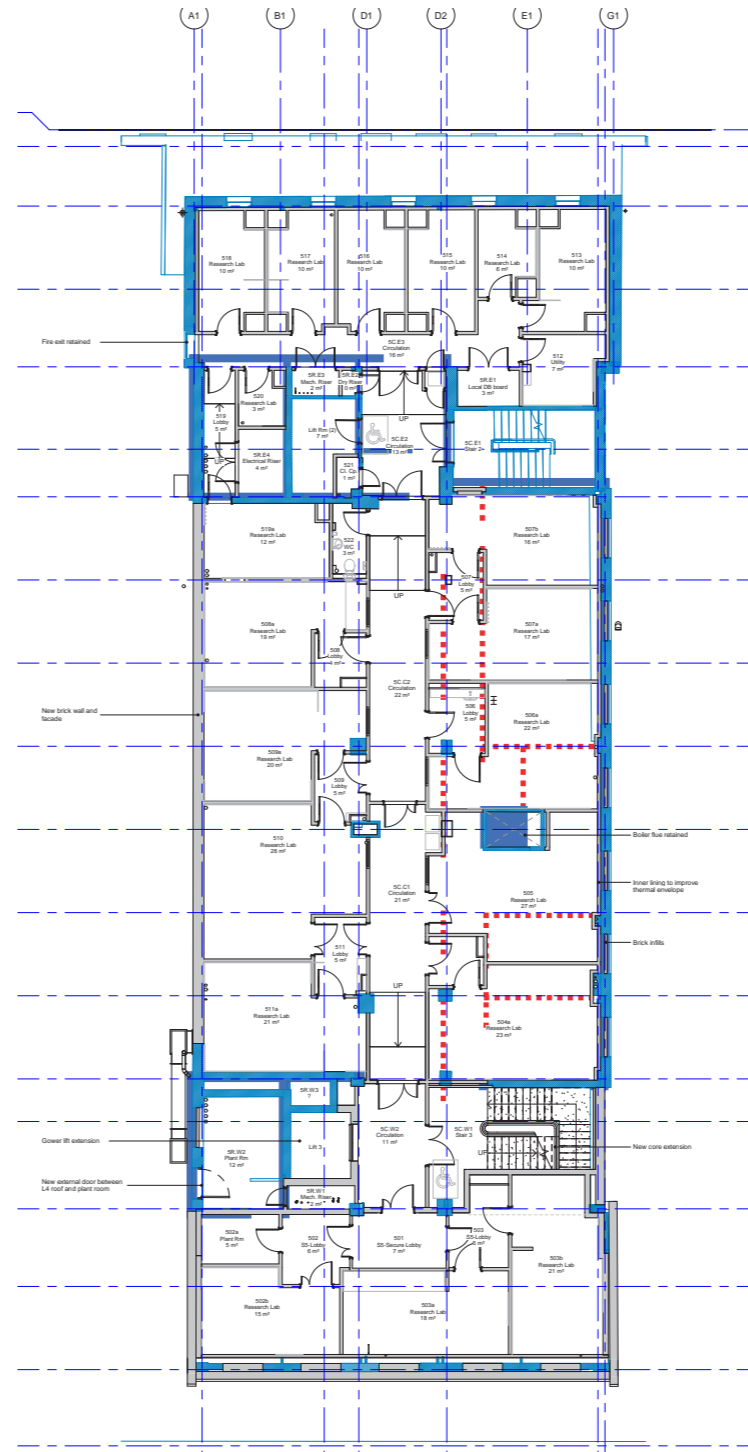
Proposed 2022 plan with overlay of original walls left

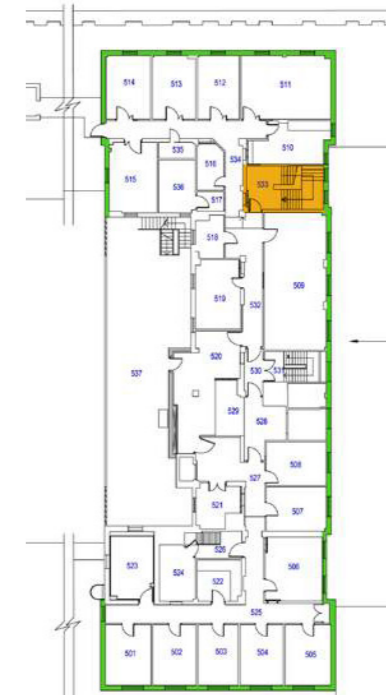
Plan defining Heritage significance from Richard Griffiths Architects Conservation Management Strategy (Appendix C).

The above plan distinguishes the significant areas within the building on Level 5 as being the Malet Street stairwell extension as 'Significant' and the building facades as 'Neutral'. The footprint of internal lab spaces are not considered key to the heritage of this building.

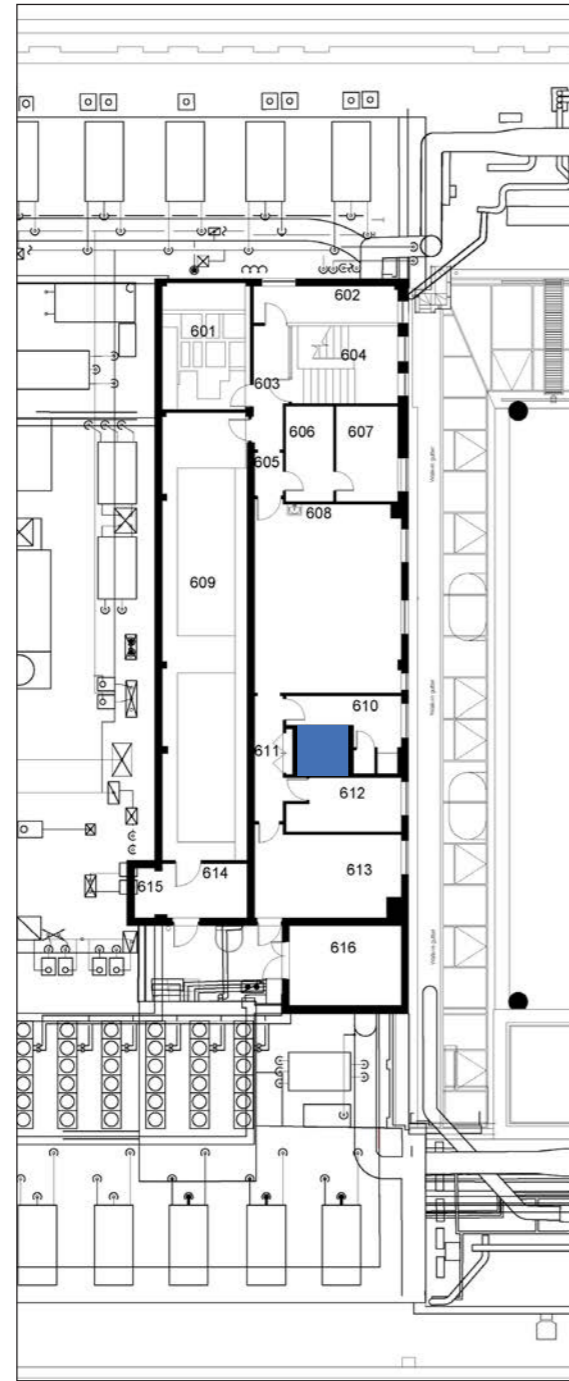
Existing 2018 plan with overlay of original walls left

The plans to the left show there is no demolition of the internal original walls to Level 6.

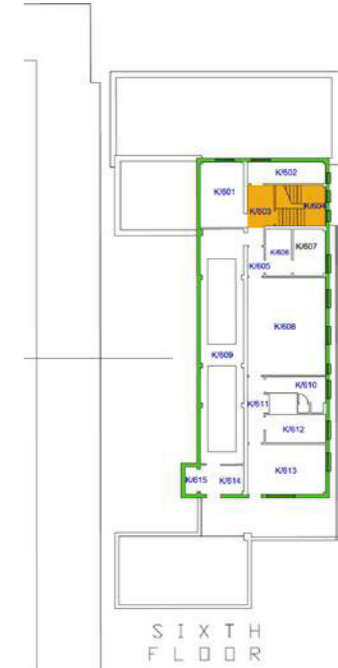
Plan defining Heritage significance from Richard Griffiths Architects Conservation Management Strategy (Appendix C).

The above plan distinguishes the significant areas within the building on Level 6 as being the Malet Street stairwell extension as 'Significant' and the building facades as 'Neutral'. The footprint of internal lab spaces are not considered key to the heritage of this building.
