25 OAKHILL AVENUE, LONDON, NW3 7RD

Structural Engineer's Desk Study Report

March 2023

P2 - Planning

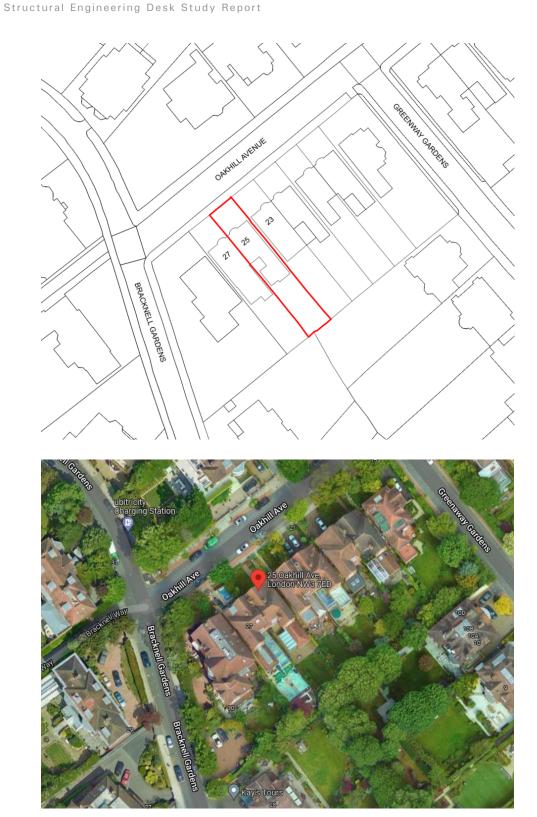
Figures 4.1 & 4.2: Maps showing the location and surrounding areas of the property (Extract from Location Plan and Google Maps)

No 25 Oakhill Avenue is part of the Royal Borough of Camden at the postcode NW3 7ED and is located on the south-east side of Oakhill Avenue, a two-way road which runs in between Redington Road and Bracknell Gardens. The existing property is Grade II listed building and was constructed in 1909. It is two-storey above ground floor, constructed of red brick with rusticated brick quoins and tiled double gabled roof with upswept other eaves to the main façade and hipped to the rear. No 25 forms with No 27 to the south-west a pair of symmetrical semi-detached houses as shown on the cover picture above and location plan Figure 4.1 and 4.2.

No 25 Oakhill Avenue forms with No 27 a symmetrical semi-detached house of the same style. A planning permission was granted for No 27 in 2014 for new single storey basement extension, which will be consider during the design process. No 25 Oakhill Avenue abuts the side passage with No 23 to north-east side. There are fence walls at the front and to the side with No 23. Rear garden fence is shared with both No 10B Greenway Gardens and 28 Bracknell Gardens (refer to Figure 4.1 and 4.2).

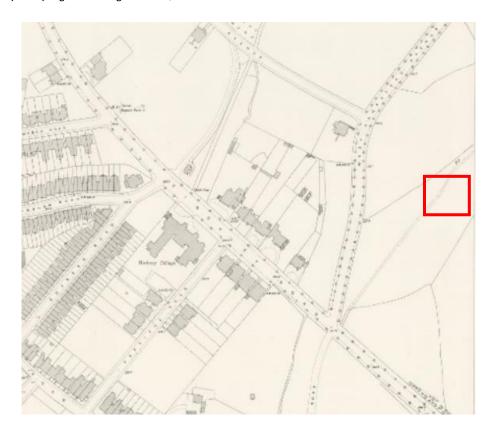
Figure 5.1: Extract from London II.98 - OS London Town Plan 1894-96

Historical maps show that the area around Oakhill Avenue was not developed until early 20th century. Maps given in Figures 5.1, 5.2 illustrate this.

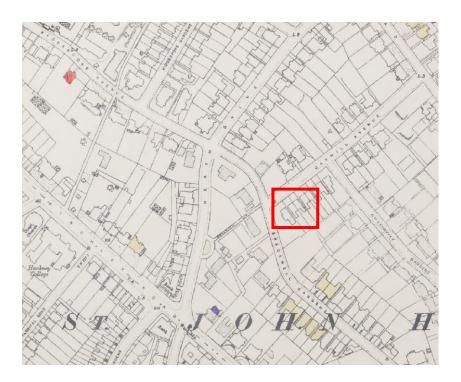
Figure 5.4: Extract of Bomb Damage Map

Figure 5.4 below shows the extent of the damage from enemy action during WWII. This map indicates that 25 Oakhill Avenue and the adjacent area were not damaged during the attacks. This suggests that the current building at is original, built at the beginning of the 20th century.

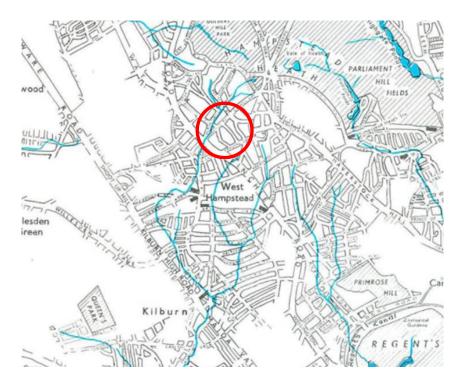
Figure 6.1: Extract from Lost Rivers of London by Nicholas Barton, 1982

There are numerous 'lost' rivers running below the ground in London. Figure 6.1 is an extract from a map showing the site location encircled in red and its surrounding area. The map shows small stream, which run on the north west side of the Oakhill Avenue and it is a one of the tributaries of the Westbourne River. Stream is not close enough to be consider during the further site investigation.

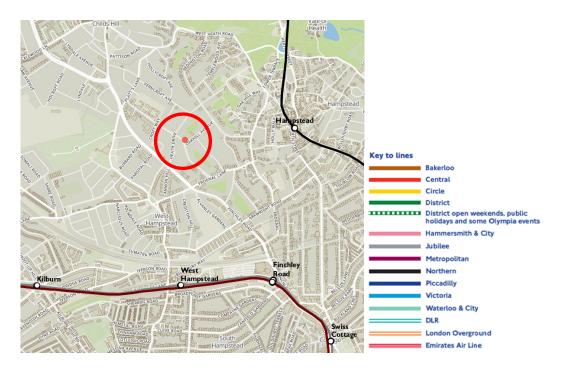
Figure 6.2: London Underground Lines

Figure 6.2 shows that none of the London Underground lines run in close proximity to the site and therefore will not have an effect on the proposed development, and neither does the property fall within the Crossrail 2 Safeguarding Limits.

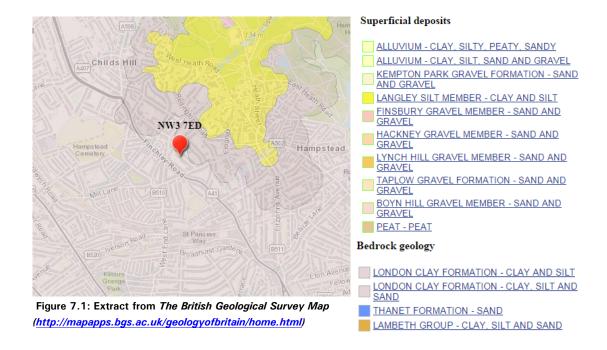
The information from the British Geological Survey are shown in Figure 7.1 below. The survey indicates the site to be underlay by London Clay Formation with posible silt and sand deposit.

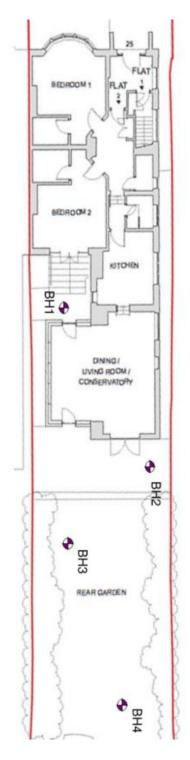
Figure 7.2: Bore hole location log extract from Factual Report by GEA

The initial site investigations carried out at 25 Oakhill Avenue by GEA (Figure 7.2, 7.3 and 7.4) confirms the information presented on British Geological Survey map. The borehole report shows a superficial stratum of made ground to a depth of 1m with a Claygate Member encountered between 1 and 2.5m, overlaying London Clay which extend to the full depth of investigation (1.2m - 12m). During site investigation additional 3 window samples were taken to a depth of 2.5m. Groundwater seepage was observed in Borehole No 2, with shallow inflow associated with a high proportion of surface water infiltrating into the shallow soil.

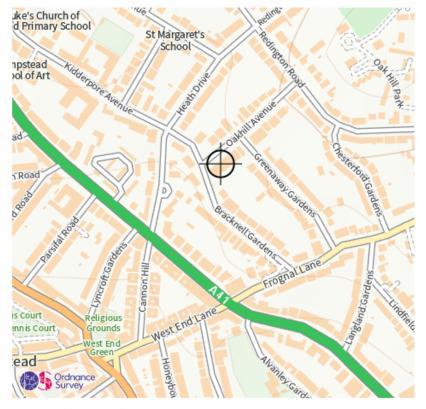
Figure 8.1: Risk of flooding from river and sea

The information available from British Geology Survey and from the Flood Risk Summary for the area, provides initial guidance for the identification of site subject to flood risk. A flood risk map shows that there is no risk of flooding from rivers or the sea (Figure 8.1), a very low risk of the surface water flooding (Figure 8.2), together with an indication of the areas with a significant risk of drains surcharge during heavy rainfall periods.

Extent of flooding from rivers or the sea

The maps in figure 8.1 and 8.2 above show the site outside the risk area, therefore the flood risk of the proposed development is not considered relevant.

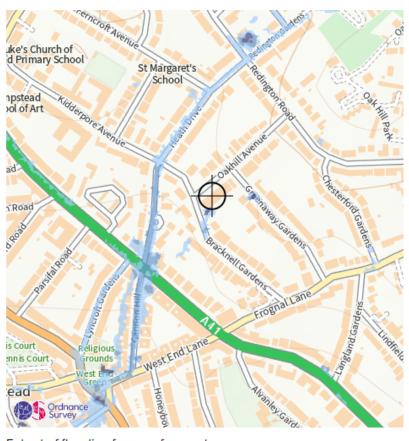
Figure 8.2: Risk of flooding from surface water

Extent of flooding from surface water
