HIGHGATE CEMETERY

MAIN WEST CEMETERY GATE TO SWAINS LANE: REPAIRS NOTES TO ACCOMPANY APPLICATION FOR LISTED BUILDING CONSENT

April 2023

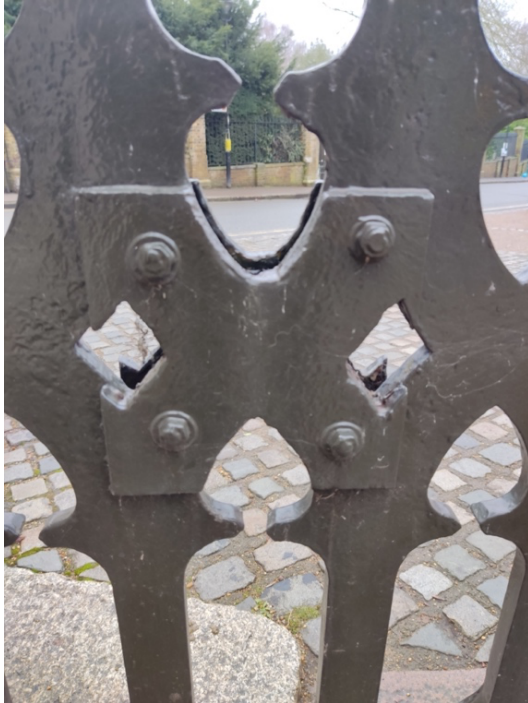
The gates have been damaged in the past and repaired with pattress plates bolted through the grillage of the cast iron or welded to the back face. These are mounted on the inside face of the gates and painted to match the railings in a dark green. They are not prominent from the outside but are less satisfactory in appearance from within the cemetery.

Bolted plate

As previously carried out; the appearance is less prominent than the bolted repair but nonetheless intrusive. The repair is not particularly robust.

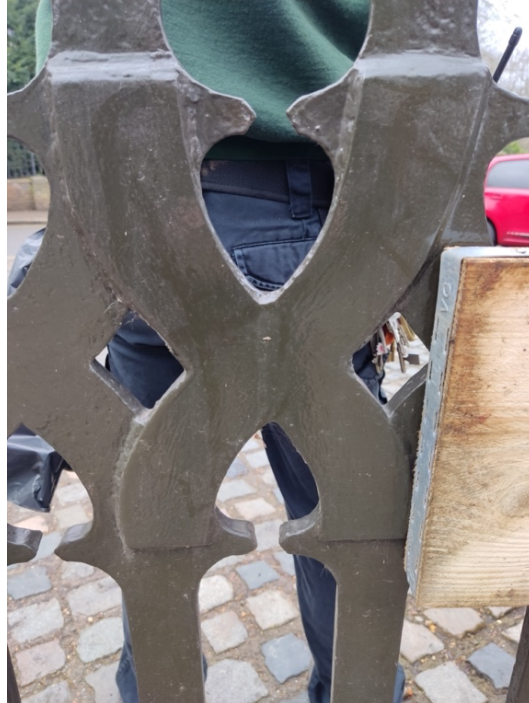
Welded plate

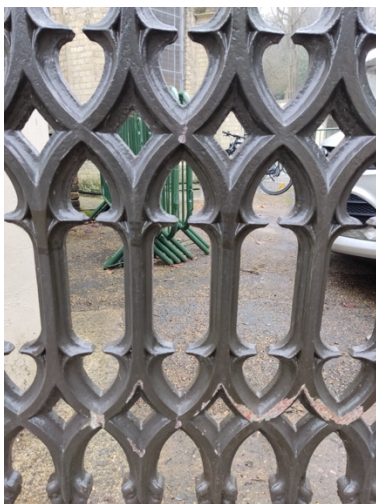
A vehicle has recently collided with the gates and has further cracked the castings through in several places.

General view

Whilst the cracks are not (yet) displaced they require immediate and essential repair. This could be carried out in a number of ways:

This involves heating the whole casting almost to melting point, at which temperature cast iron can be successfully welded to repair the cracks. When the metal has cooled the repair can be ground flush with the original surface, and when repainted the intervention will be invisible.

The proposal is therefore for the full repair of all of the present and historic defects to the gates which are shown on drawing 968-GD-01

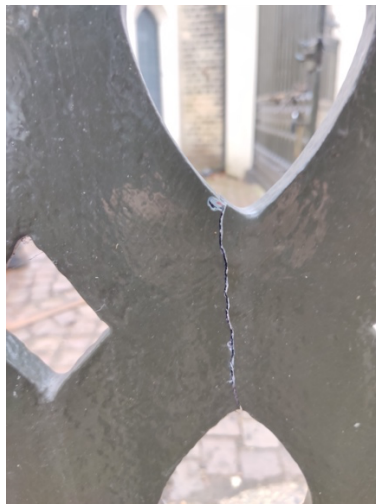
Inside face

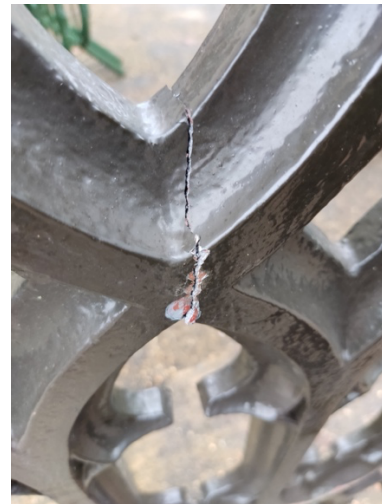
Outside face
