A2 Site Investigation

13 Belsize Crescent

Factual Report

24022-A2SI-XX-XX-RP-X-0001-02

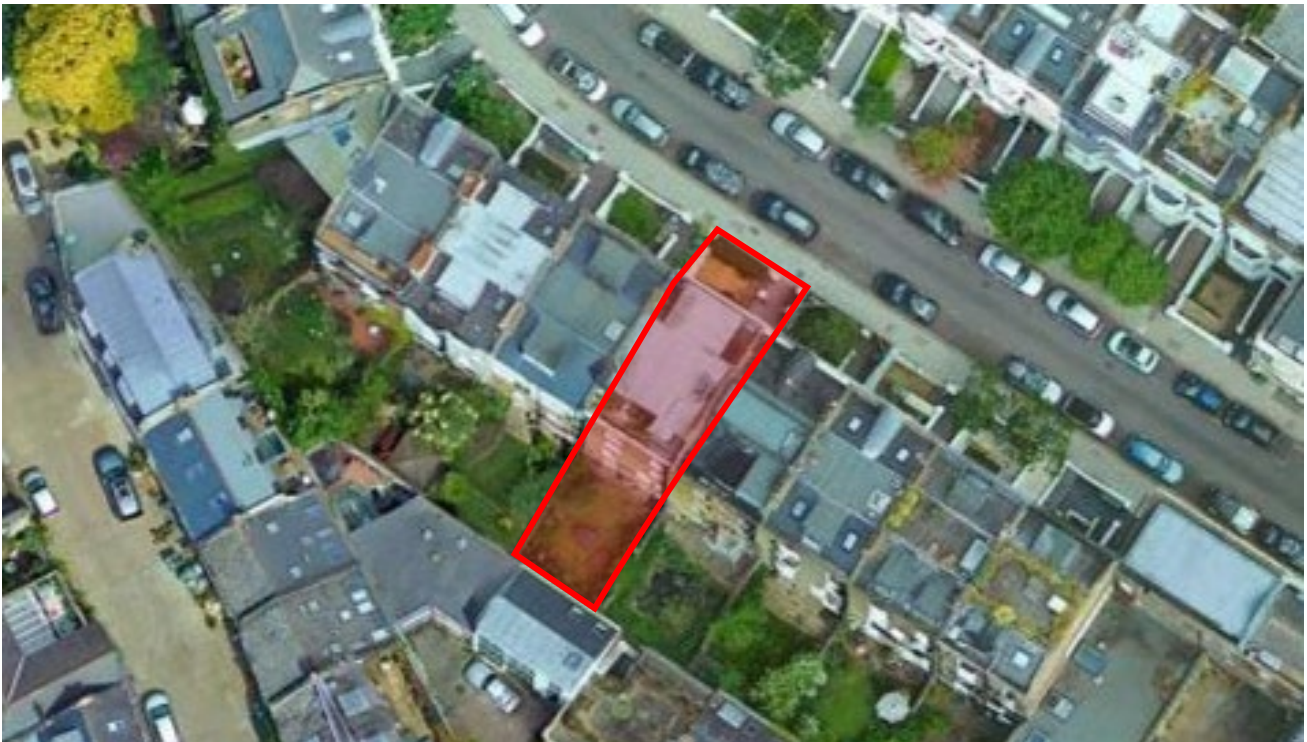
Figure 2.1 Site location and extent marked in red

The site extent is shown in Figure 1. The site is located at National Grid Reference 526772, 184981 and falls within the administrative boundaries of the London Borough of Camden. The site, covering an area of approximately 0.02ha, comprises the terraced residential property of No.13 Belsize Crescent and associated private front and rear garden spaces.

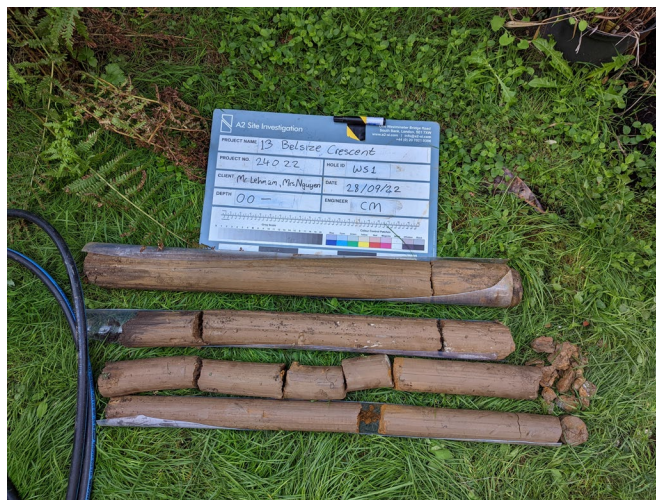
Figure 2. WS1 arisings 0.0-6.0 m bgl.

A standpipe was installed in each of the boreholes for monitoring of ground gas. Detailed exploratory hole logs can be found in Appendix B. Arisings were photographed, and are presented in Appendix B.

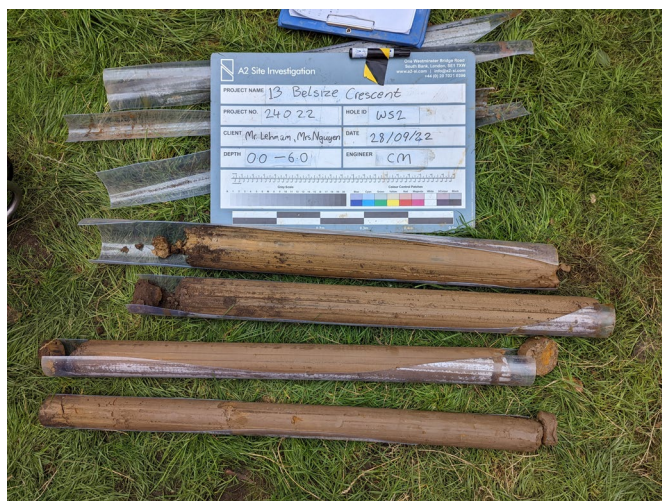
Figure 3. WS2 arisings 0.0-6.0 m bgl.

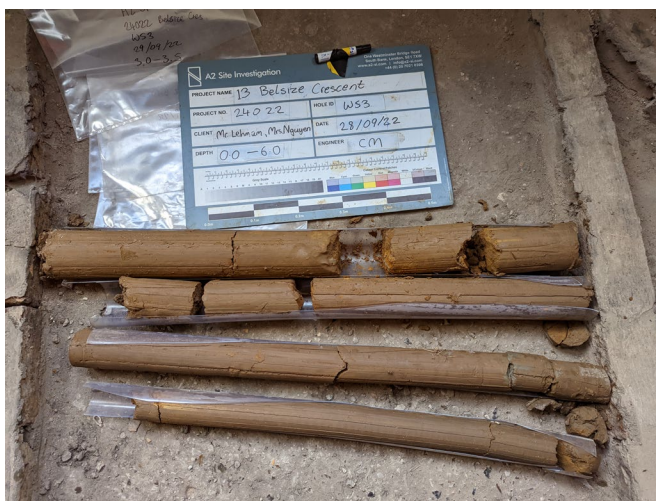
Figure 4. WS3 arisings 0.0-6.0 m bgl.

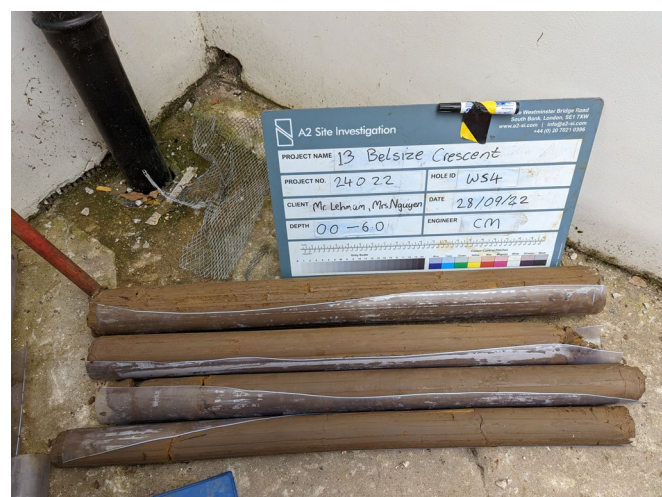
Figure 5. WS4 arisings 0.0-6.0 m bgl.

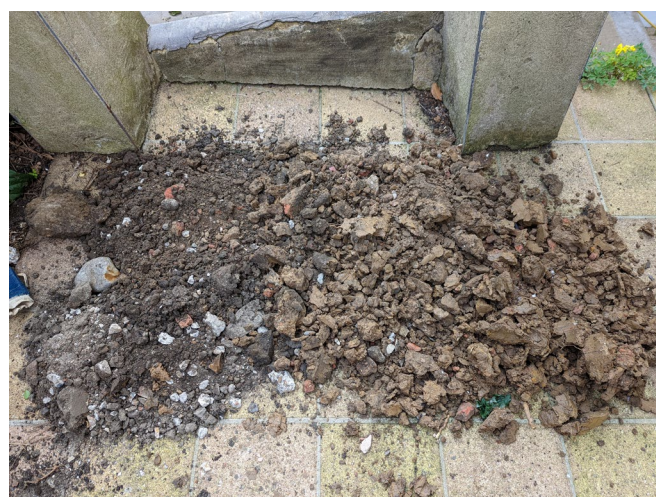
Figure 6. HP1 arisings 0.0-1.2 m bgl.

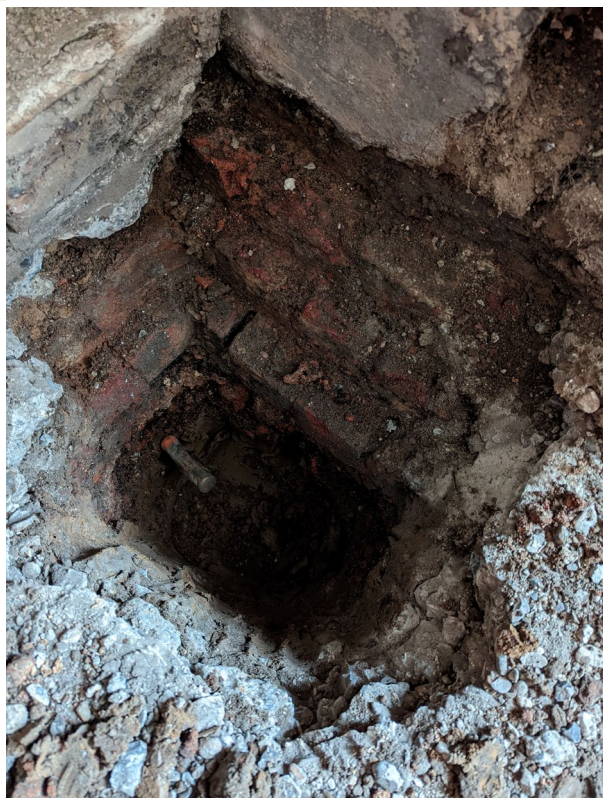
Figure 7. TP1 completed to 0.6 m bgl.

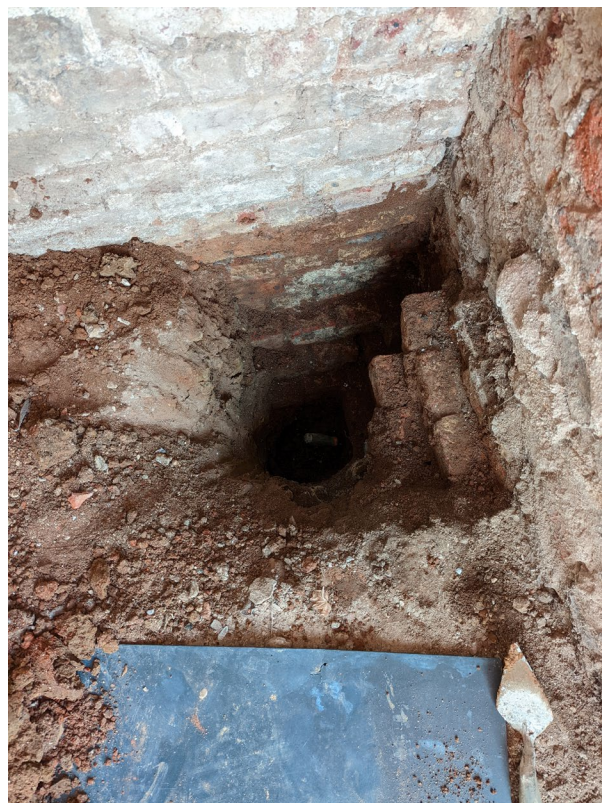
Figure 8. TP2 completed to 0.78 m bgl.

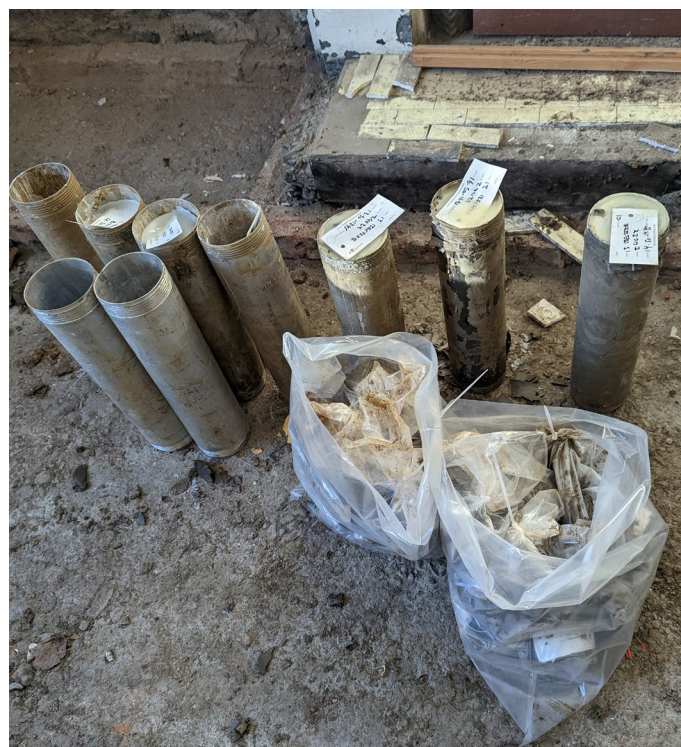
Figure 10. BH01 samples 0.0 – 20.0 m bgl.

The modular cable percussion borehole (BH01) was progressed using a Dando 1000 cut-down drill rig with geotechnical sampling to a maximum depth of 20.00 m bgl. SPTs were alternated with UT100s throughout the hole.
