**Arboricultural method statement to install a traditional root barrier.**

Optera Structural Solutions

POLICY HOLDER ADDRESS: Flat 2, 34 Frognall, London. NW3 6AG

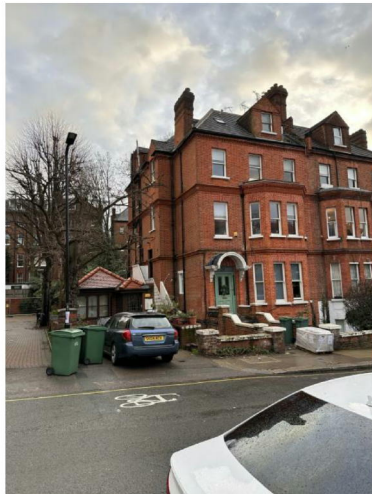
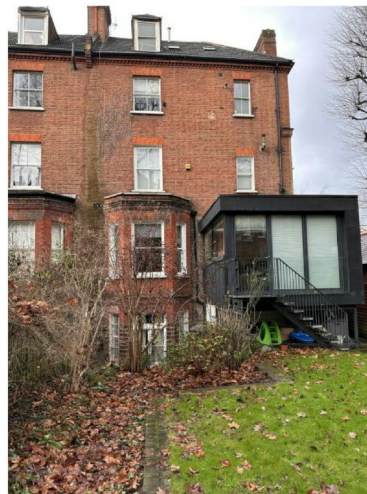
### Front and rear elevations of property

The property is large semi-detached period property of traditional construction with solid brick walls under a pitched tiled roof. The property has been converted in 5 self-contained flats. Flat two occupies the upper ground floor flat that has an original rear projection supported with steel columns. Added to this is a modern contemporary conservatory extension supported by a steel framework upon steel column supports, with steps leading down into the garden. It is understood that extension support columns utilise a pad foundation understood to be 2.5-3m below ground.

The subsidence movement affects the rear projecting contemporary conservatory extension.

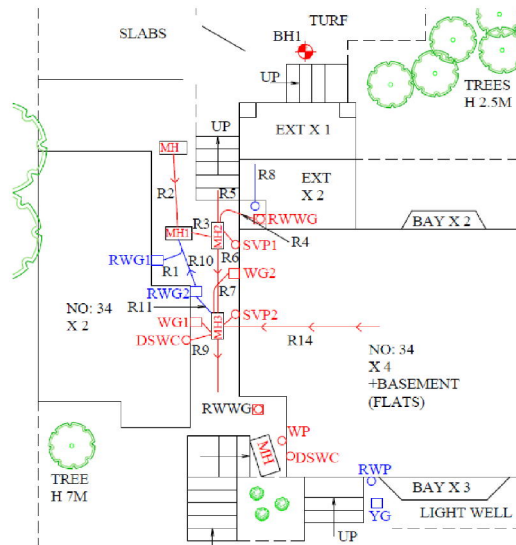
Site investigations in January 2020 included a single borehole within the rear garden adjacent to the rear access steps leading from the extension into the garden. The soil was firm mid brown/orange sandy and silty clay with occasional gravel with the soil makeup remaining consistent to the termination of the borehole. The soil at 1.2m progressed from firm to very stiff to the base of the borehole at 4m. No roots were observed below 3m and water seen to be entering the borehole and standing at 3.7m. Soil samples showed peak soil suctions at 2m. Moisture contents dropped lowest at 3m. The clay was determined as having an intermediate plasticity at upper level becoming highly plastic at 2m. The roots retrieved were identified as *Platanus* (plane) and *Tilia* (lime) consistent with trees located in the rear garden. All drainage is shown to extend down the flank wall of the property.

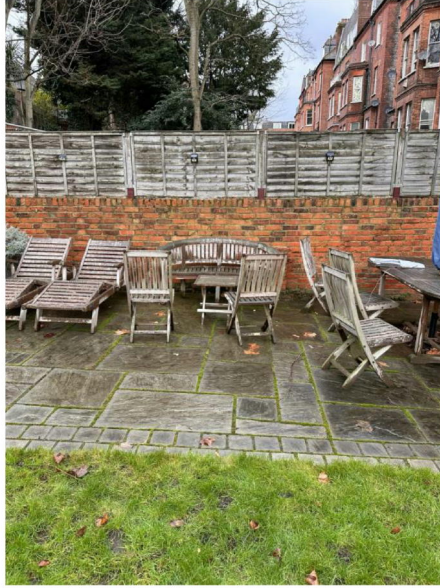
Walling and paving to be removed to facilitate works

- The left boundary fence will be taken down and c2m section of the boundary wall will be taken down to facilitate plant access. Due to the 0.5m drop in level ramped access will need to be constructed. A 6t long reach excavator will then be brought to site.

- A section of the patio and brick edging will be lifted and set aside for re-use. Where re-use is not possible then new near match slabs and edging will be sourced. The sub-base will then be broken out and the virgin soil exposed.

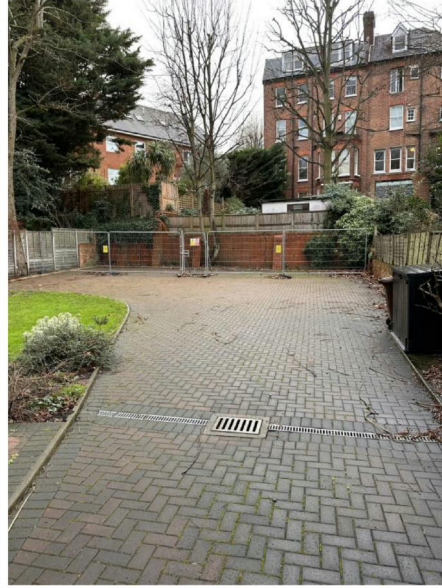
Rear car park to 36 Froggnal to be used for compound

- Set up site, including compound area to left side neighbours rear car park. This will be boarded, protected and secured with site fencing.
  - The barrier will be marked out on the ground and the area CAT scanned prior to mechanical excavation. Any detected services are to be hand excavated and exposed prior to machine excavation.
