Earthworks and Remediation Plan

Chilton Square

KXC-CS-001-R-RAM-XX-RP-00001

KING'S CROSS CHILTON SQUARE EARTHWORKS AND REMEDIATION PLAN

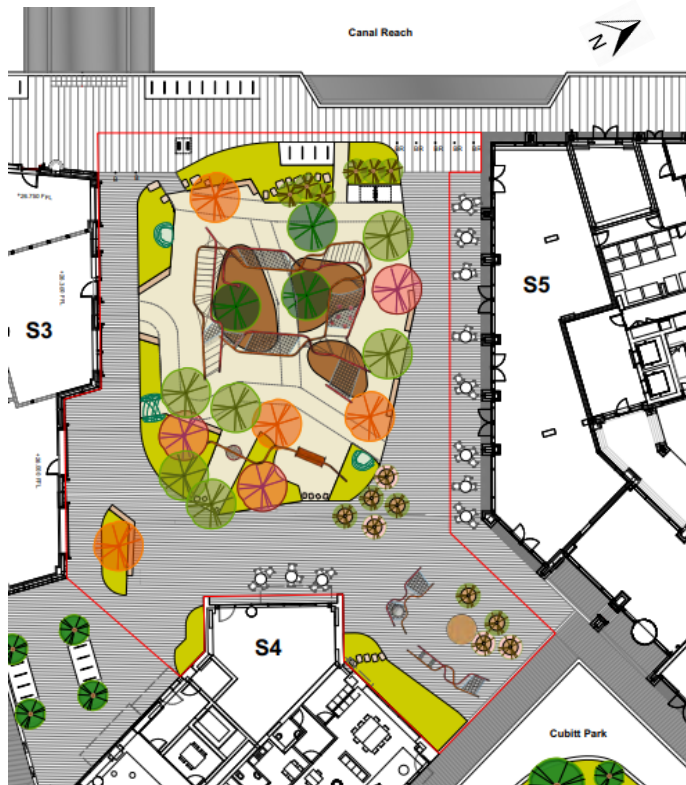
Figure 2.1: Chilton Square Redline Boundary. Source: Erect Architecture.

The site is located within the London Borough of Camden and constitutes part of the King's Cross Central (KXC) Development. The site has an approximate National Grid Reference 530098, 183890, and is circa 0.12 hectares in size. The red line boundary for Chilton Square is shown in Figure 2.1 below and site location plan is provided in Appendix 1.

The site is irregular in shape and is bound by Canal Reach road to the north; Plot S5 to the east; Lewis Cubitt Park to the south-east; Plot S4 to the south; and Plot S3 to the west.

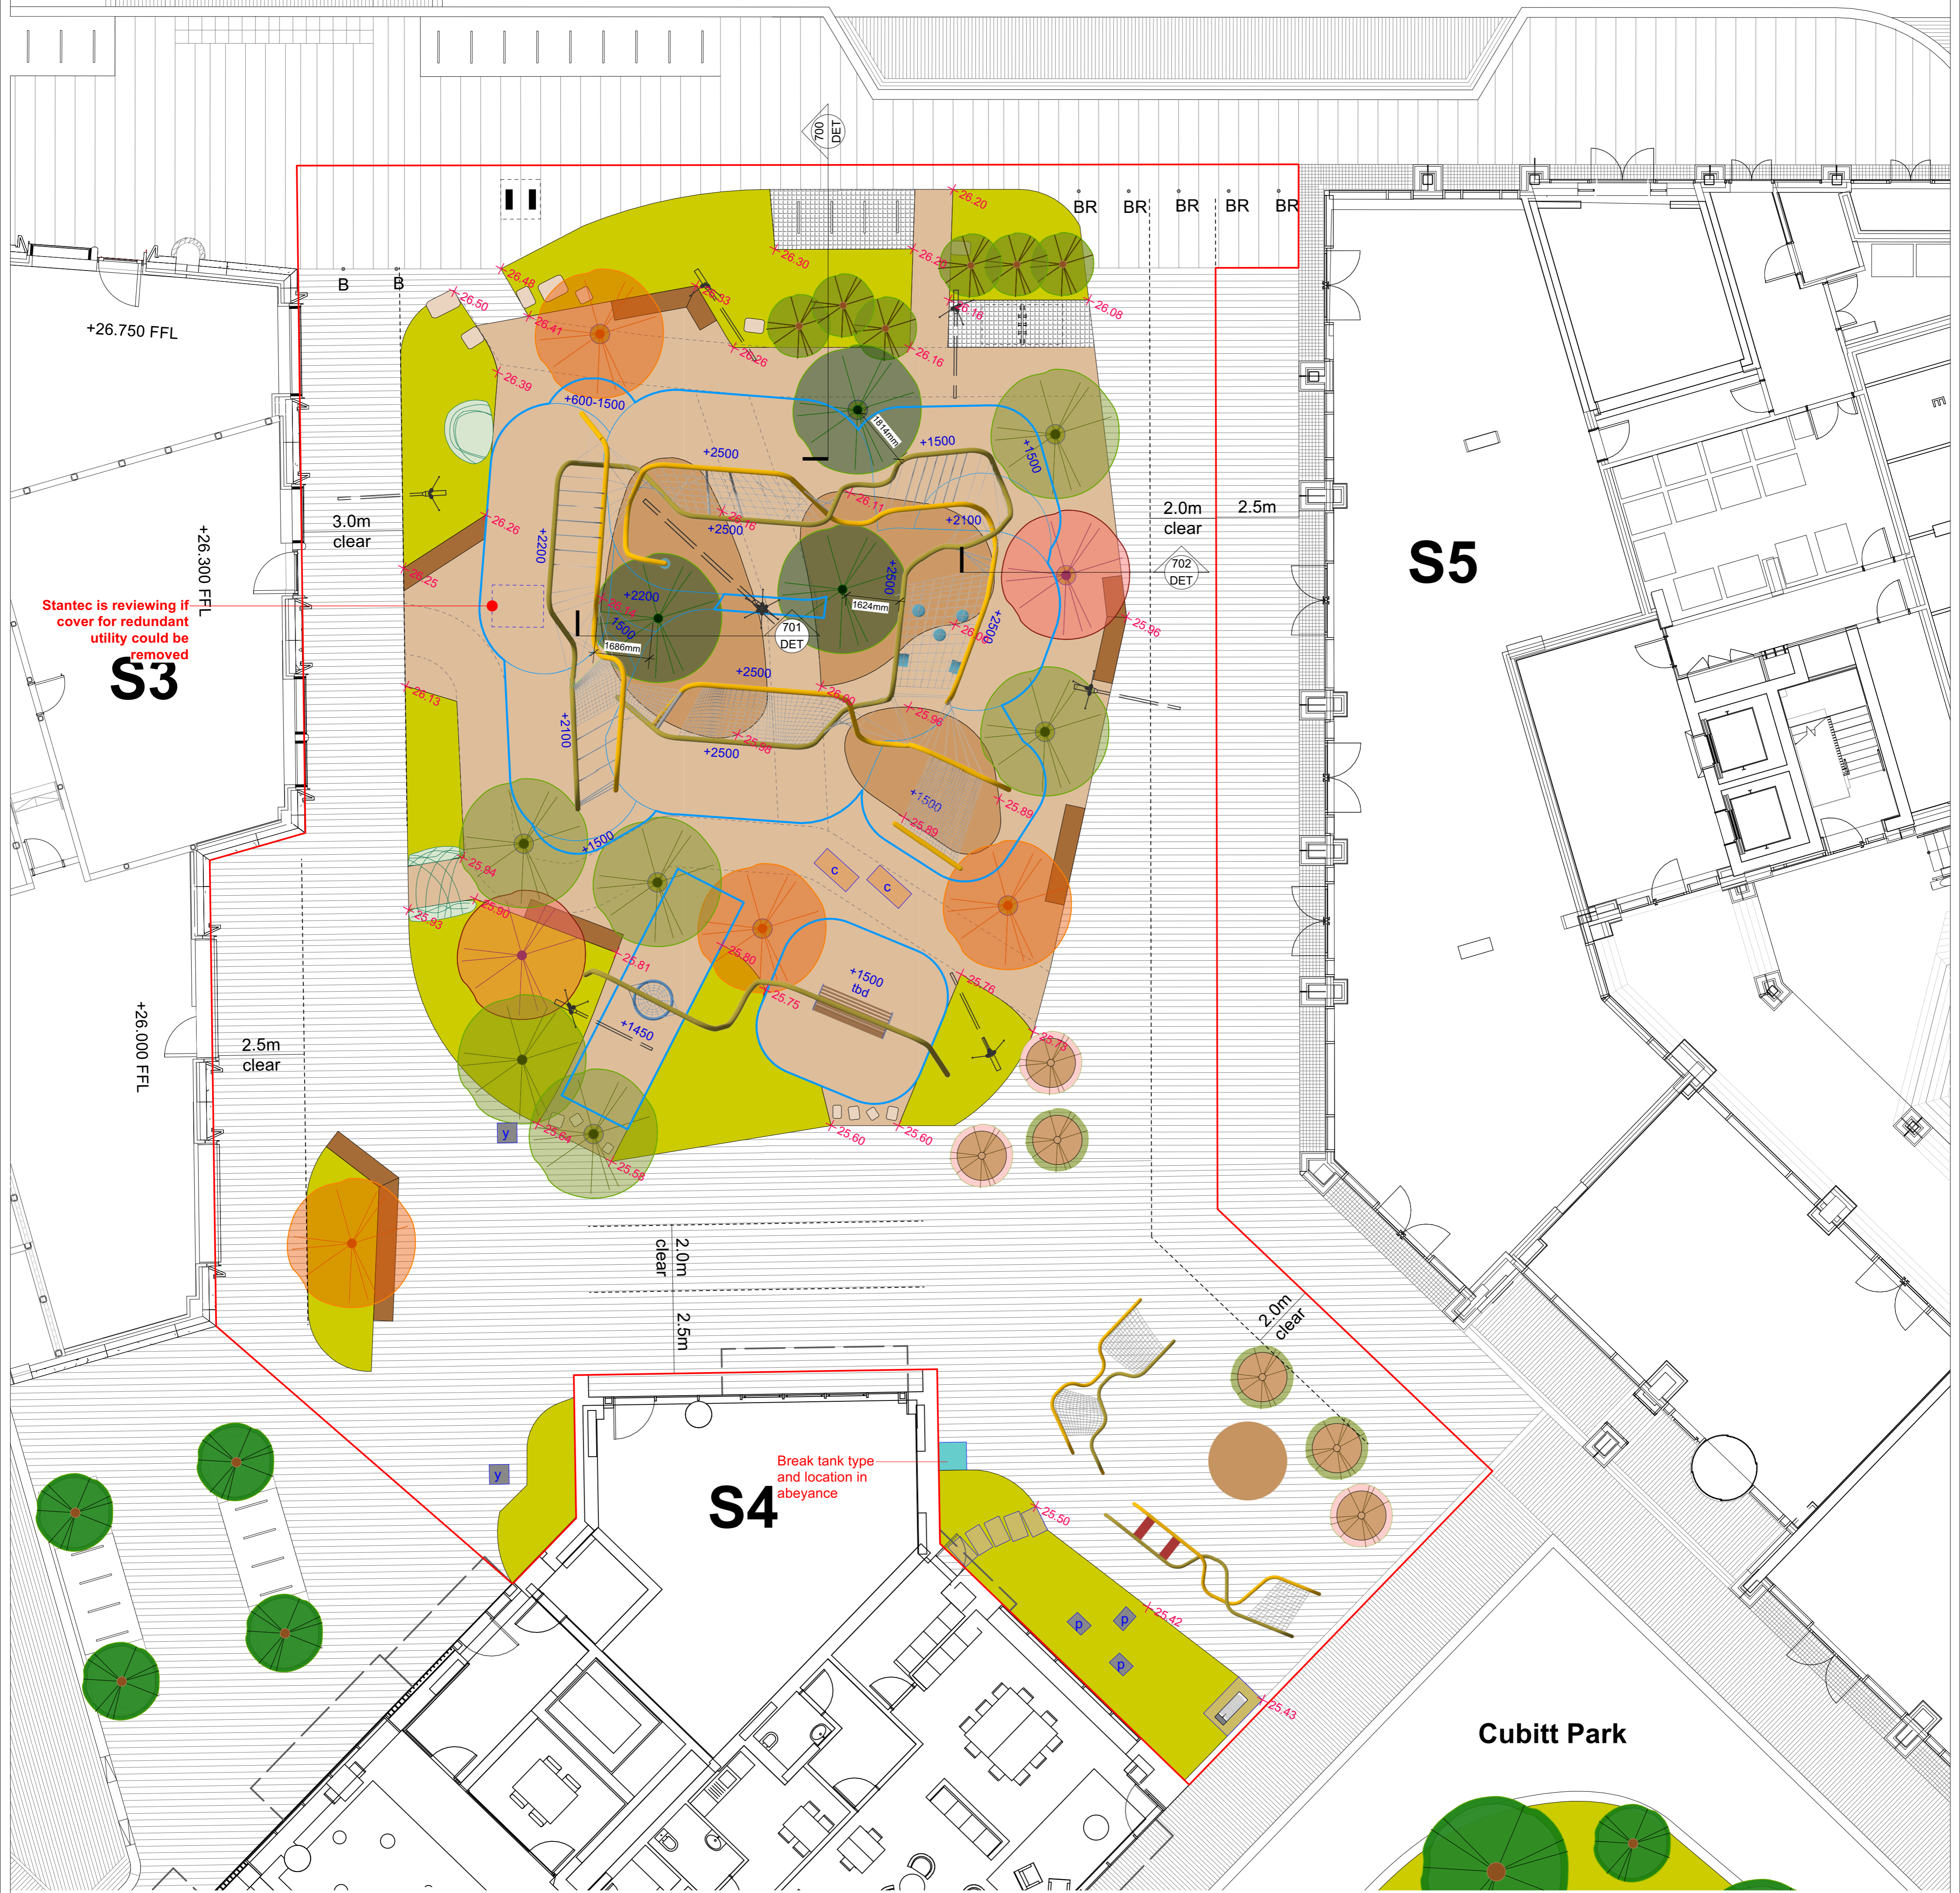
Loose Play Safety Surface "Hardwood Chips"
Depth: 250mm
Bottom layer to be: Eco Grid
Subbase if required to be: inert (to maintain PH balance in treepits) & fine free (required for Corkeen warranty);
Hardwood Chips area overlaps proposed tree pit area. Tree pit soil specification together with subbase to be reviewed and developed with soil specialist and civil engineer in Stage 4

- Refer to drawing 332410744-900-700-02 for maximum permissible extent of vertical root barriers relative to below ground services, play feature foundations and Thames Water guidance.
