Cameron Mackintosh Limited Offices Nos.1-2 Bedford Square

Minor Alterations - Project 1 - Second Floor Link

Second Floor - Archive Photographs (1981)

Title	Photographs
Drawing No.	DMT/Nos.1-2/JM/SK/200/02
Date	20230510
Scale	NTS @ A3

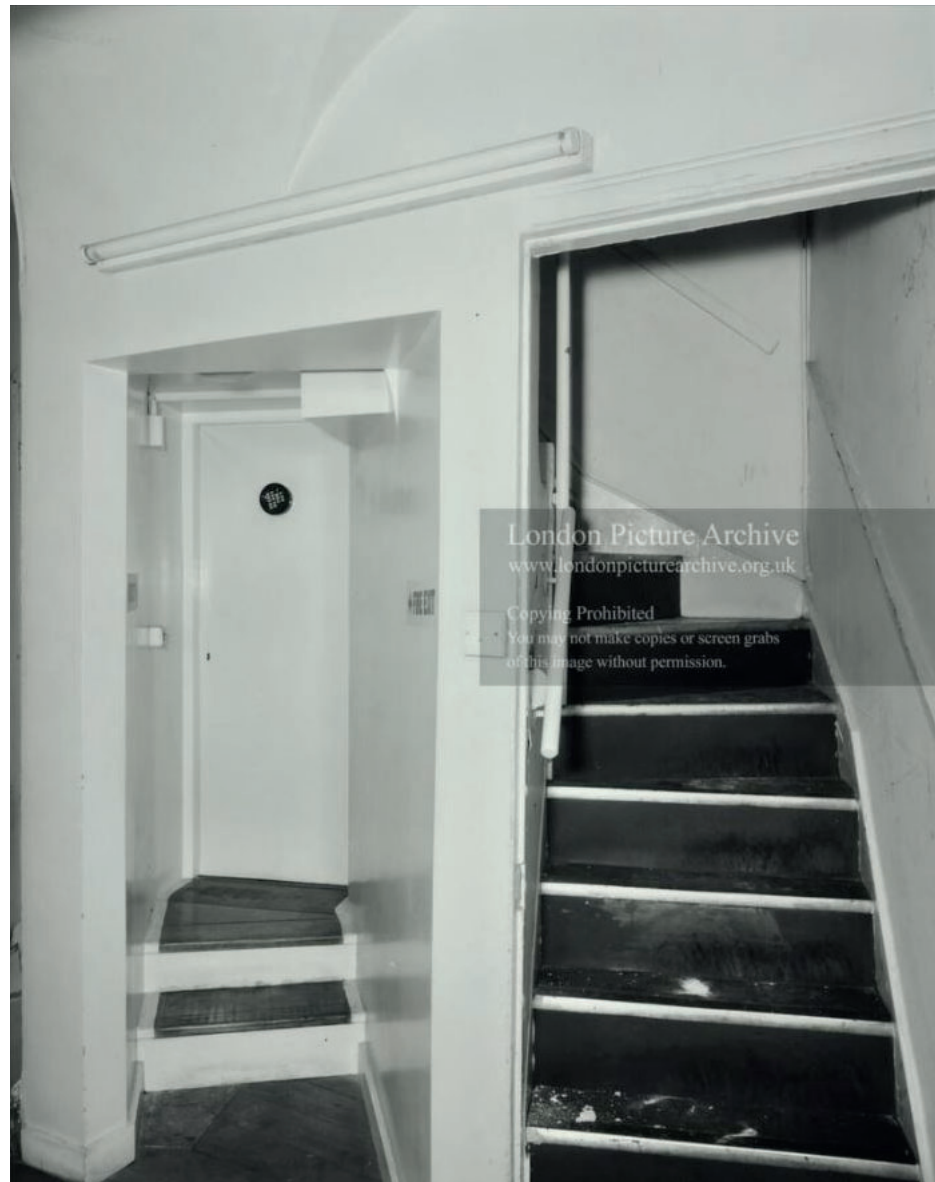
Previous link

- 1981 Photograph.
- Stair up to third floor/attic on the right (unchanged)
- Narrow link (fire escape) from No.2 where current kitchenette is located.

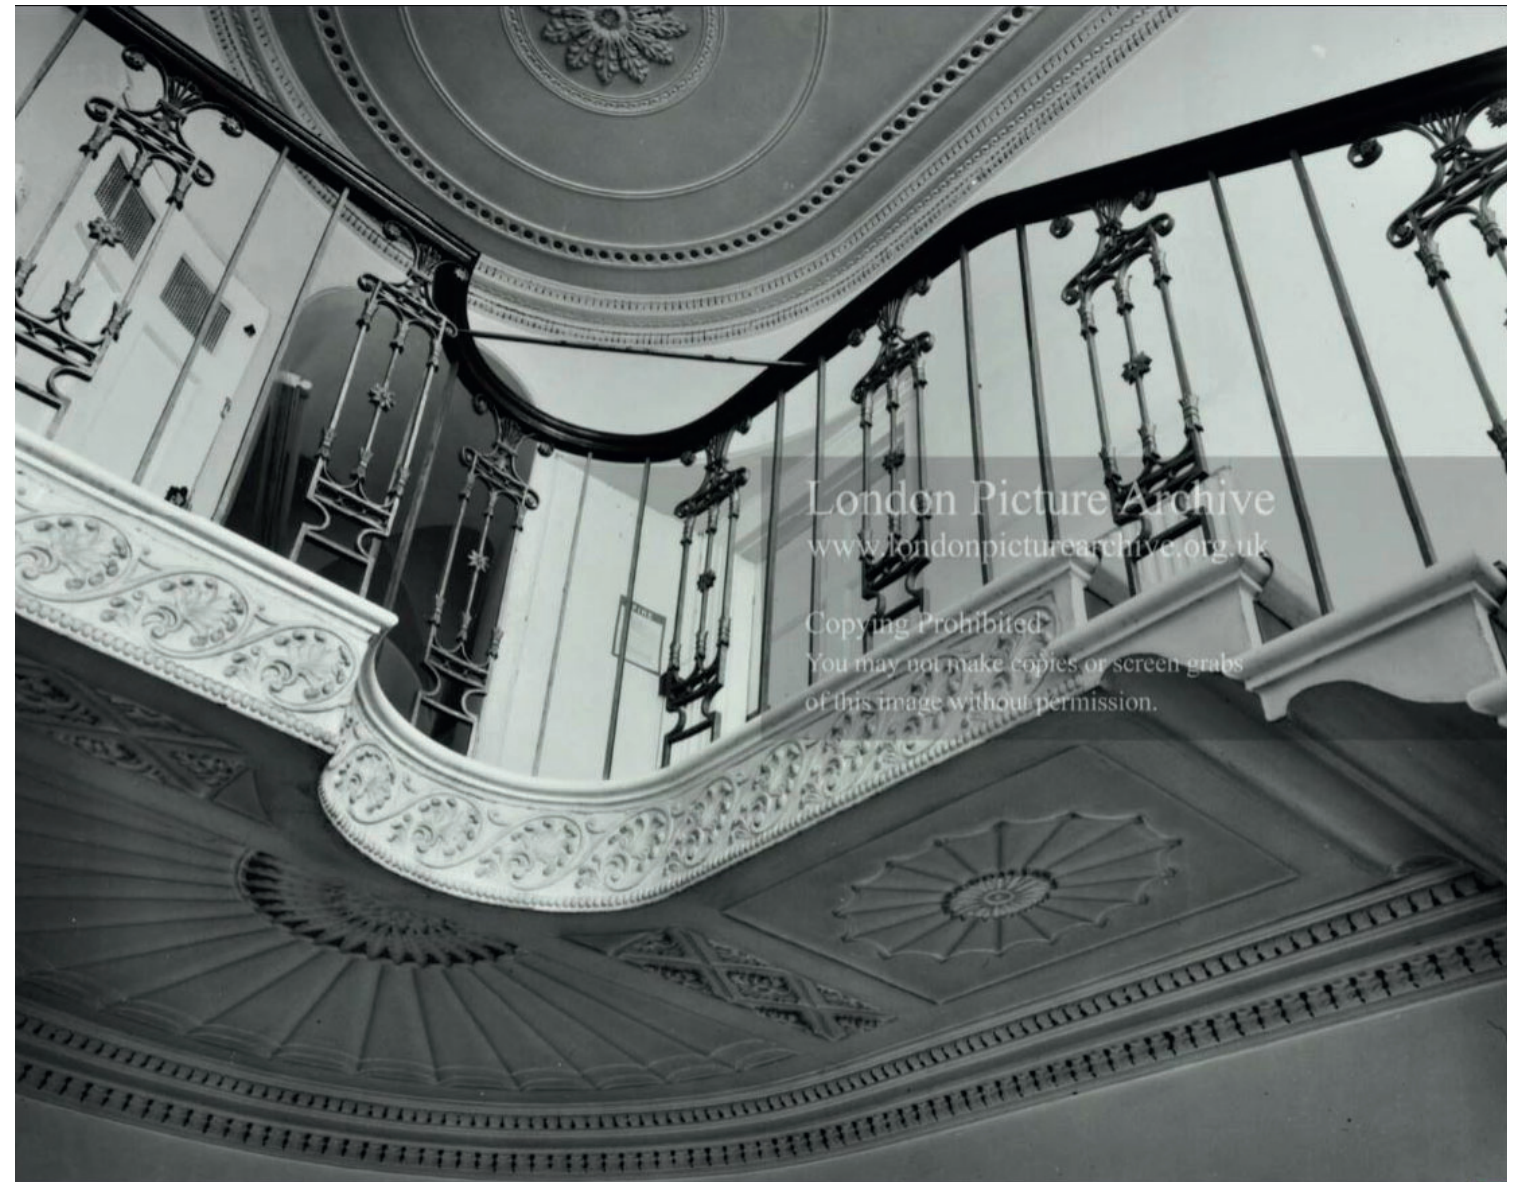
Main staircase looking up

- 1981 Photograph.
- Note, no fanlight/door within the arch at the top of the stair - four part vaulted ceiling can be seen in the open ante-space beyond.
- (Current door and fanlight added at a later date).
